Inspection Photos
Operator: Catamount
API: 067-08217
Date: 5/10/2021

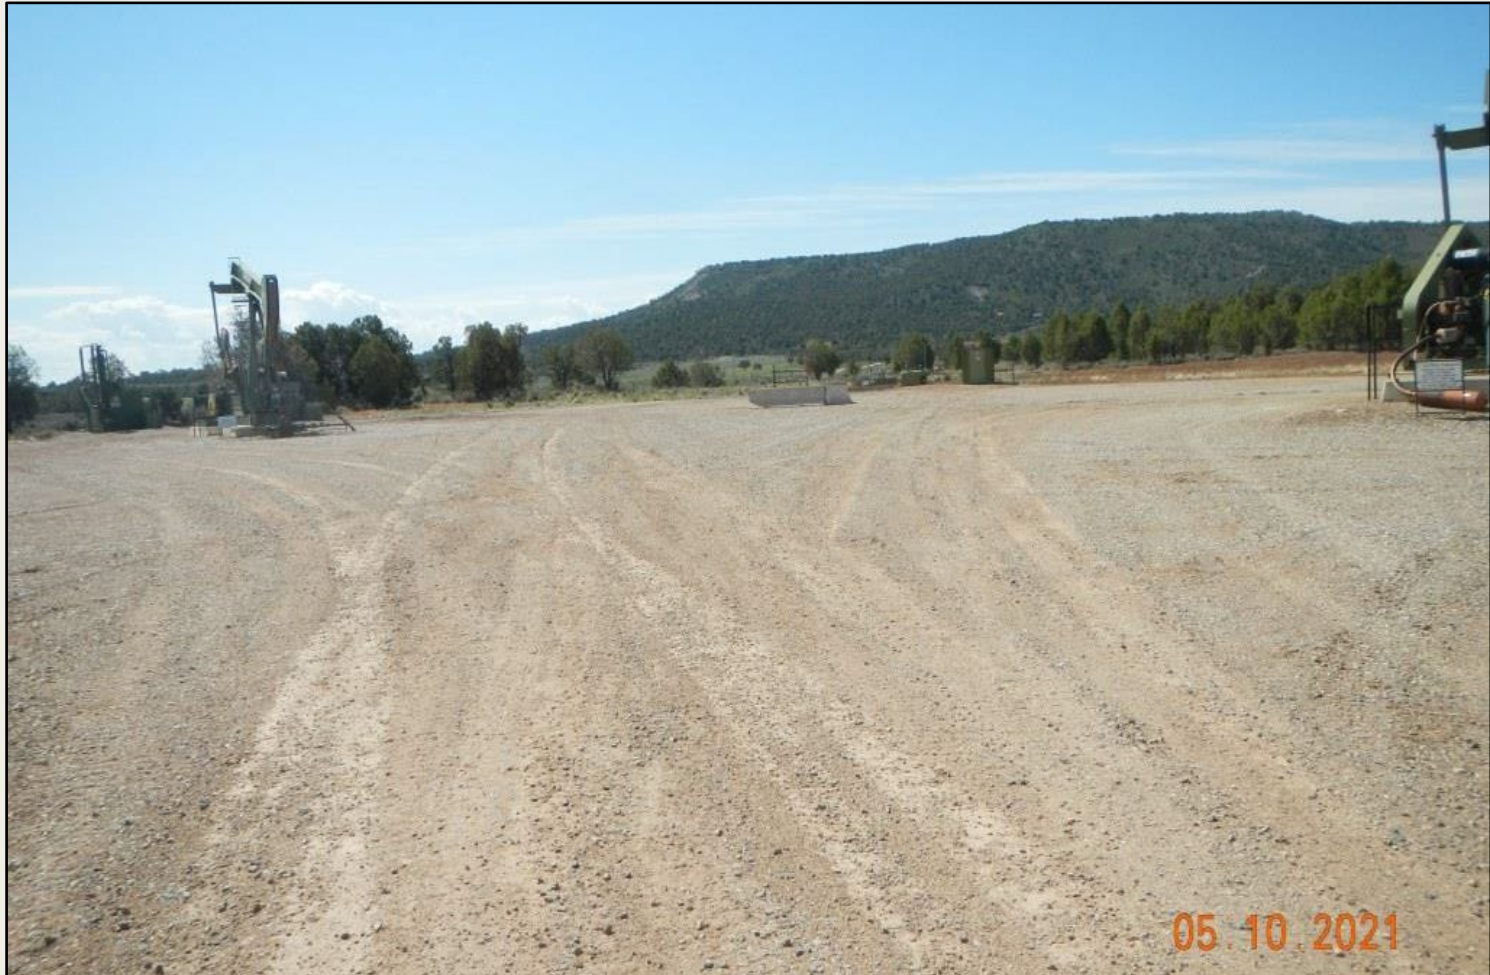
Photo 1. View of the project area from the well pad entrance facing center.

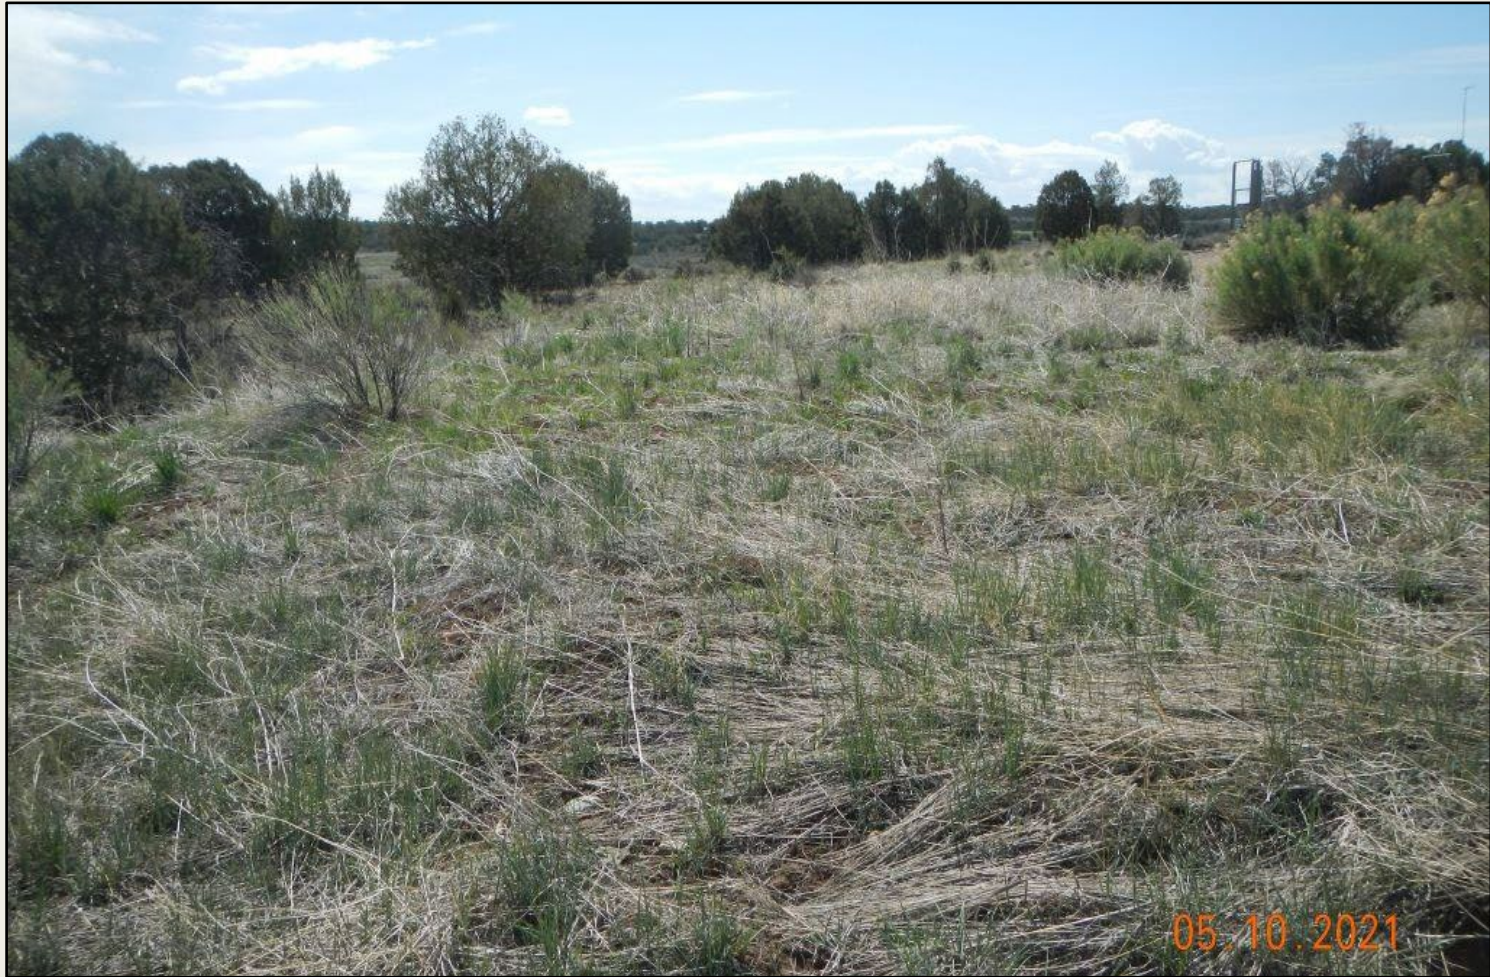
Photo 2. View of the northern project area from the northwestern corner facing eastward. Revegetation is becoming established within the interim reclamation areas with western wheatgrass, crested wheatgrass, and sand dropseed.

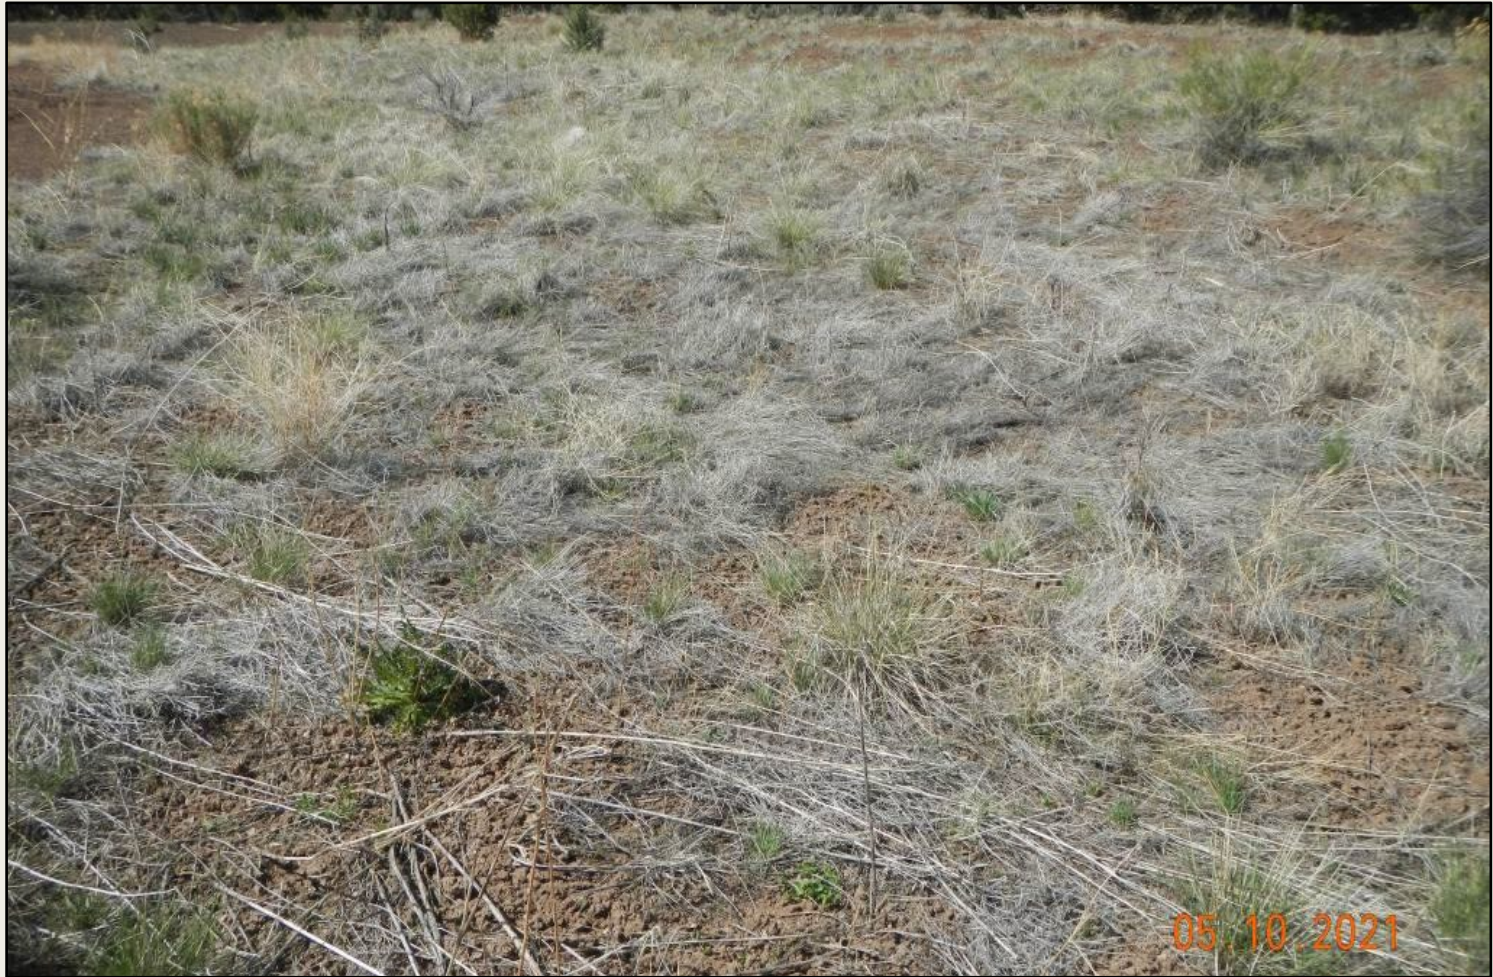
Photo 3. View of the western project area from the northwestern corner facing southward.

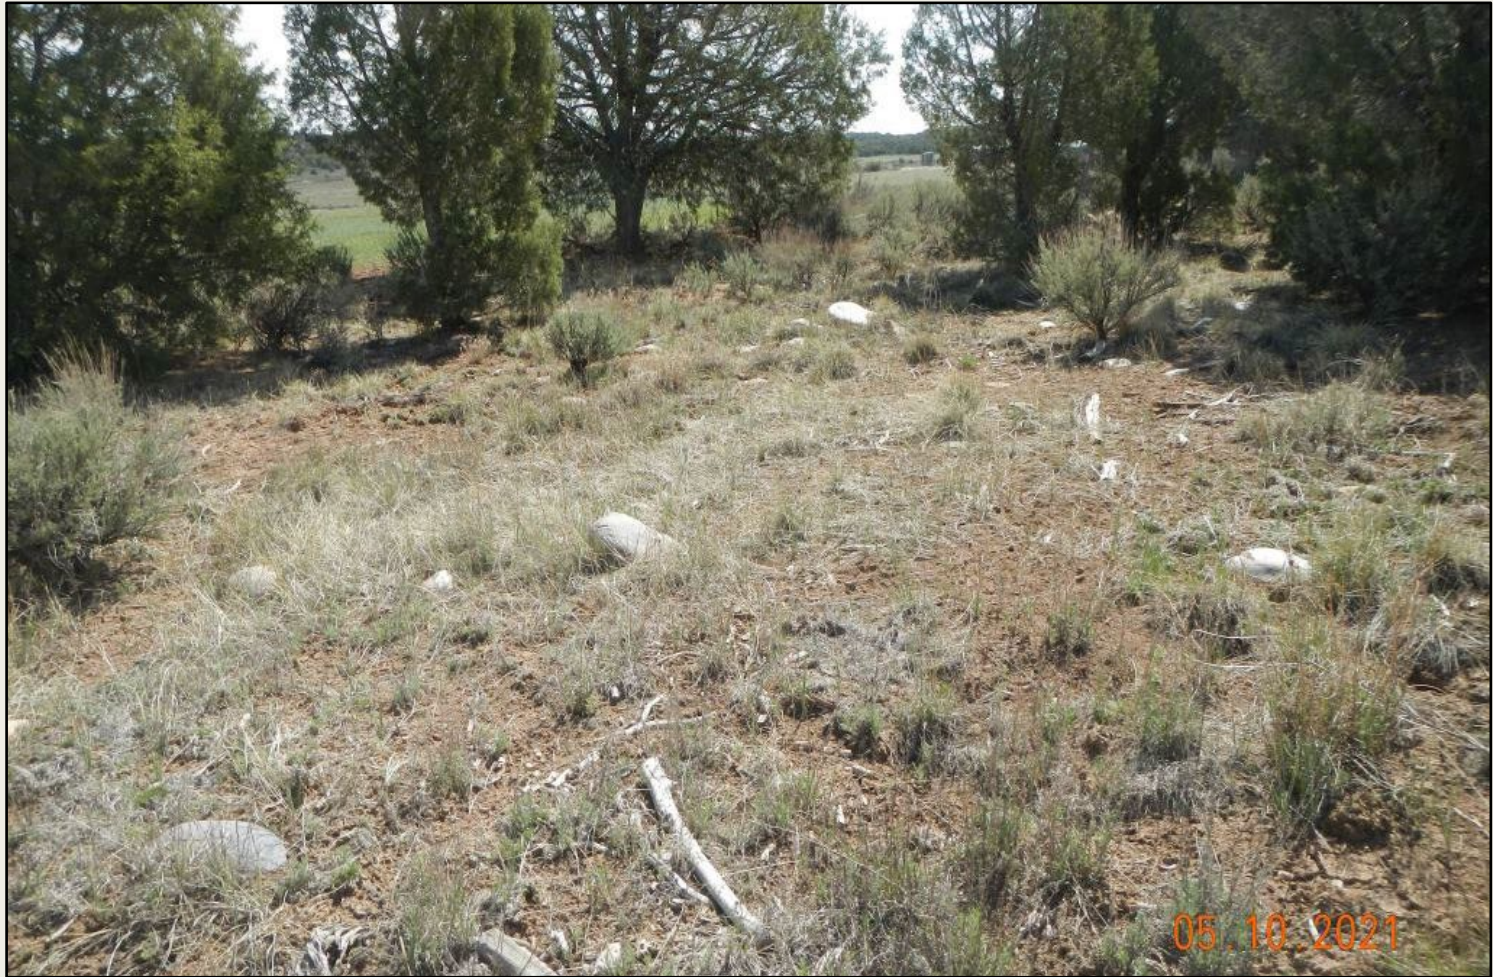
Photo 4. View of the reference area comprised of pinyon and juniper woodland with understory of black sagebrush, squirreltail, western wheatgrass, and forbs such as penstemon, and phlox.
