Inspection Photos
Operator: Catamount
API: 067-05410
Date: 5/10/2021

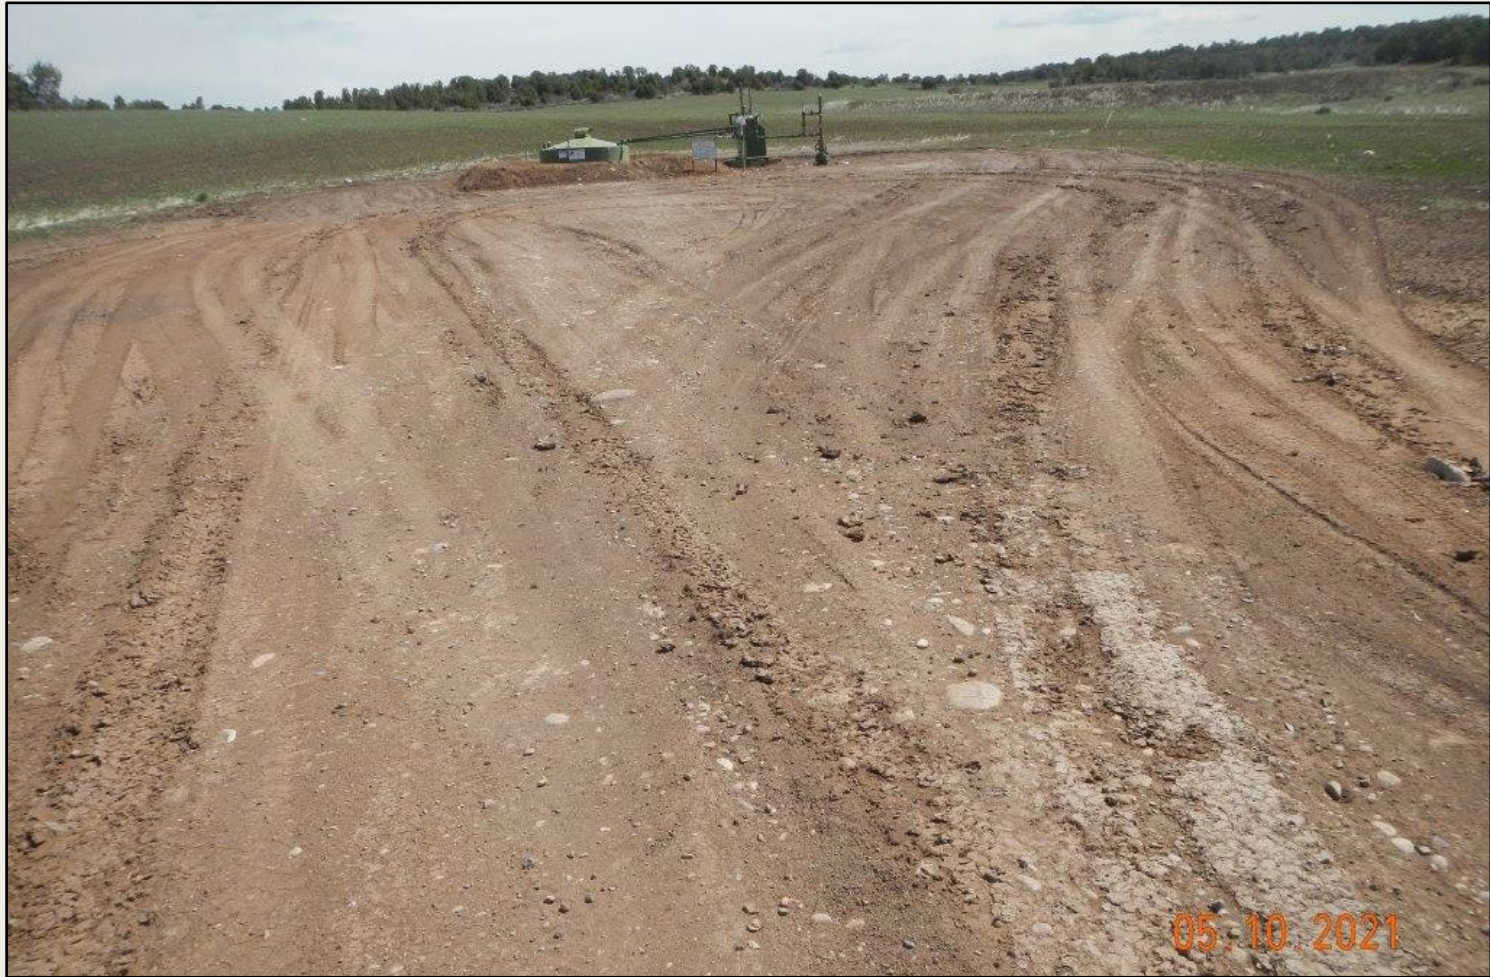
Photo 1. View of the project area from the well pad entrance facing center.

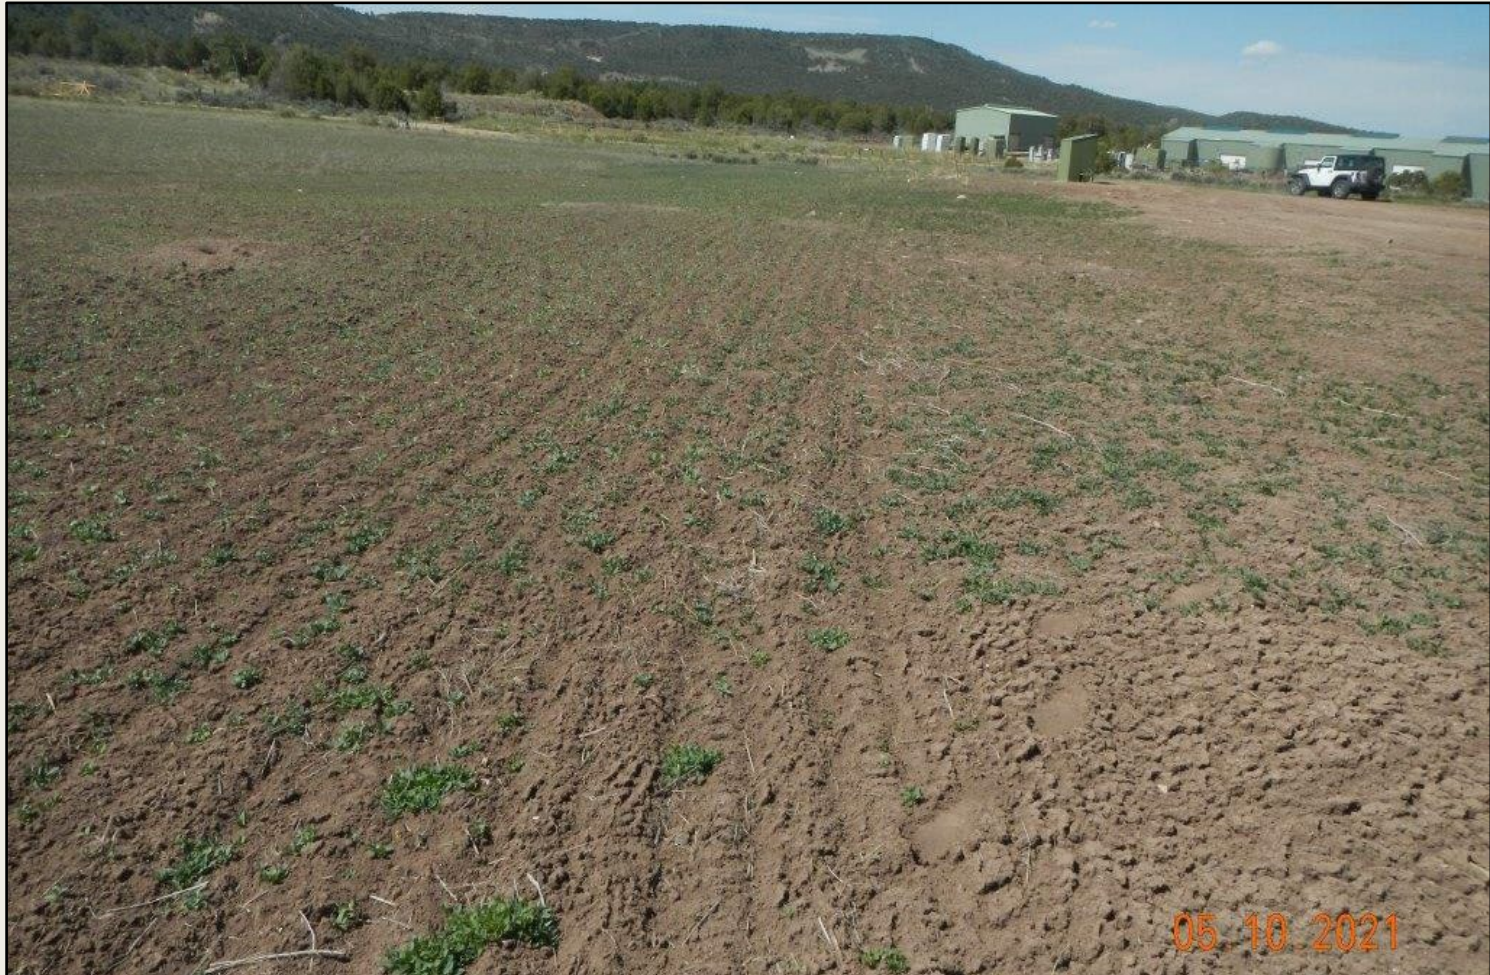
Photo 2. View of the southern project area from the southeastern corner facing westward. Interim reclamation areas are comprised of cultivated field with young crop vegetation present at this time.

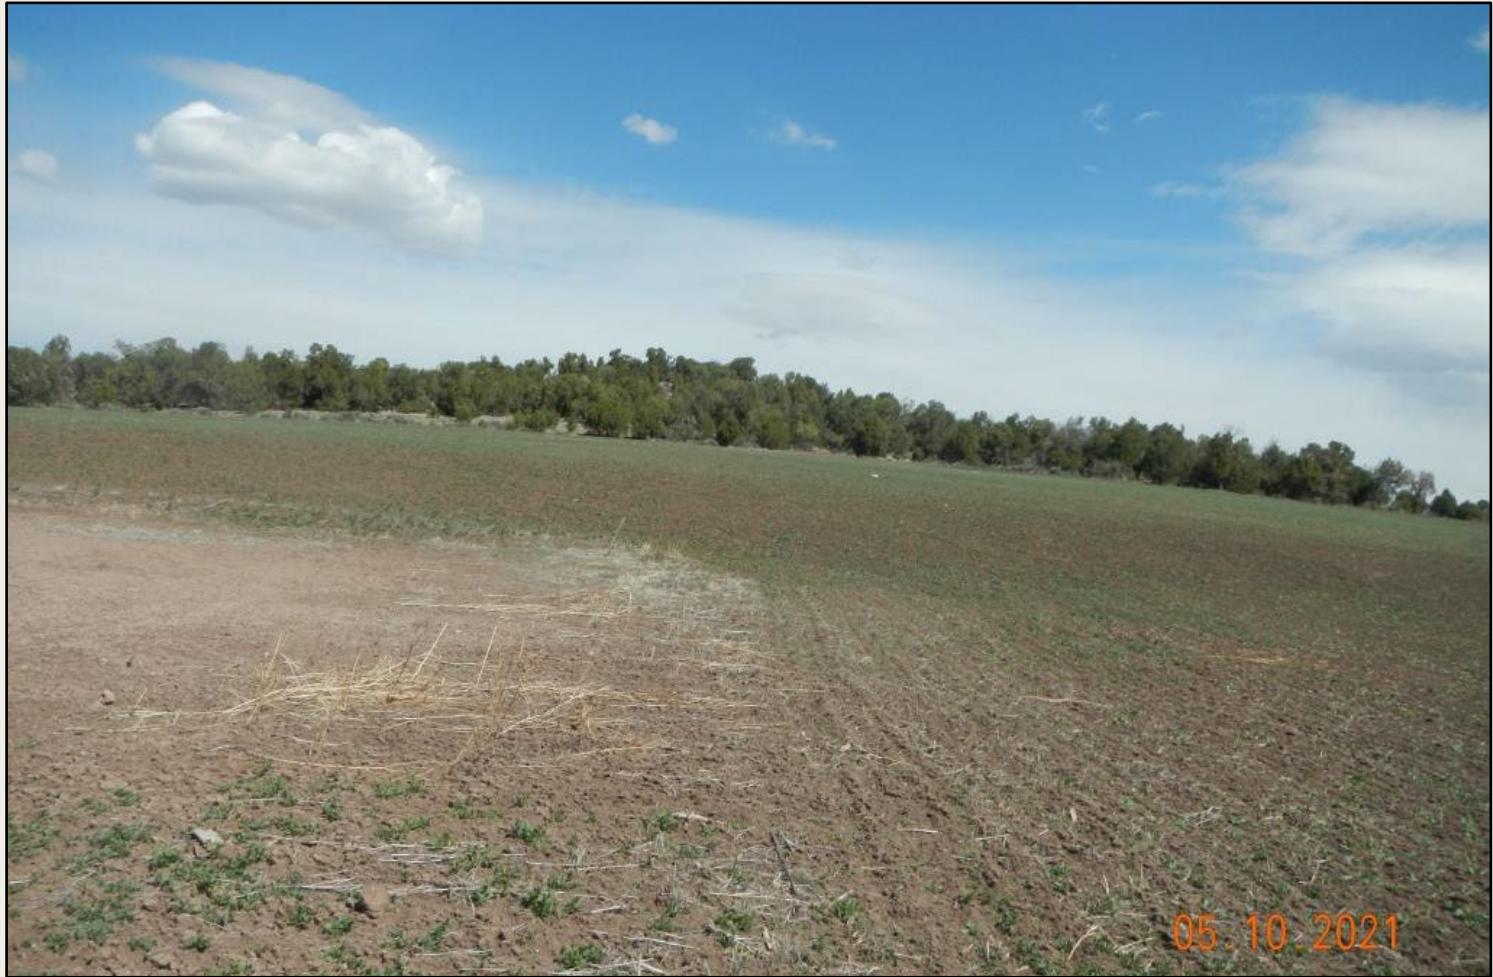
Photo 3. View of the eastern project area from the southeastern corner facing northward.

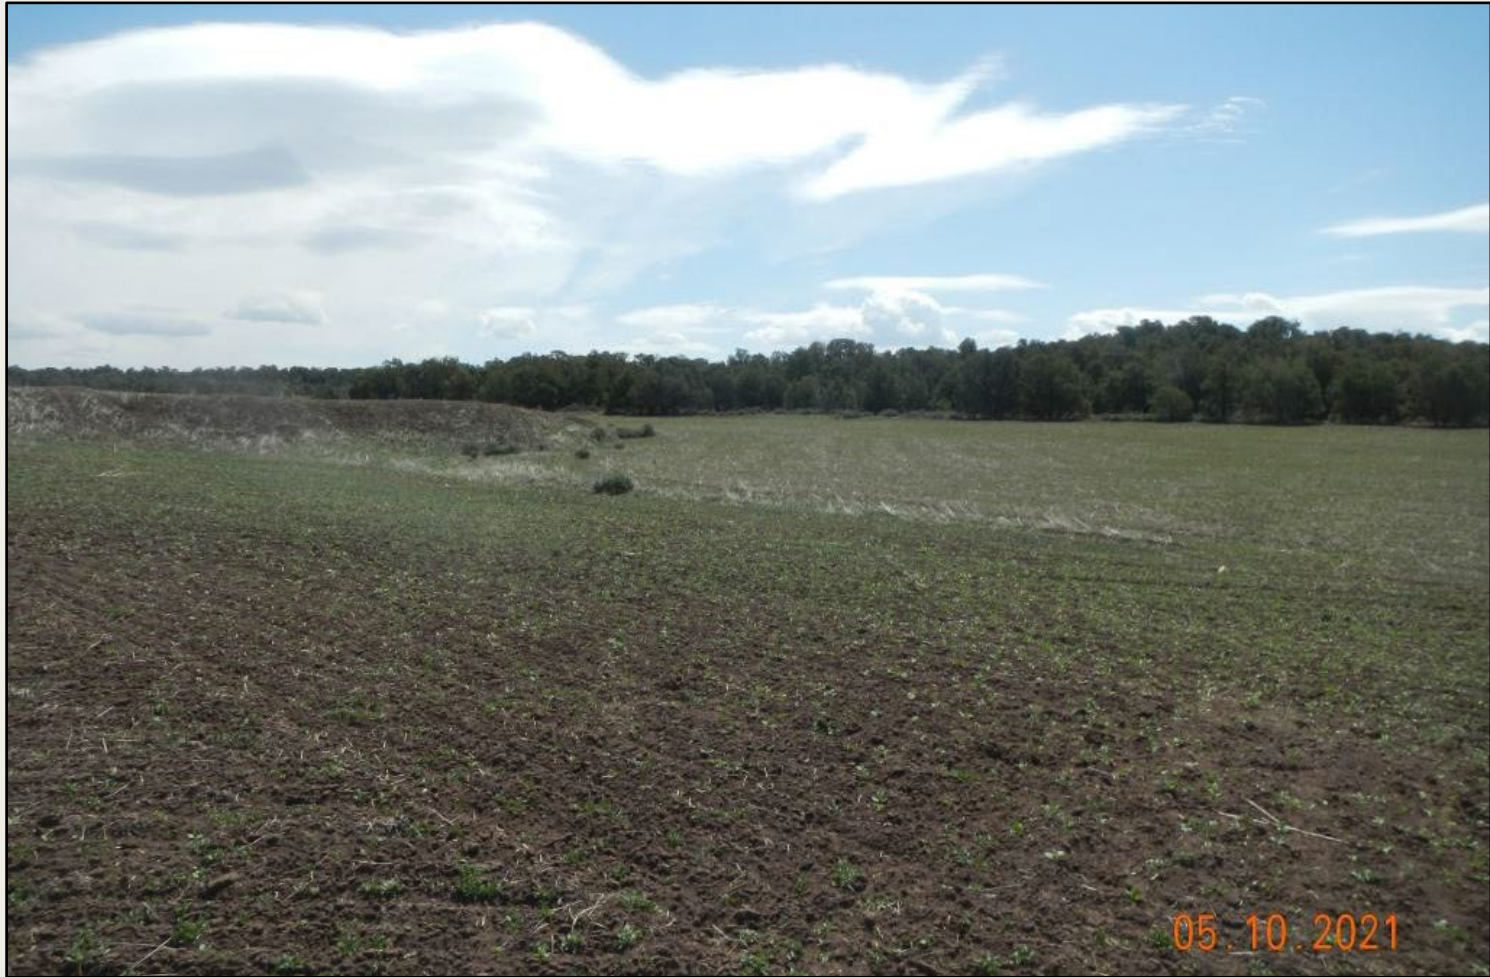
Photo 4. View of the reference area comprised of cultivated field. Crop species and condition compared to the interim reclamation areas are no apparent at this time due to early vegetative condition.
