# Inspection Photos

API: 061-06376

Operator: BERRY ENERGY INC

Inspection Date: 5/12/2021

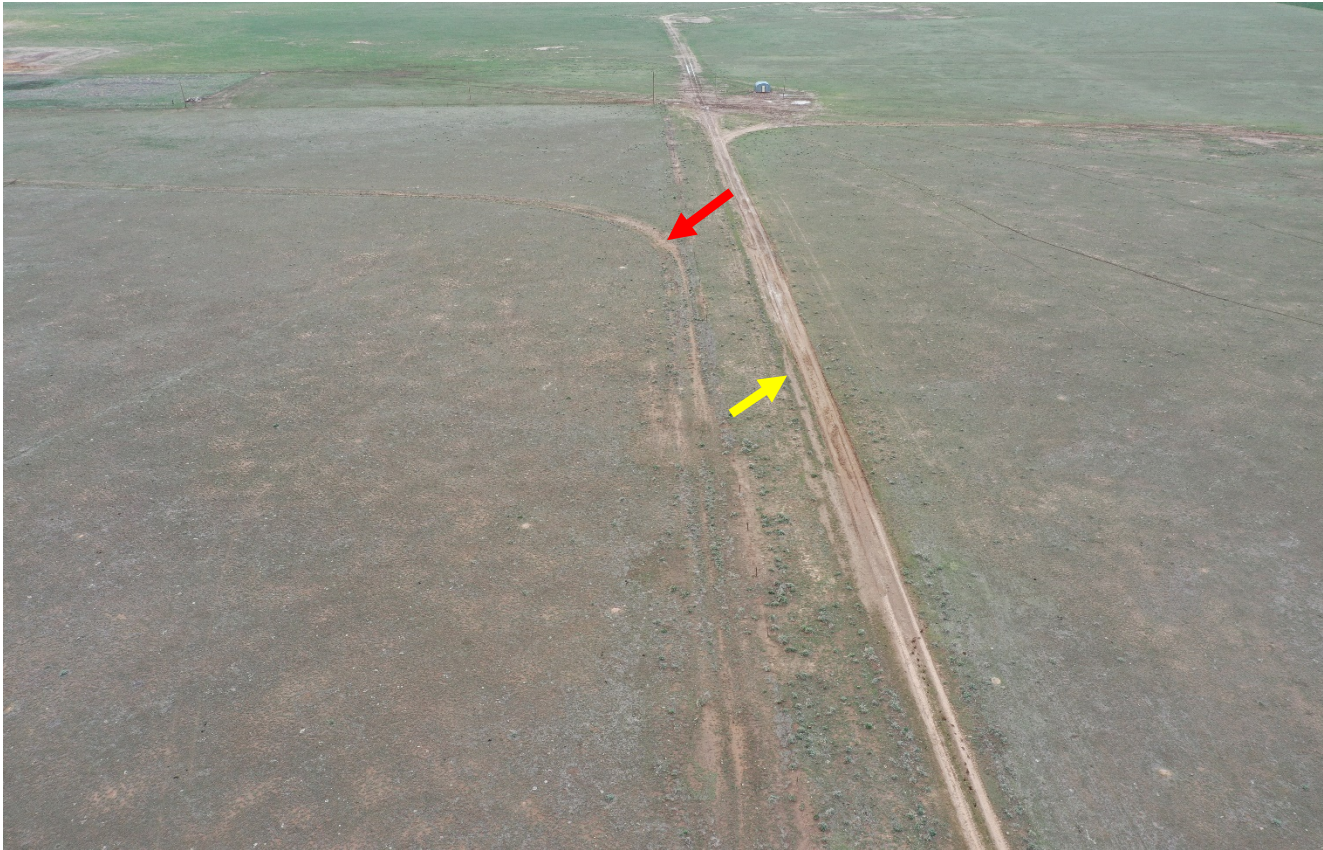
**Photo 1.** Drone aerial photo facing east toward the access road. The access road has not been reclaimed. Arrow points to where the road turns north toward the location. The other road at yellow arrow is a separate road which access an active well site.

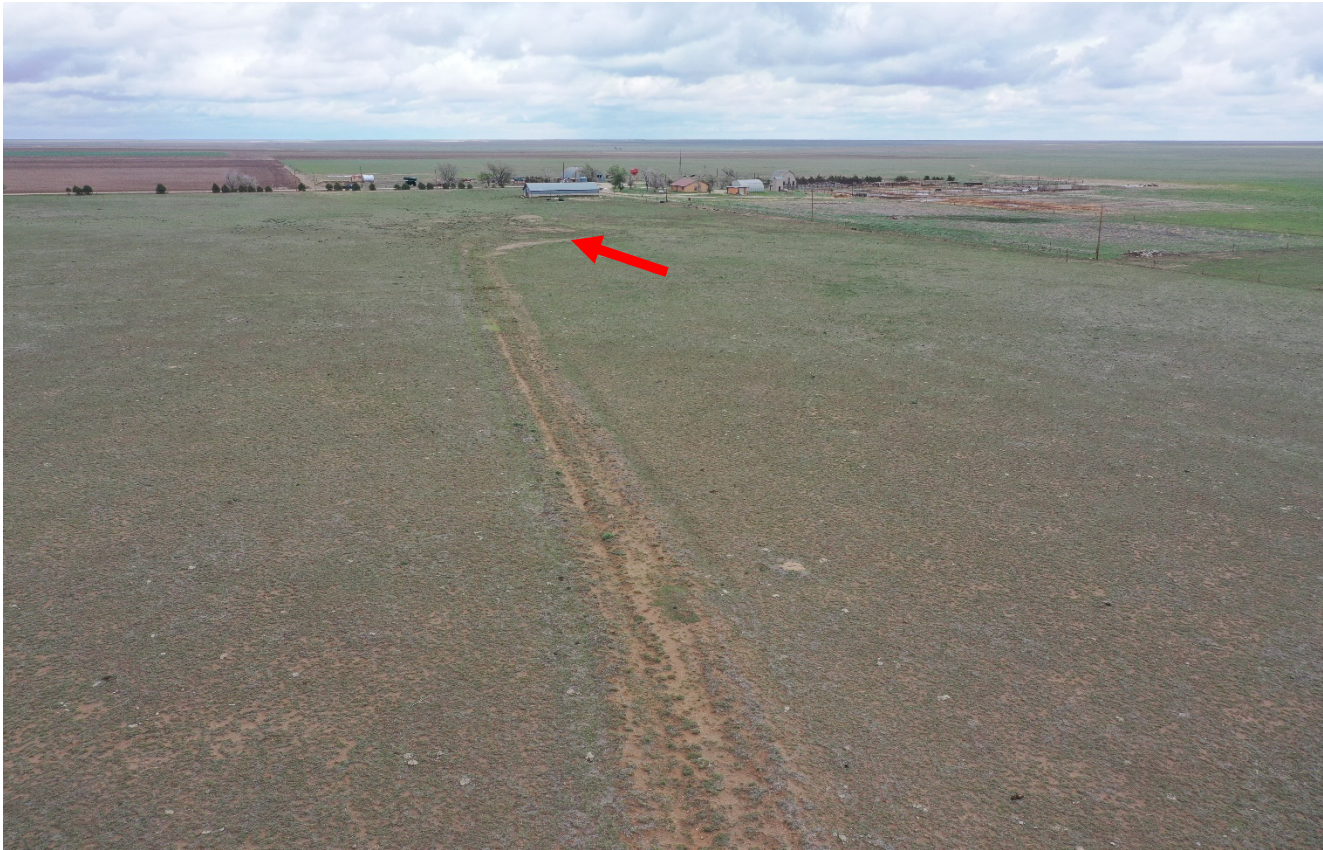
**Photo 2.** Facing northeast along the access road which dead ends at the location shown at red arrow.

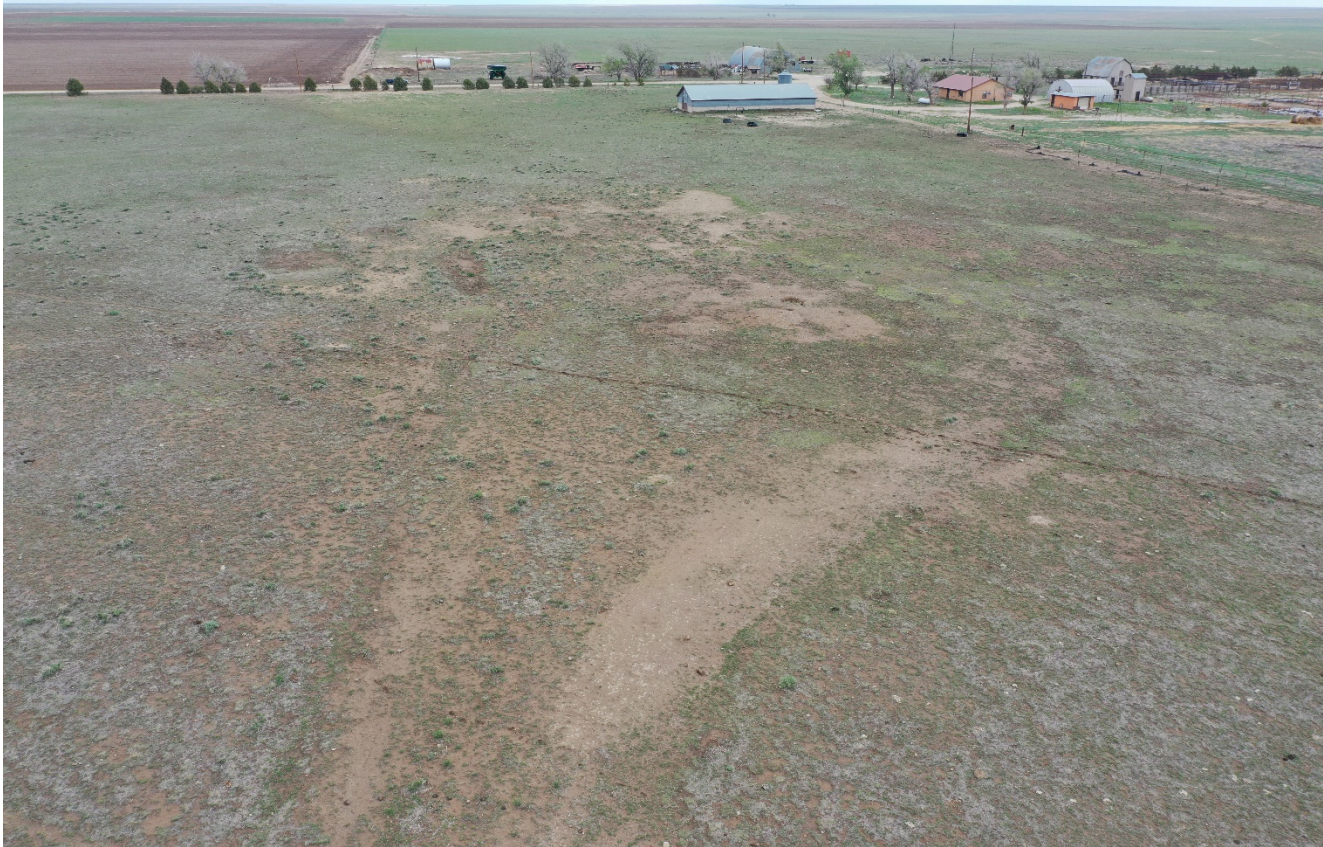
**Photo 3.** Facing north toward the location which has not been reclaimed. Previous corrective action was not performed.

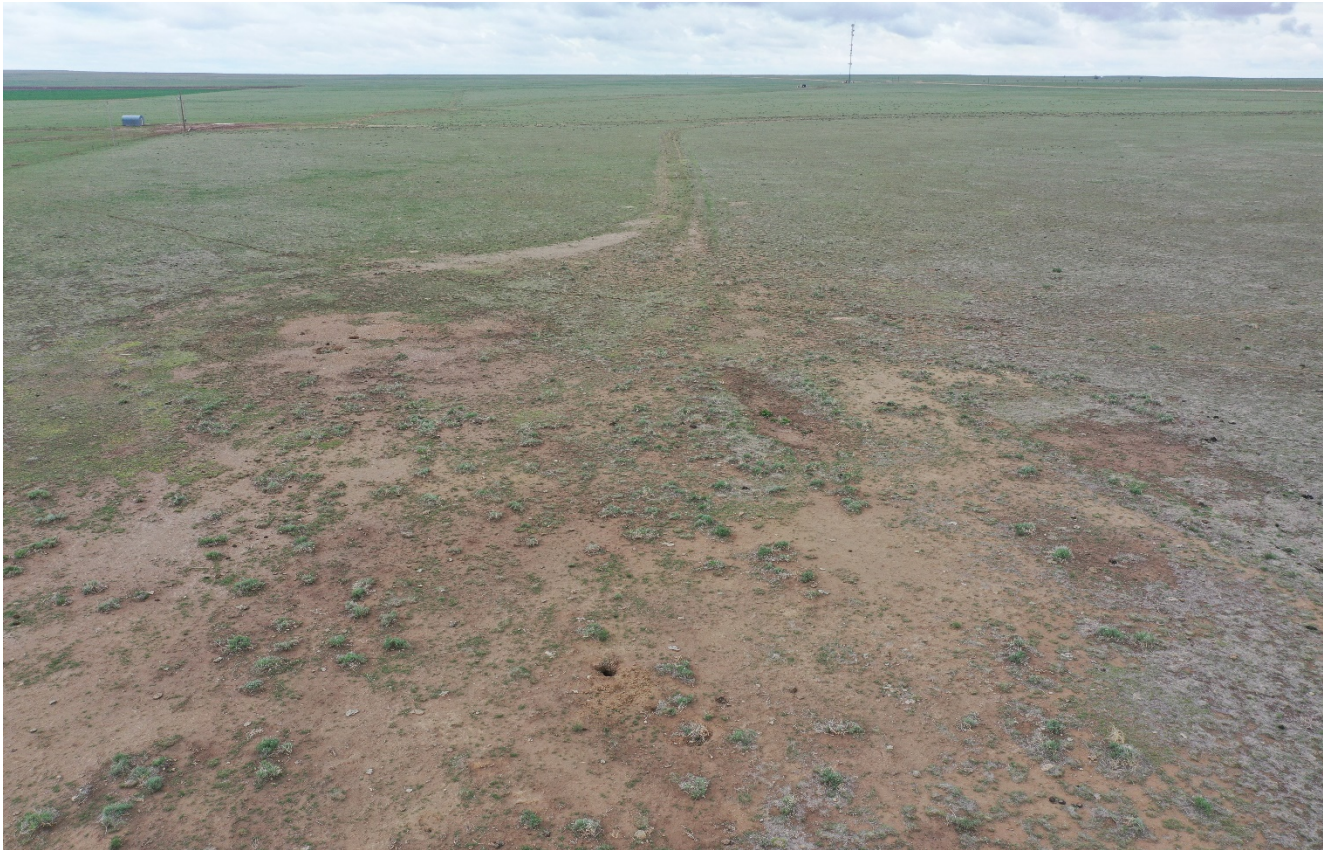
**Photo 4.** Facing south toward the location. The location remains mostly devoid of vegetation growth.

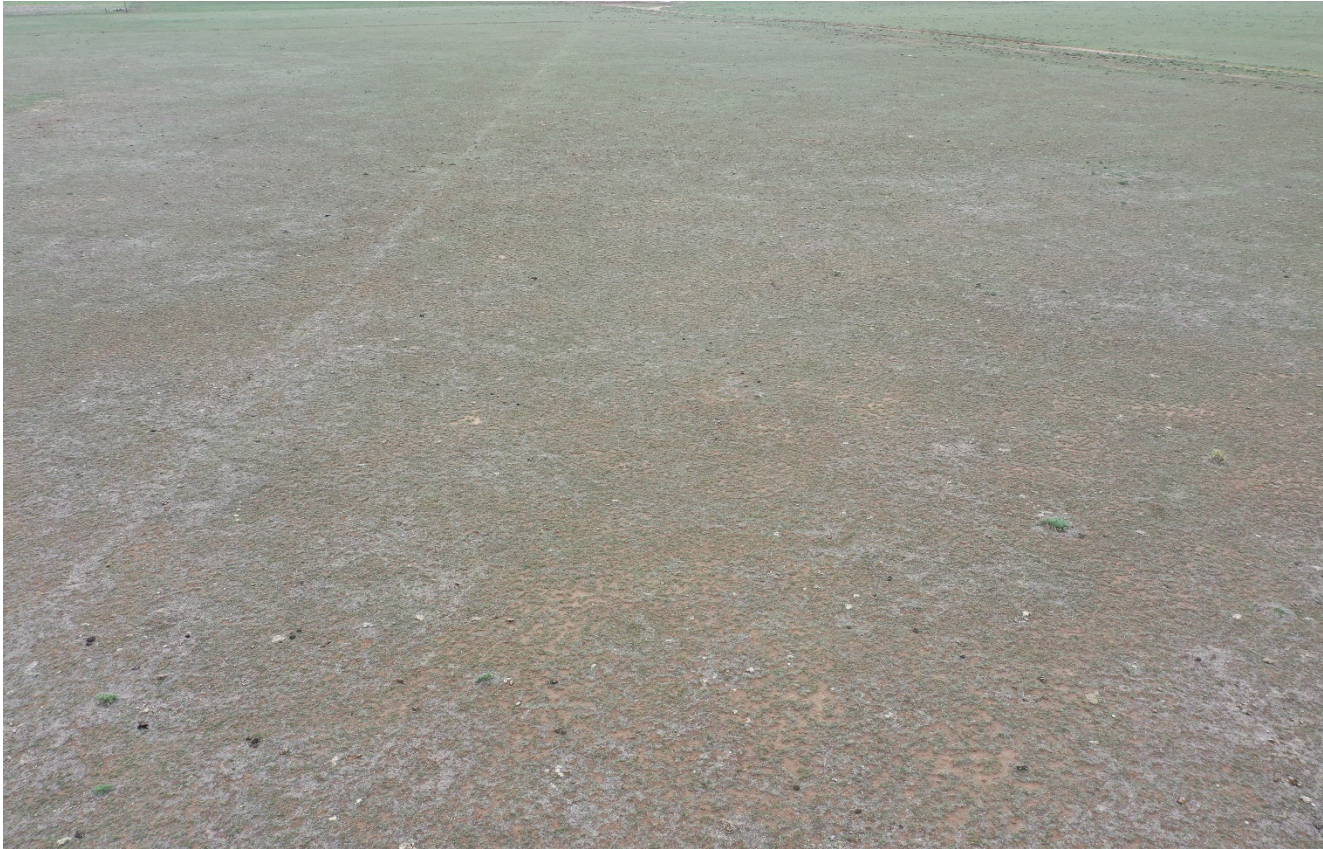
**Photo 5.** Facing southeast toward the surrounding undisturbed pasture which shows a uniform vegetation cover.
