Inspection Photos

API: 061-06397

Operator: BERRY ENERGY INC

Inspection Date: 5/12/2021

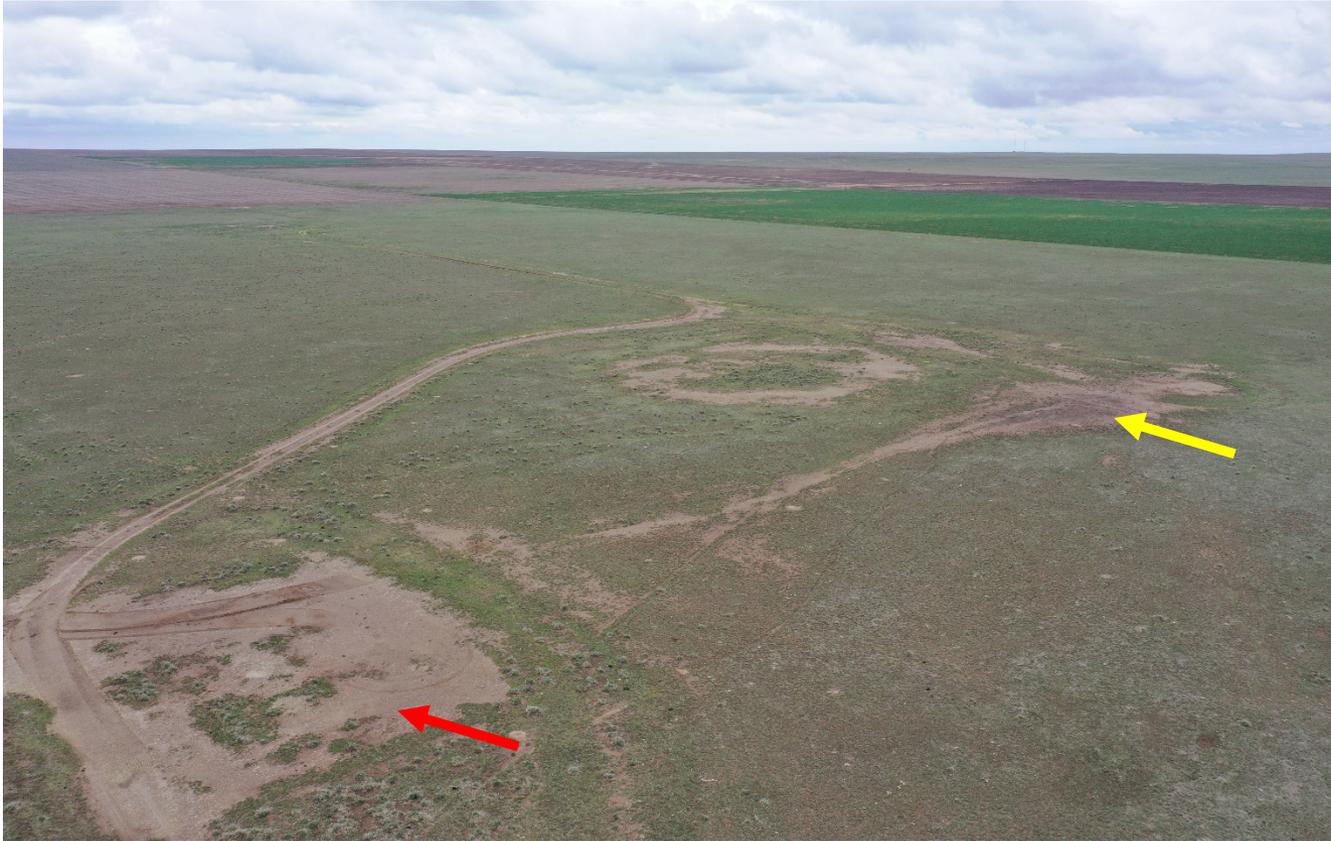
Photo 1. Drone aerial photo facing southwest toward the location. Red arrow points to tank battery site. Yellow arrow points to the well site. The vegetation has not re-established in the disturbance area. Reclamation has not been completed.

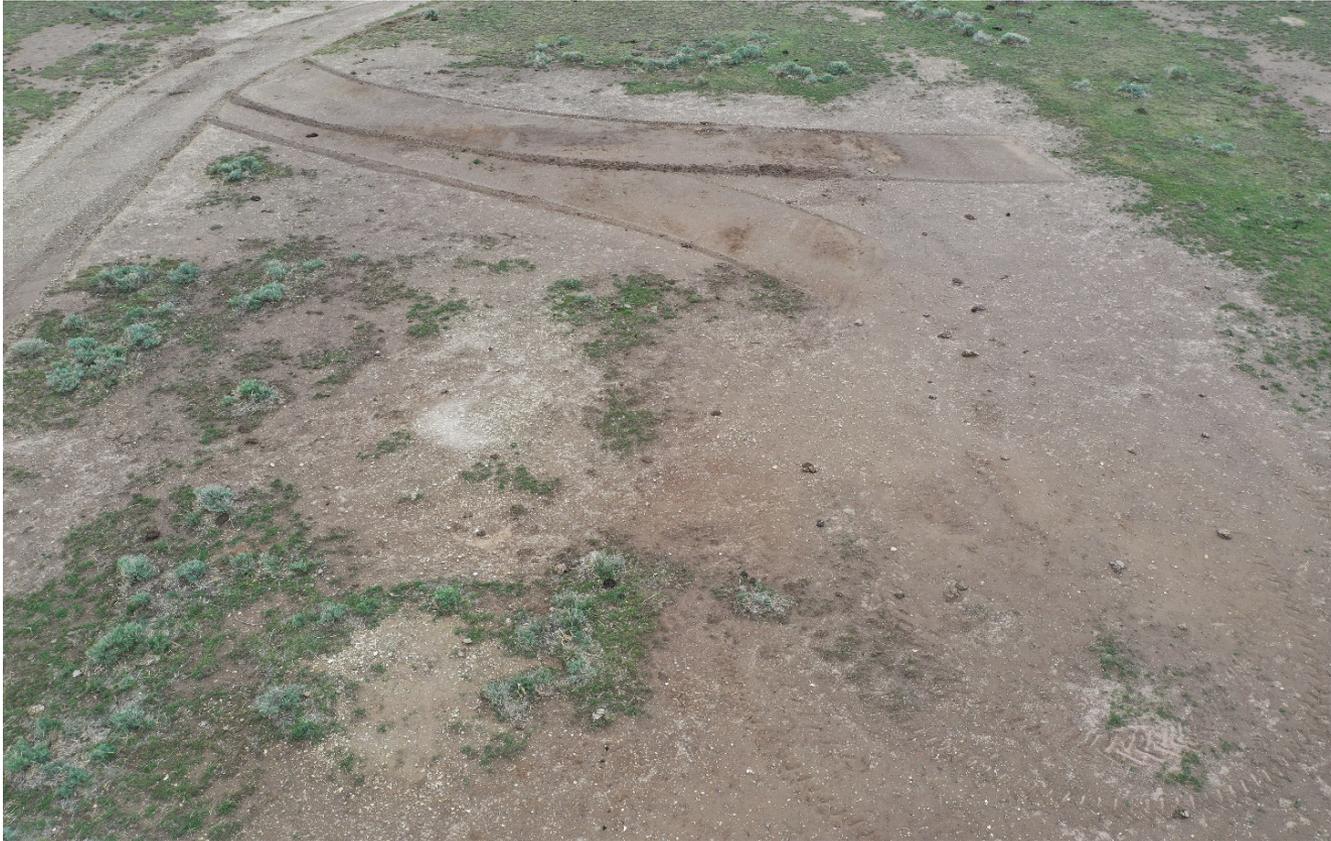
Photo 2. Close up view of the former battery site. This area remains mostly devoid of vegetation growth. There is no indication that reclamation was performed.

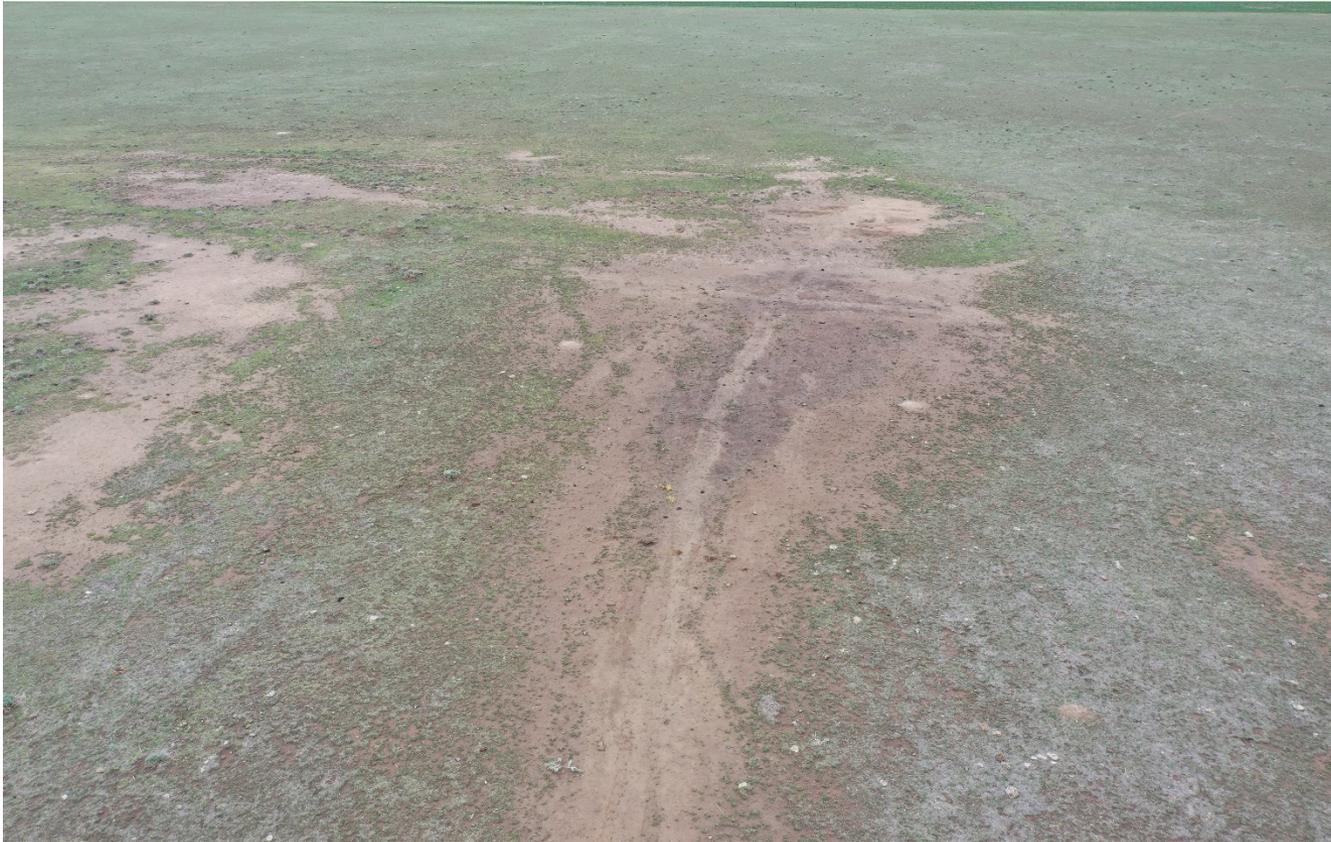
Photo 3. Facing south toward the well site. The location remains mostly devoid of vegetation growth. There is no indication that reclamation was performed.

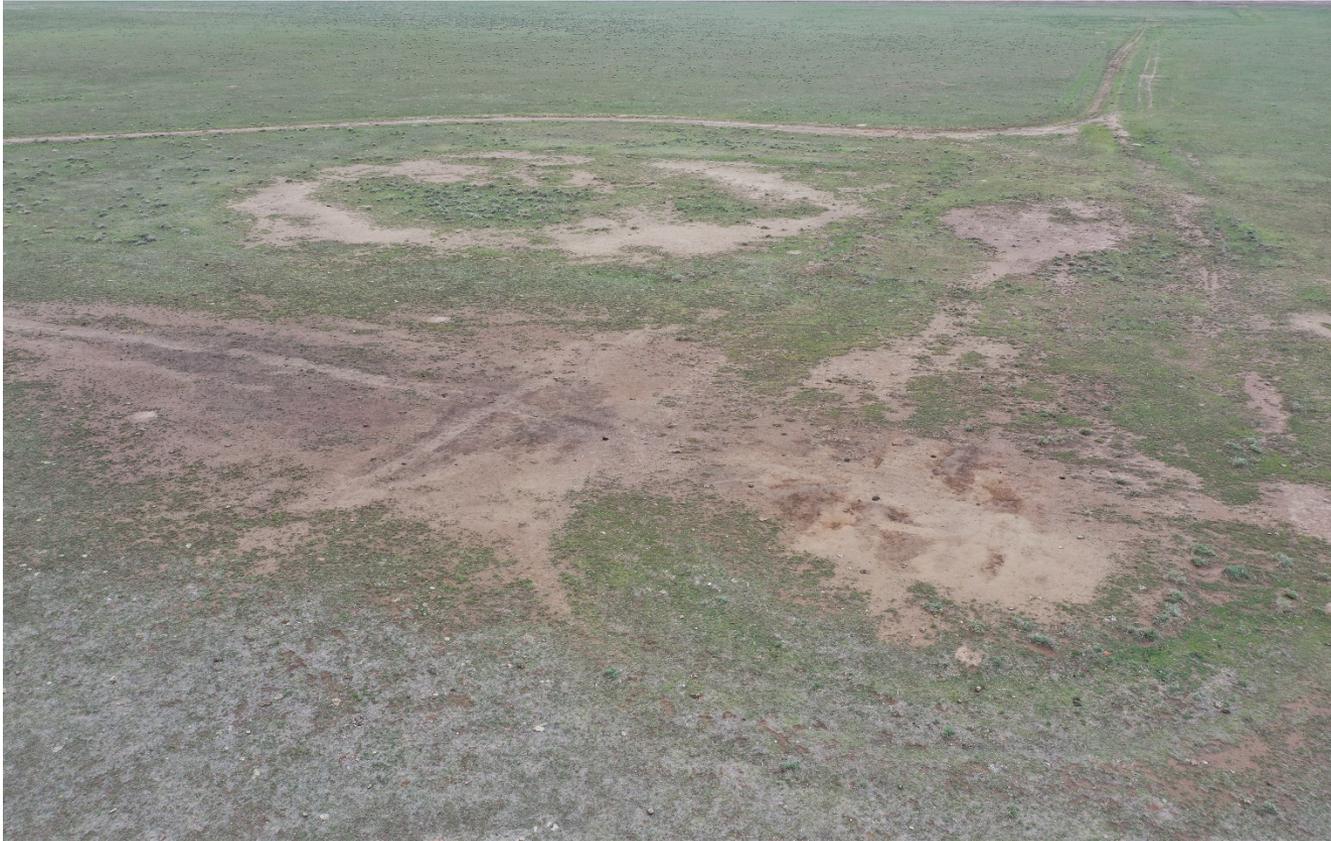
Photo 4. Facing east toward the well site. The location remains mostly devoid of vegetation growth. There is no indication that reclamation was performed.

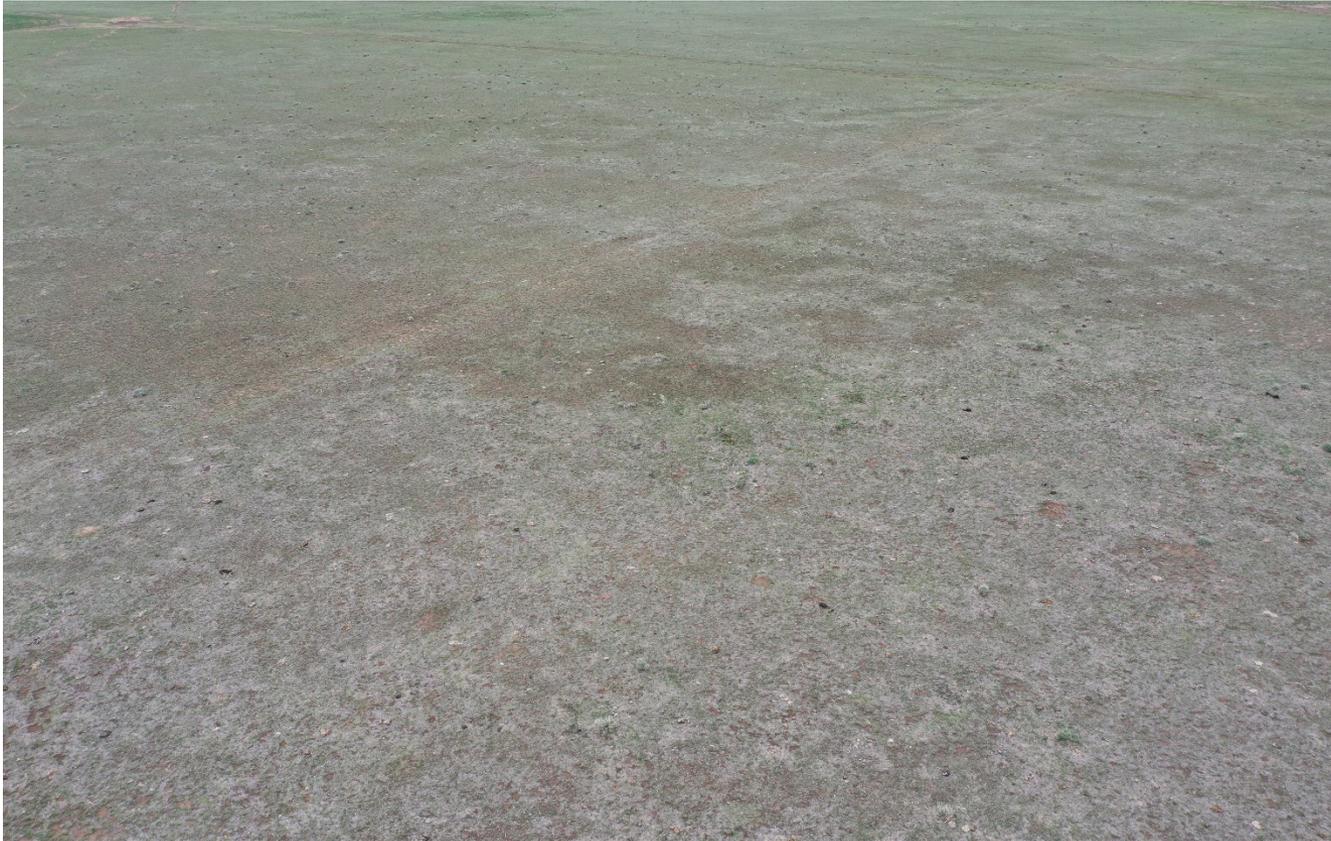
Photo 6. Facing south toward the surrounding undisturbed pasture which shows a uniform vegetation cover.
