Inspection Photos

ID: 150131

Operator: STRACHAN EXPLORATION

Inspection Date: 5/12/2021

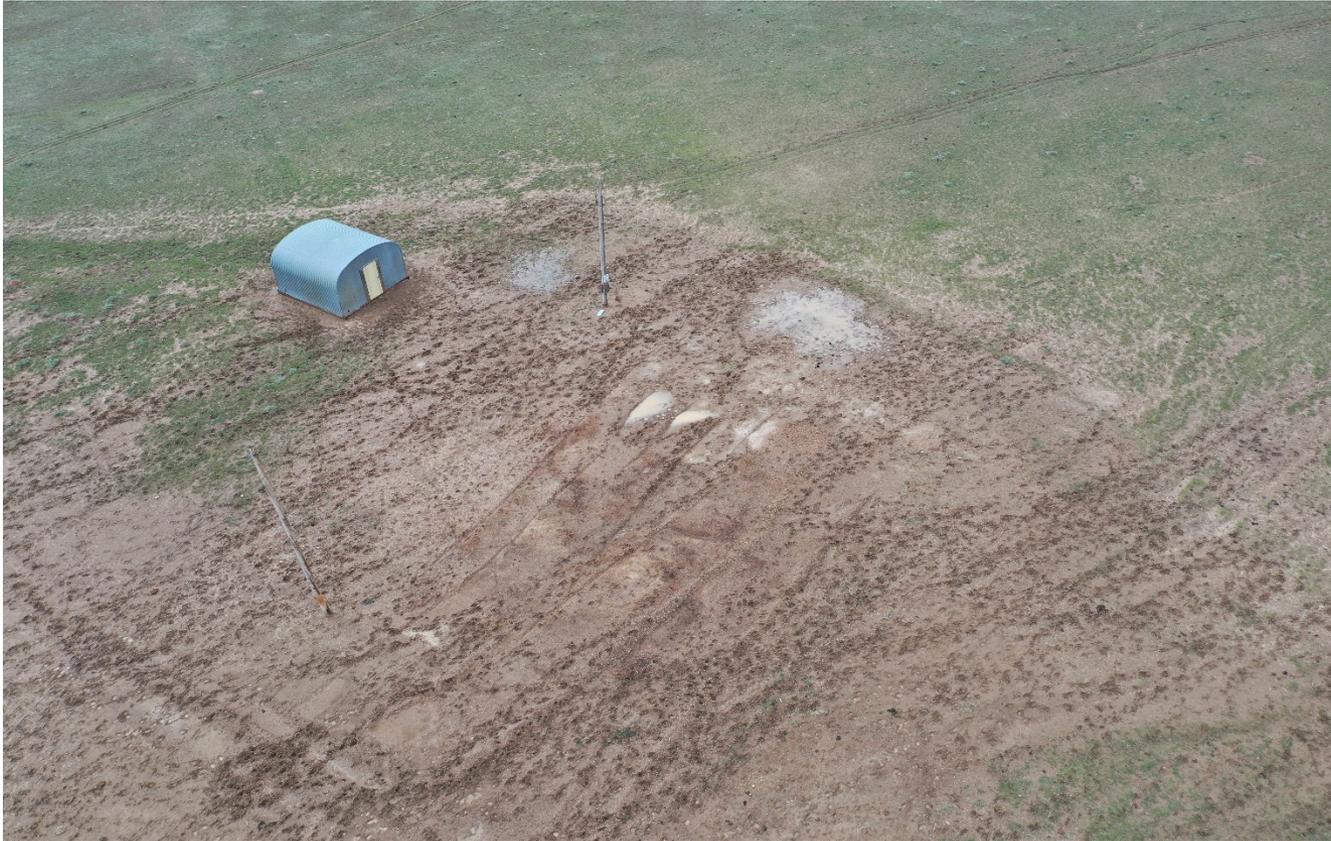
Photo 1. Facing southwest toward the Salt Lake unit abandoned facility. The electric utilities and steel shed remain at the location. The location has not been reclaimed.

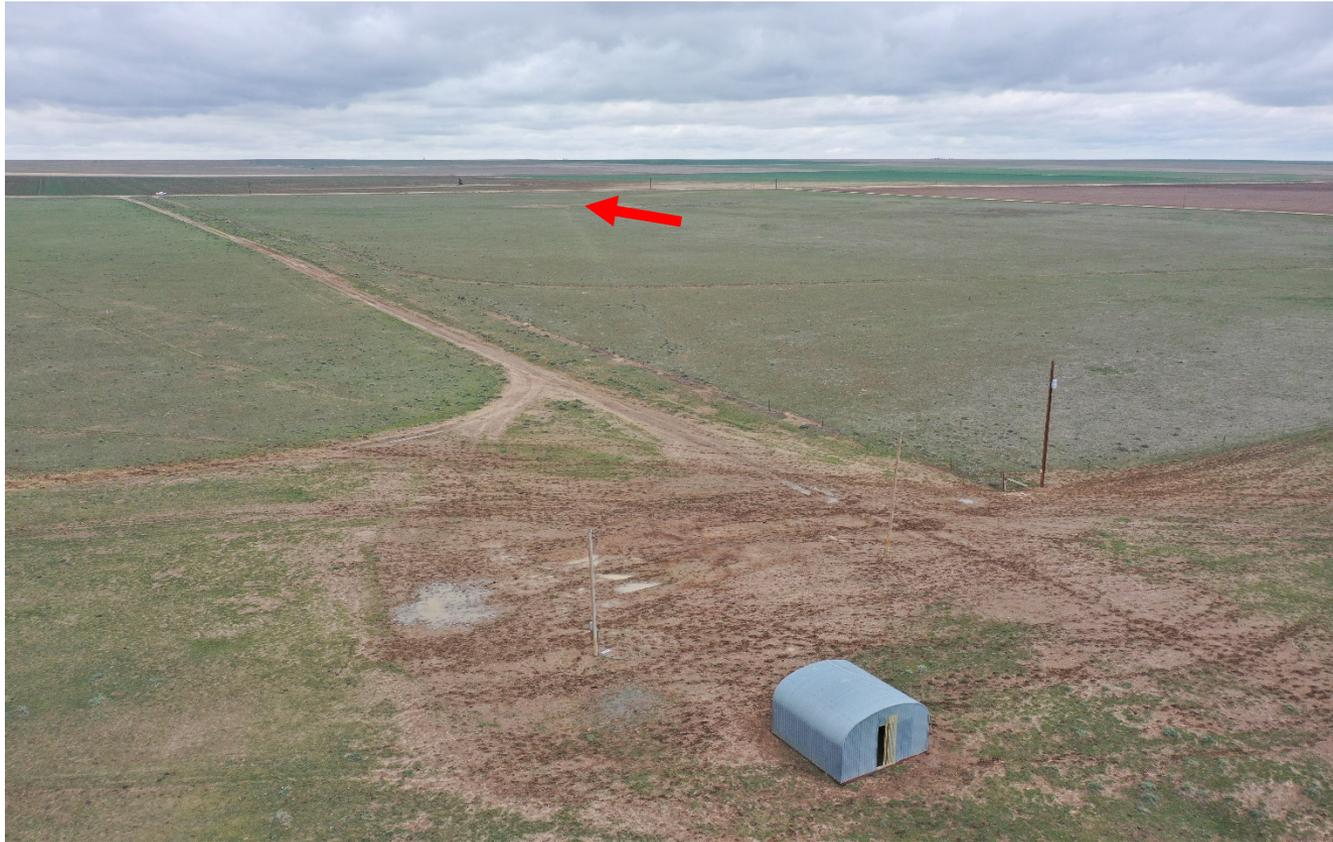
Photo 2. Facing northwest toward the location which has not been reclaimed. Previous corrective action was not performed. Arrow points to battery site shown in the following photos.

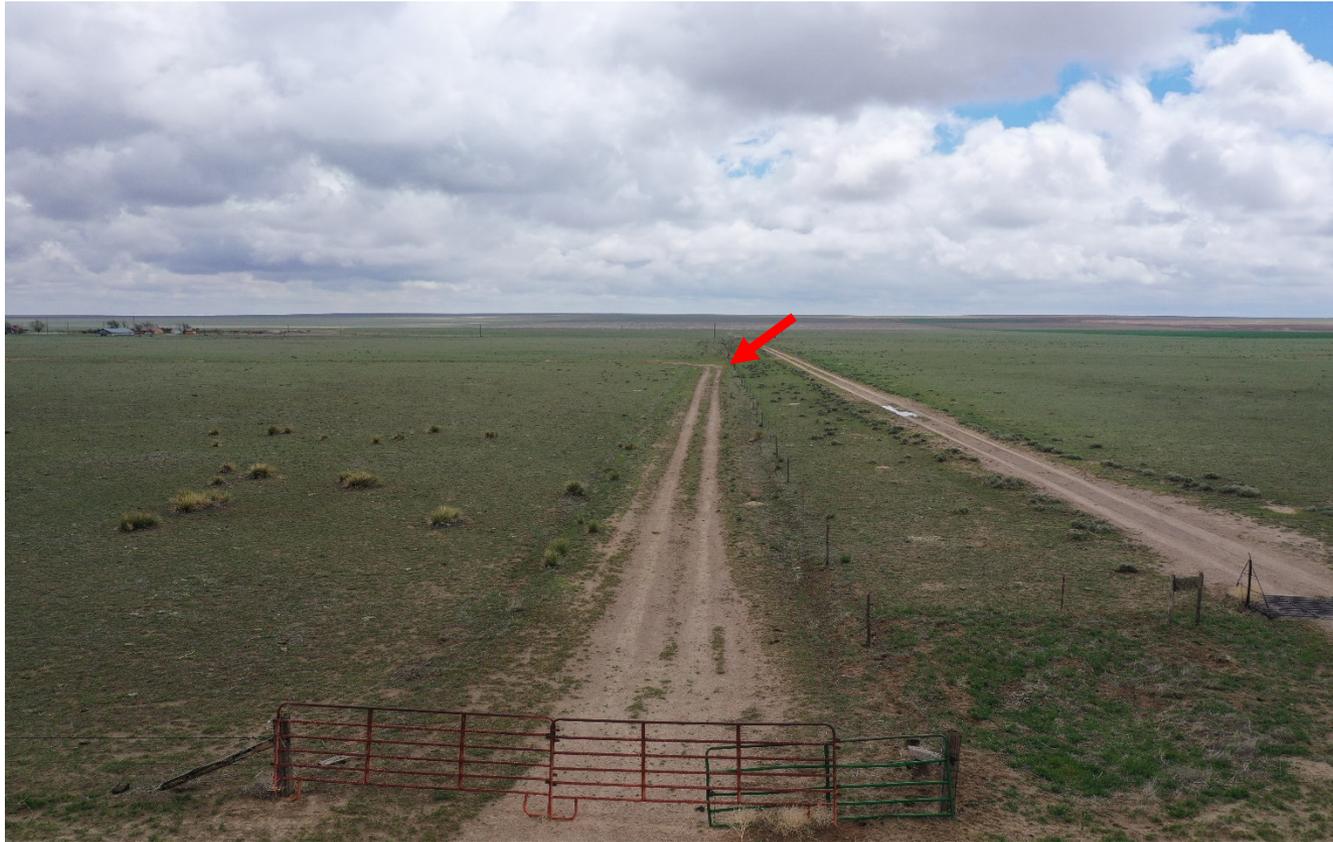
Photo 3. Drone aerial photo facing east toward the access road. The access road has not been reclaimed. Arrow points to where the road turns north toward the location.

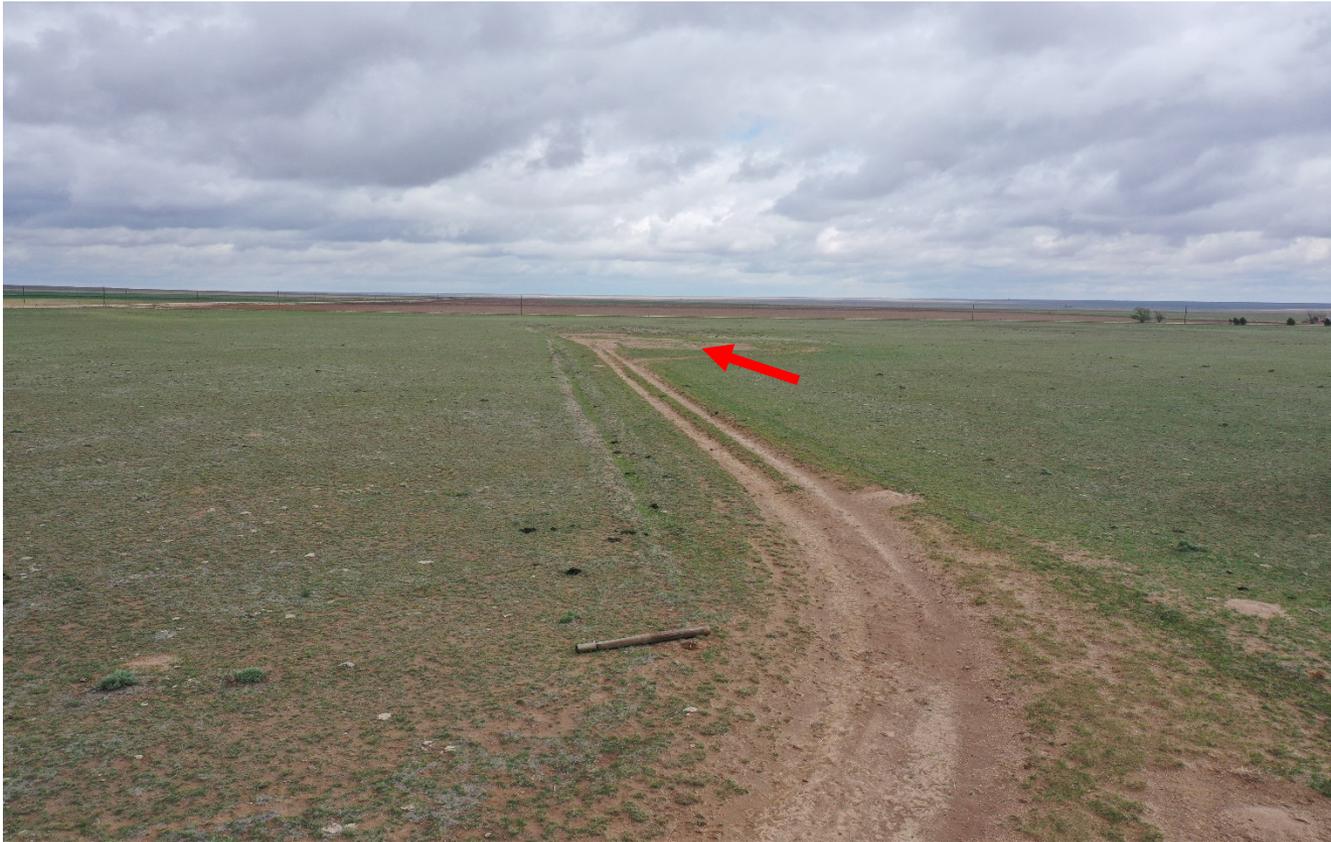
Photo 4. Facing northeast along the access road which dead ends at the location shown at red arrow.

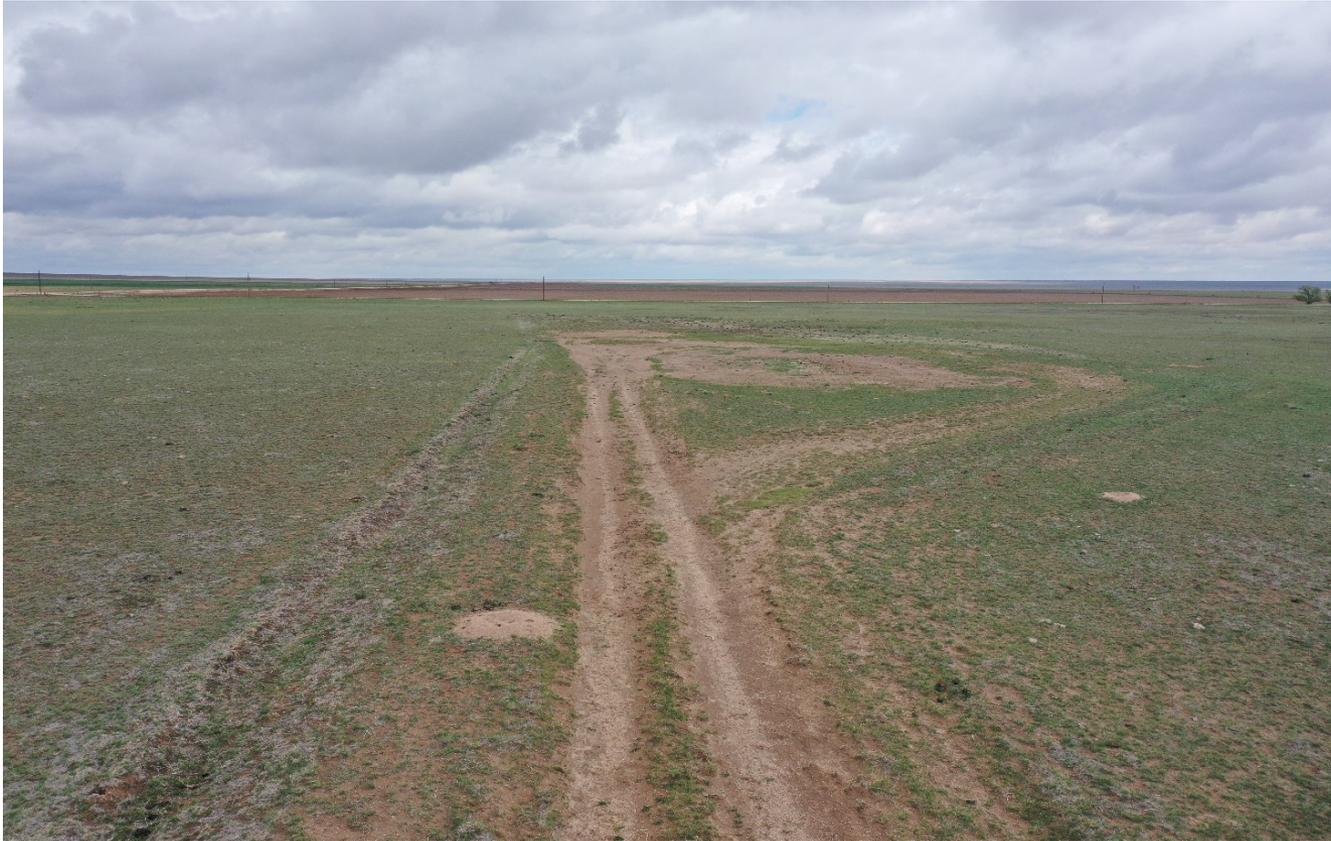
Photo 5. Facing north toward the location which has not been reclaimed. Previous corrective action was not performed.

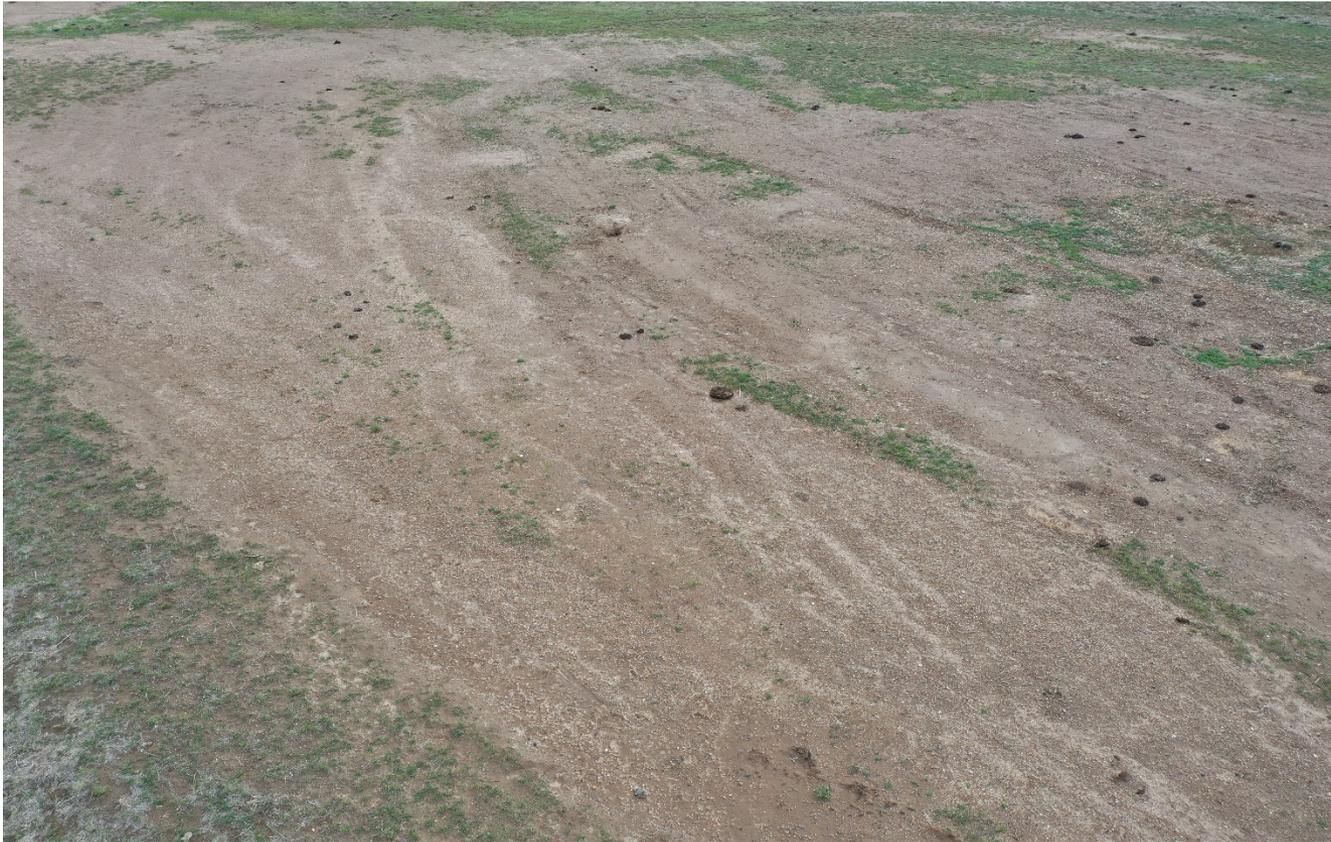
Photo 6. Facing down toward the location. The location remains mostly devoid of vegetation growth. There is no indication that reclamation was performed.

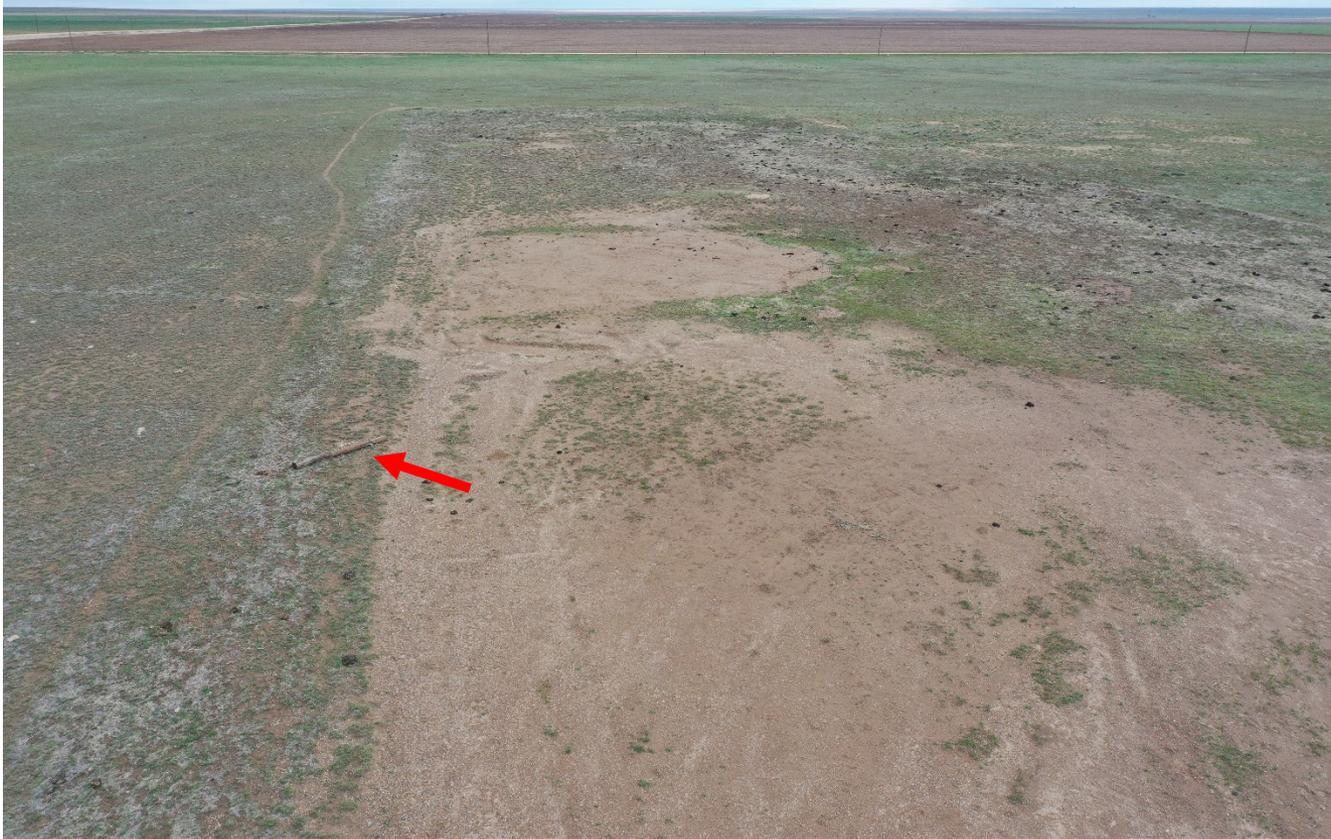
Photo 7. Facing north at the location. Fence posts remain around the location shown at red arrow.

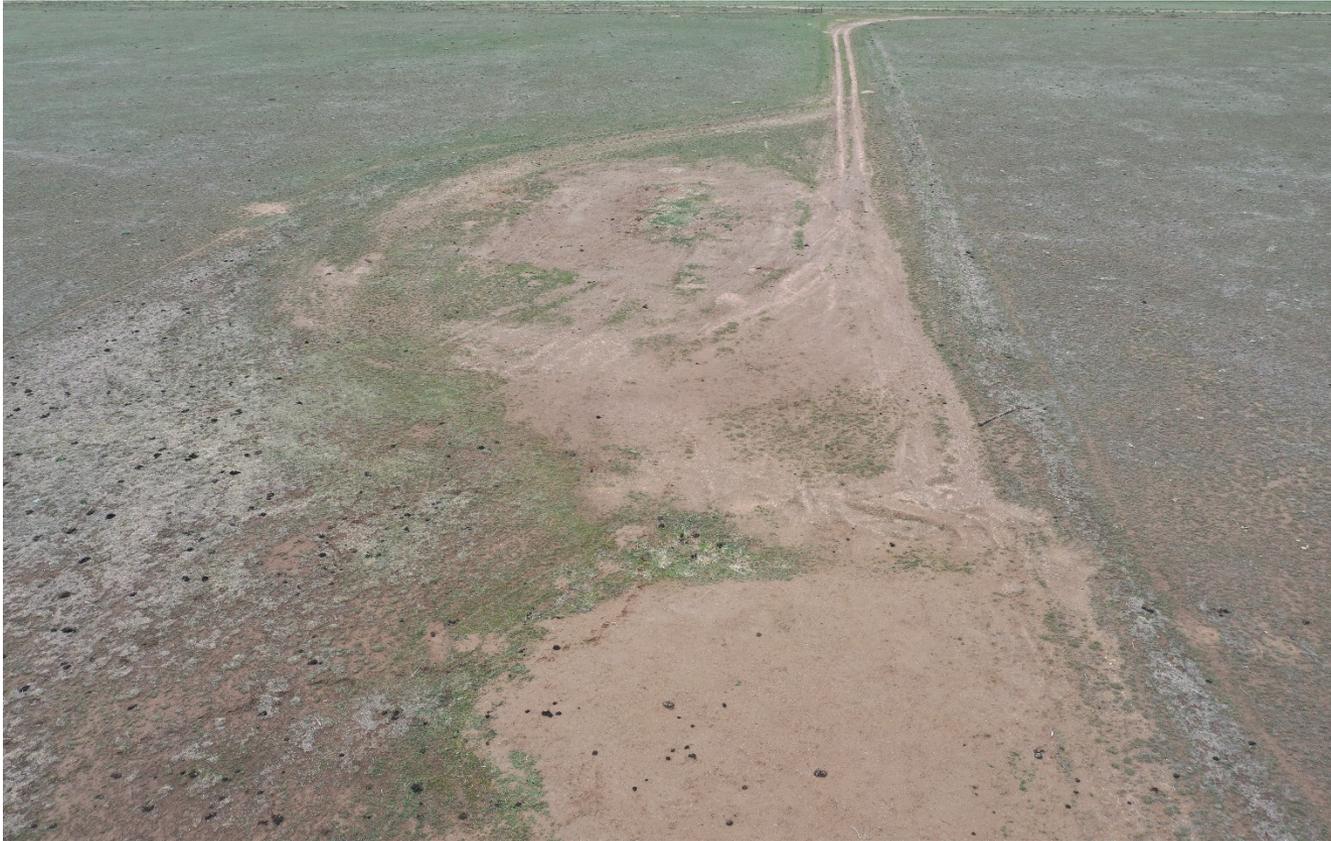
Photo 9. Facing down toward the location. The location remains mostly devoid of vegetation growth. There is no indication that reclamation was performed.

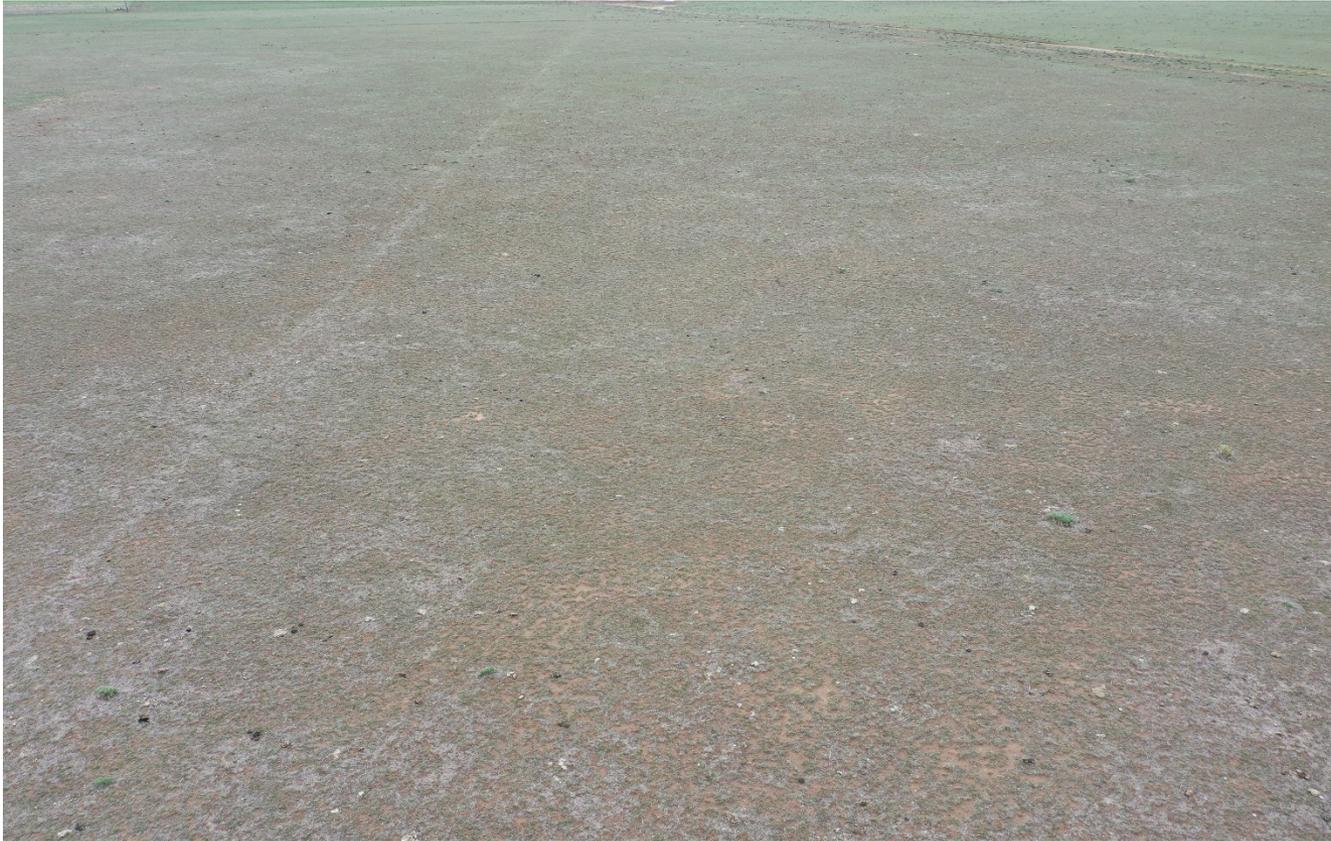
Photo 10. Facing southeast toward the surrounding undisturbed pasture which shows a uniform vegetation cover.
