Inspection Photos

API: 061-06471

Operator: MARATHON OIL COMPANY

Inspection Date: 5/12/2021

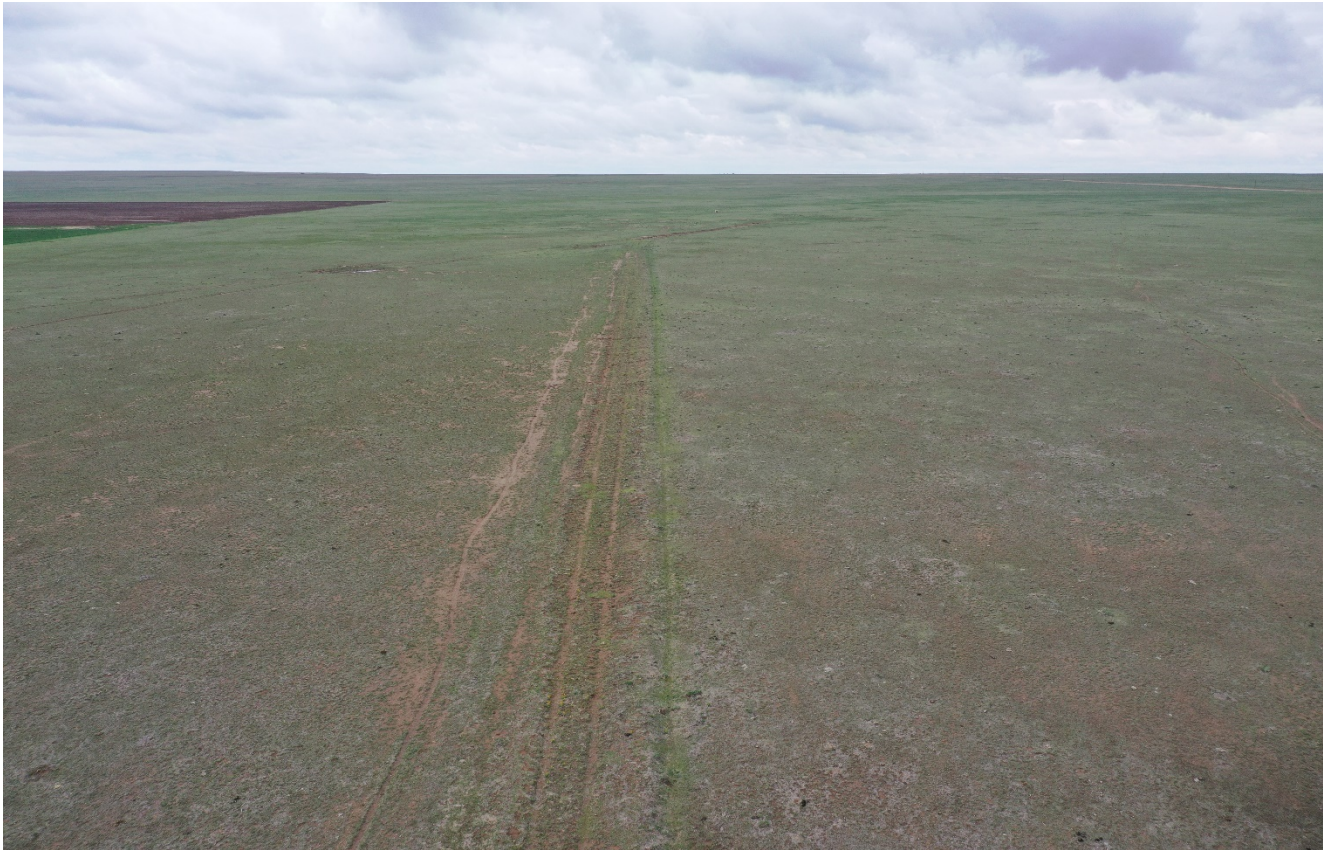
Photo 1. Facing south along the former access road which is still evident.

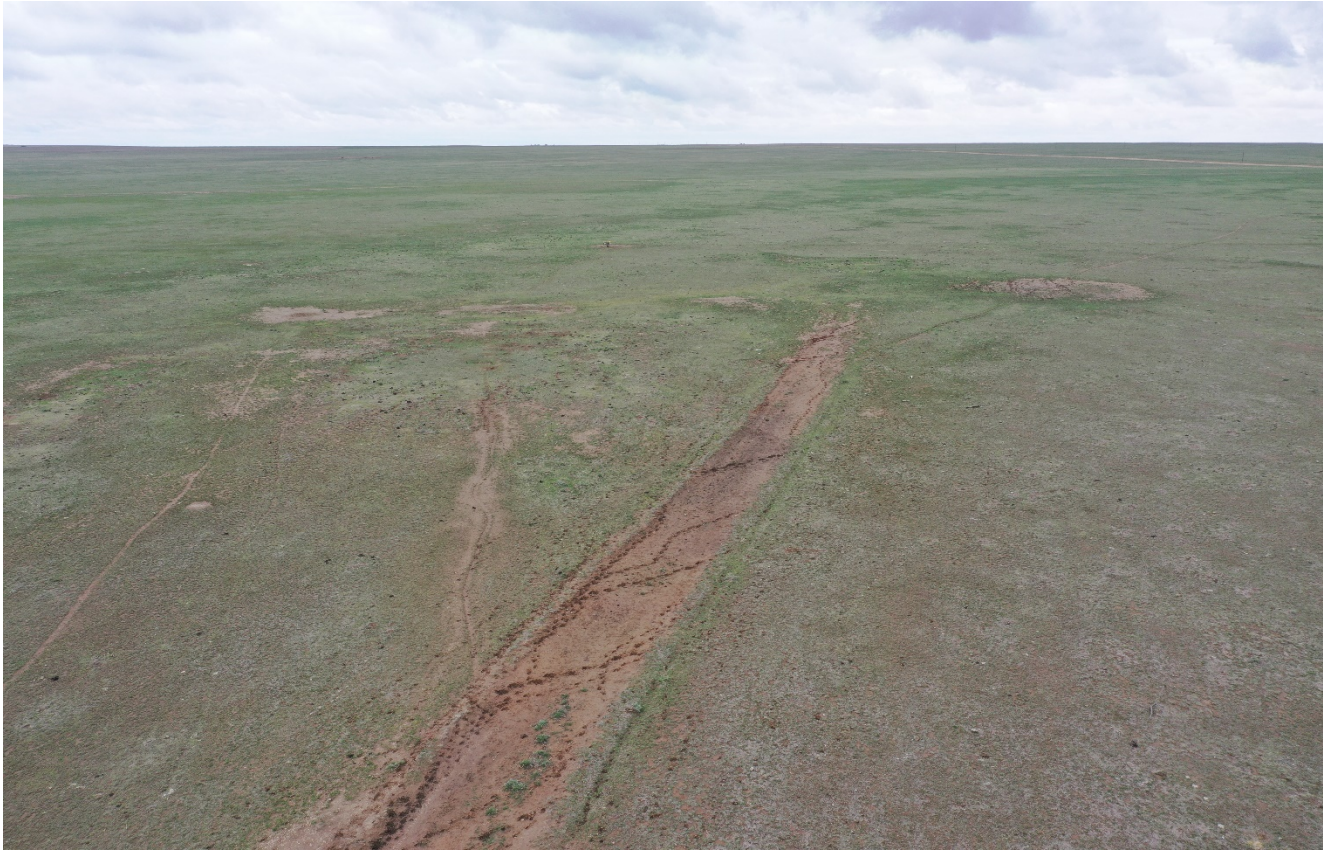
Photo 2. Facing south along the road towards the location. This portion of the former access road is bare of vegetation and has not been reclaimed.

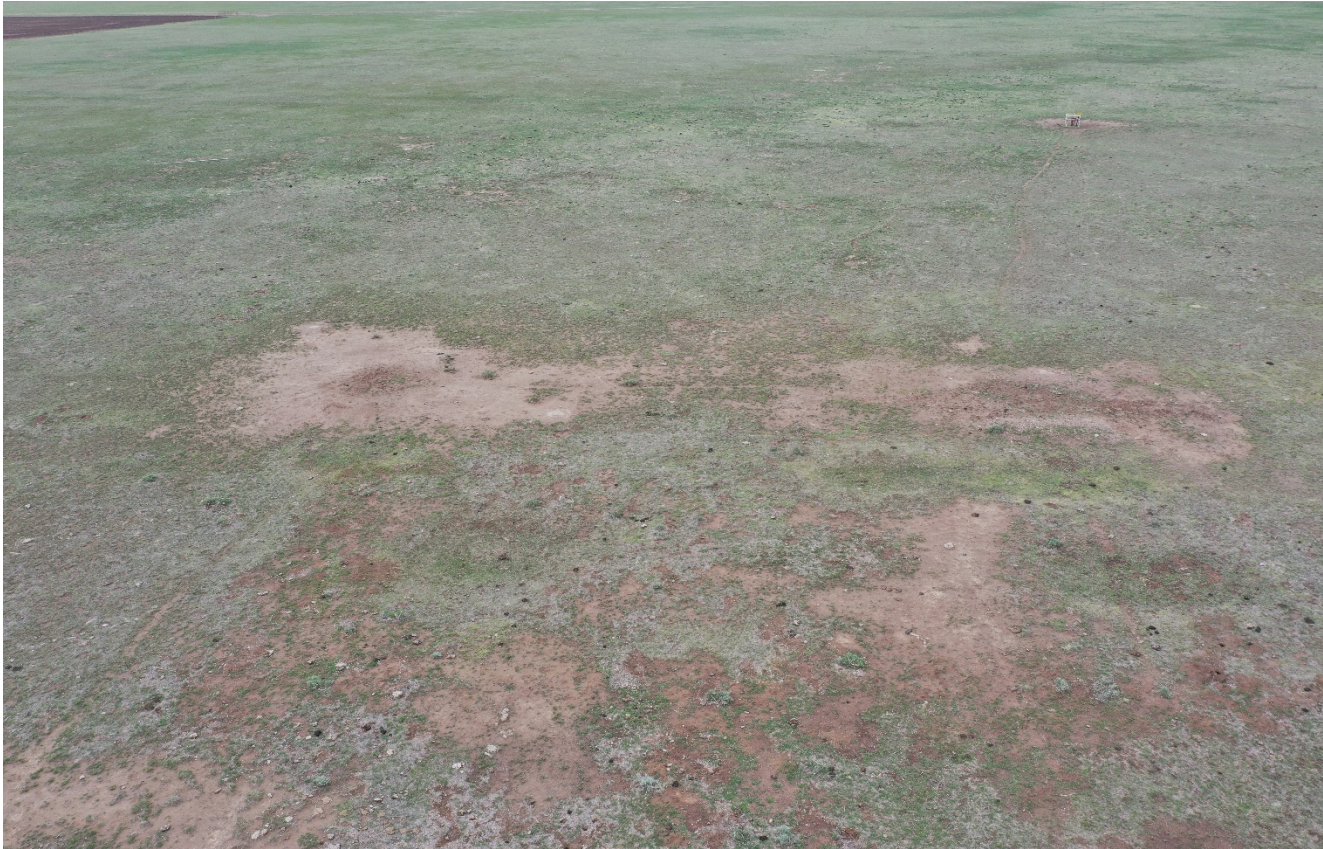
Photo 3. It appears equipment and pipe risers have been removed since the previous inspection. The bare areas of the location need to be reclaimed to re-establish vegetation cover.

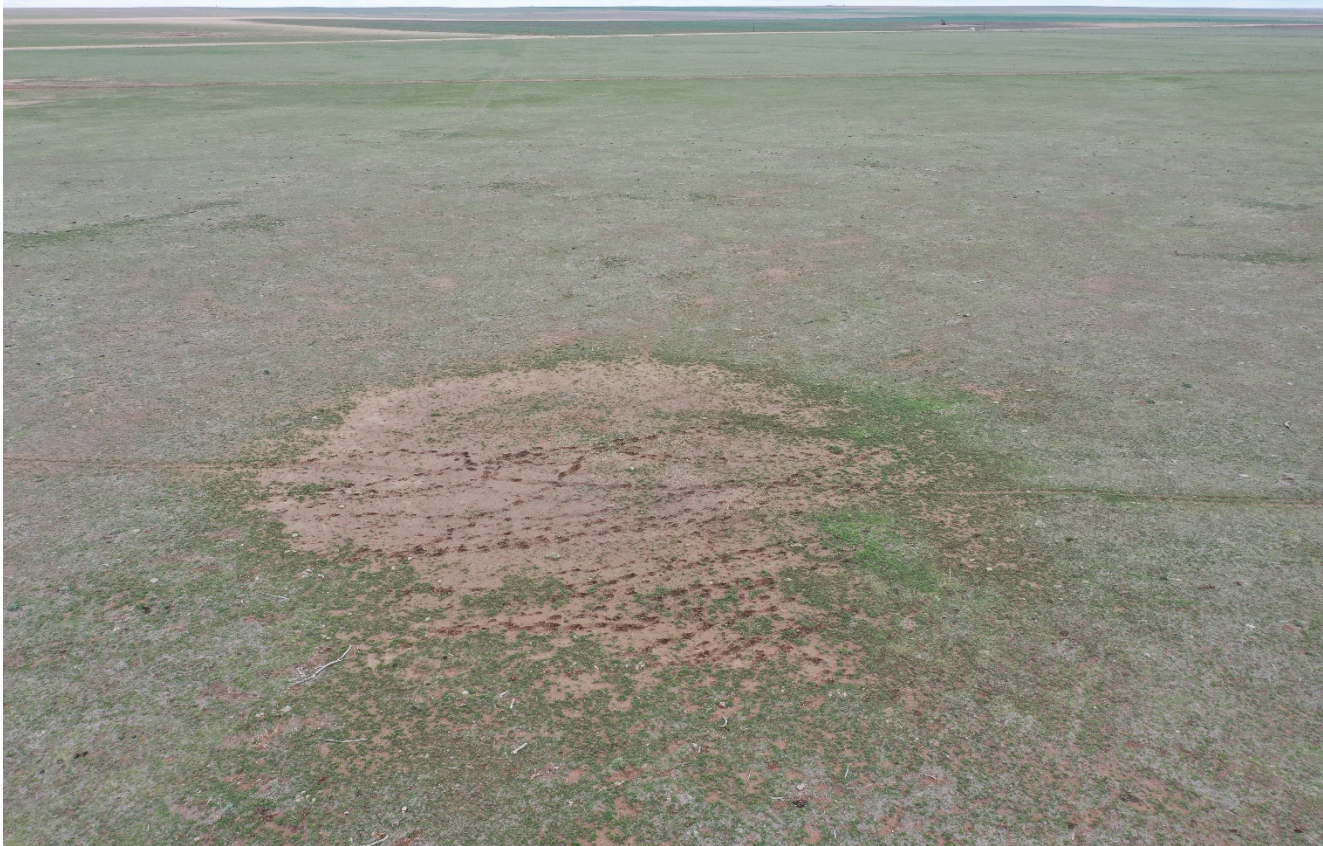
Photo 4. It appears equipment and pipe risers have been removed since the previous inspection. The bare areas of the location need to be reclaimed to re-establish vegetation cover.

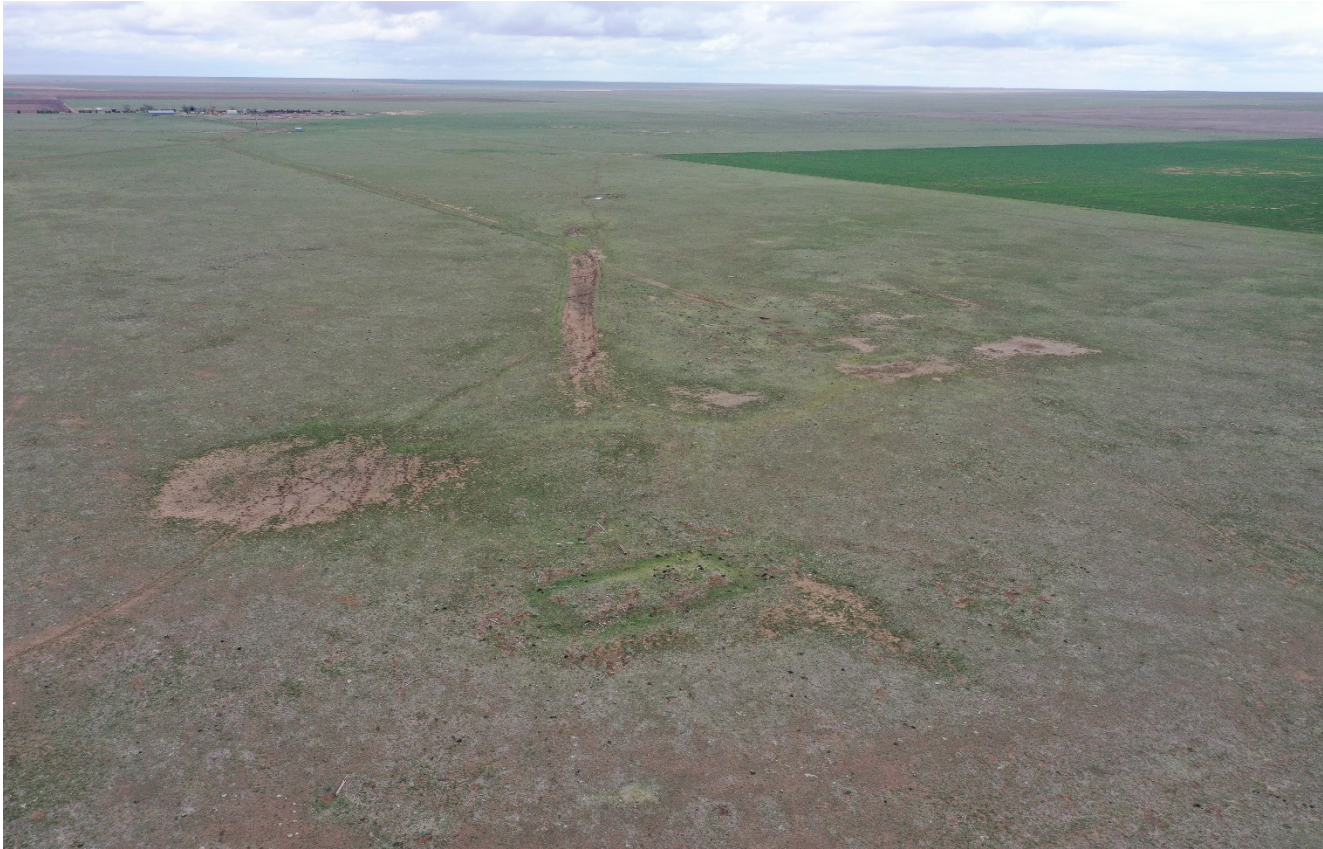
Photo 5. Facing northwest overlooking the access road and bare disturbance areas of the location.
