Inspection Photos

Location Name: TEP ROCKY MOUNTAIN LLC SPECIALTY RESTAURANTS-67S96W /33SWNW

Location ID: 383330

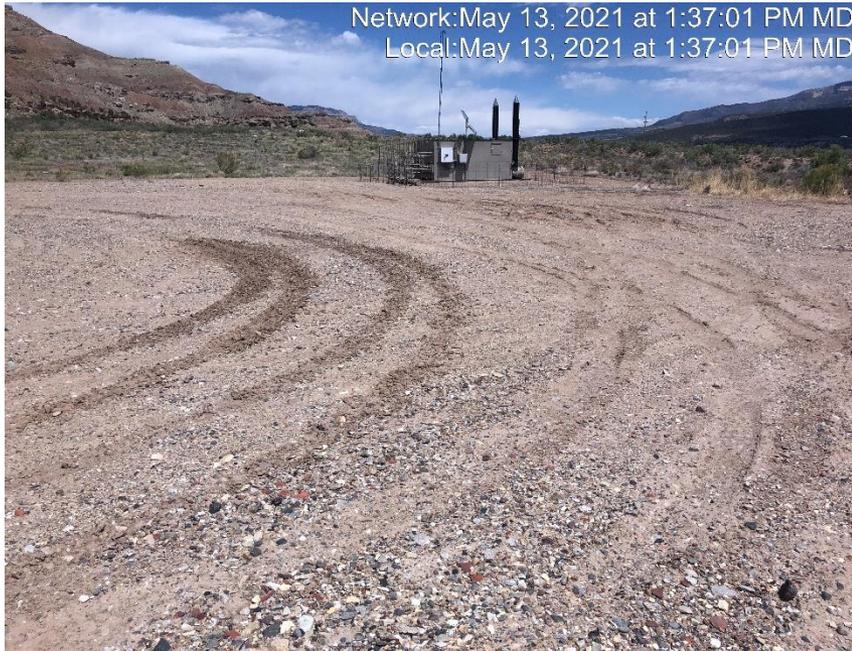
Photo #3802 Location lacks stabilization.

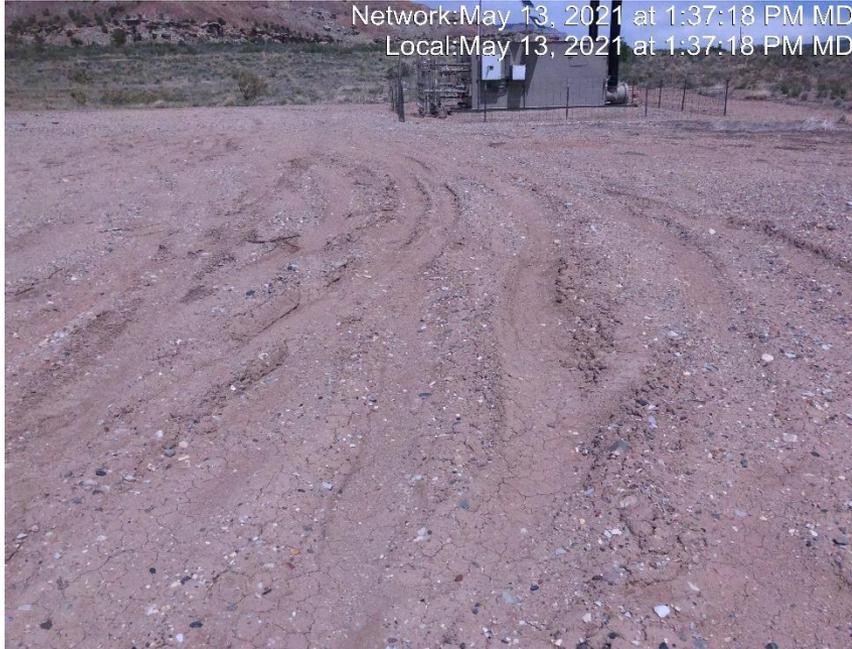
Photo #3803 Location lacks stabilization.

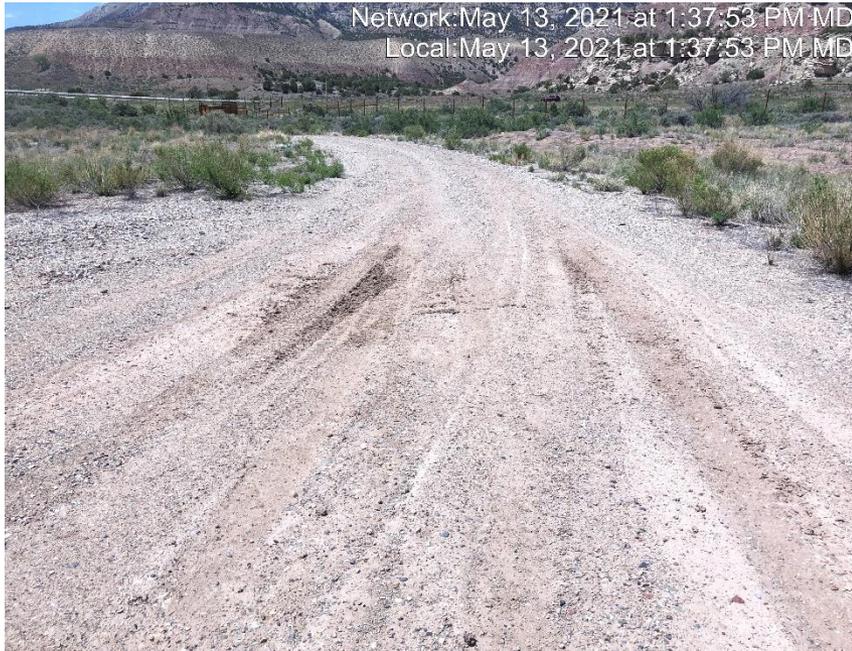
Photo #3804 No form of tracking BMP located at the entrance to location.

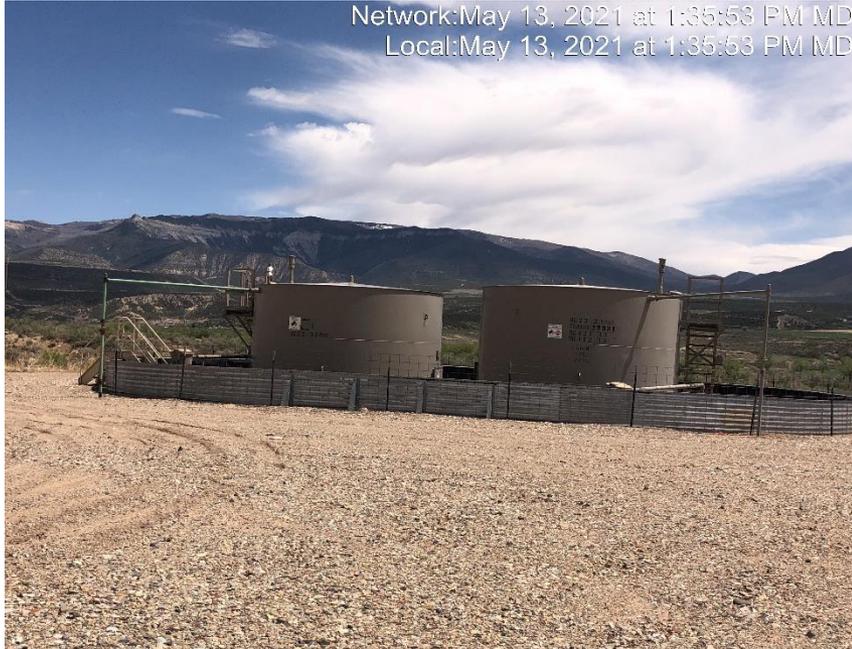
Photo #3800 No battery sign located at the tank battery
