**Inspection Photos**  
**Camenisch 1 sx Flowline Release**  
**Spill ID 479713 (AC)**

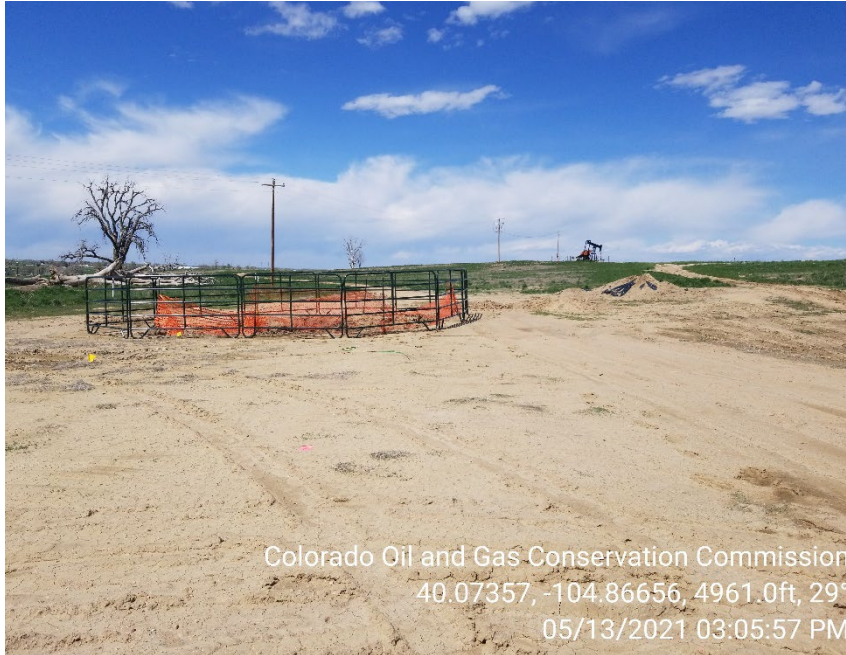
**Photo 1 – Spill area. Fencing up around open excavation.**

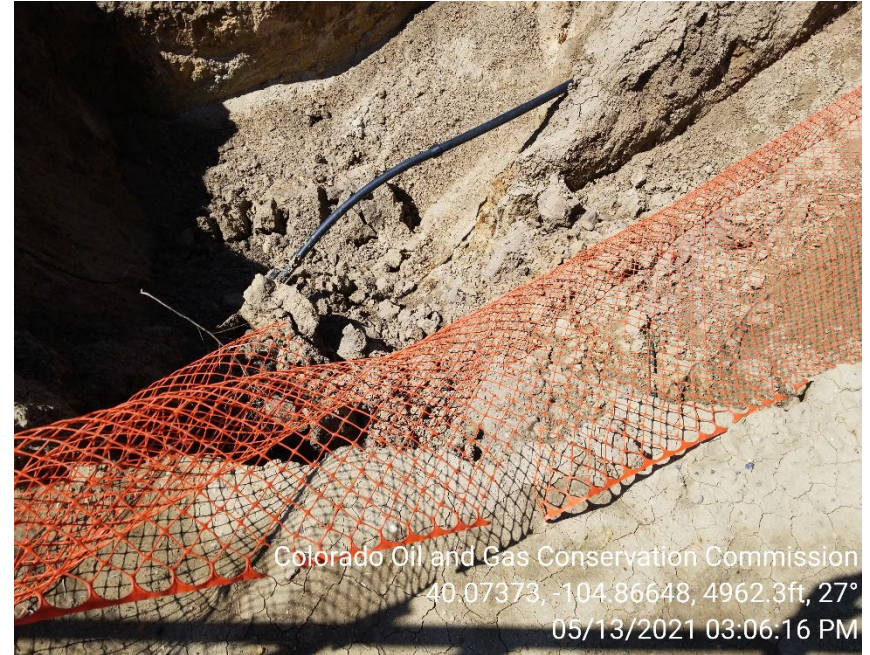
**Photo 2 – Spill excavation. Impacts remain in situ.**

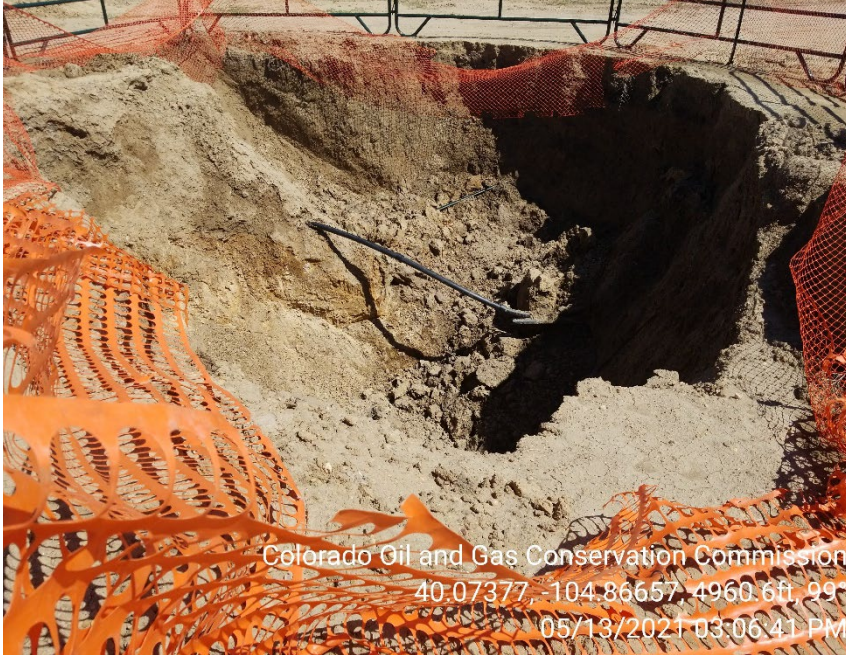
**Photo 3 – Spill excavation.**

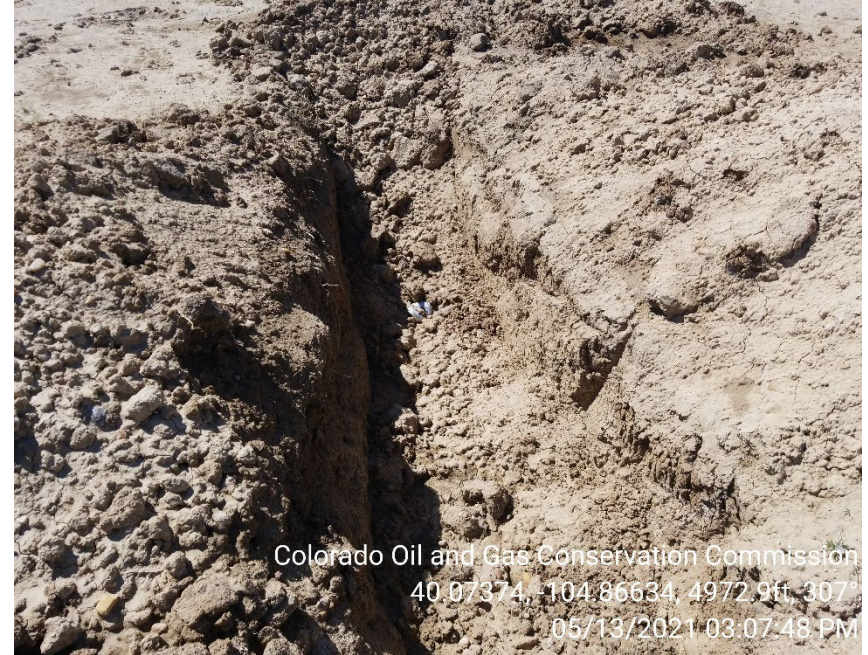
**Photo 4 – Additional disturbed area on site. Trash observed in disturbed area.**

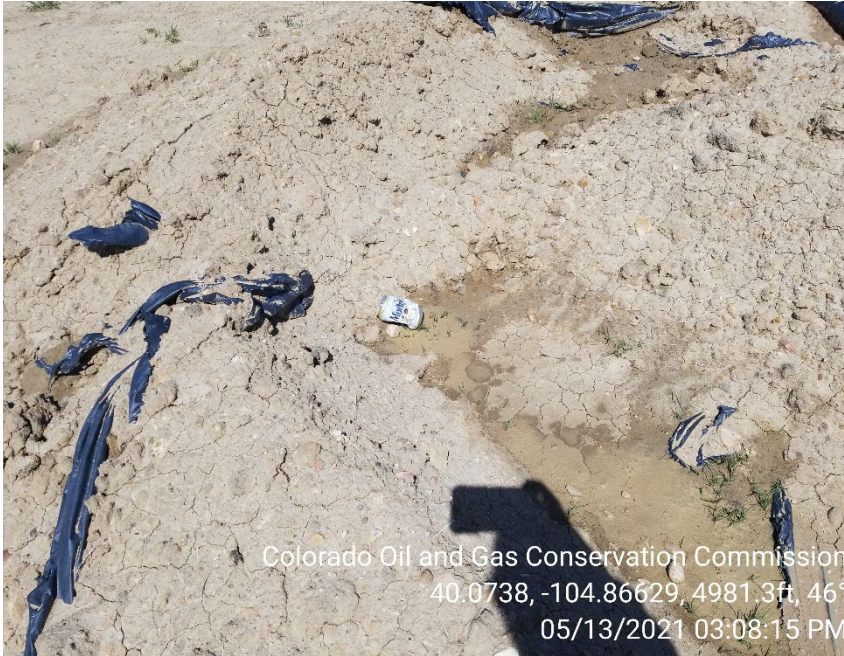
**Photo 5 – Soils stockpiled on location. Lining does not adequately protect surface soils. Trash remains on location.**

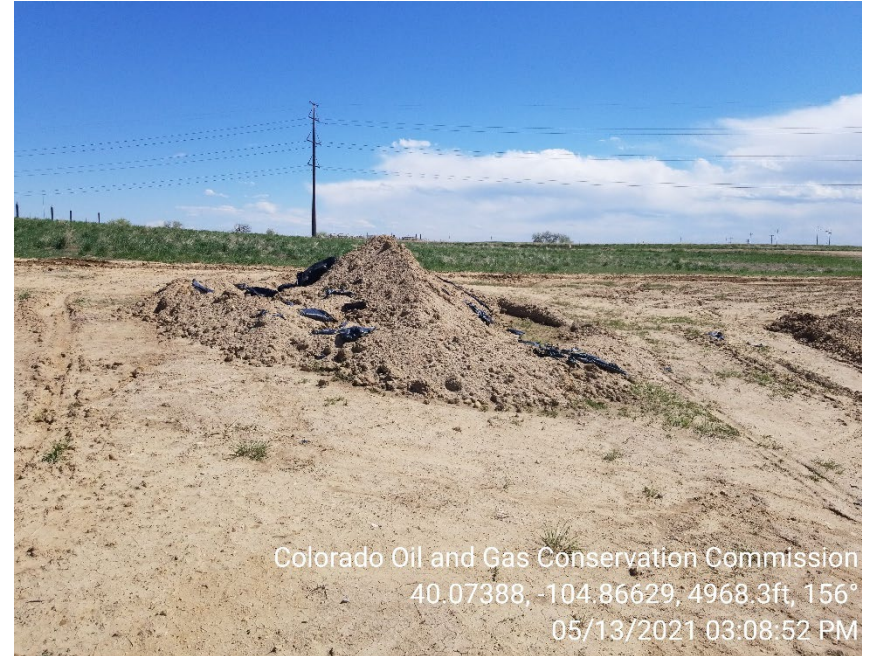
**Photo 6 – Soils stockpiled on location. Lining does not adequately protect surface soils. BMPs inadequate for stormwater runoff.**

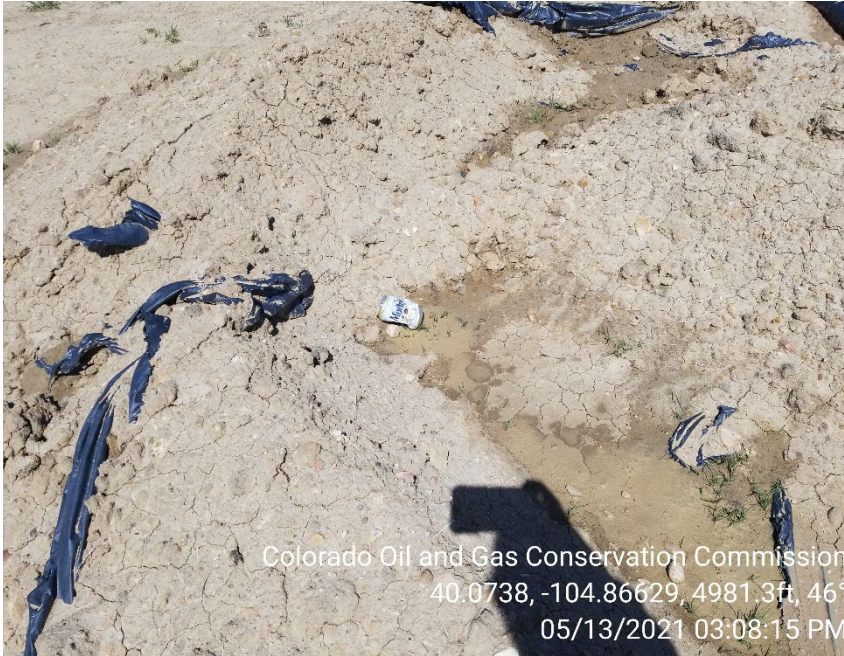
**Photo 7 – Stained soil observed around open excavation.**

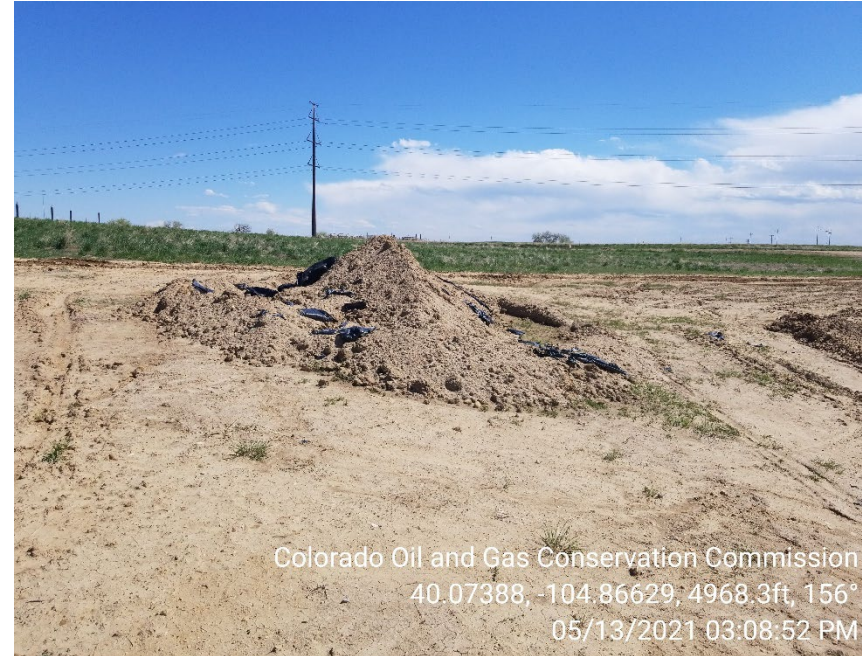
**Photo 8 – Stained soil observed around open excavation.**
