Inspection Photos

Location Name: CAERUS PICEANCE LLC NOCKS-68S96W /2NENE

Location ID: 334078

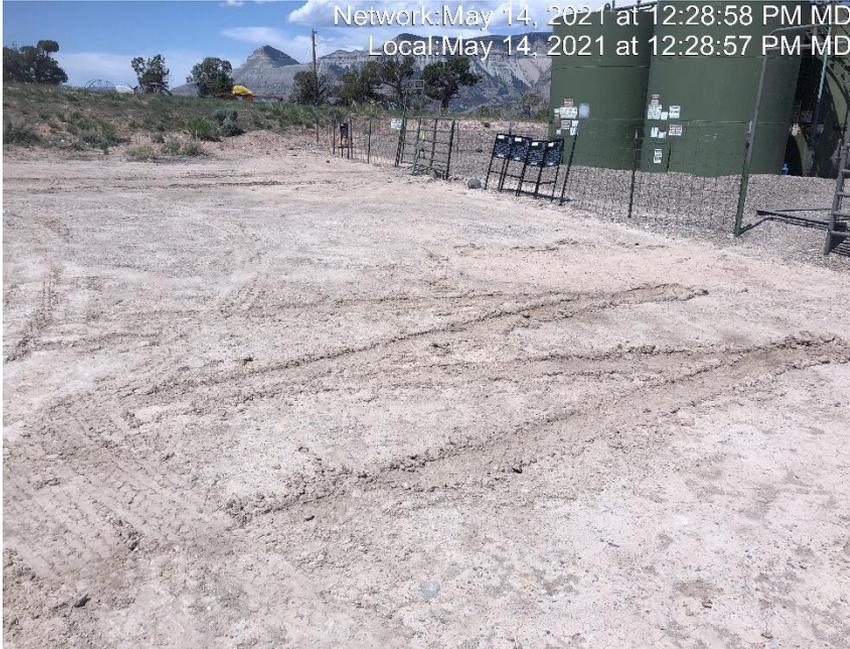
Photo #3813 location lacks stabilization.

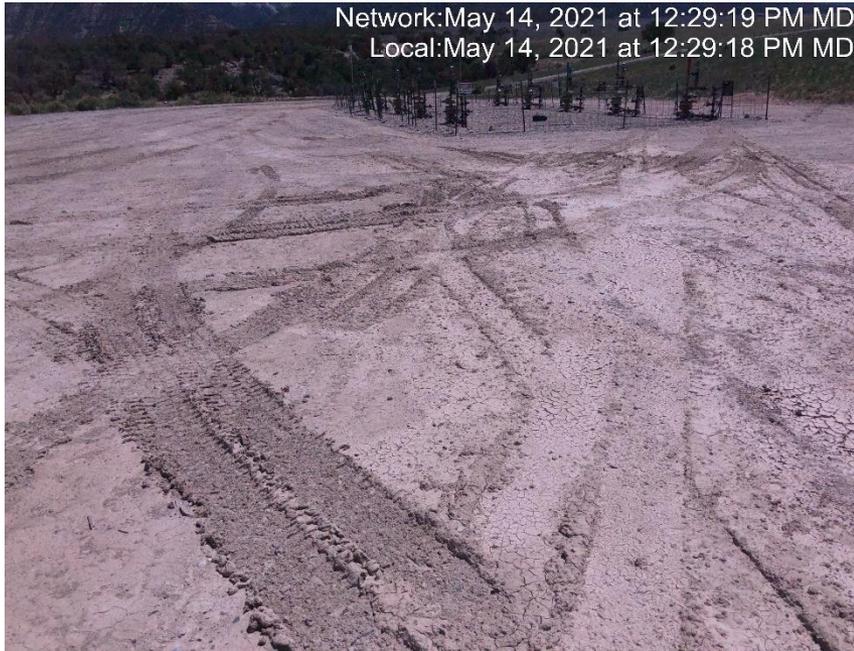
Photo #3814 Location lacks stabilization.

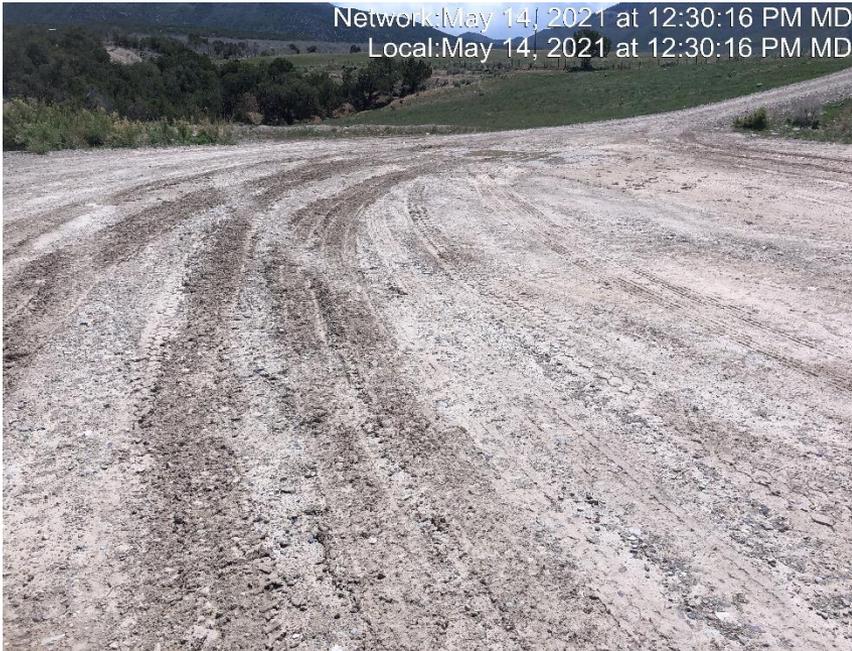
Photo #3815 No form of tracking BMP located at the entrance to location.
