Lorencito 14-20-34-66

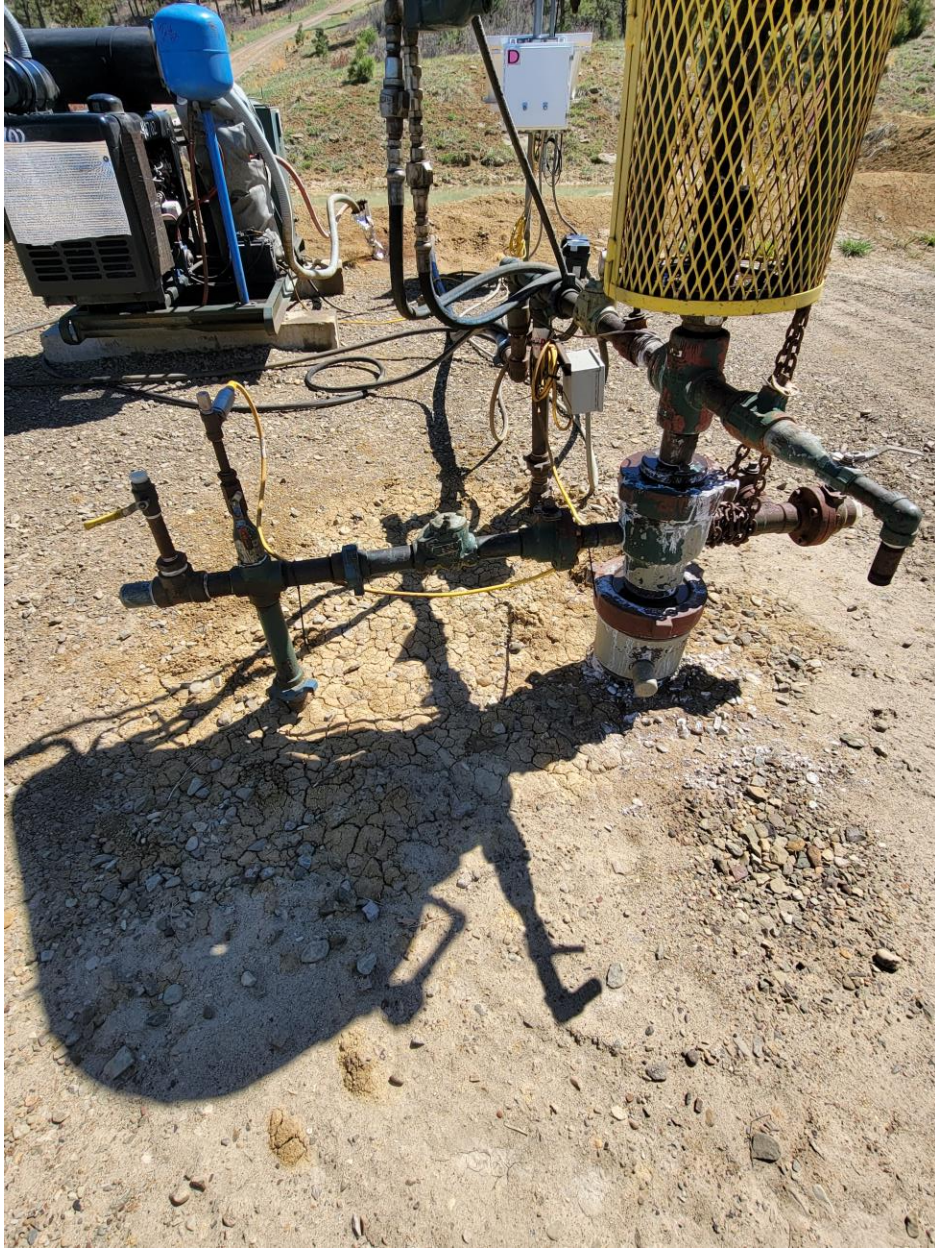
Cleaned up area of impacted soil under drive head also repaired source of leak for hydraulic oil. To comply with 901.b in handling solid waste material. Also complied with Rule 608.e. inspection and repair of leaks at regular intervals
