Stormwater Inspection Report

| Operator: | Laramie Energy, LLC |
| Project: | Collbran |
| Location: | Laramie Land & Cattle Co 36-10 Pad |

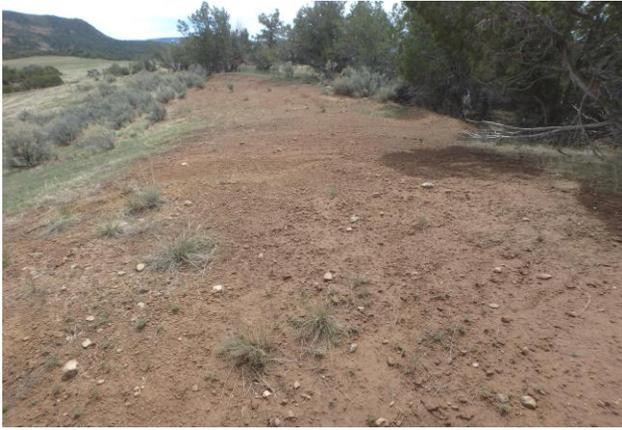
Photo 1

Western Bare Soils after Seeding

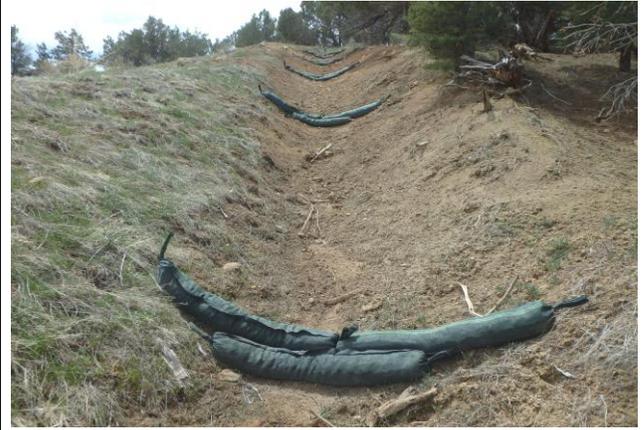
Photo 2

Rock Socks Installed in Northern Containment

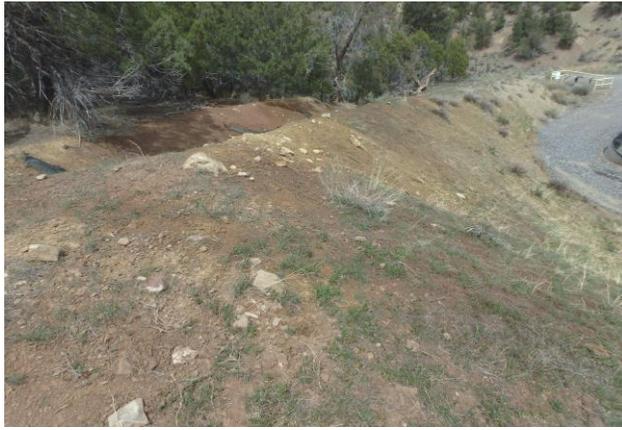
Photo 3

Northern Cut-Slope after Seeding

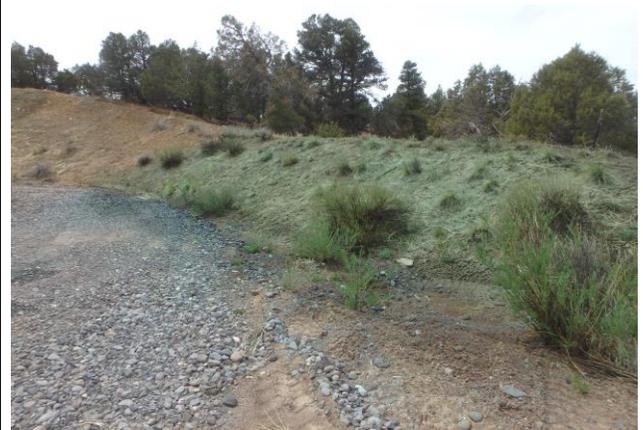
Photo 4

Northern Cut-Slope after Seeding
