Inspection Photos
Operator: Bayless
API: 083-05350
Date: 5/11/2021

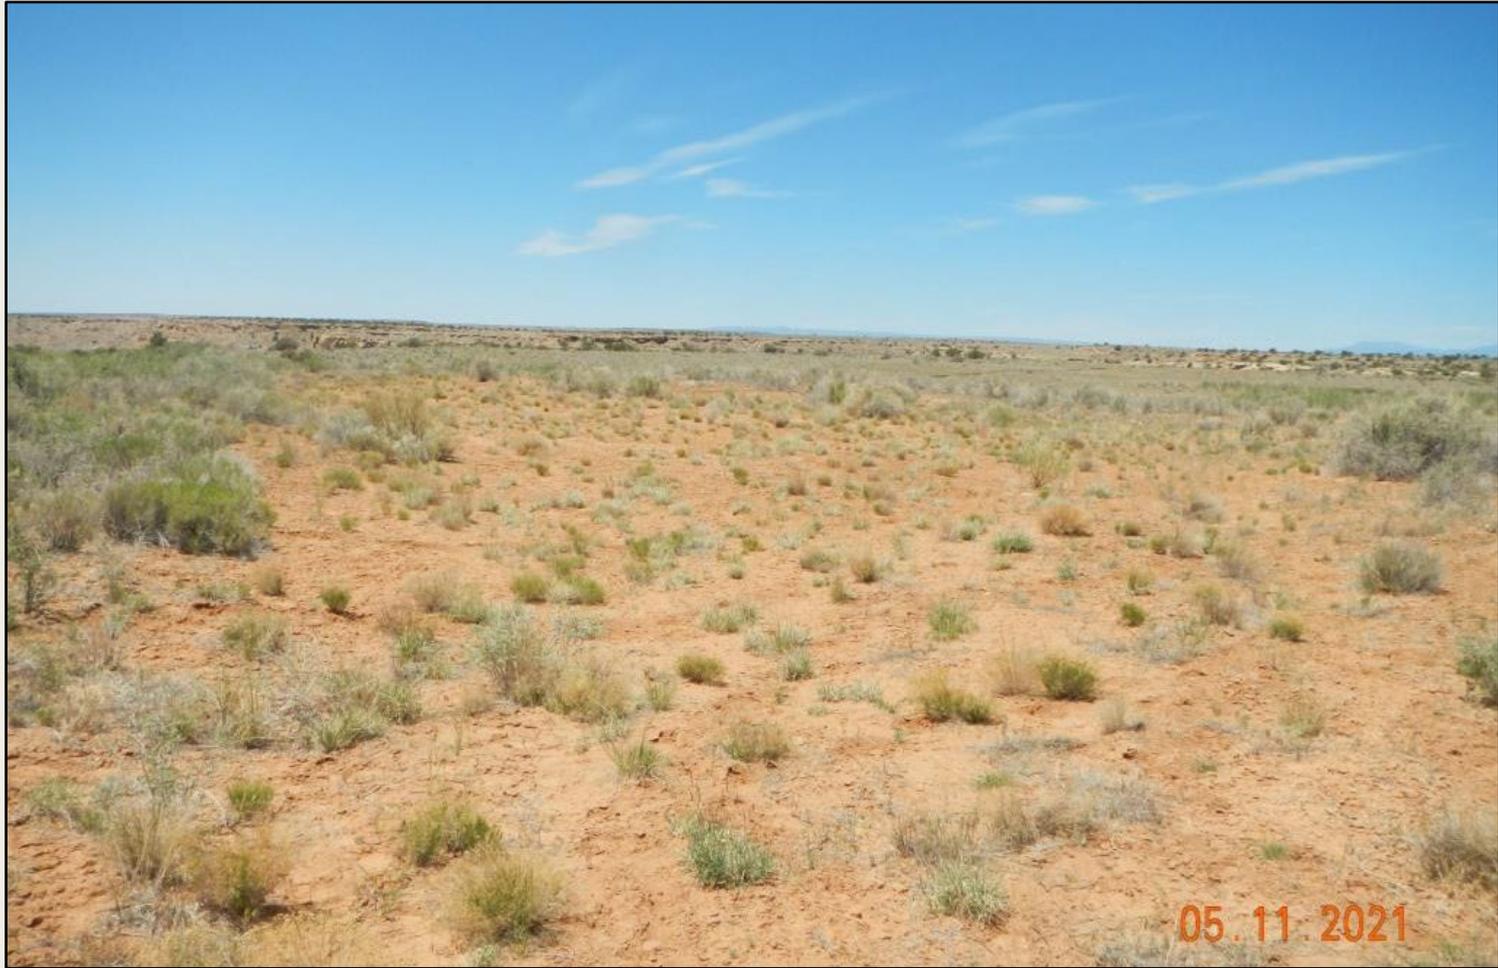
Photo 1. View of the project area from the well pad entrance facing center. Revegetation is progressing in portions of the project area with james galleta, Indian ricegrass, snakeweed, and rubber rabbitbrush.

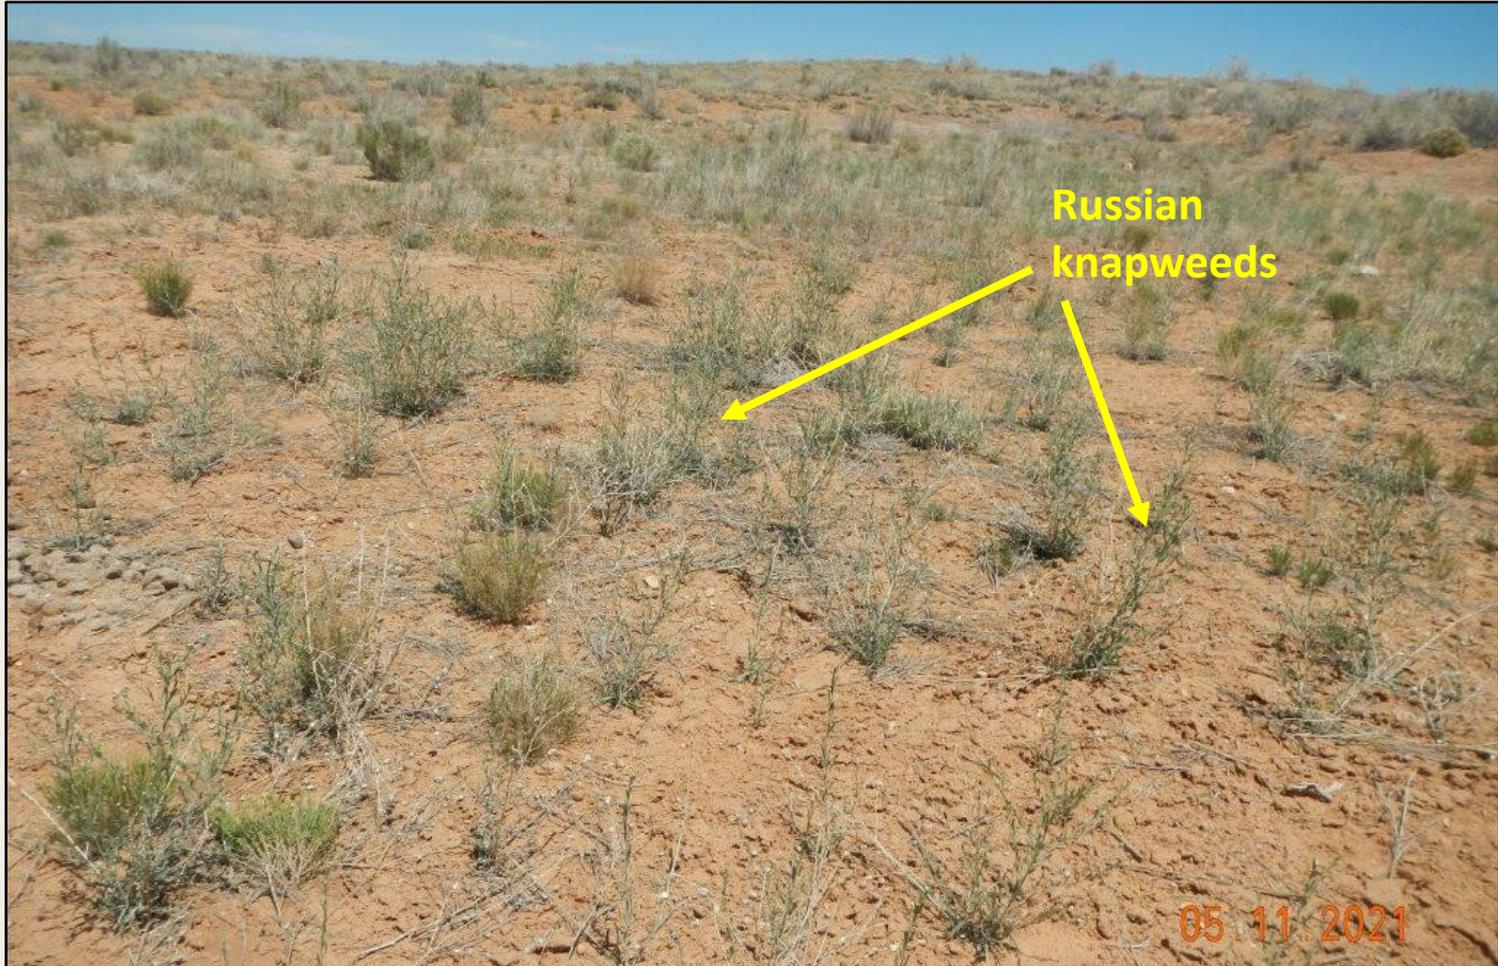
Photo 2. View of Russian knapweed infestation within the northern project area. Approximately 2000 Russian knapweeds observed.

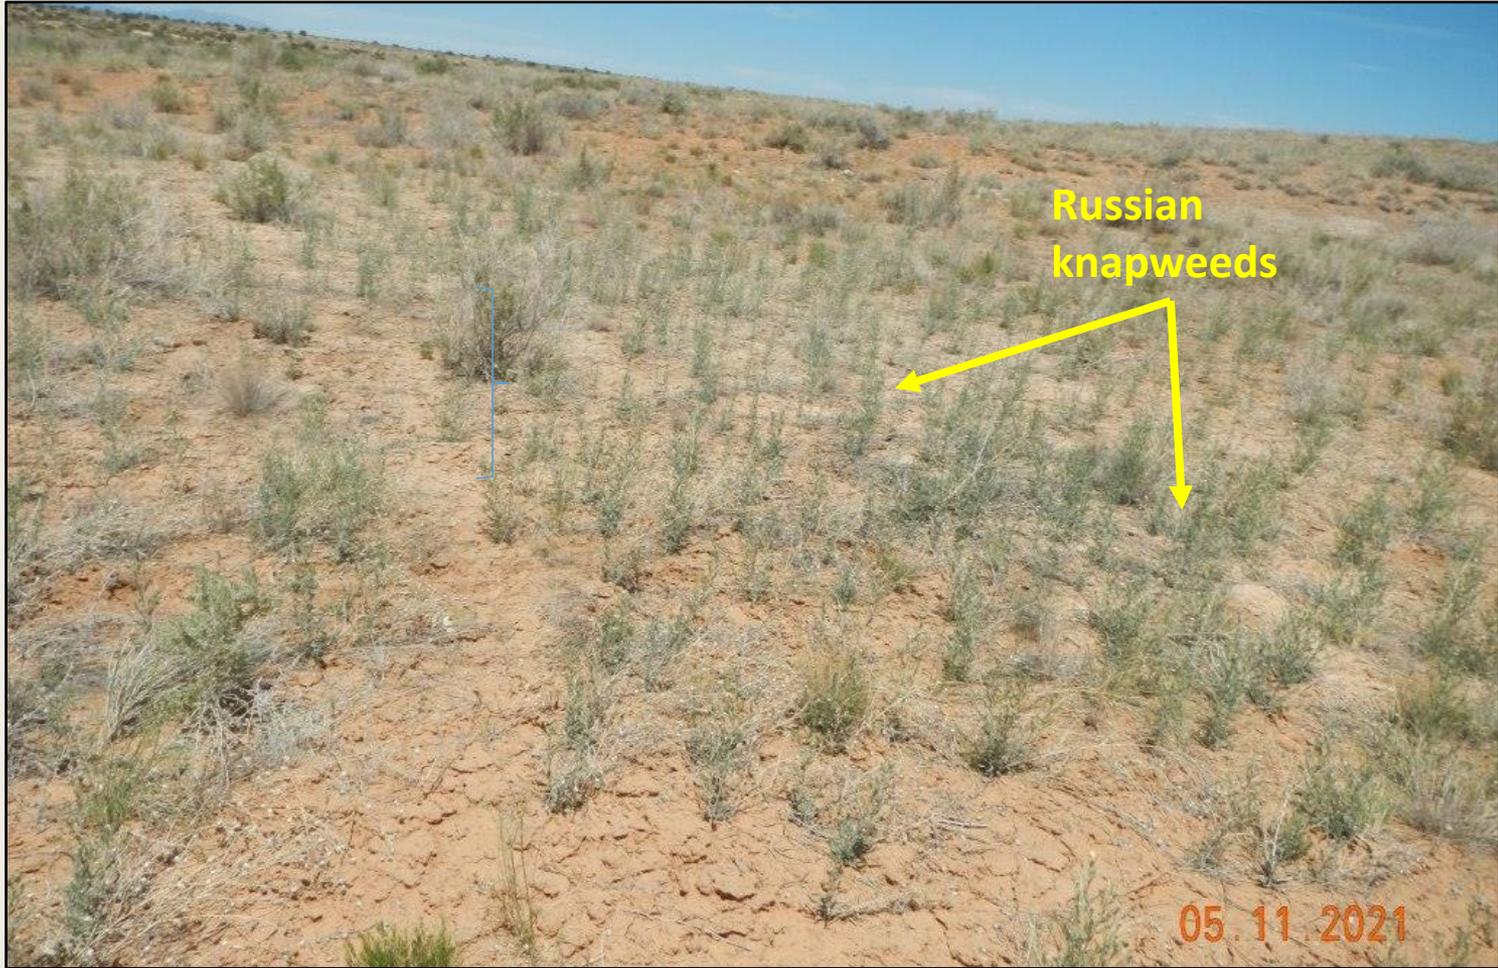
Photo 3. View of more Russian knapweeds within the northern project area.

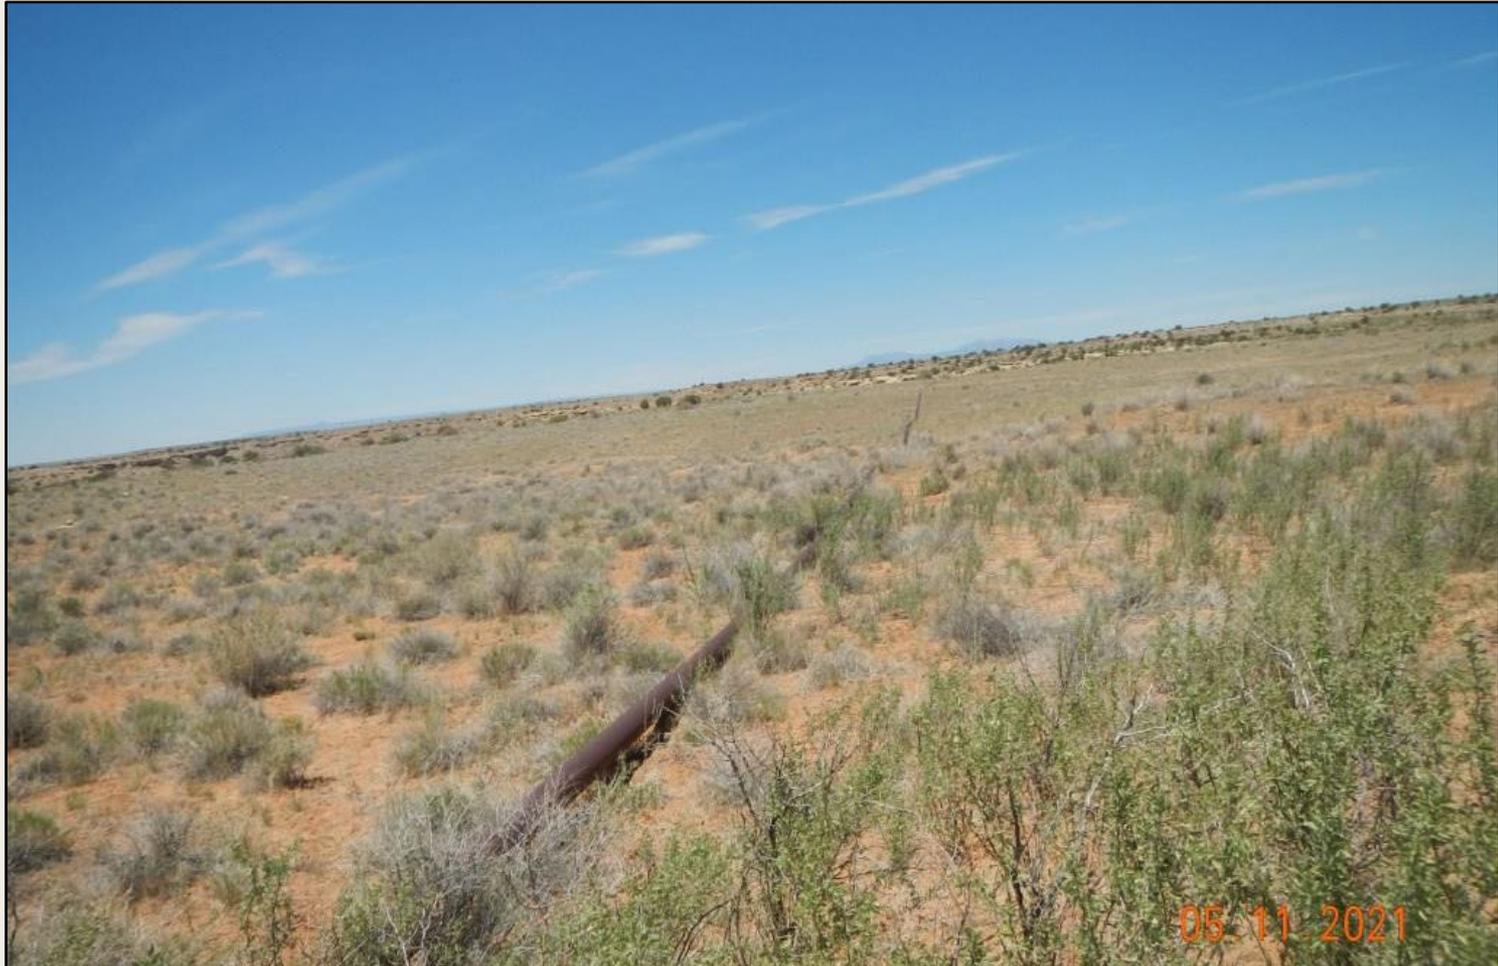
Photo 4. View of surface line remains in place, facing westward.

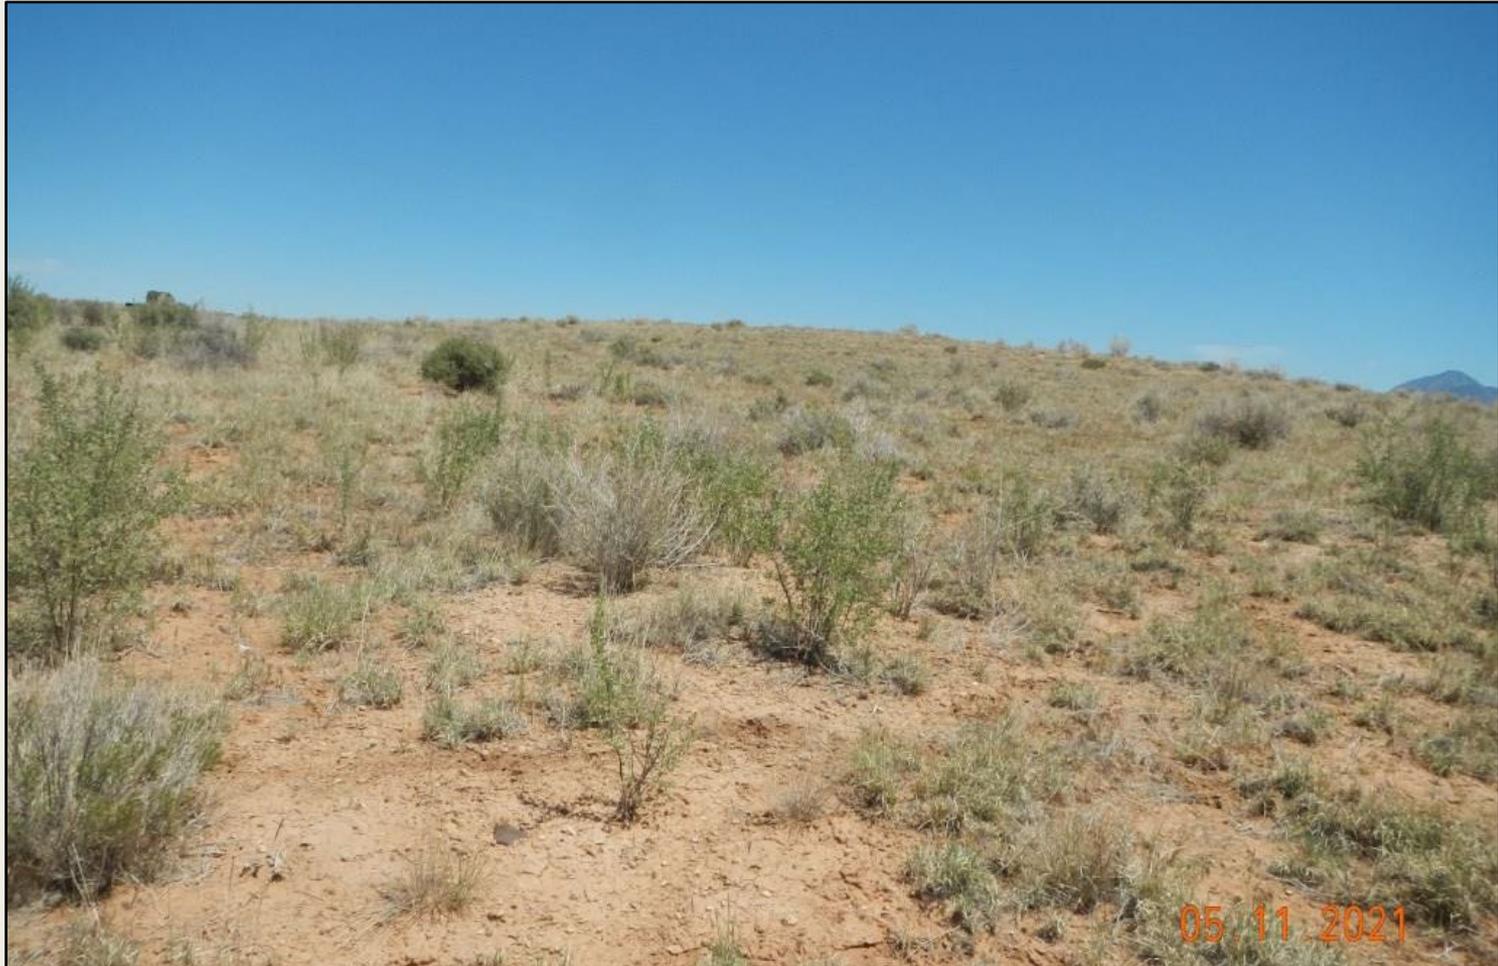
Photo 5. View of the reference area comprised of mixed james galleta grassland and wolfberry shrubland with a diversity of shrubs and herbs such as shadscale, purple threeawn, Indian paintbrush, and goldenaster.
