Inspection Photos

Operator: Bayless

Date: 5/11/2021

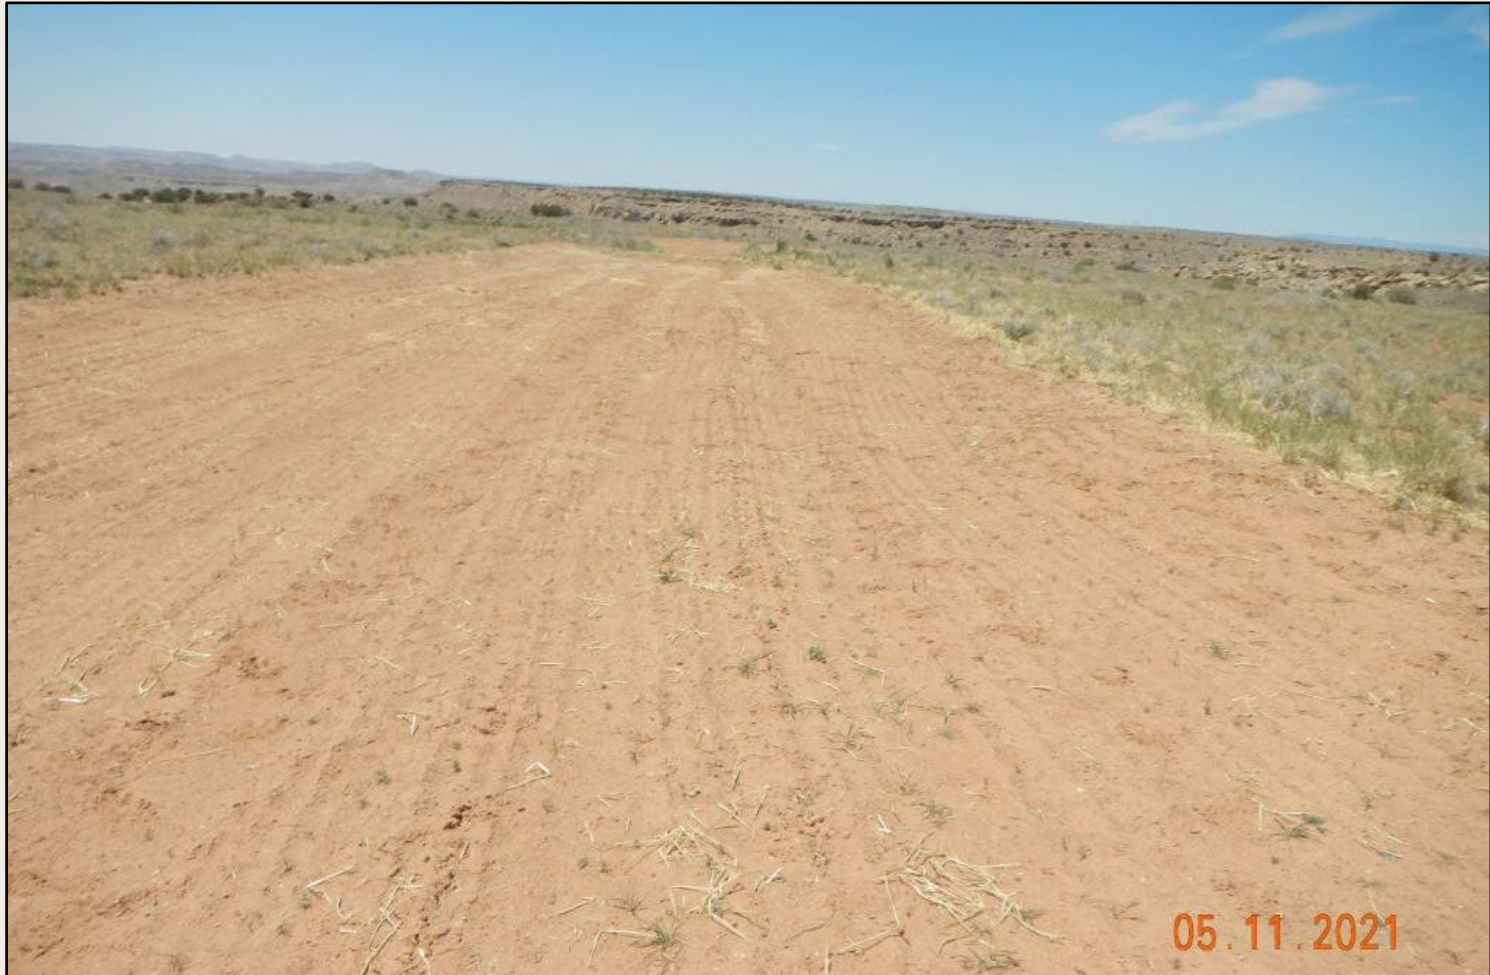
Photo 1. View of the reclaimed access road from the access entrance facing west, toward the reclaimed well pad.

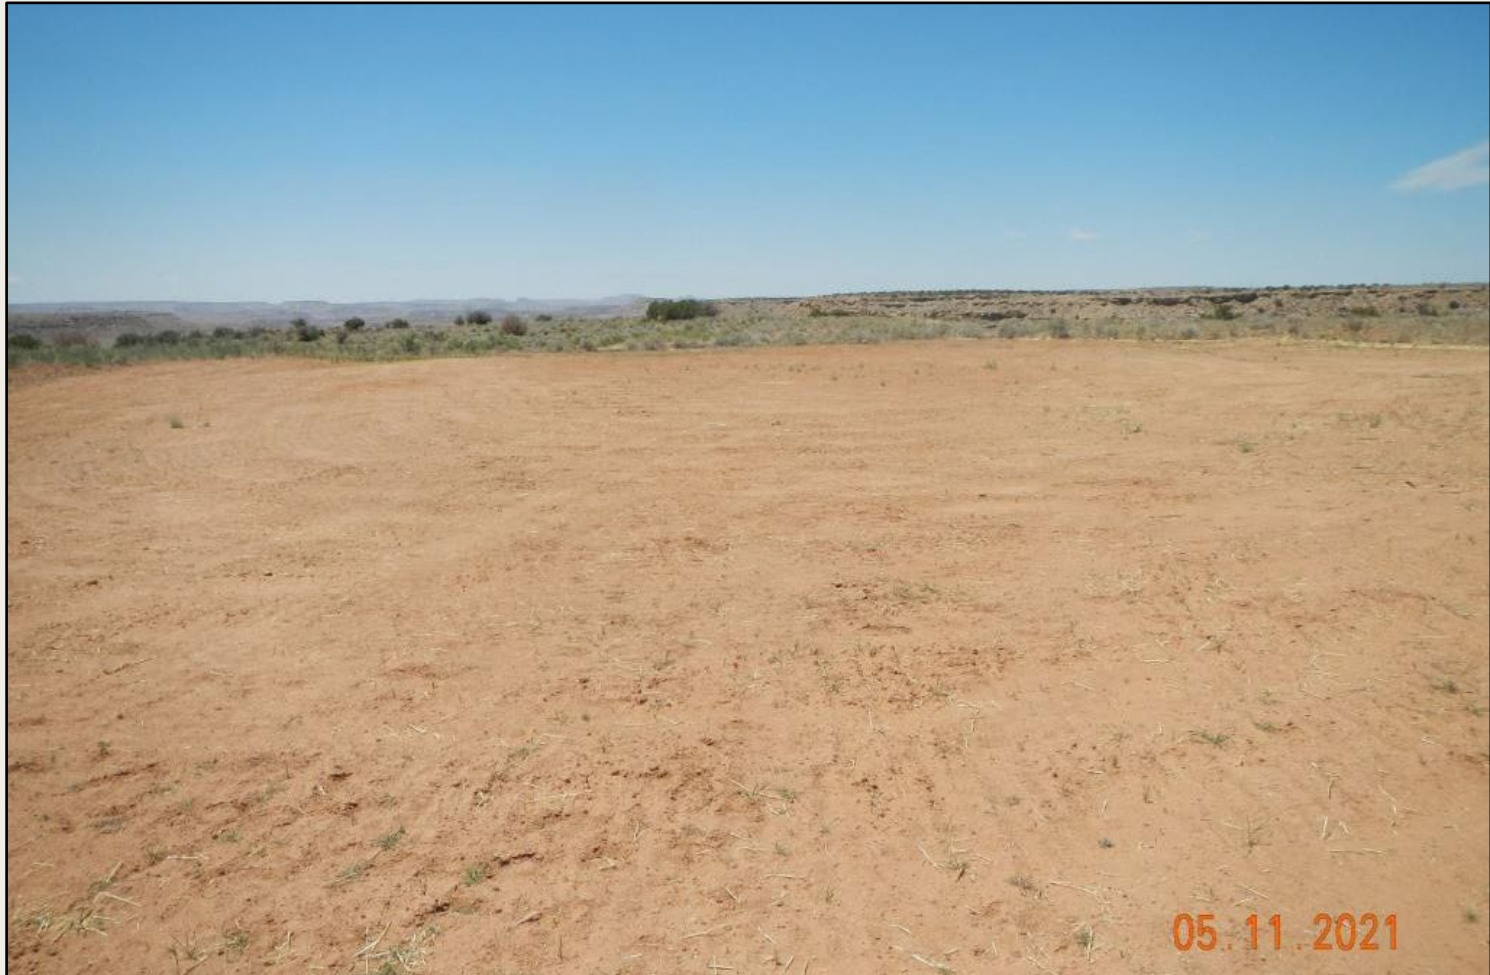
Photo 2. View of the reclaimed well pad from the northwestern corner facing center.

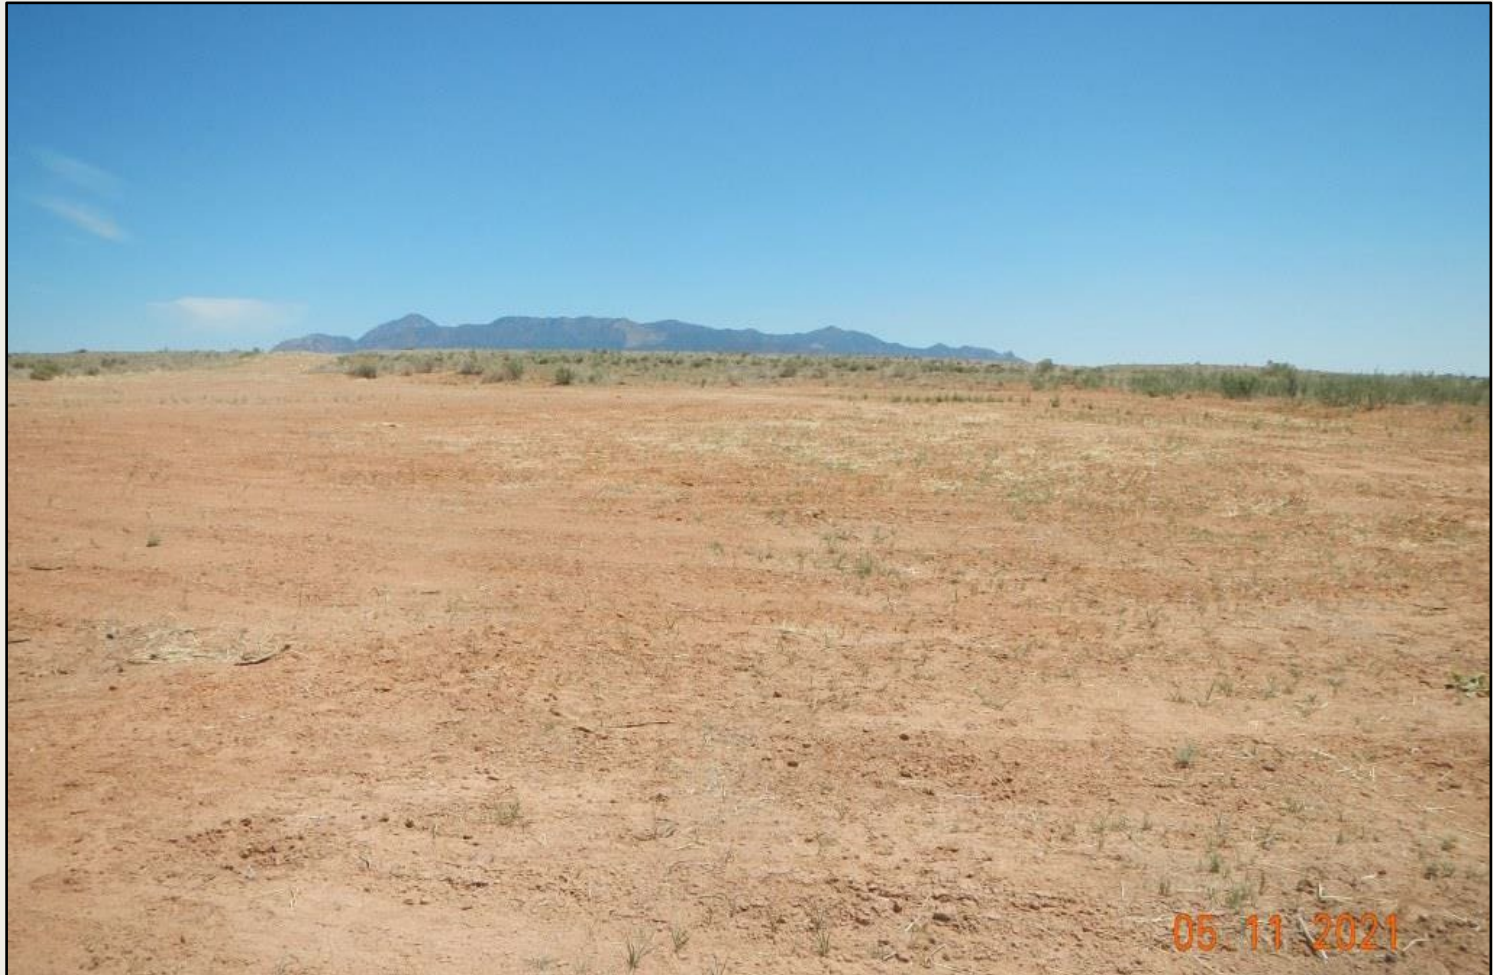
Photo 3. View of the southern project area from the southwestern corner facing eastward.

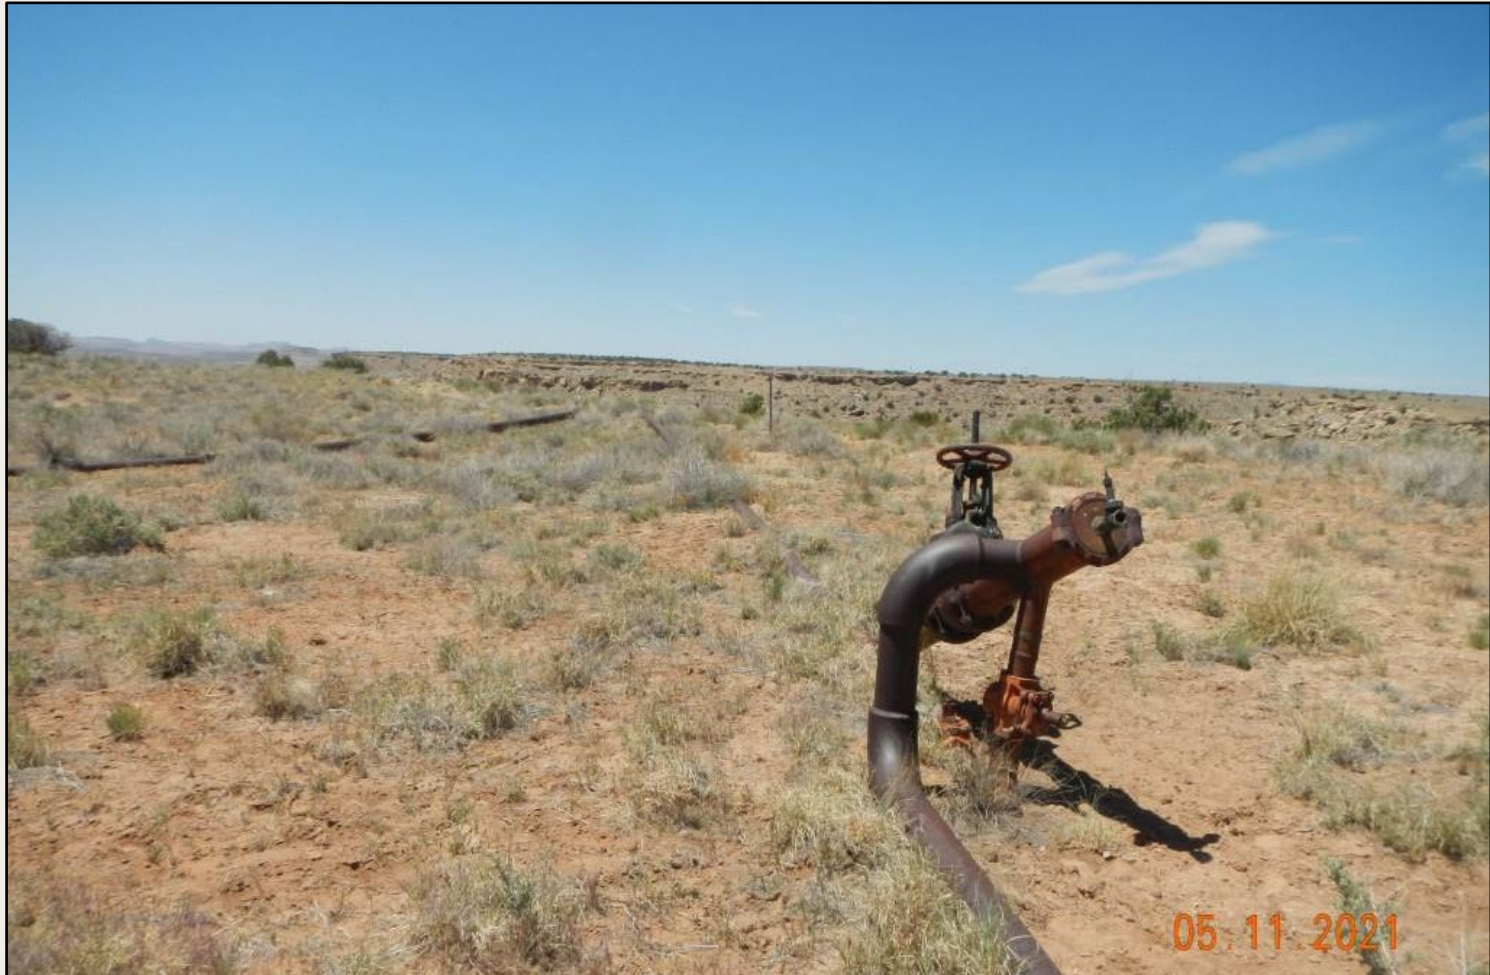
Photo 4. View of surface pipeline and associated equipment remains in place.

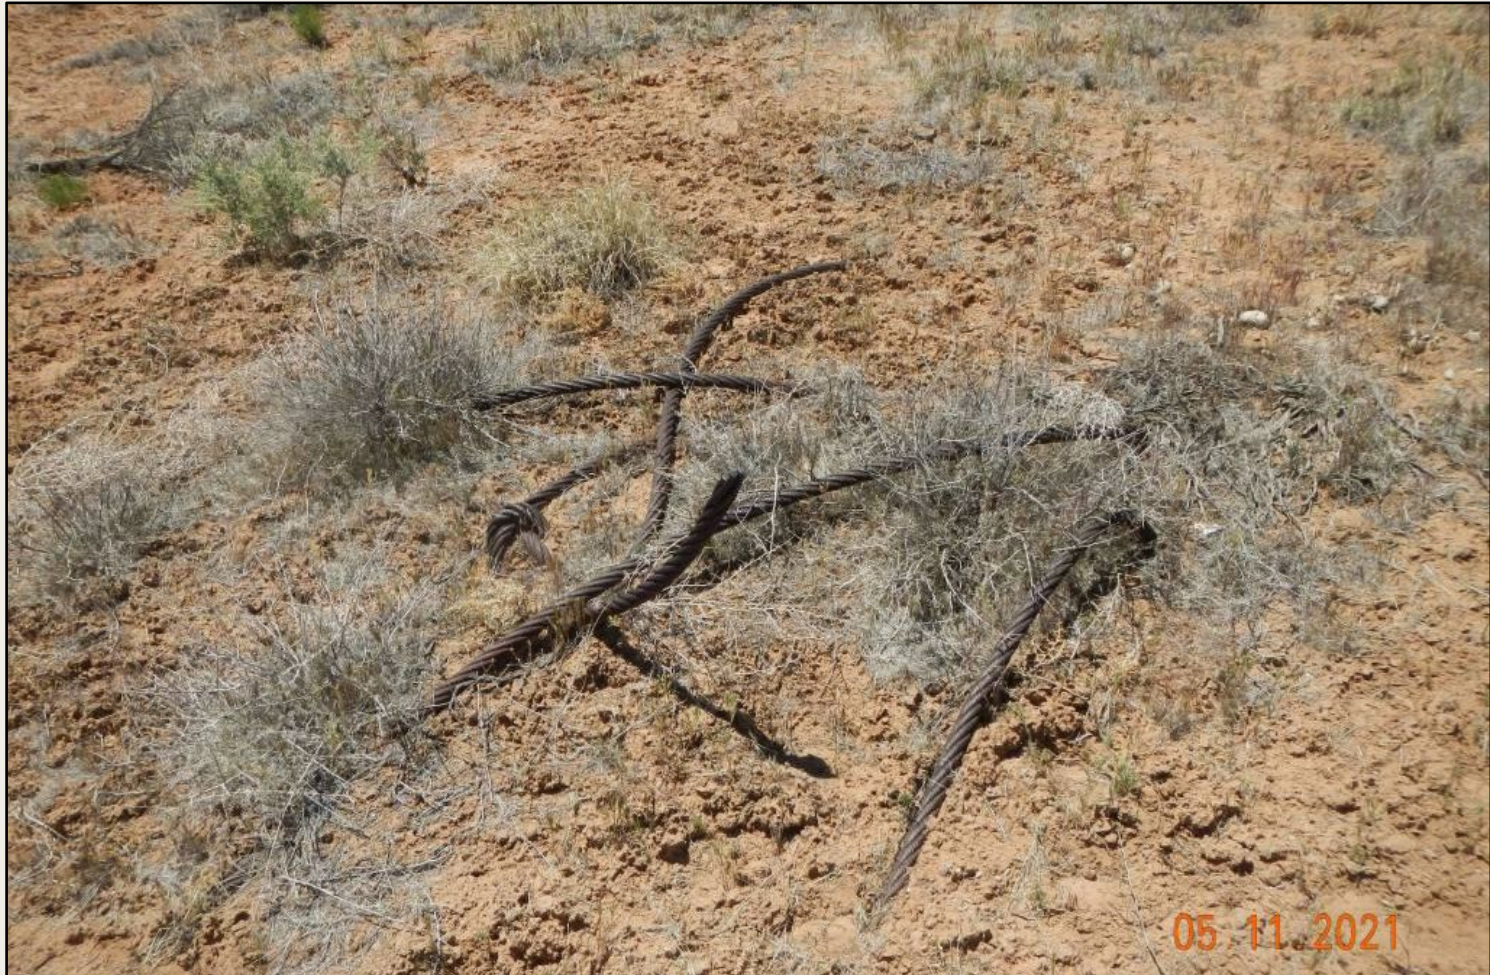
Photo 5. View of cable debris west of the reclaimed well pad.

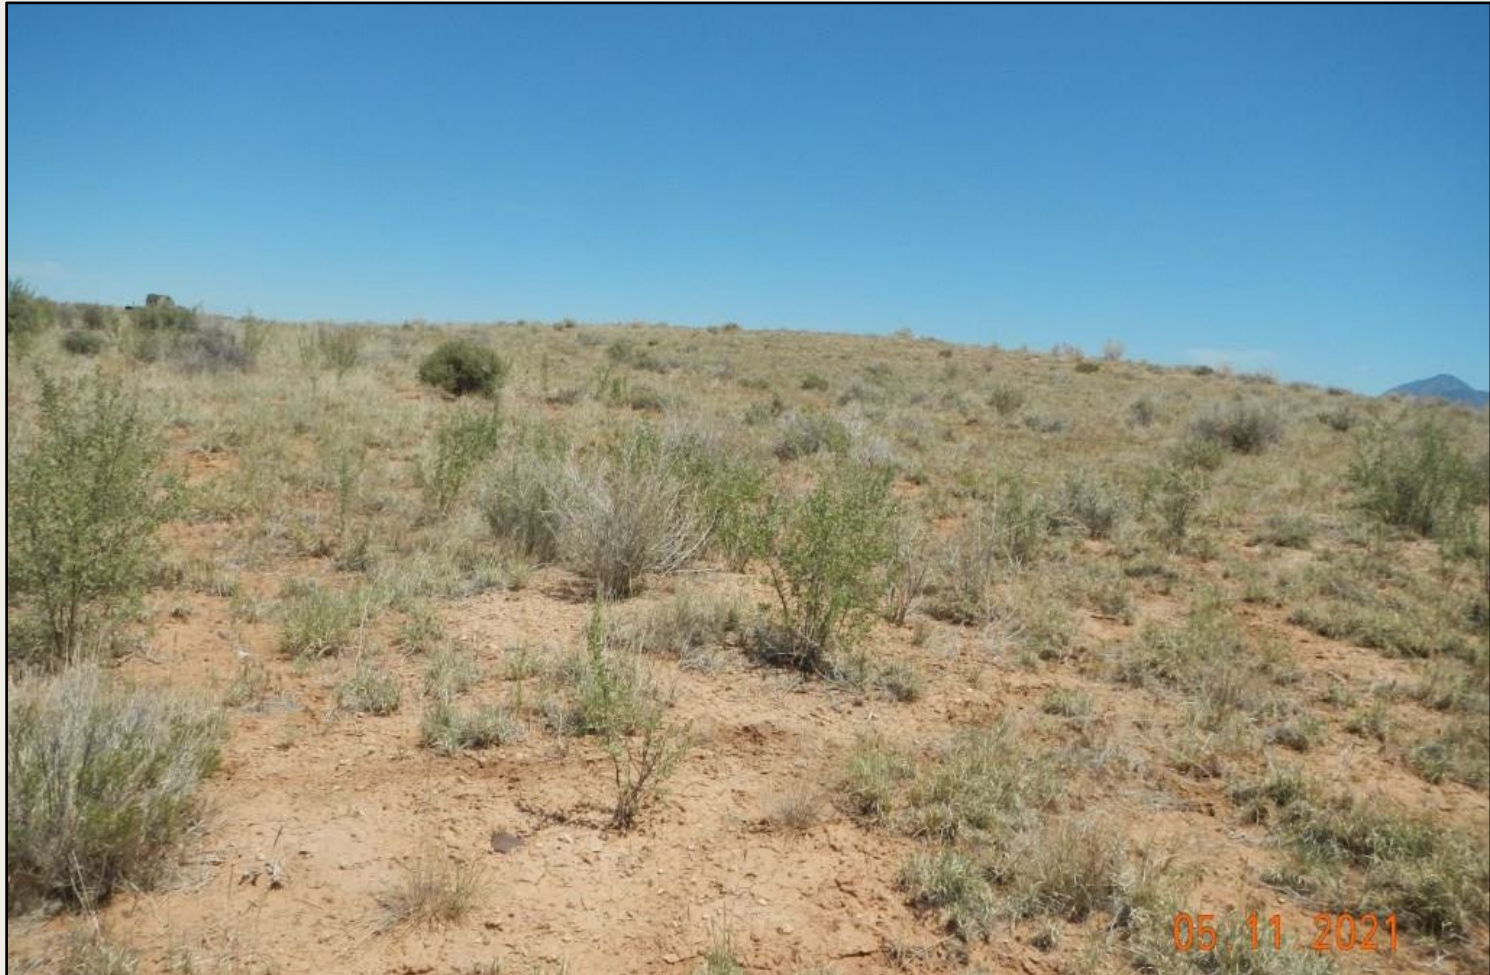
Photo 6. View of the reference area comprised of mixed james galleta grassland and wolfberry shrubland with a diversity of shrubs and herbs such as shadscale, purple threeawn, Indian paintbrush, and goldenaster.
