Inspection Photos  
Operator: Simcoe  
API: 067-07233  
Date: 5/17/2021

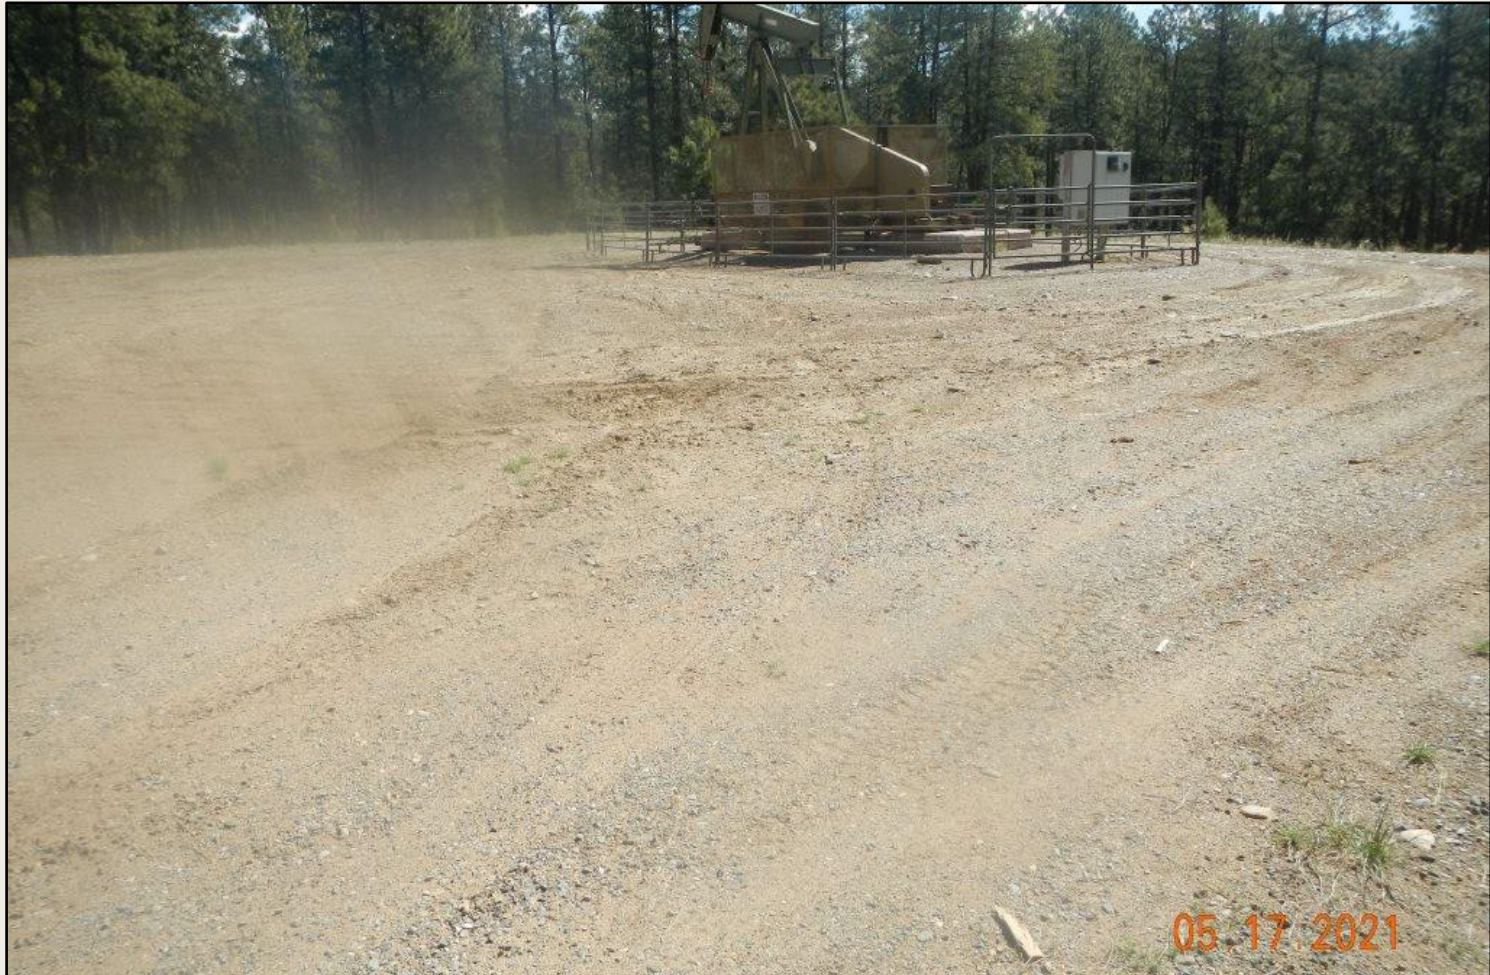
Photo 1. View of project area from the well pad entrance facing center.

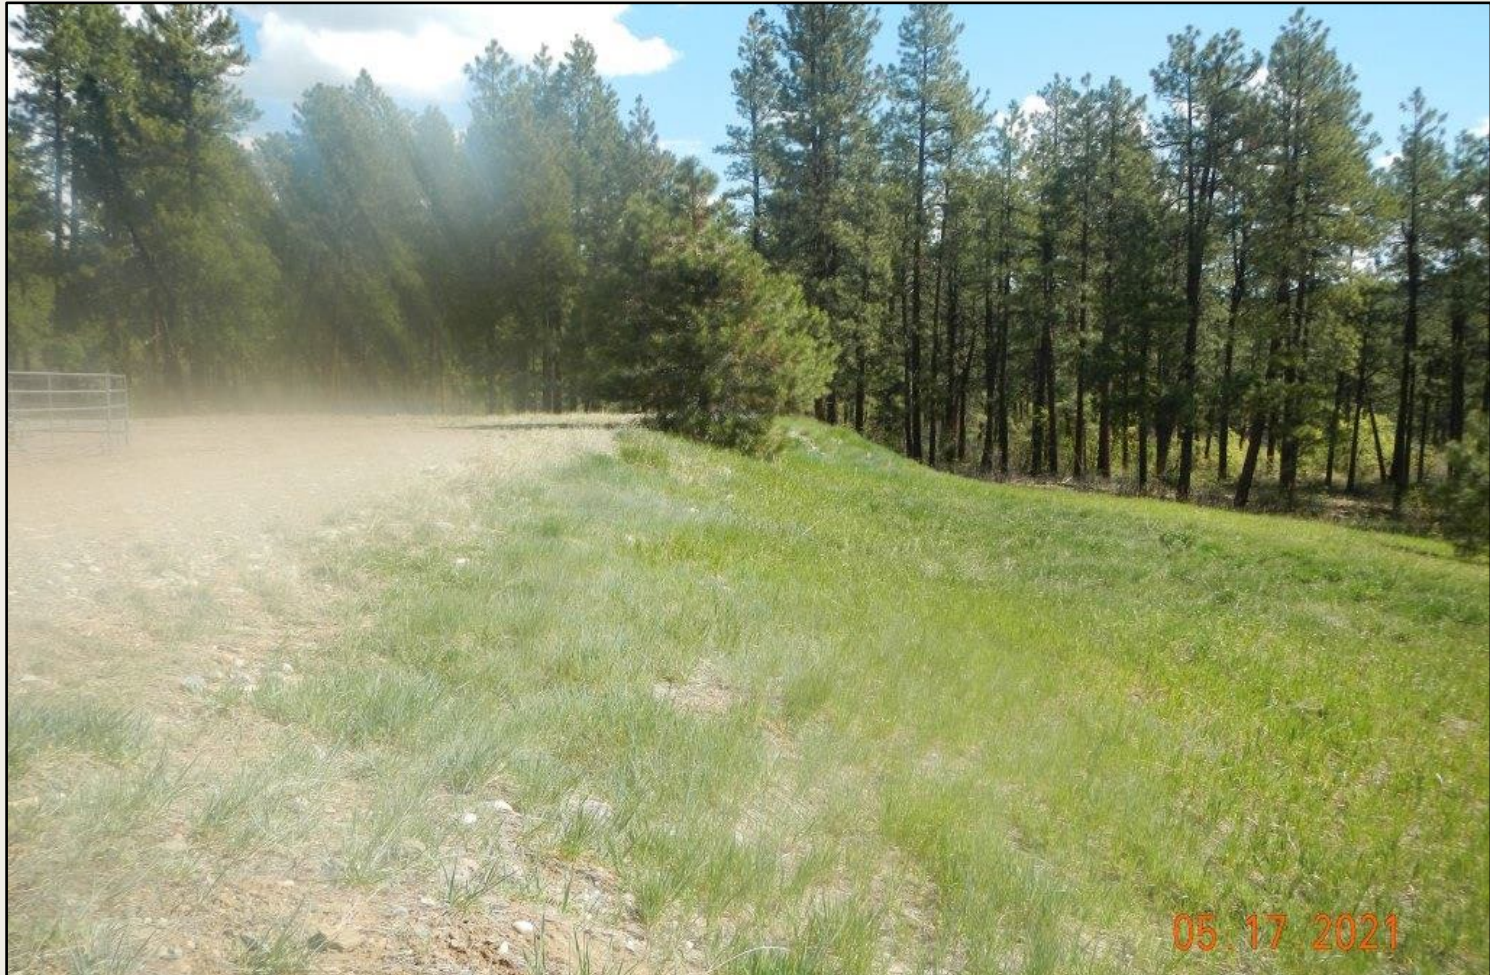
Photo 2. View of the eastern project area from the southeastern corner facing northward. Revegetation is progressing with a mixture of grasses such as western wheatgrass, smooth brome, and sand dropseed.

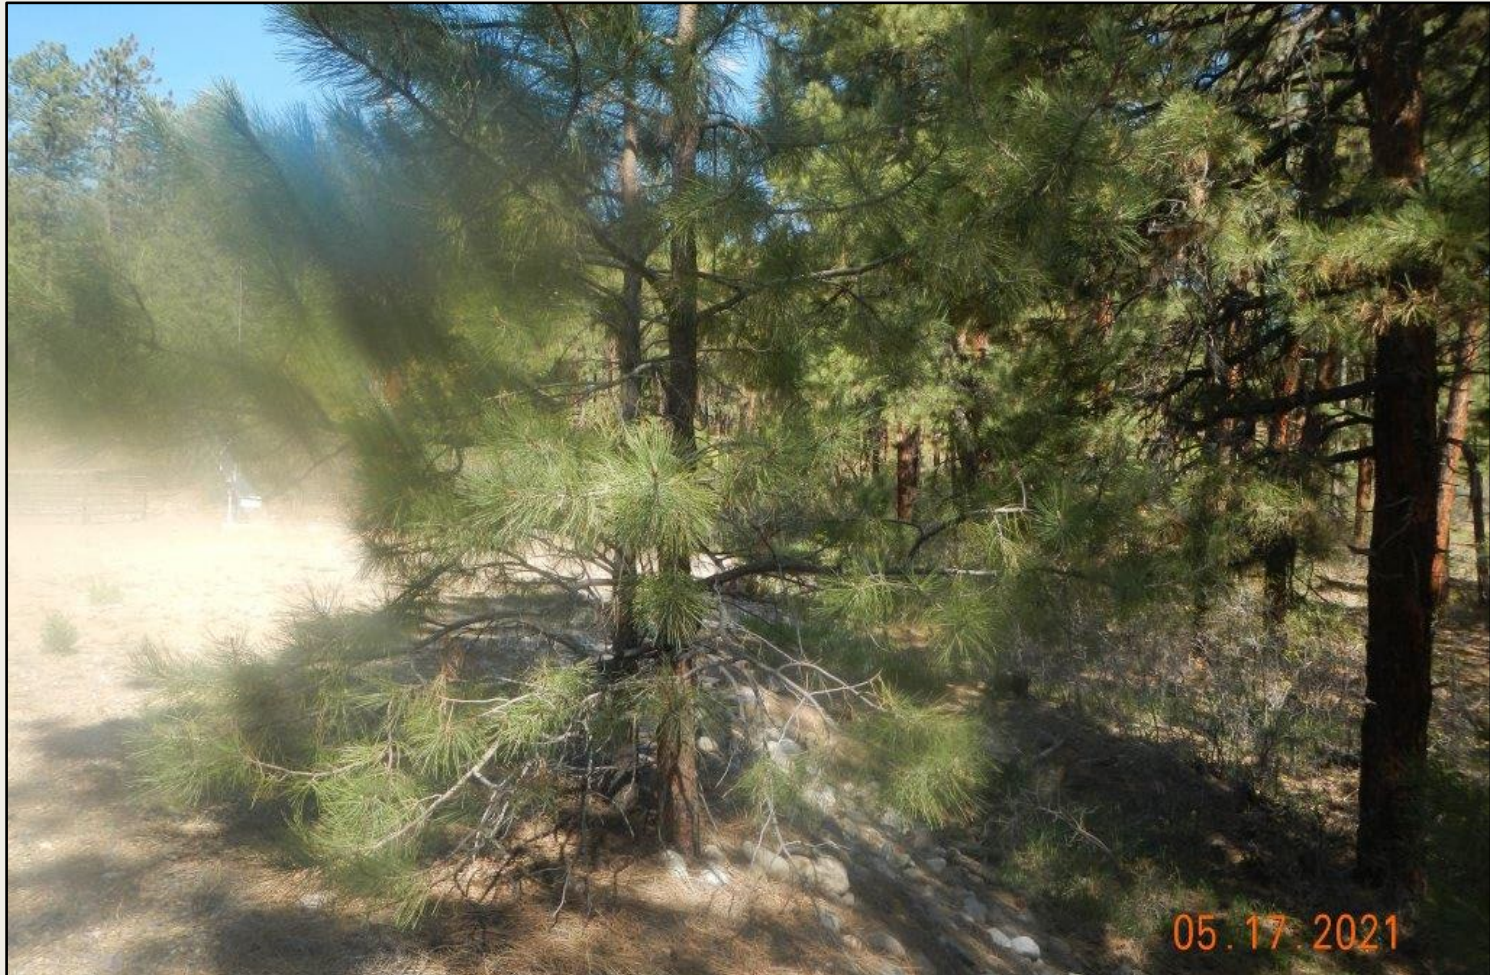
Photo 3. View of northern project area from the northeastern corner facing westward.

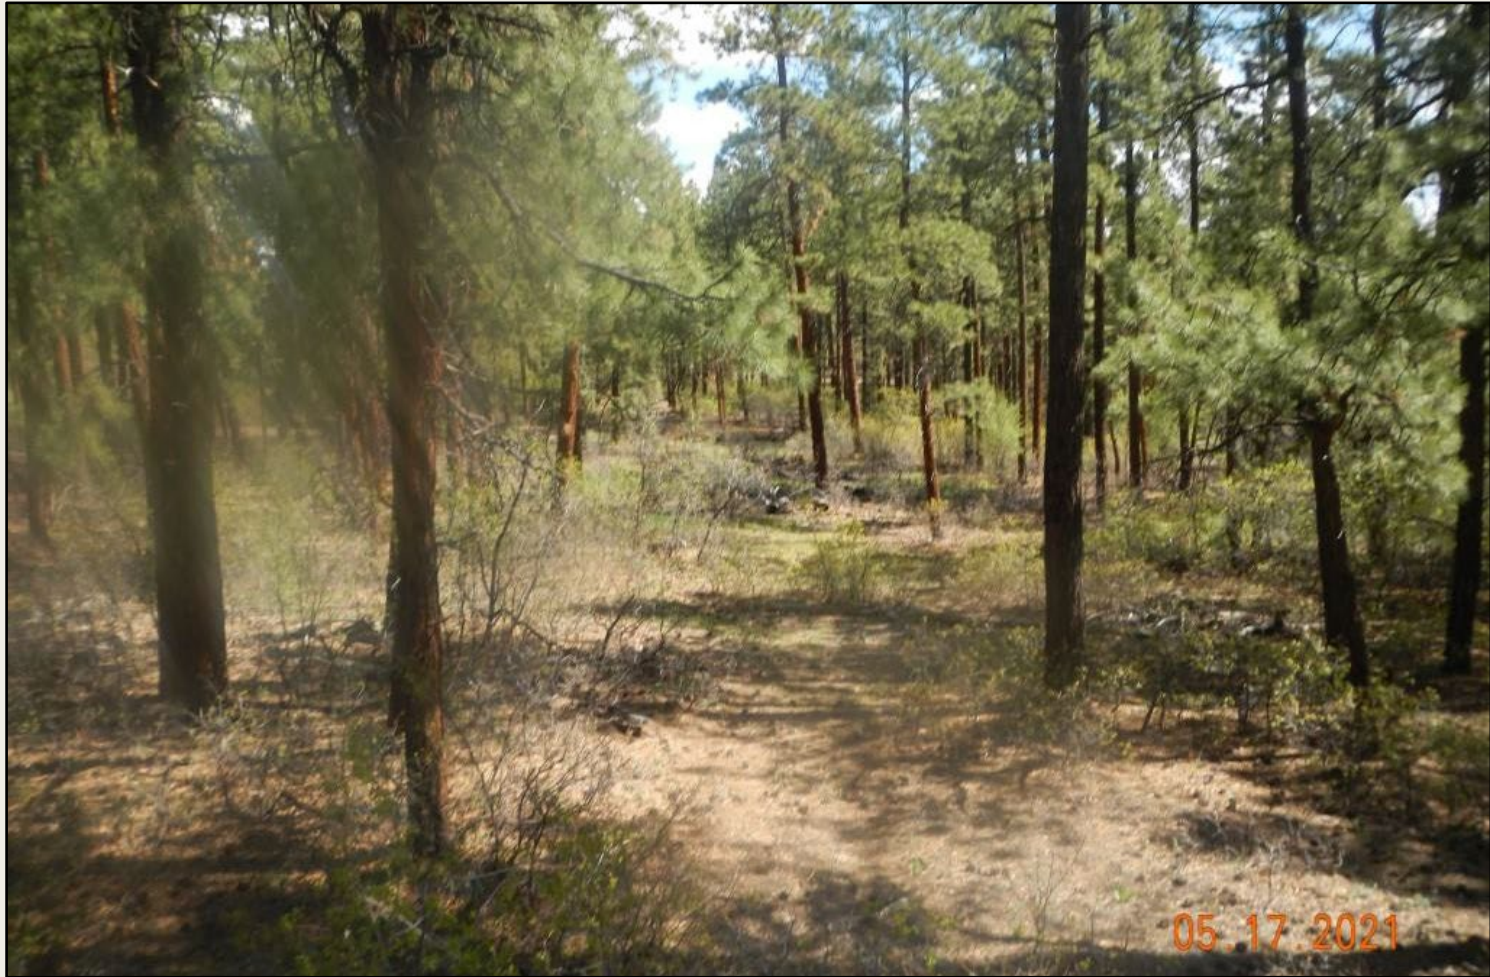
Photo 4. View of the reference area comprised of ponderosa pine forest with understory of gambel oak, Oregon grape, *Poa secunda*, and serviceberry.
