Inspection Photos  
Operator: Simcoe  
API: 067-09079  
Date: 5/17/2021

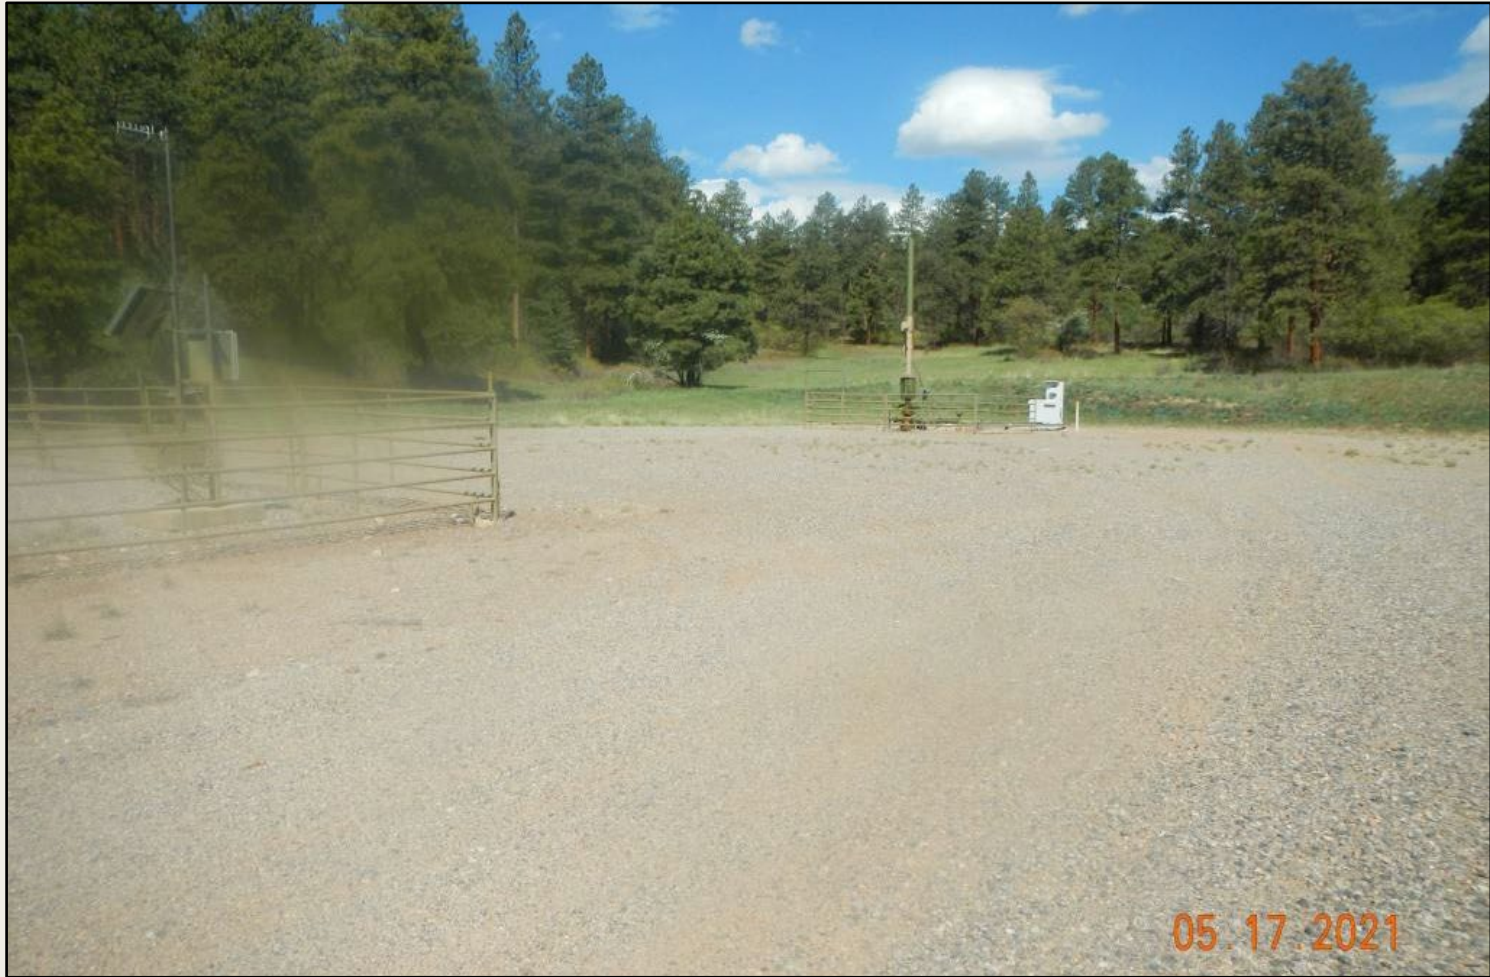
Photo 1. View of project area from the well pad entrance facing center.

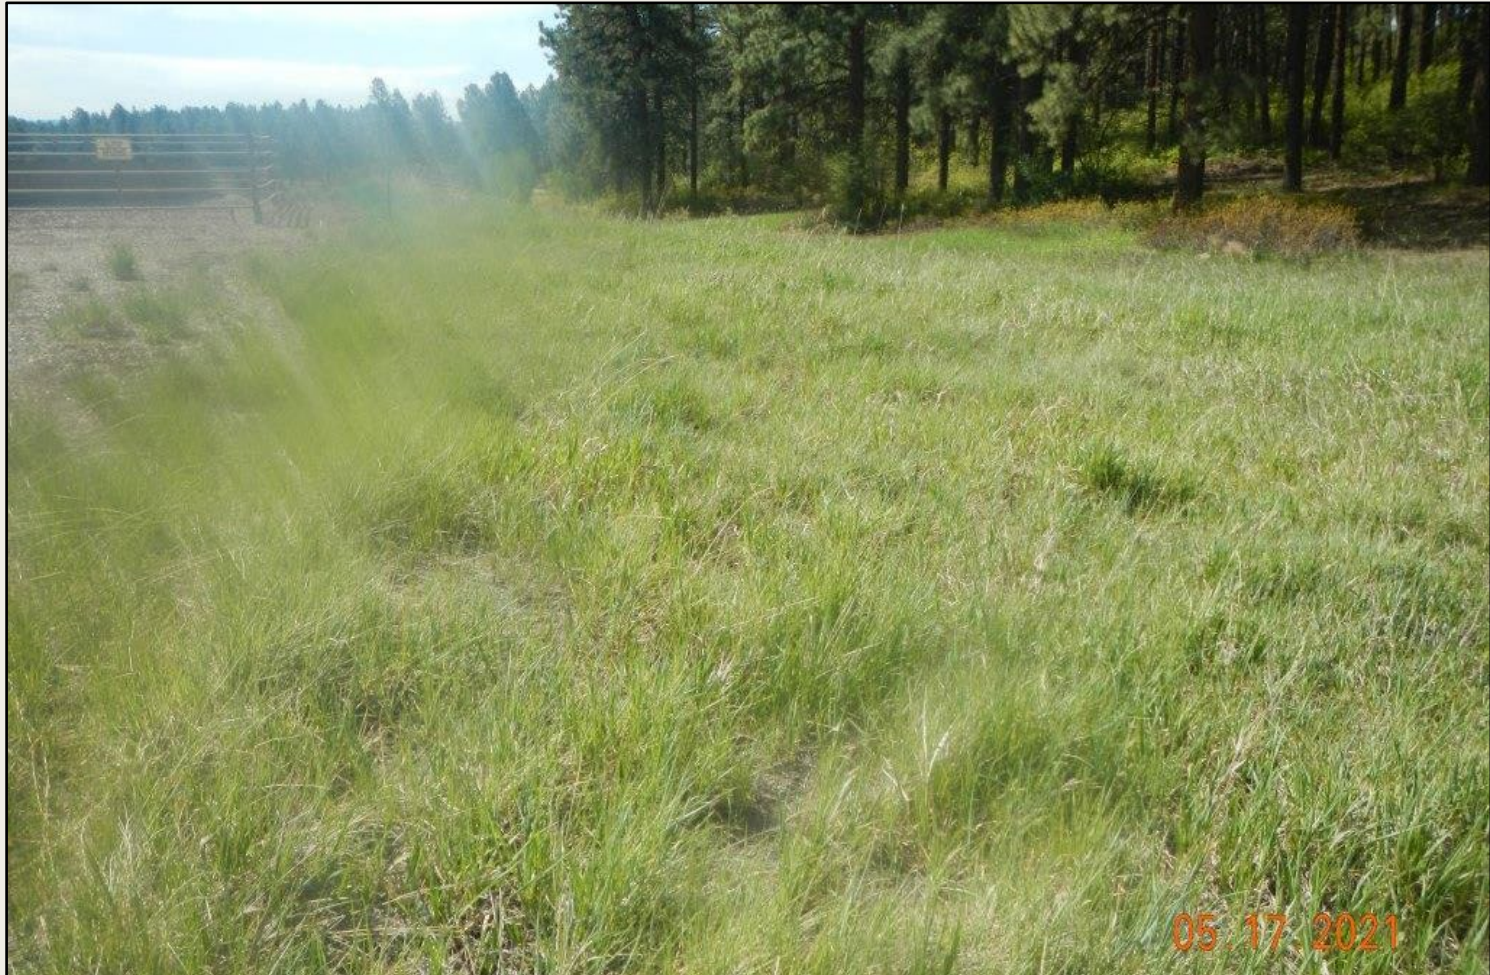
Photo 2. View of the western project area from the northwestern corner facing southward. Revegetation is progressing with a mixture of grasses such as western wheatgrass, smooth brome, and sand dropseed.

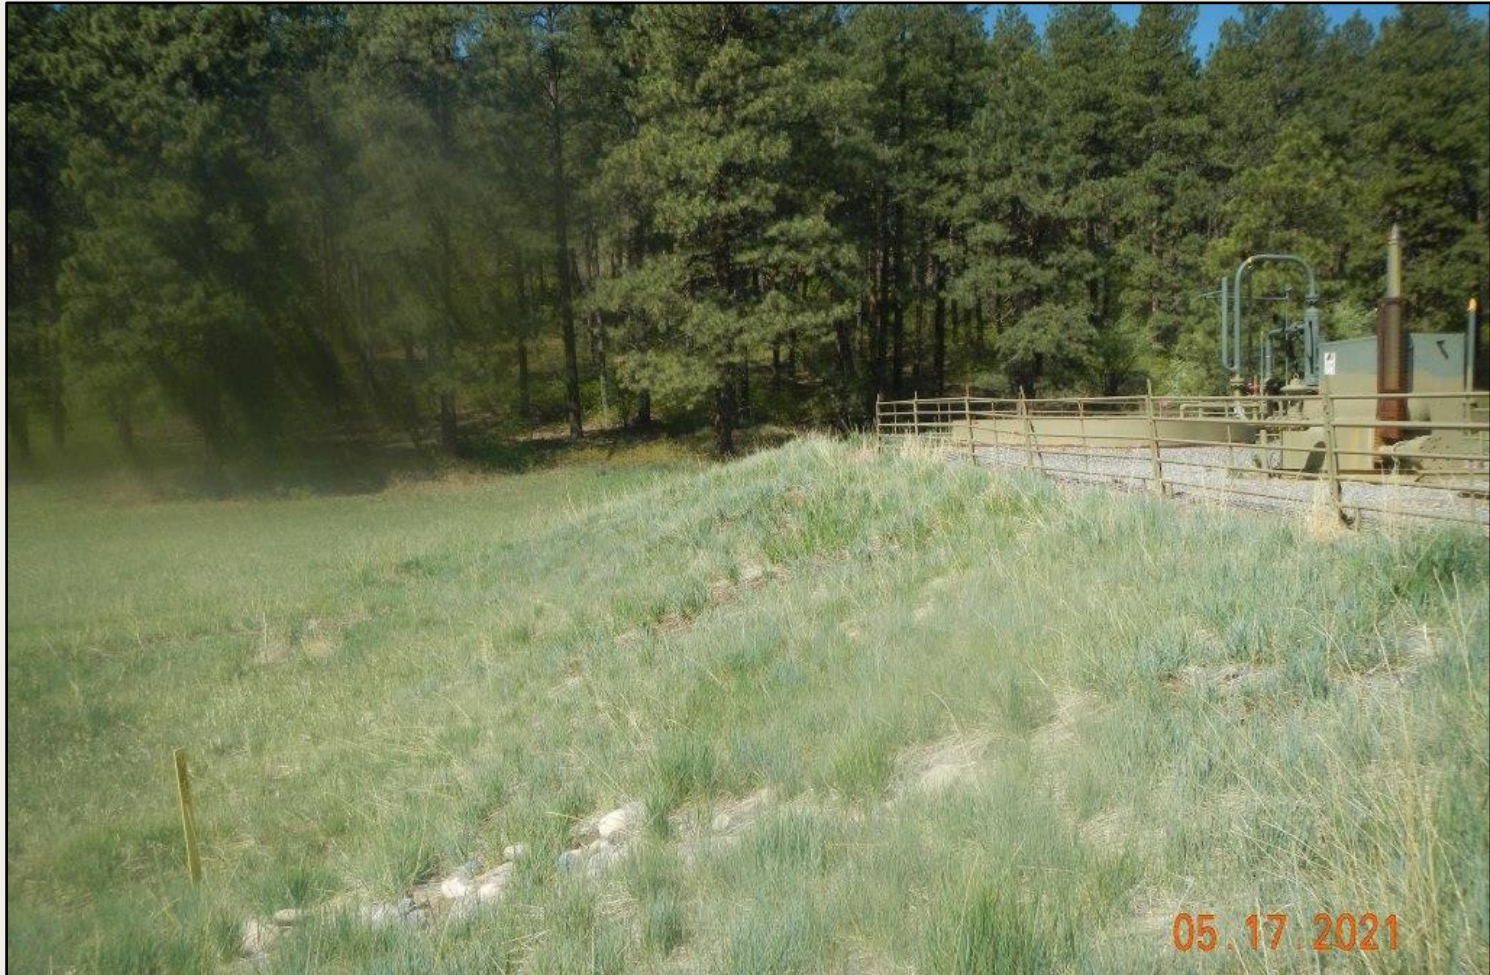
Photo 3. View of southern project area from the southeastern corner facing westward.

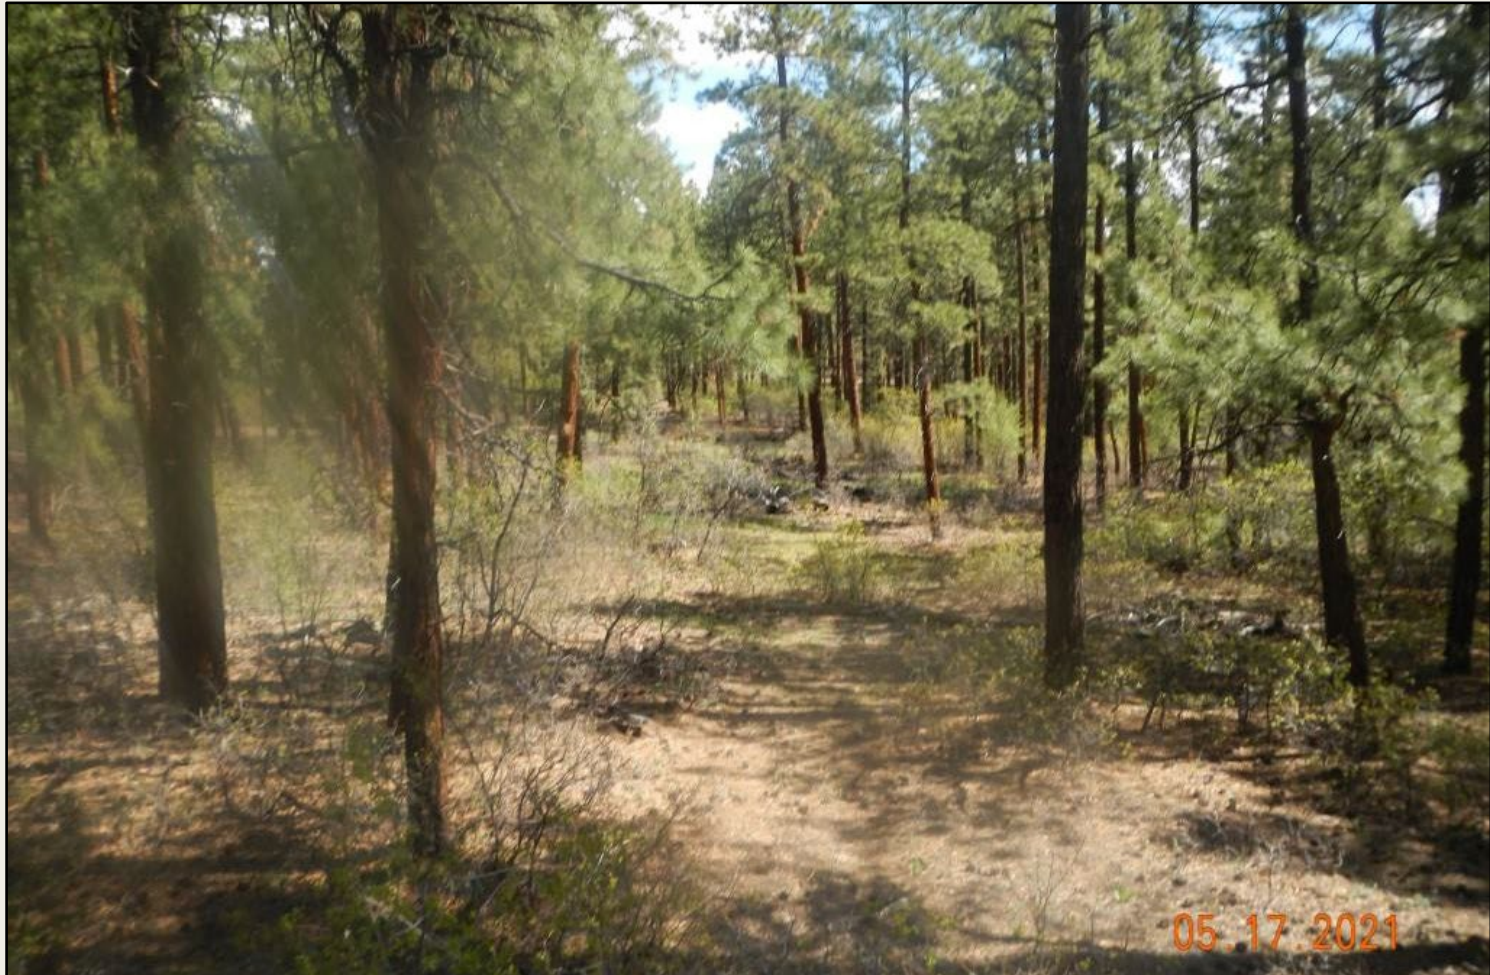
Photo 4. View of the reference area comprised of ponderosa pine forest with understory of gambel oak, Oregon grape, *Poa secunda*, and serviceberry.
