Inspection Photos

5/14/2021

Operator: LARAMIE ENERGY LLC #10433

Location ID: 452807

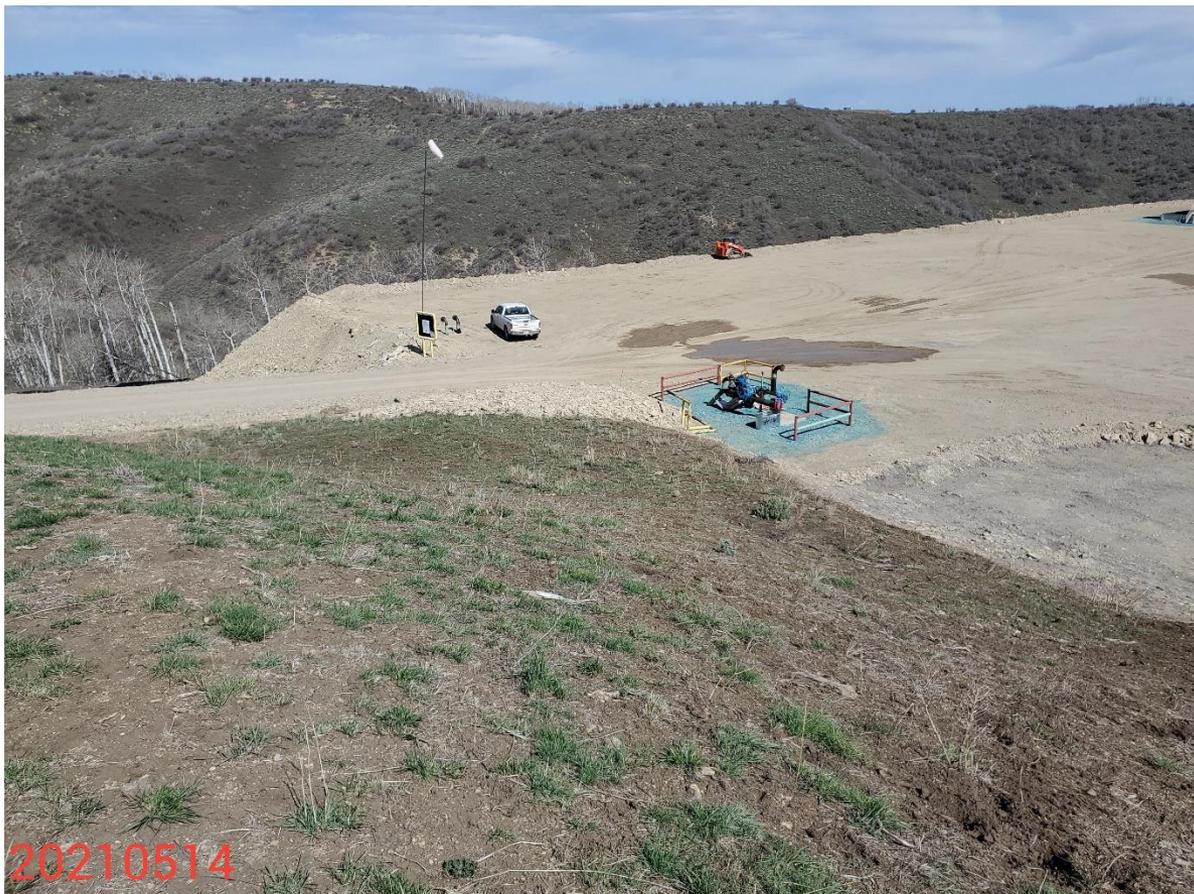
Photo 1: Photo taken from the south end of the Location, facing northwest. Photos 1-3 provide an overview of the Location from northwest, north to northeast. Photos also show that interim reclamation of areas not needed for production on the Location has not been conducted in accordance with 1003 Rules and Corrective actions.

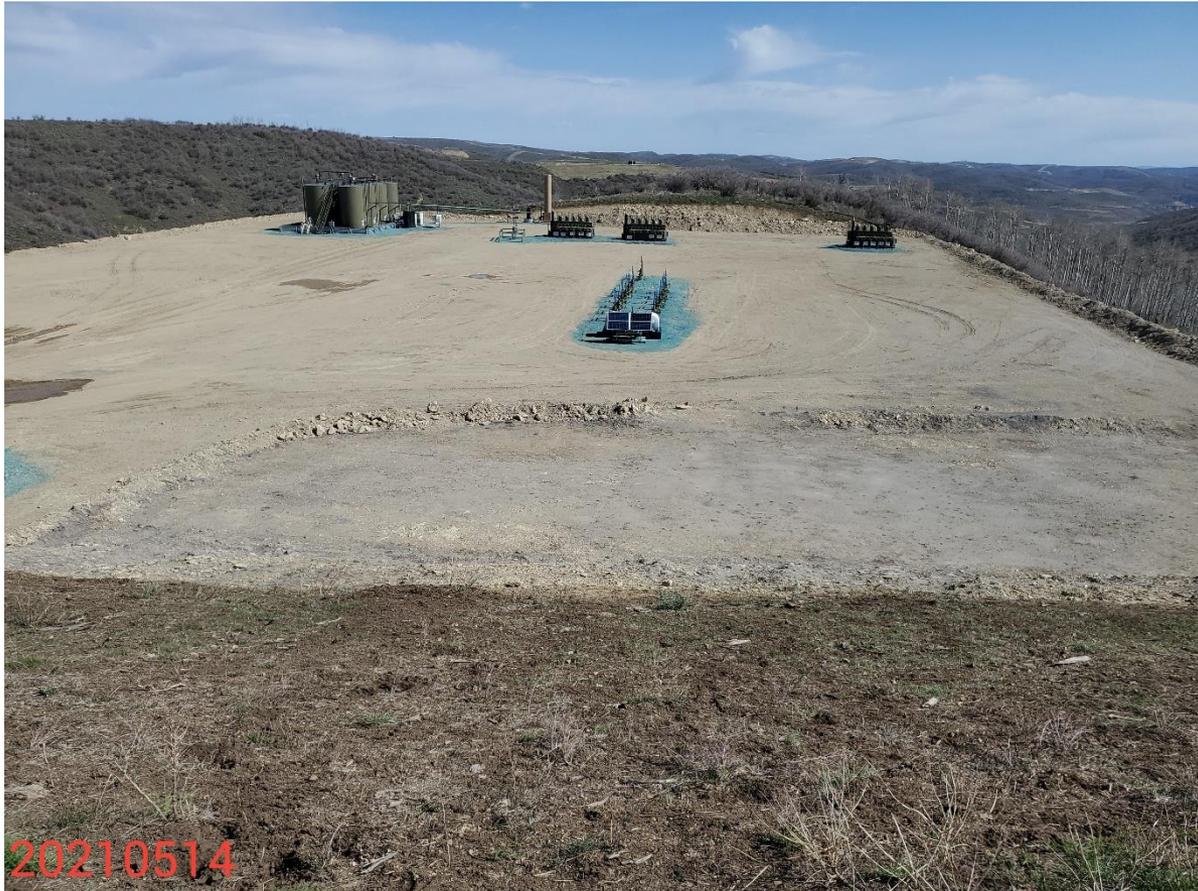
Photo 2: See comments under photo 1.

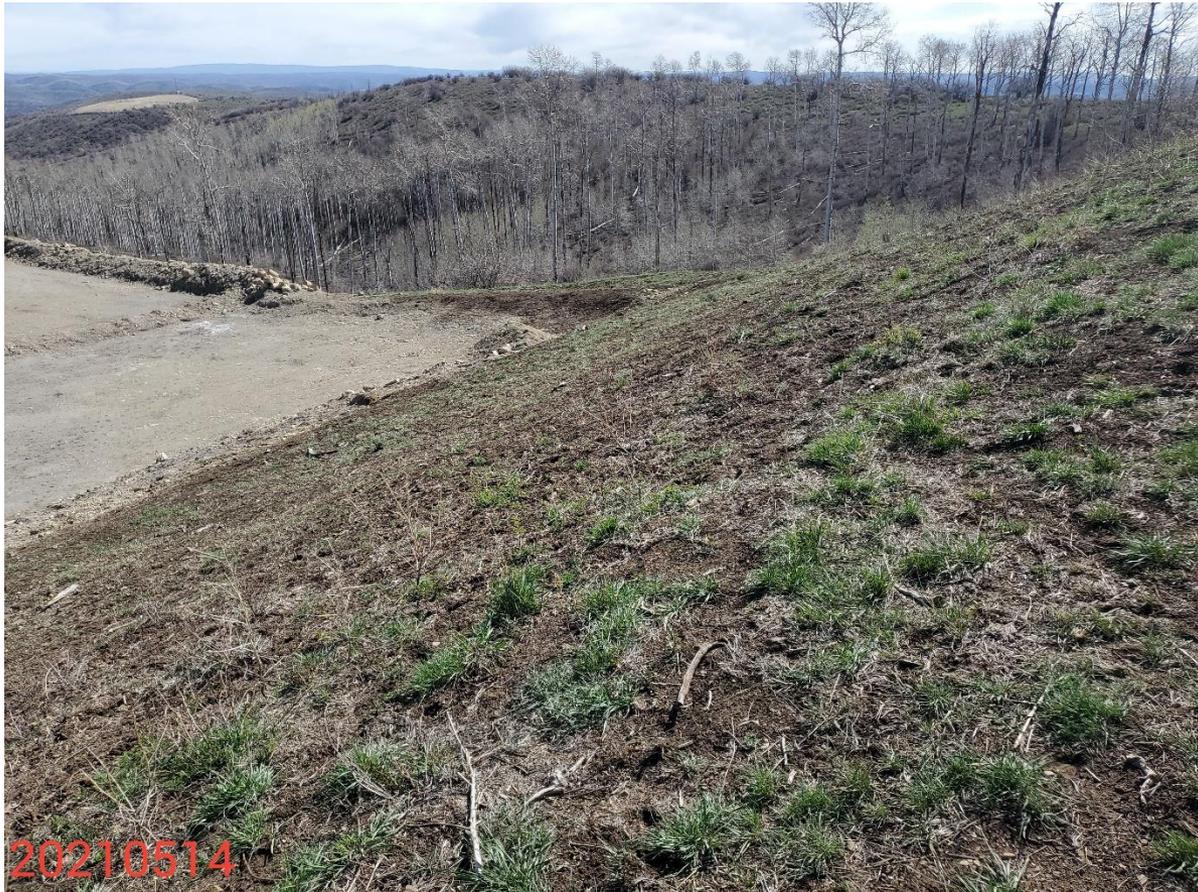
Photo 3: See comments under photo 1.

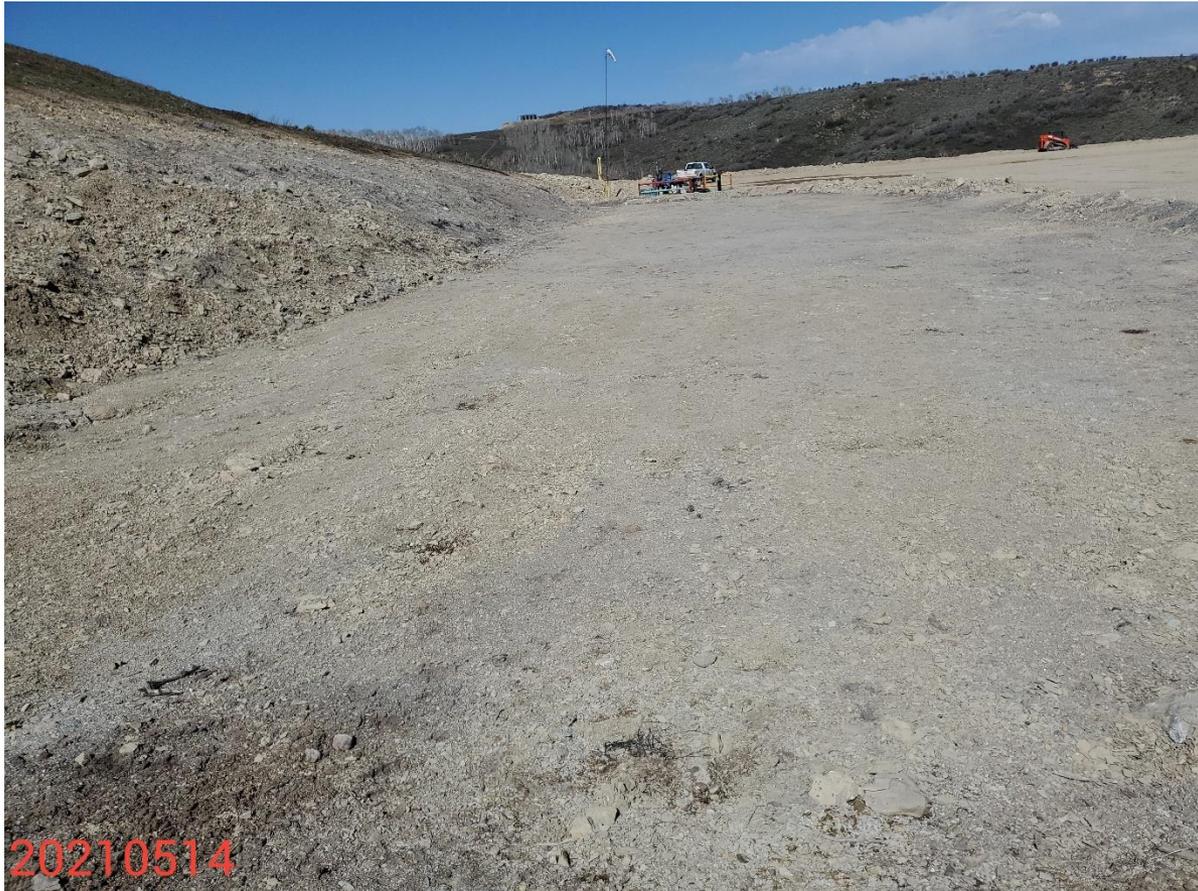
Photo 4: Photo taken from the south end of the Location, facing west. See comments under photo 1.

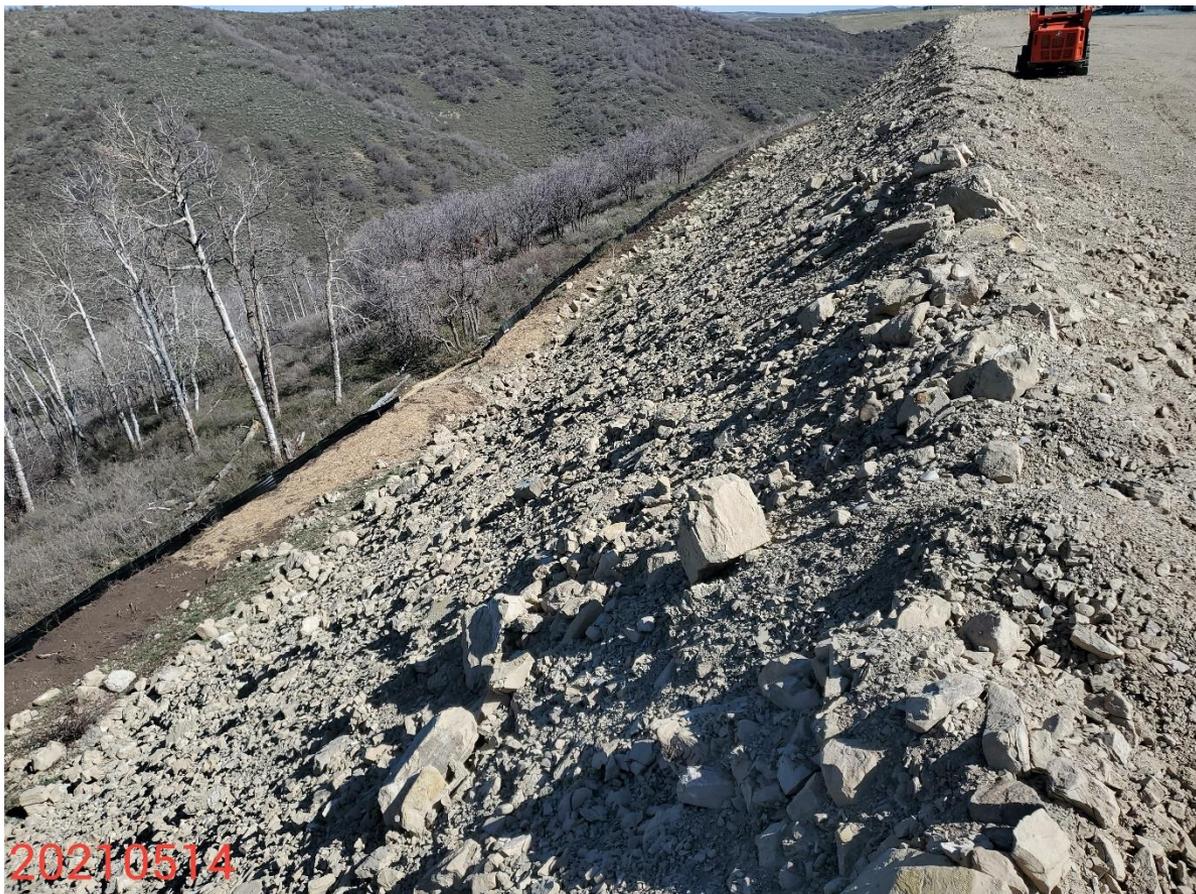
Photo 5 Photo taken from the west end of the Location, facing north. Photo shows Operator has maintained perimeter control measures to manage stormwater runoff from the Location. Photo also shows that required control measures to protect/stabilize the fill slopes on the Location remain missing or insufficient.

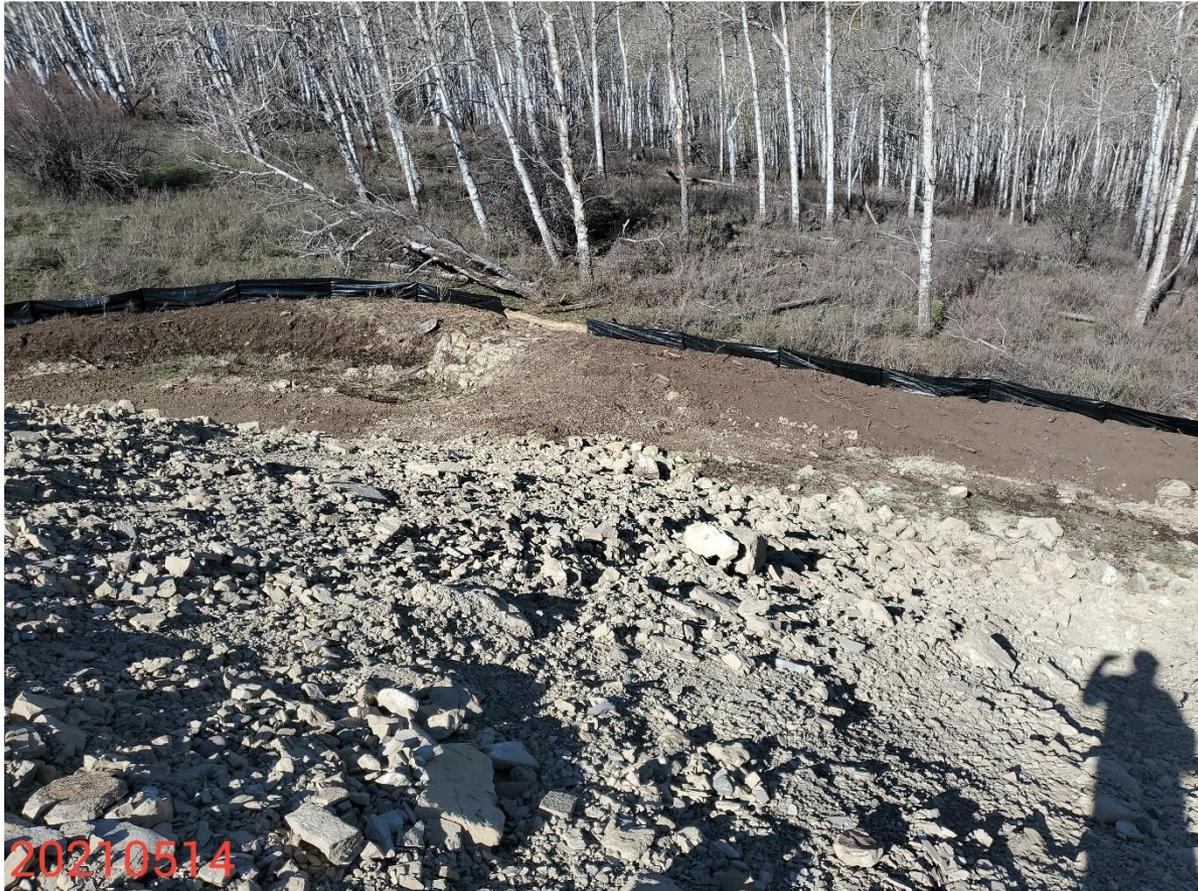
Photo 6: Photo taken from the west end of the Location, facing southwest. Photo shows Operator has maintained perimeter control measures to manage stormwater runoff from the Location. Photo also shows that required control measures to protect/stabilize the fill slopes on the Location remain missing or insufficient.

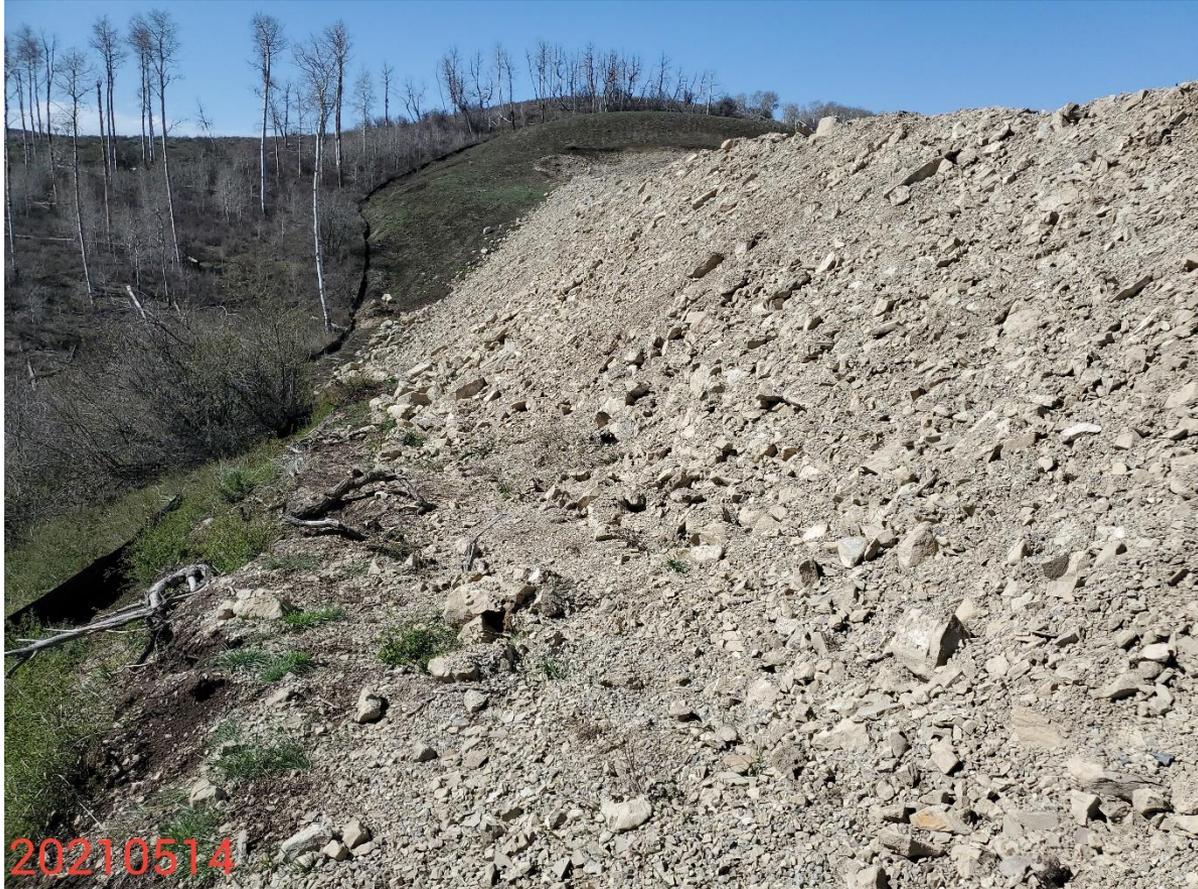
Photo 7: Photo taken from the east end of the Location, facing south. Photo shows that required control measures to protect/stabilize the fill slopes on the Location remain missing or insufficient.

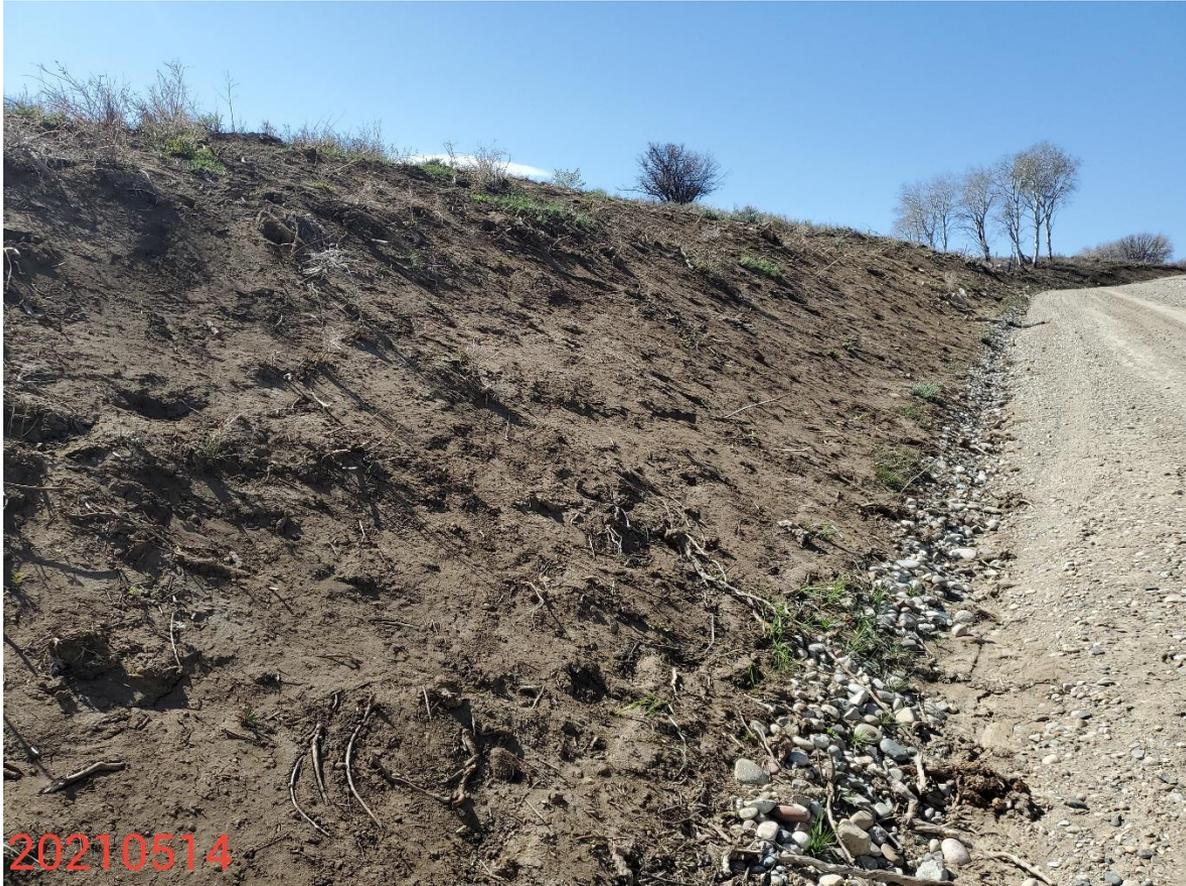
Photo 8: Photo taken from the access road, facing south. Previous inspection required Operator to conduct additional reclamation along the access road, and to implement control measures to stabilize the seeded soils; unable to find evidence that additional reclamation was performed, and control measures installed.

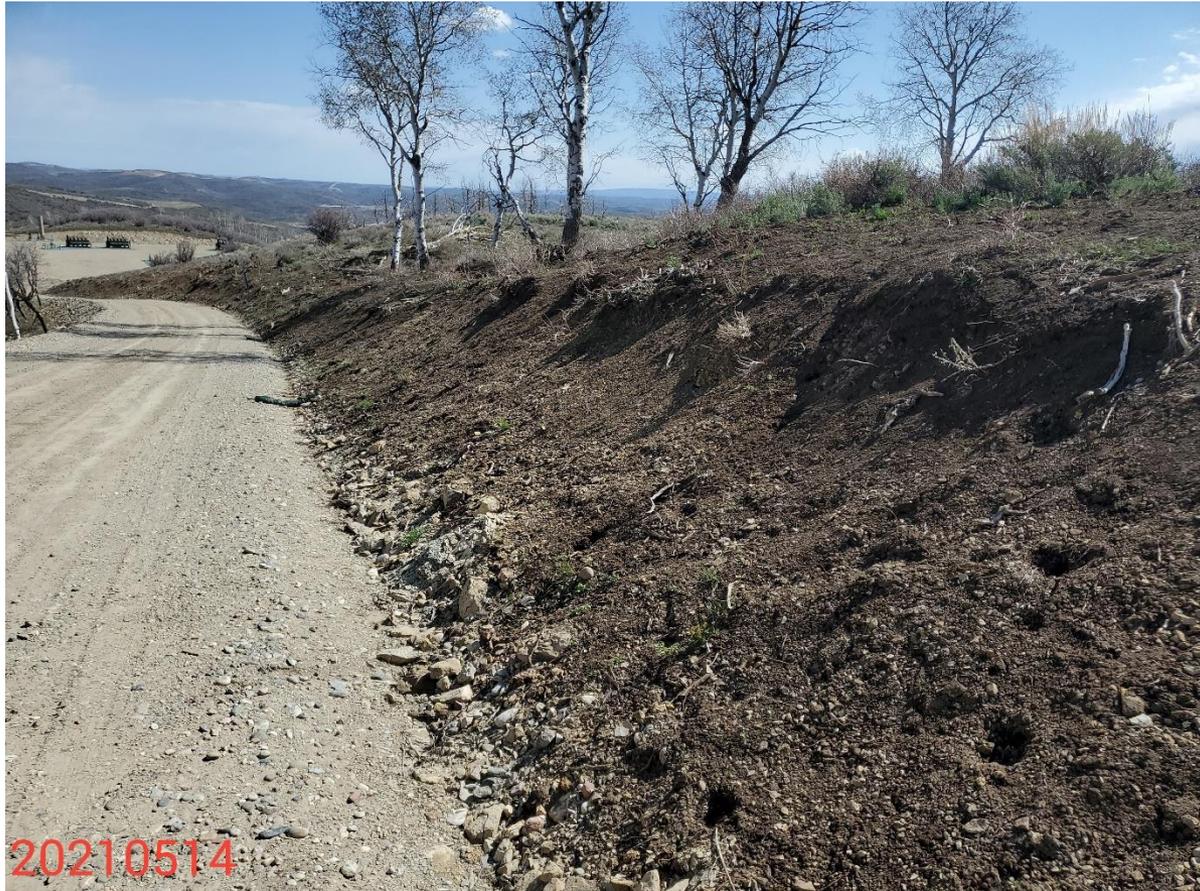
Photo 9: Photo taken from the access road, facing north. Previous inspection required Operator to conduct additional reclamation along the access road, and to implement control measures to stabilize the seeded soils; unable to find evidence that additional reclamation was performed, and control measures installed.
