Inspection Photos

5/14/2021

Operator: LARAMIE ENERGY LLC #10433

Location ID: 335647

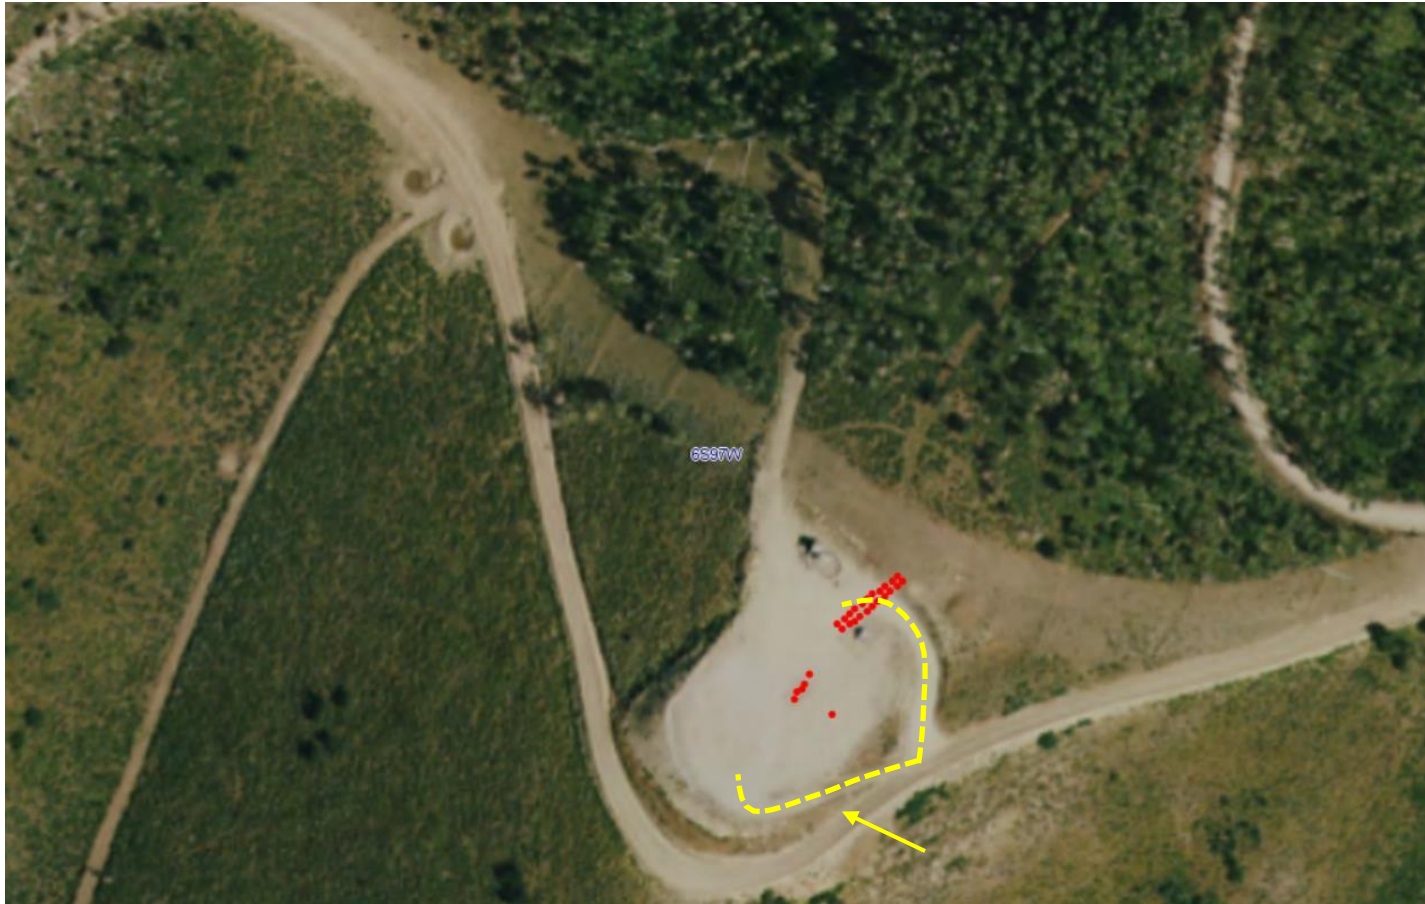
Photo 1: Photo taken from doc. #696202107. 2019 COGIS Aerial imagery. Photo shows two access points/roads have been constructed on the south end of the Location (dotted yellow lines). Previous inspection required reclamation of areas not needed for production on the south end of the Location, and the western traveling access road (arrow) also on the south end of the Location; It was observed that reclamation has not been conducted.

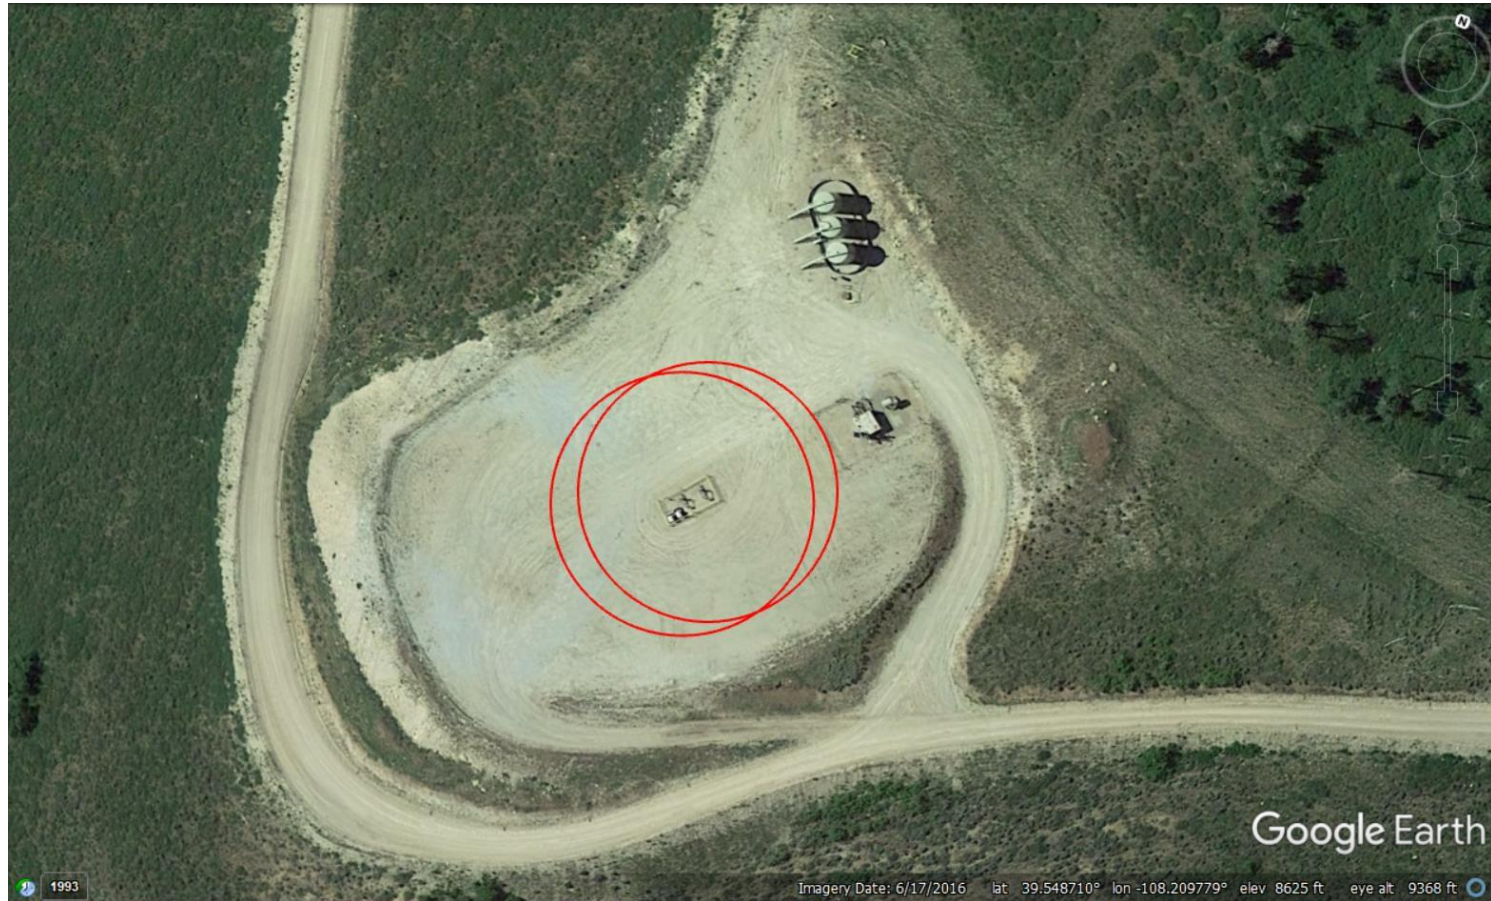
Photo 2: Photo taken from doc. #696202107. Google Earth aerial imagery. Photo shows areas of the Location not needed for production operations have not been reclaimed. Red circles represent a 75 foot buffer around producing wells.

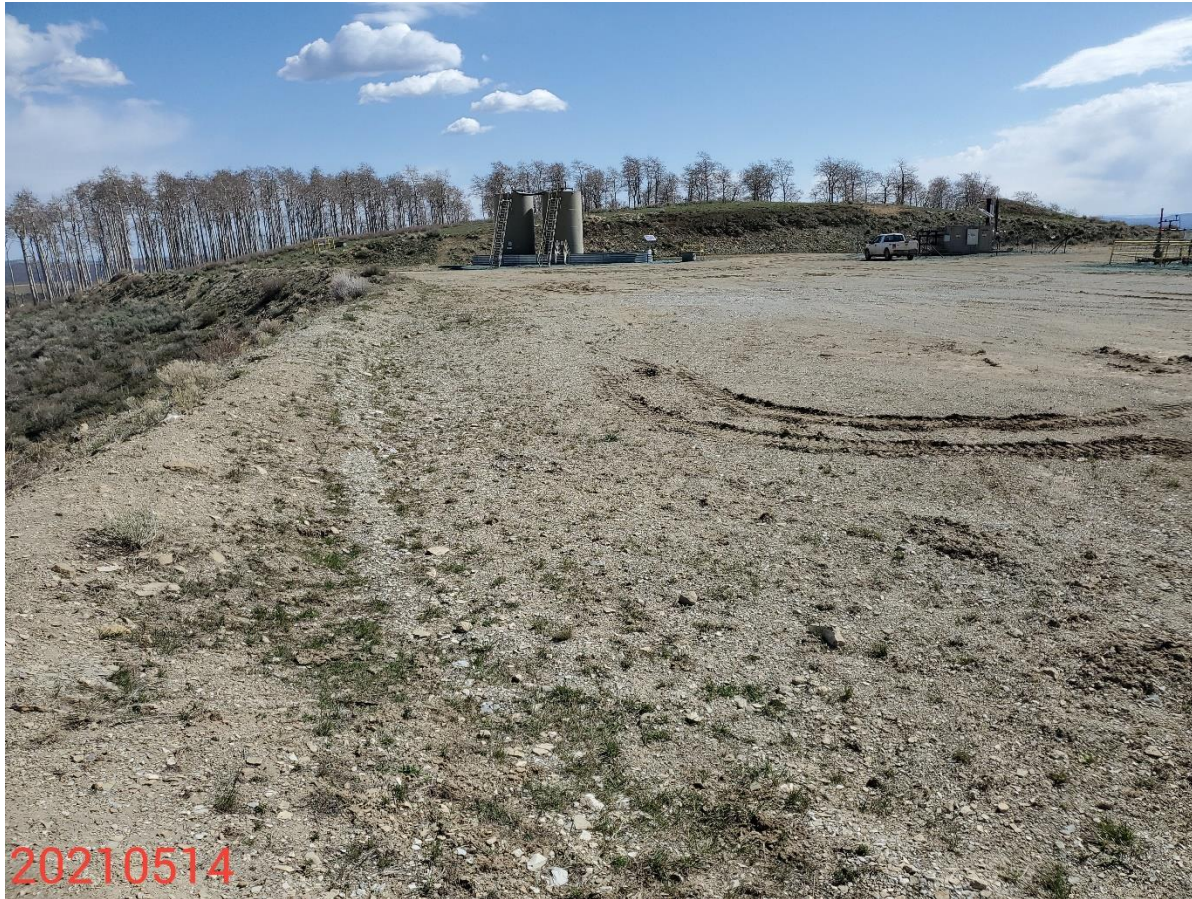
Photo 4: Photo taken from the southwest end of the Location, facing north. Photos 4-6 provide an overview of the Location from north, northeast to southeast. Photos also show that interim reclamation of areas not needed for production on the Location has not been conducted in accordance with 1003 Rules and Corrective actions.

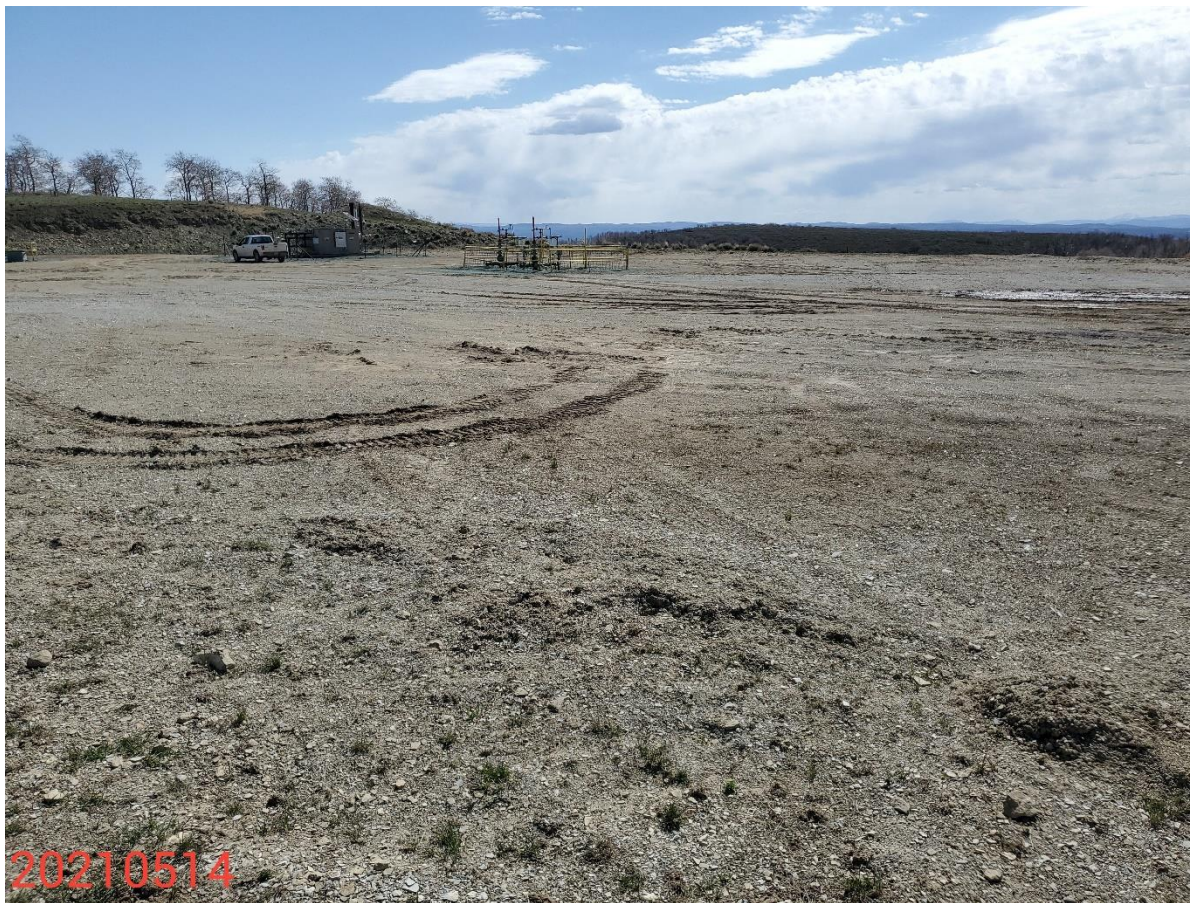
Photo 5 See comments under photo 4.

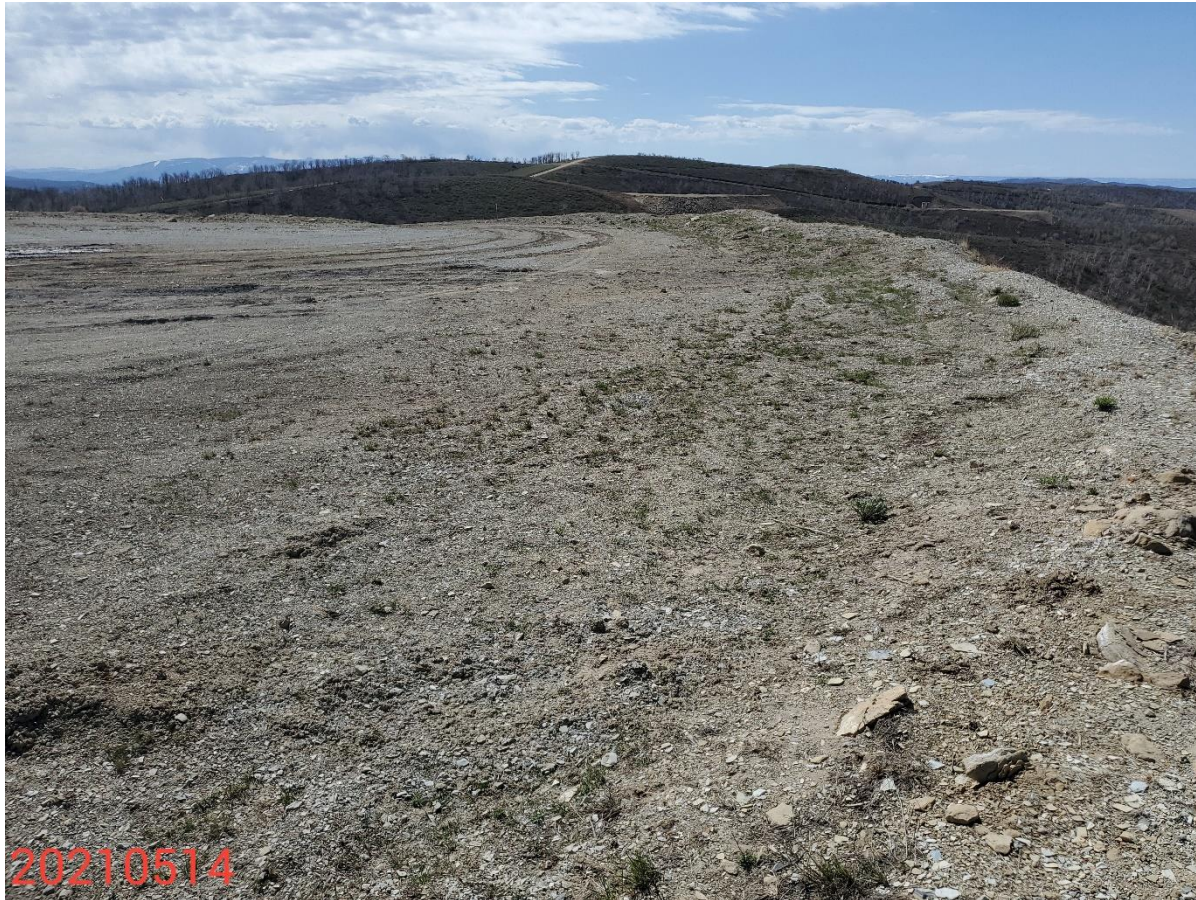
Photo 6: See comments under photo 4.

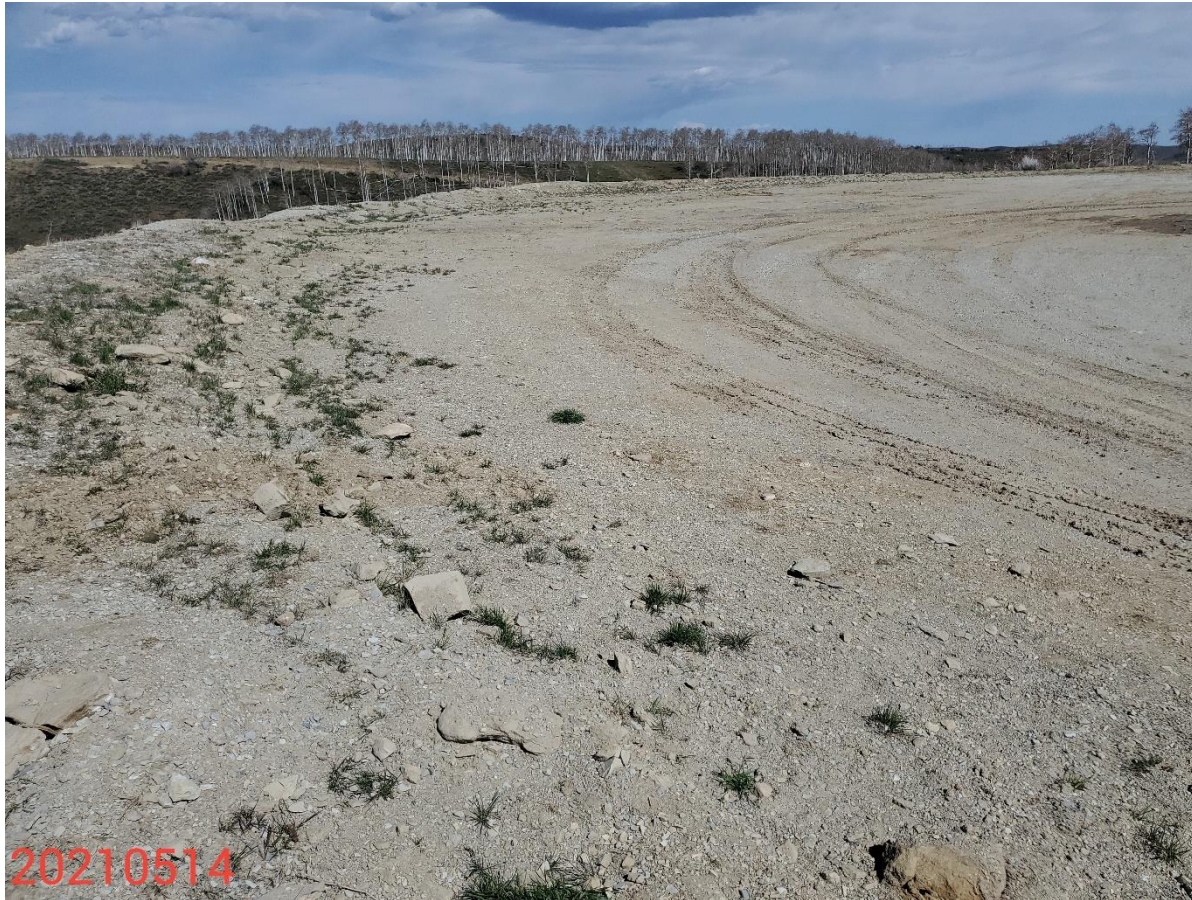
Photo 7: Photo taken from the south end of the Location, facing northwest. Photos 7-9 provide an overview of the Location from northwest, northeast to east. Photos also show that interim reclamation of areas not needed for production on the Location has not been conducted in accordance with 1003 Rules and Corrective actions.

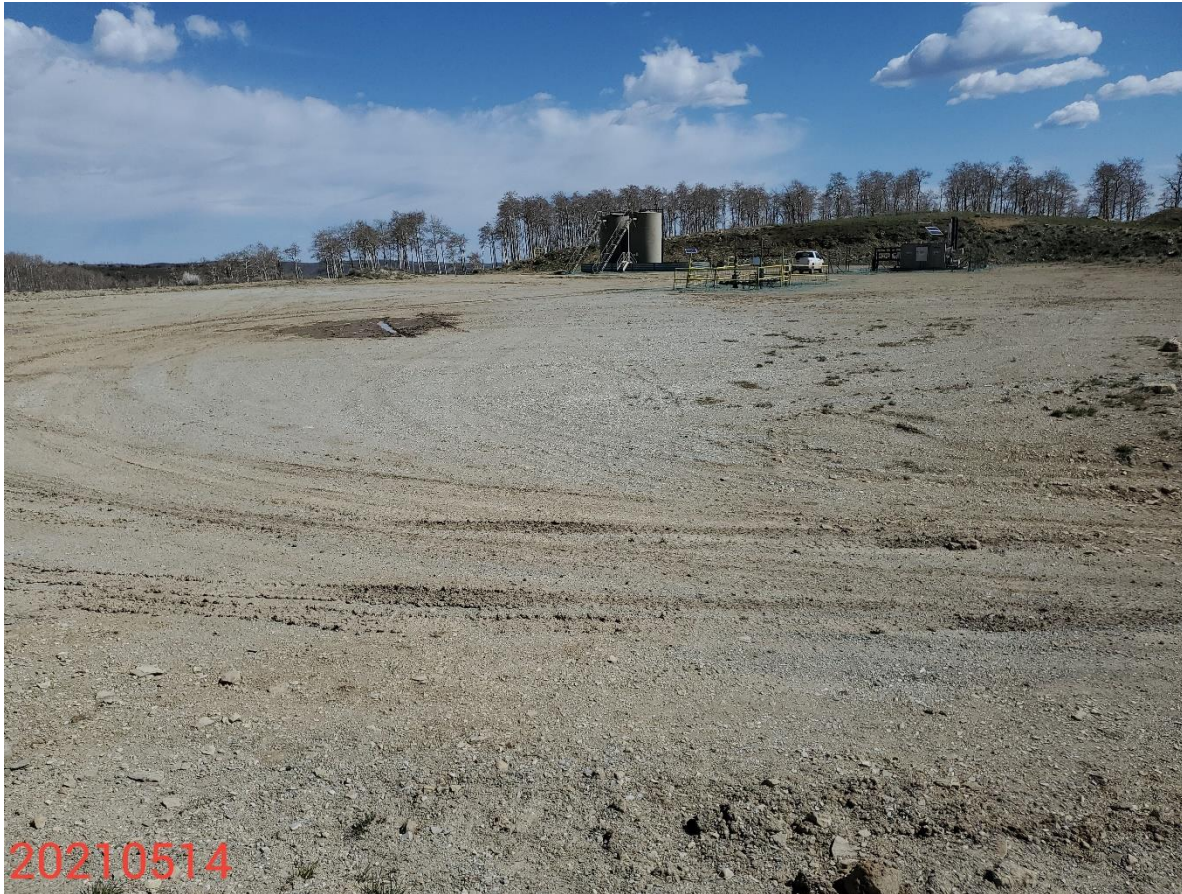
Photo 8: See comments under photo 7.

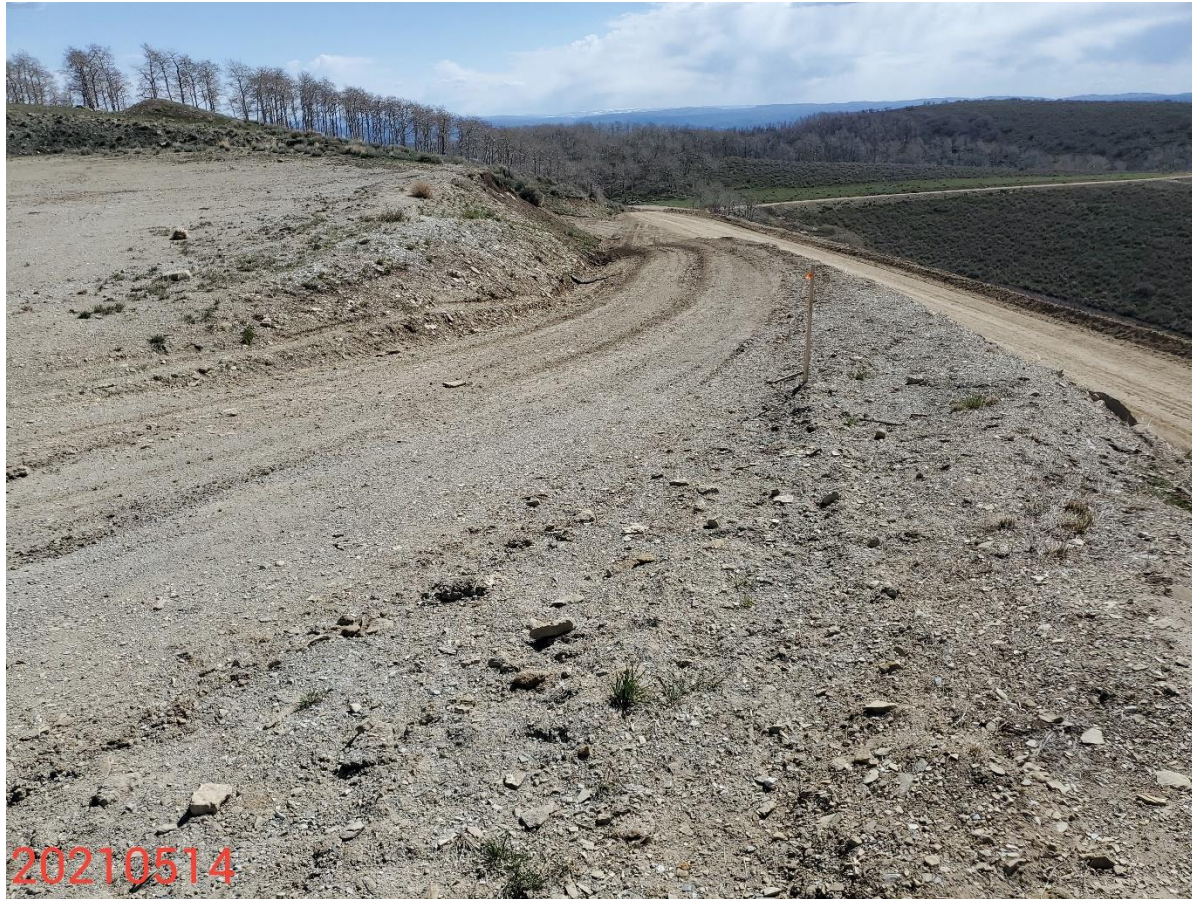
Photo 9: See comments under photo 7. Previous inspection documented that two access points/roads have been constructed on the south end of the Location; inspection required Operator to reclaim areas on the south end of the Location, including the southern access road/point. Photo also shows access road on the south end of the Location has not been reclaimed.

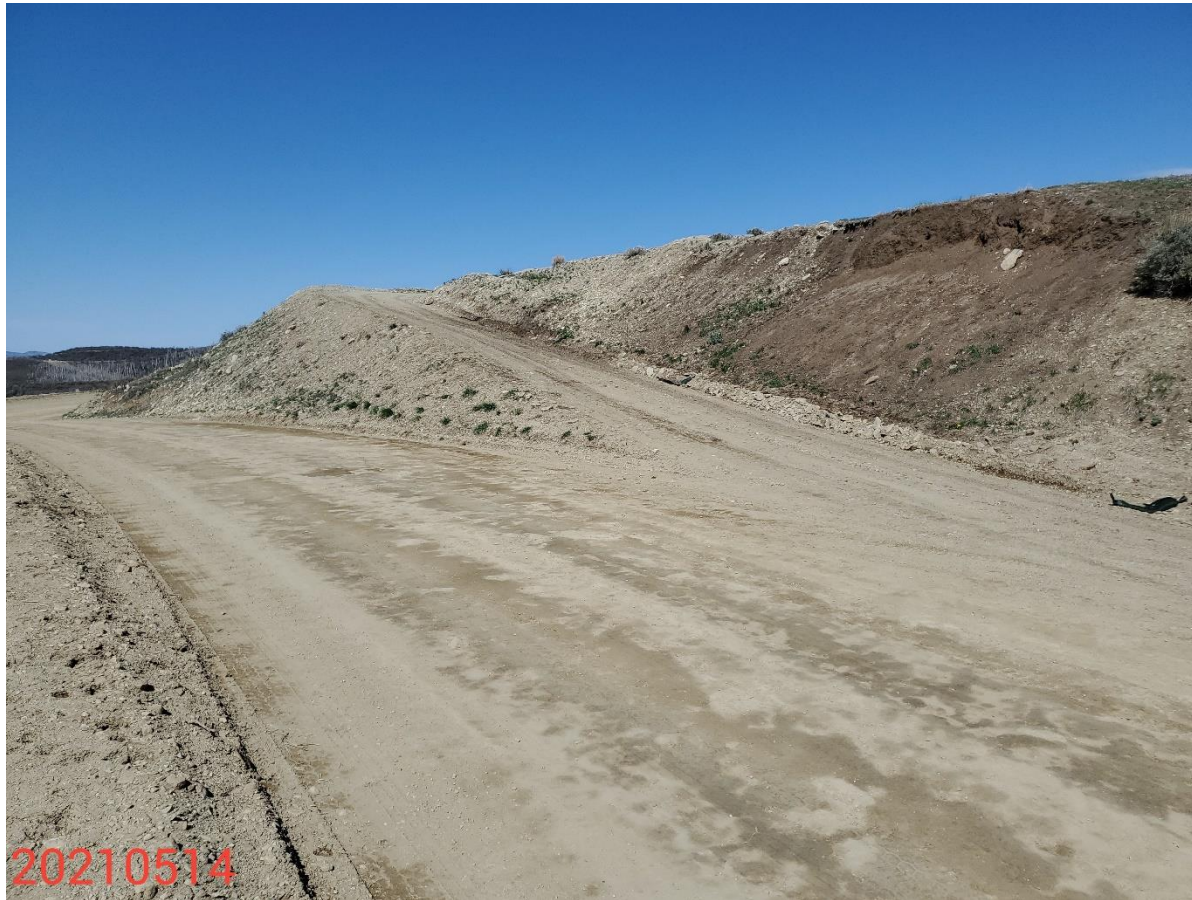
Photo 10: Photo taken from the main lease road, facing west. Photos 10-11 show that two access roads/points have been constructed on the Location. Photo also shows access road on the south end of the Location has not been reclaimed.

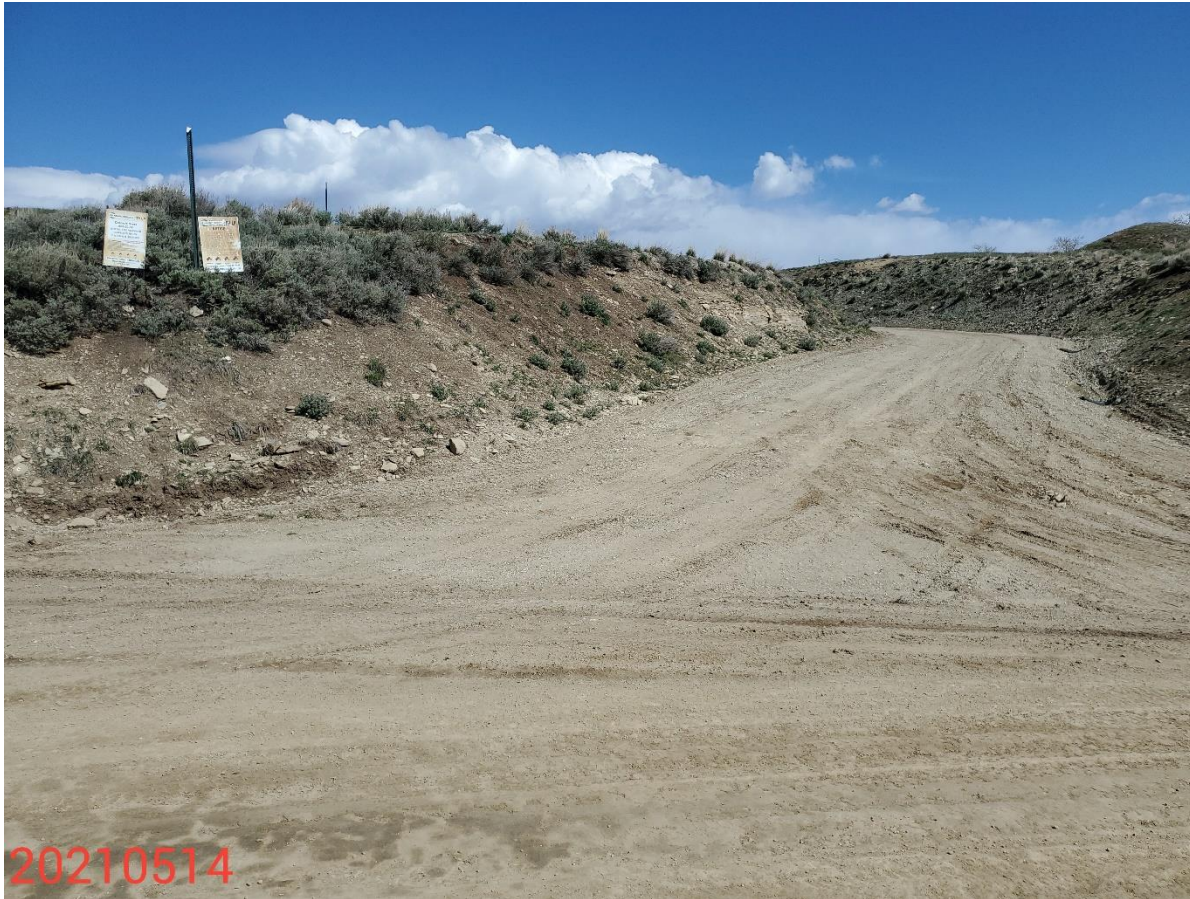
Photo 11: Continued from photo 10. Photo shows the second access road/point to the Location.

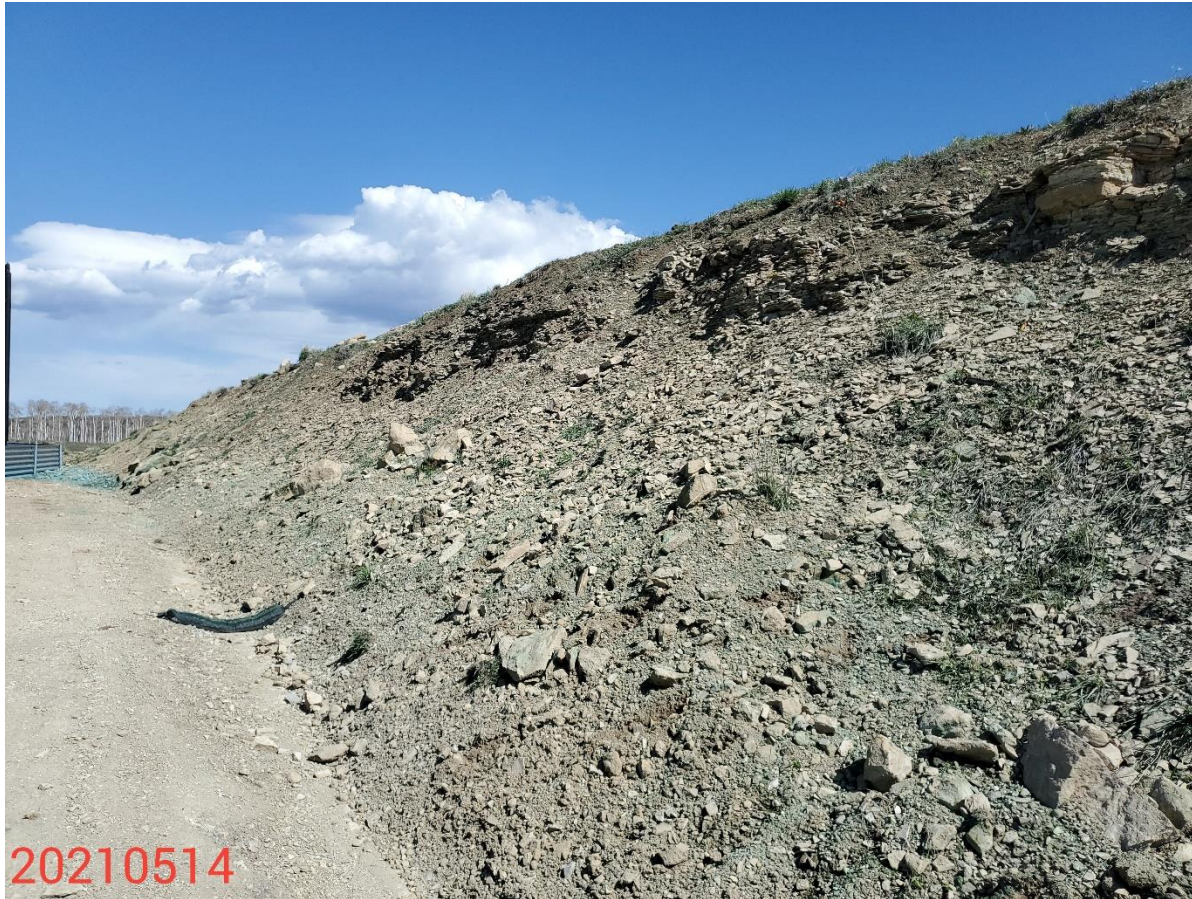
Photo 12: Photo taken from the cut slopes, facing northwest. Previous inspection required Operator to install temporary control measures on slopes until interim reclamation is conducted. Photo shows hydromulch has been applied to slopes; BMP is inadequate for long term stabilization and is showing signs of degradation.
