Inspection Photos

5/14/2021

Operator: LARAMIE ENERGY LLC #10433

Location ID: 335902

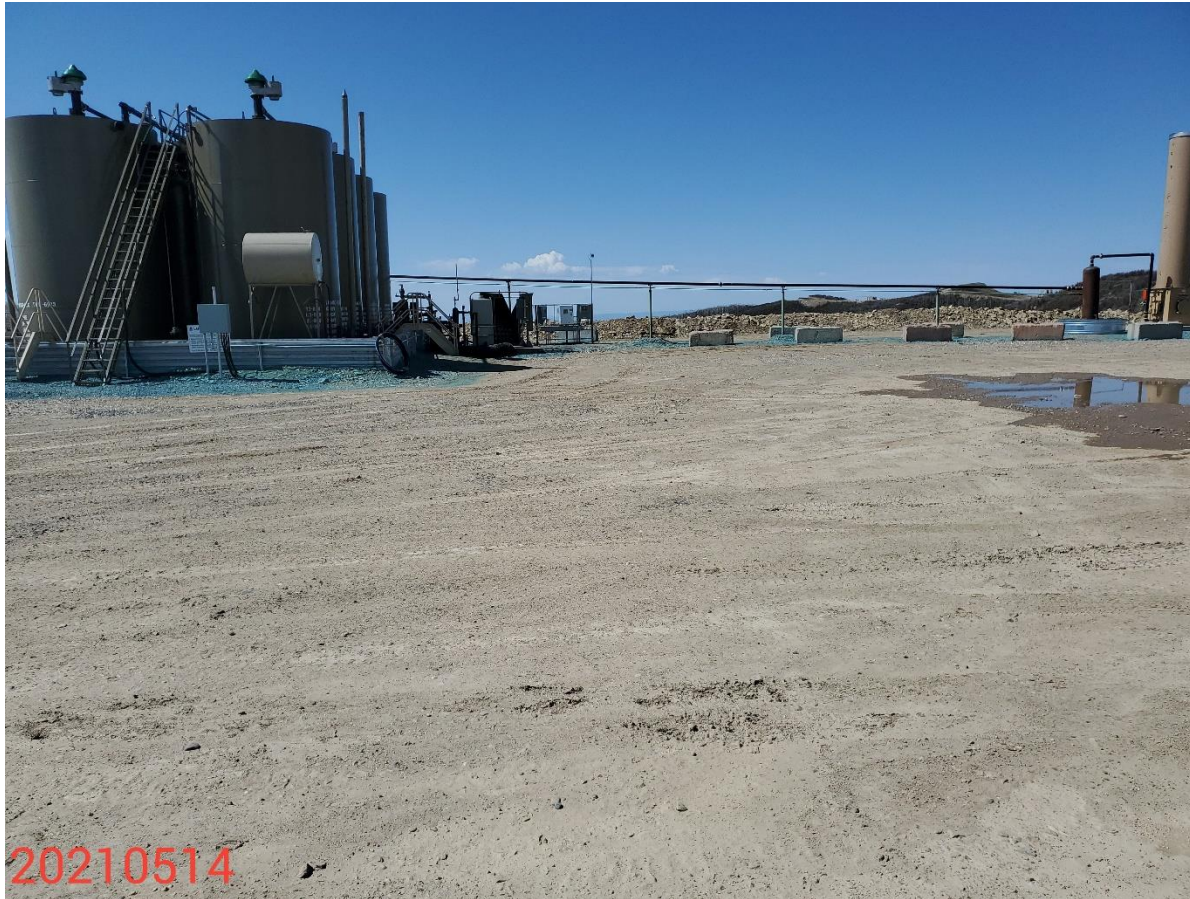
Photo 1: Photo taken from the east end of the Location, facing south. Photos 1-4 provide an overview of the Location from south, southwest, northwest to north. Photos also show that interim reclamation of areas not needed for production have been conducted.

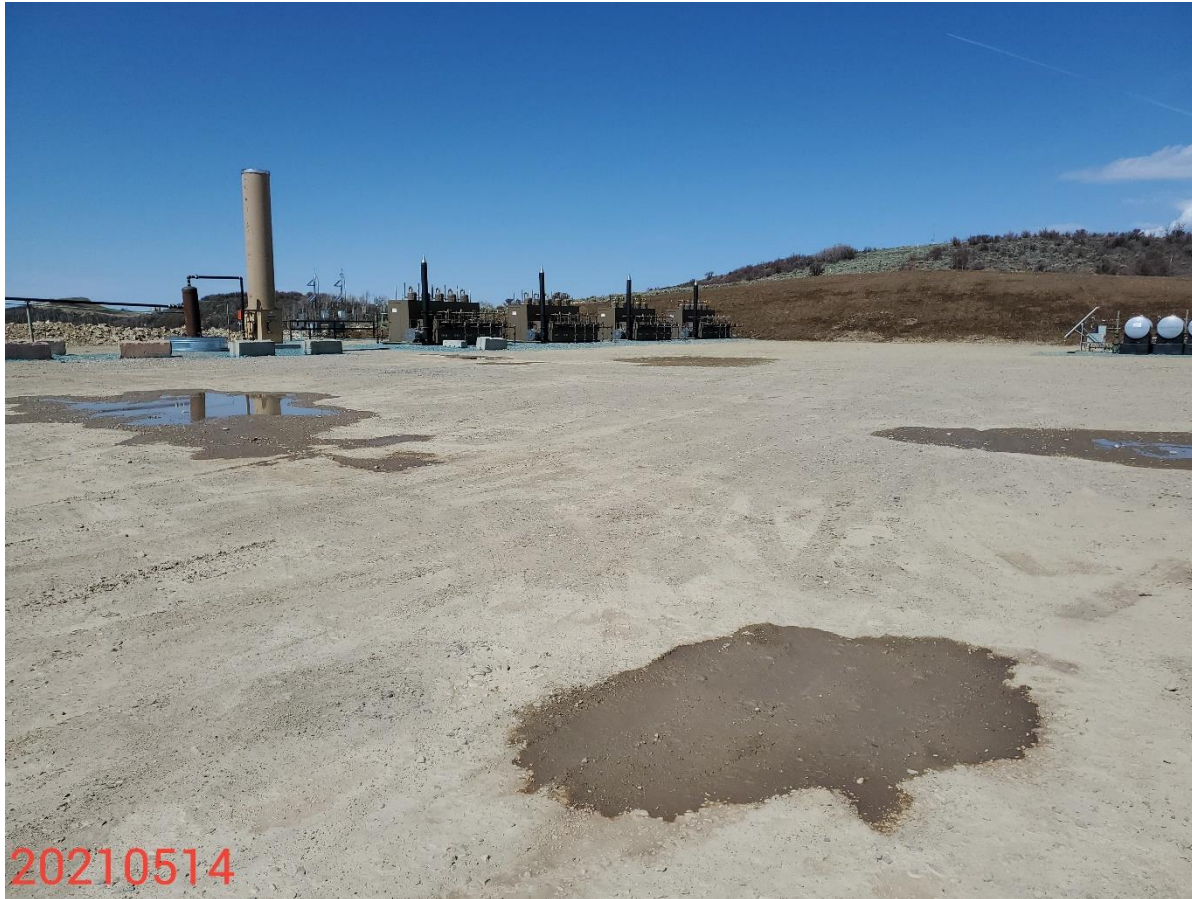
Photo 2: See comments under photo 1.

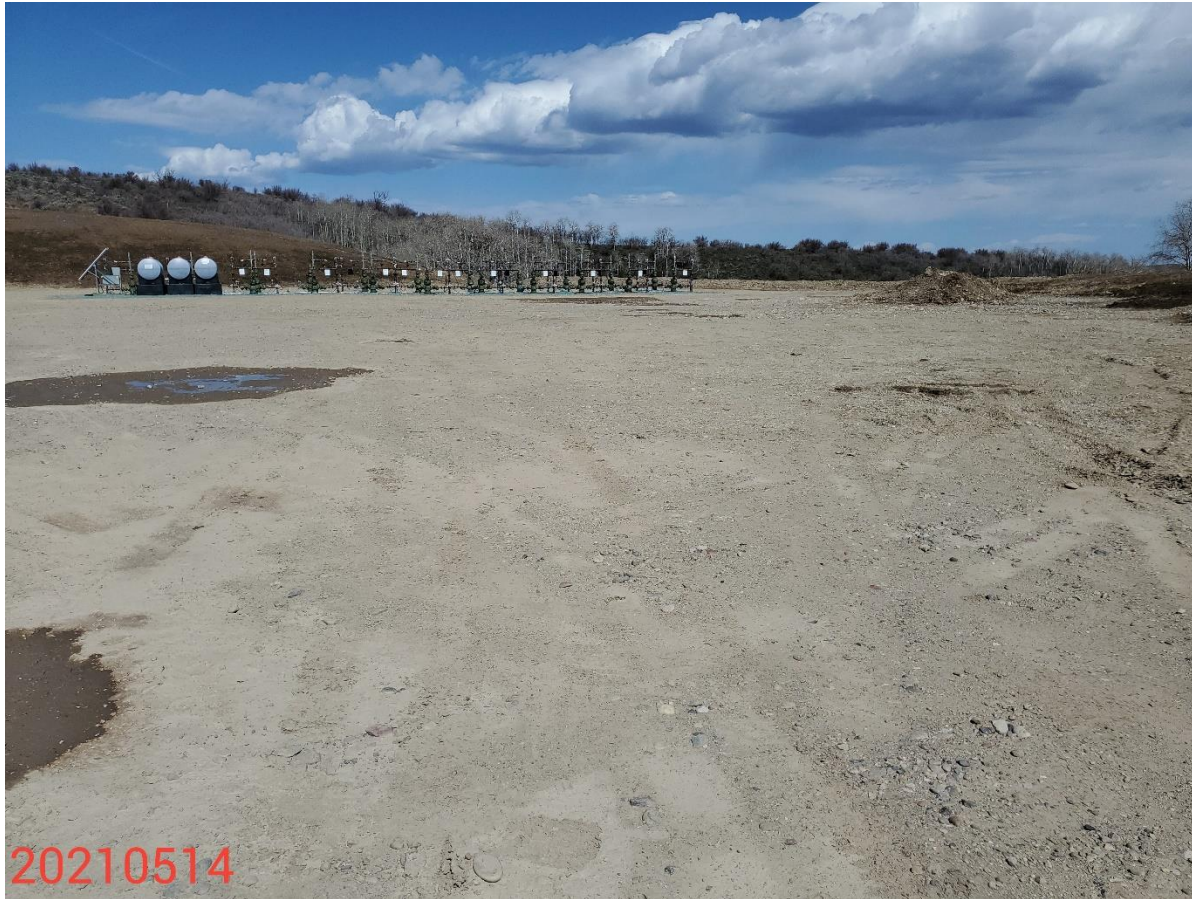
Photo 3: See comments under photo 1.

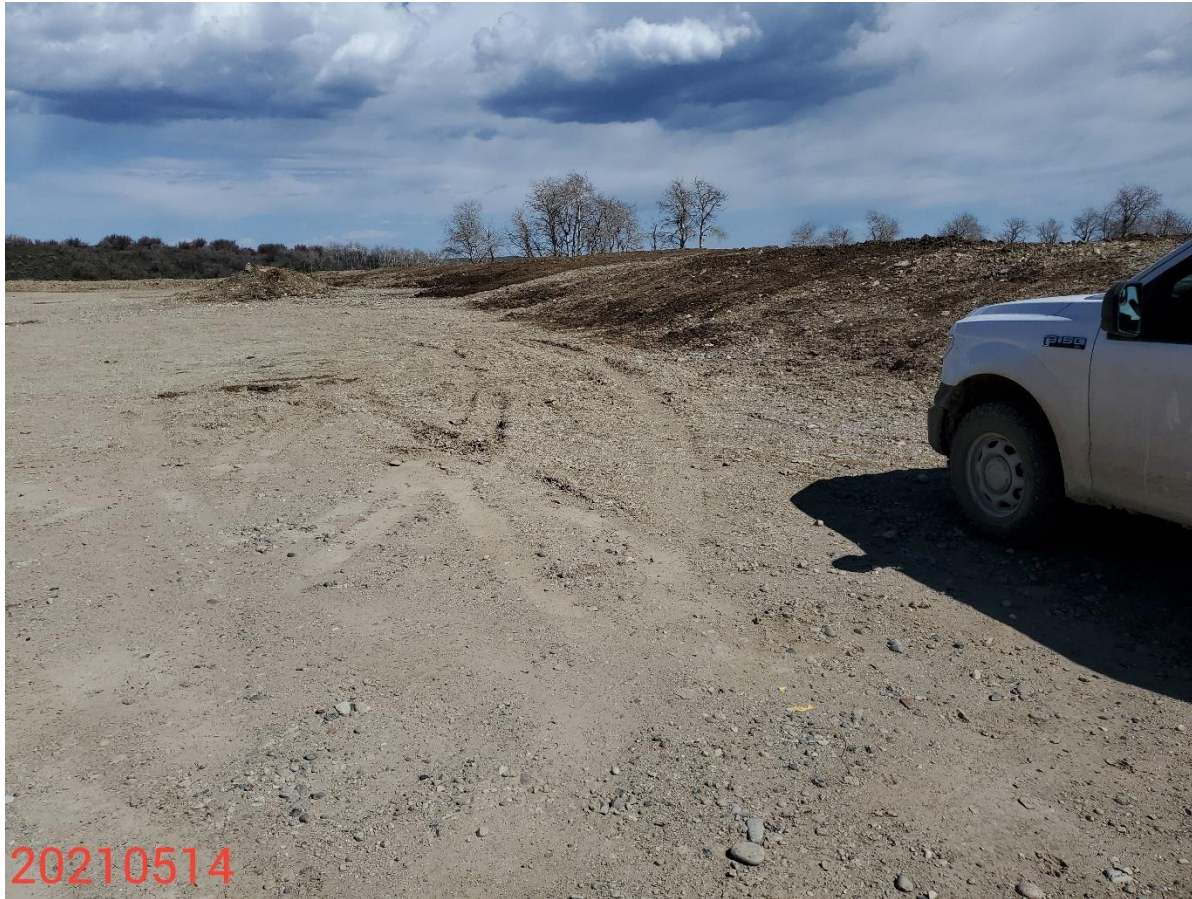
Photo 4: See comments under photo 1.

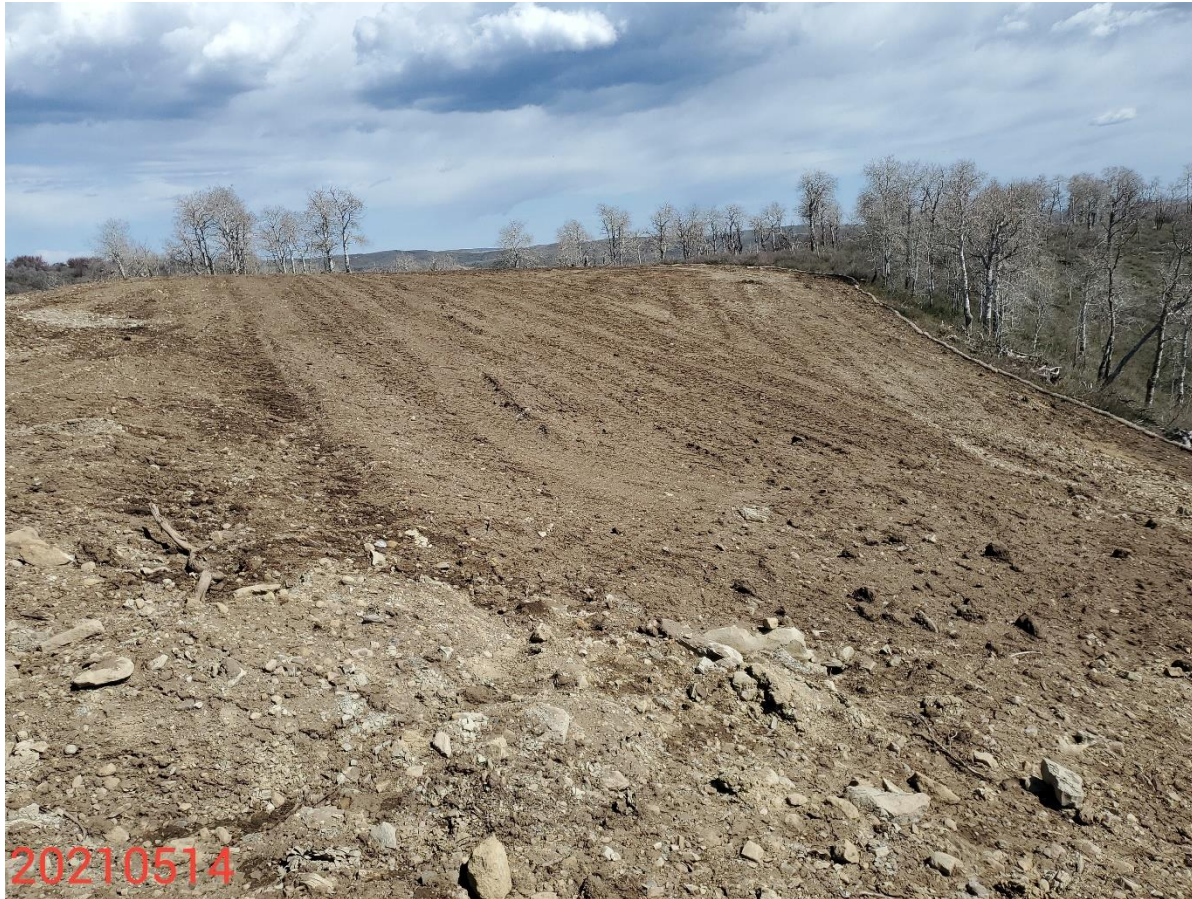
Photo 5: Photo taken from the interim areas on the northeast end of the Location, facing north. Previous inspection required Operator to implement control measures to stabilize the seeded soils. Photo shows that control measures to stabilize the slopes and soils of the interim areas of the Location have not been implemented or maintained.

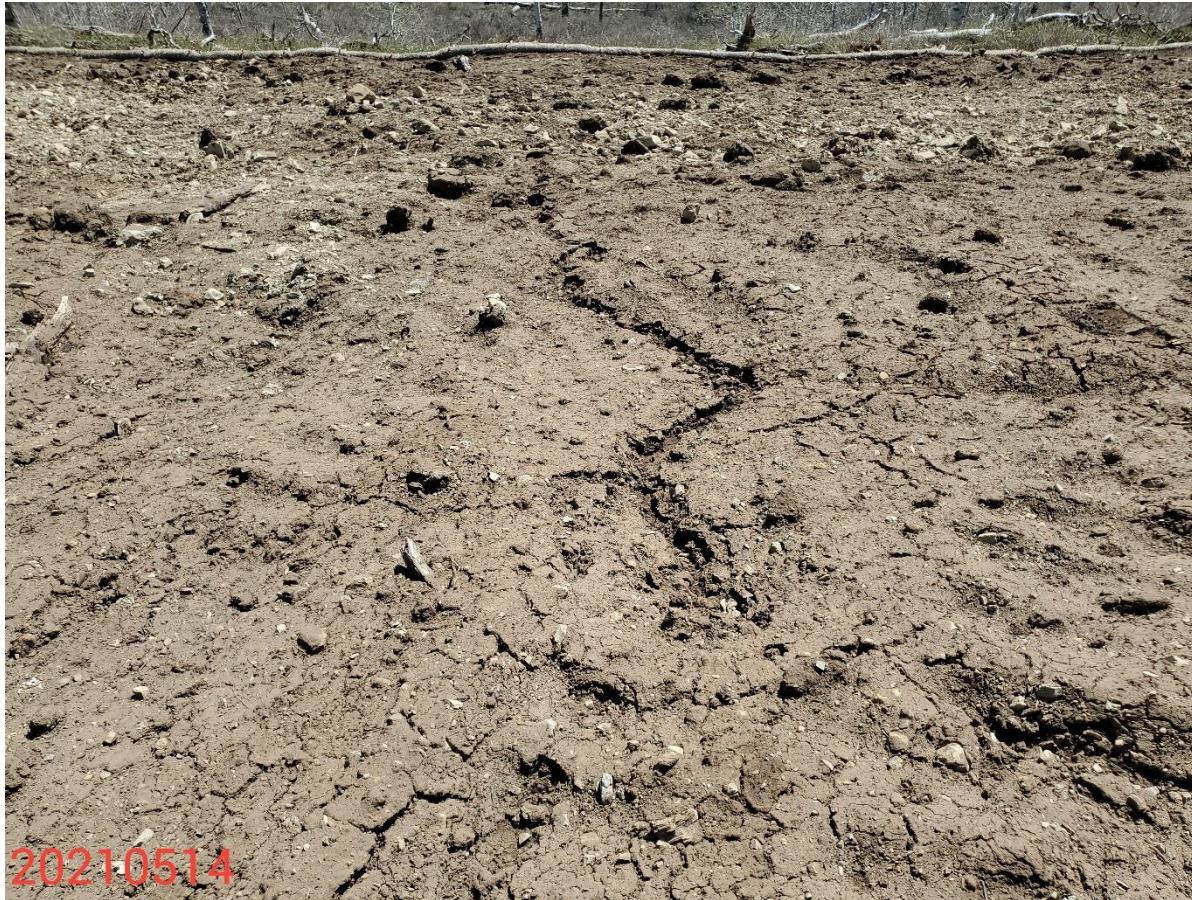
Photo 6: Photo taken from the interim areas on the northeast end of the Location. Photo shows erosion degradation observed on interim areas. Previous inspection required Operator to implement control measures to stabilize the seeded soils; control measures to stabilize the slopes and soils of the interim areas of the Location have not been implemented or maintained.

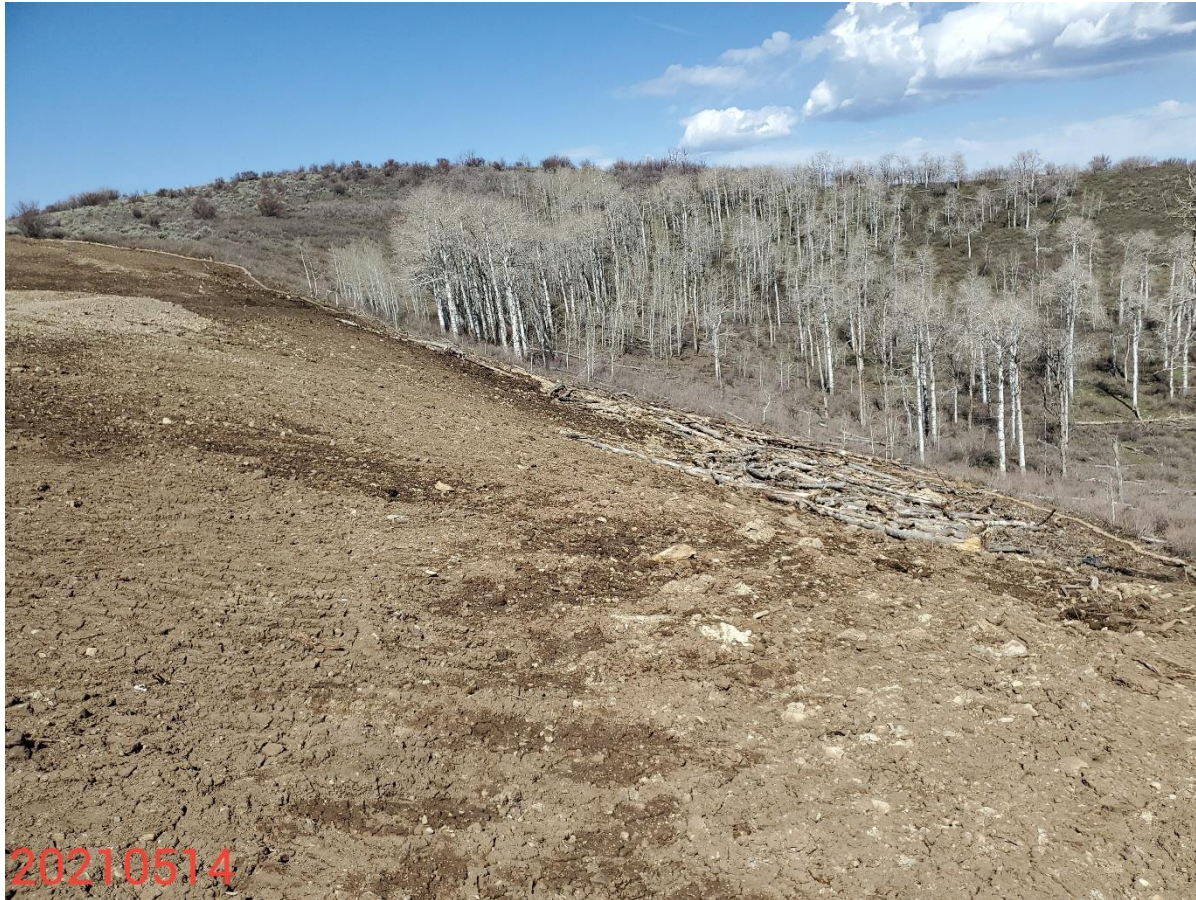
Photo 7: Photo taken from the interim areas on the north end of the Location, facing west. Previous inspection required Operator to implement control measures to stabilize the seeded soils. Photo shows that control measures to stabilize the slopes and soils of the interim areas of the Location have not been implemented or maintained.

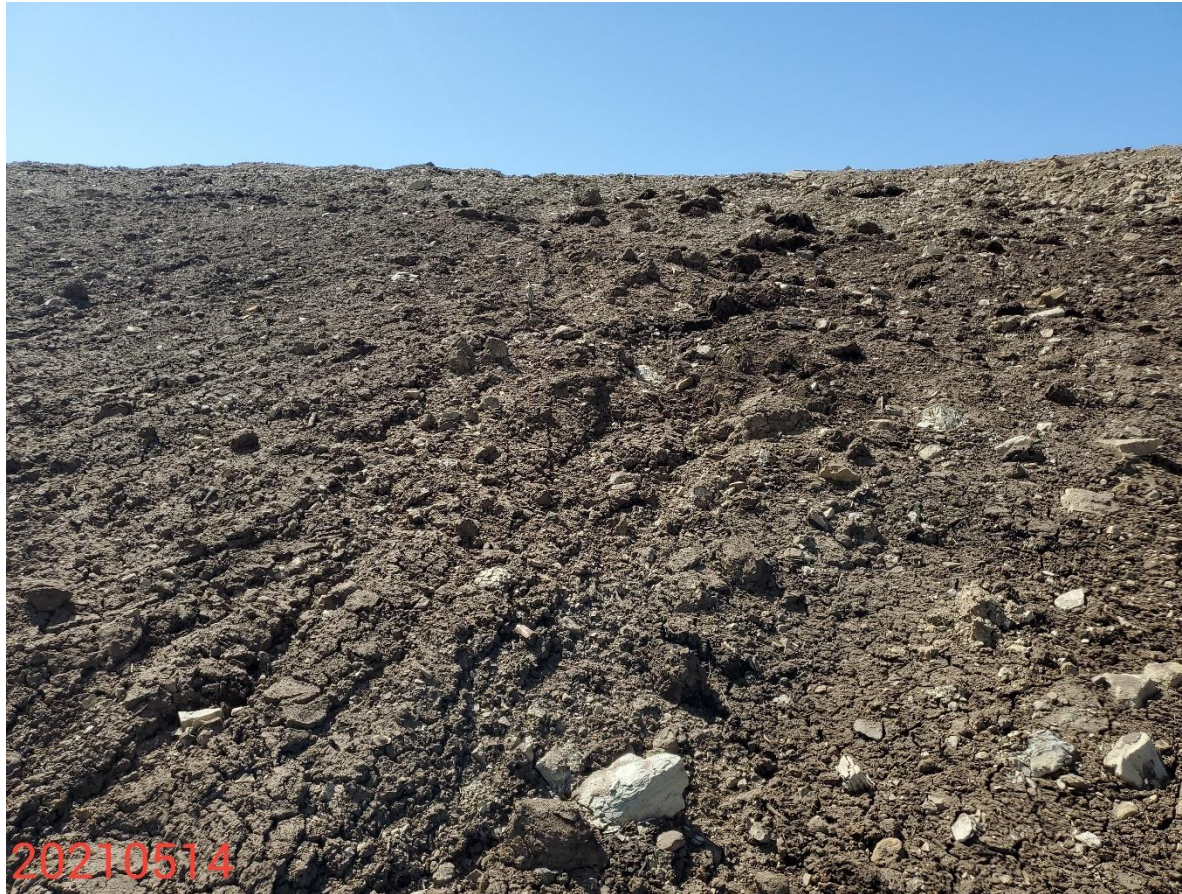
Photo 8: Continued from photo 7. Photo shows erosion degradation (rilling) observed on interim areas. Previous inspection required Operator to implement control measures to stabilize the seeded soils; control measures to stabilize the slopes and soils of the interim areas of the Location have not been implemented or maintained.

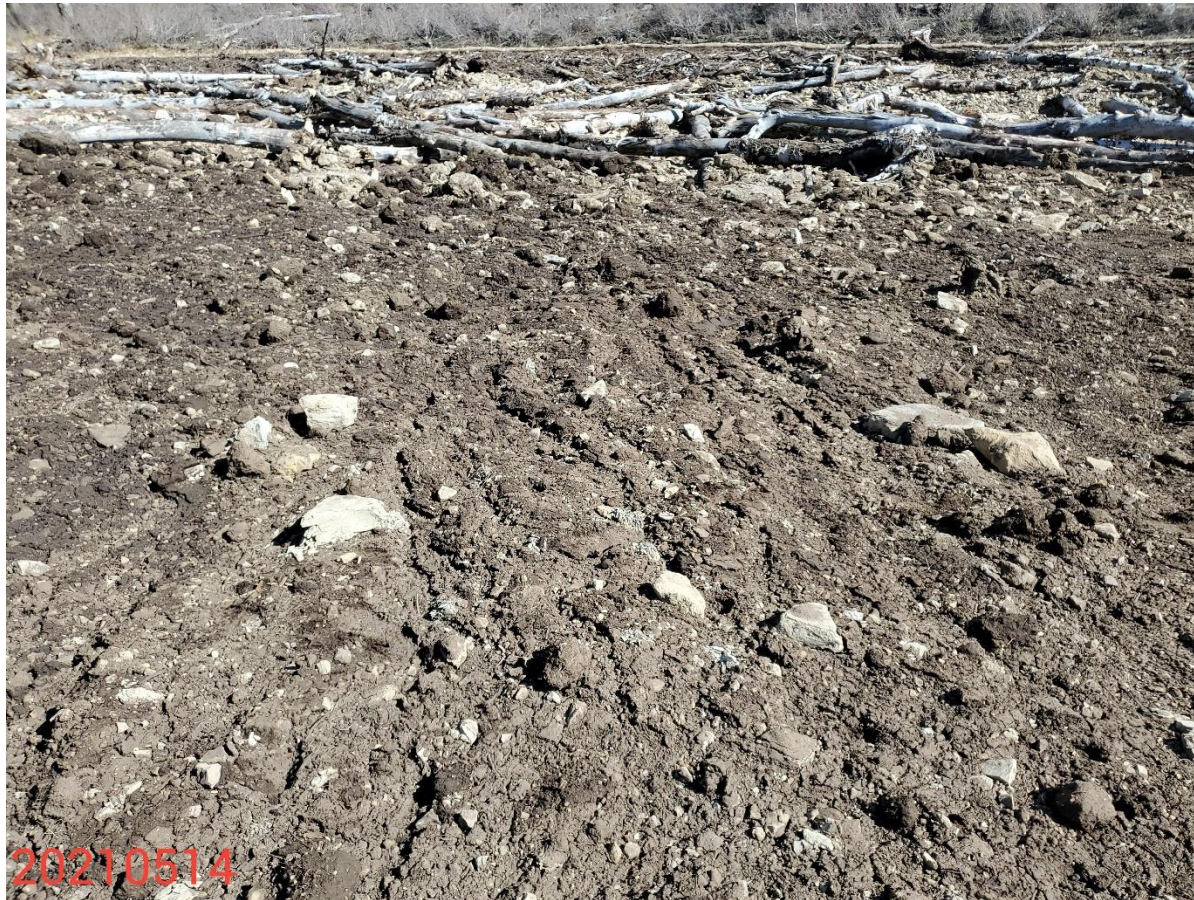
Photo 9: See comments under photo 8. Photo shows stormwater erosion degradation (rilling) observed on interim areas.

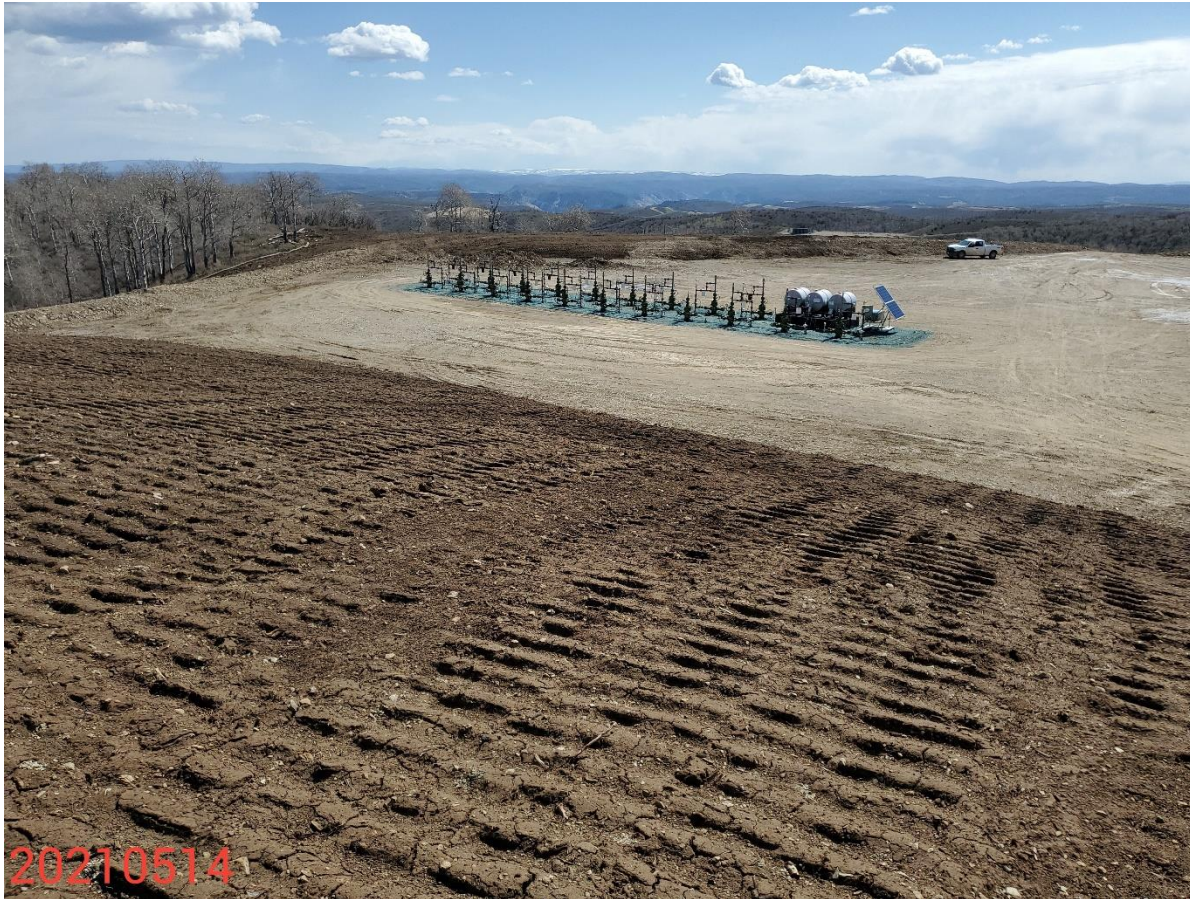
Photo 10: Photo taken from the former cut slope on the west end of the Location, facing northeast. Surface roughening (tracking) observed on western slopes of the Location.

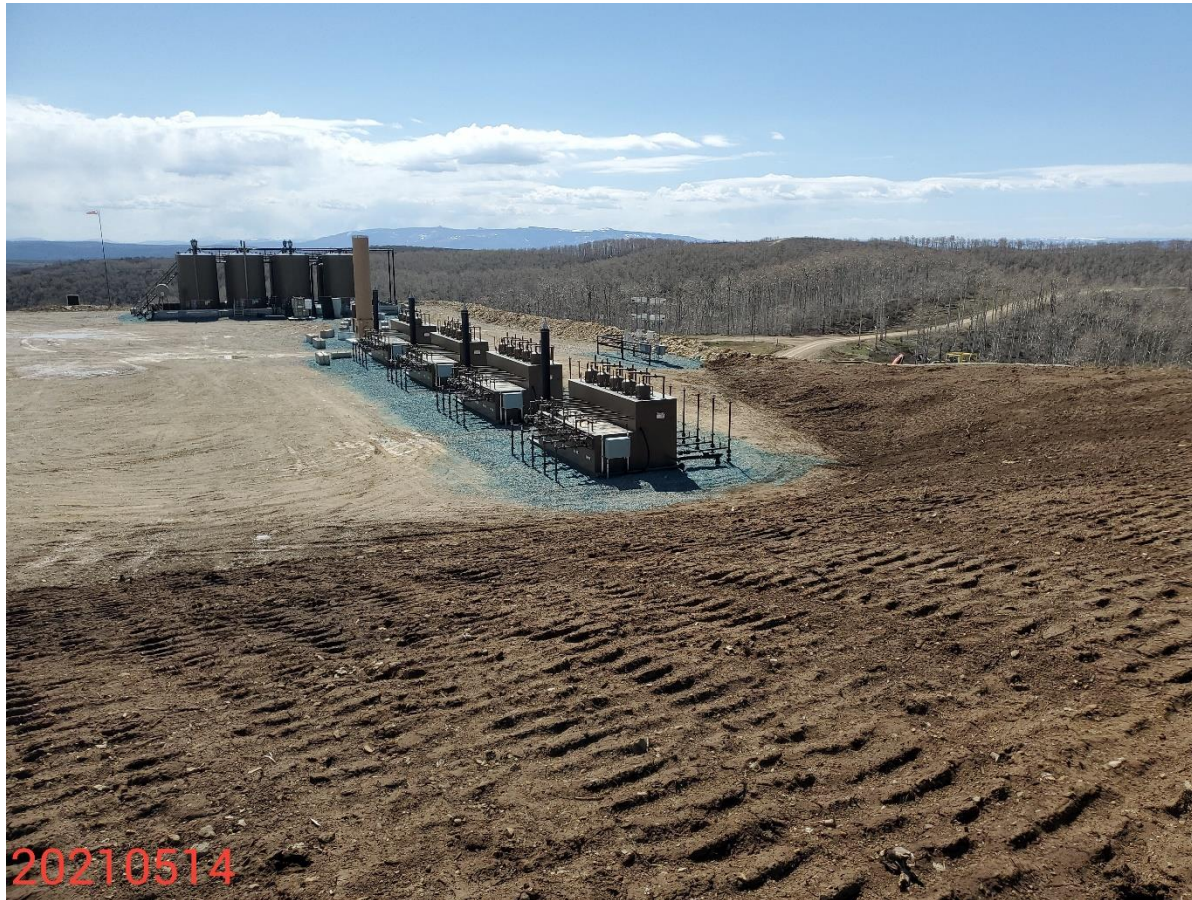
Photo 11: Photo taken from the former cut slope on the west end of the Location, facing southeast. Surface roughening (tracking) observed on western slopes of the Location.

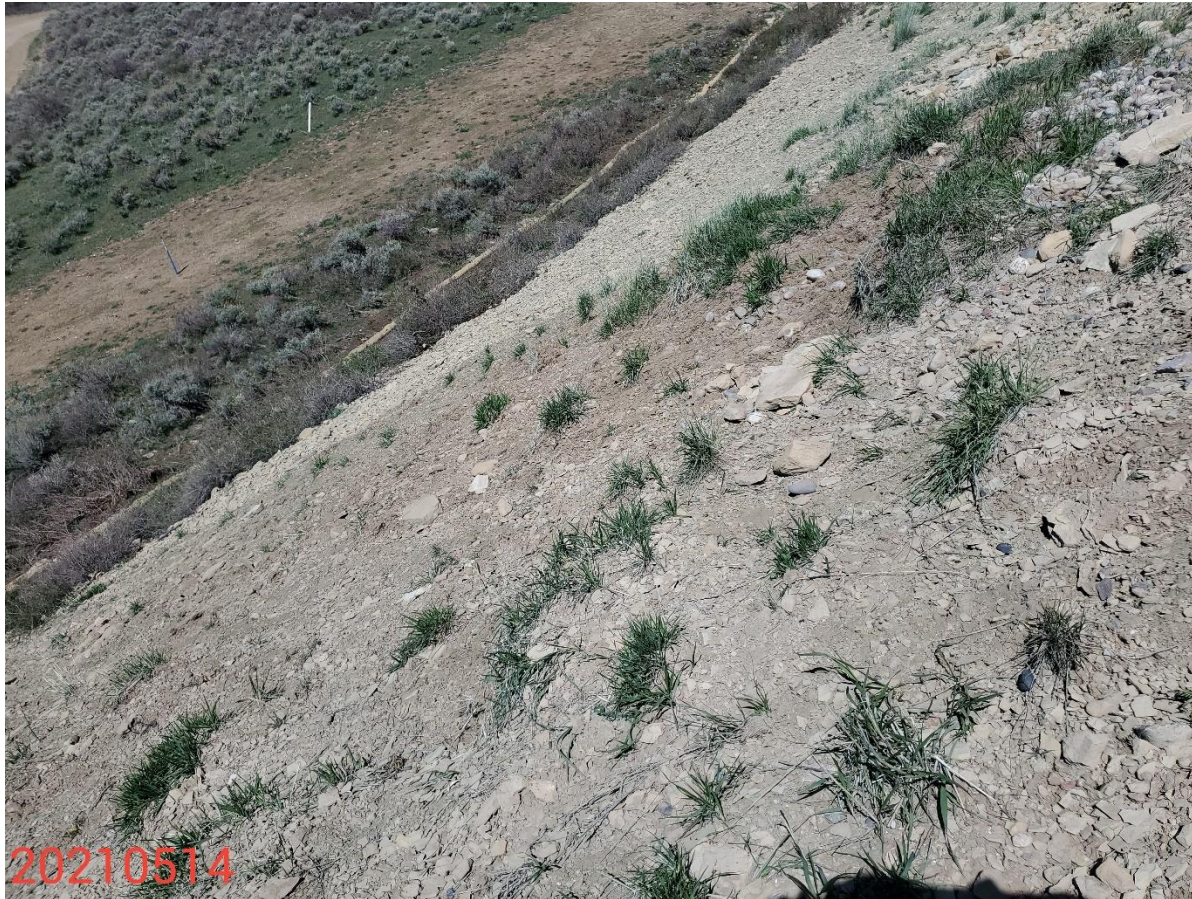
Photo 12: Photo taken from the fill slopes on the southeast end of the Location. Photo shows BMPs to protect/stabilize the fill slopes of the Location remain missing or insufficient.
