# Inspection Photos

5/14/2021

Operator: TEP ROCKY MOUNTAIN LLC - 96850

Location ID: 324375

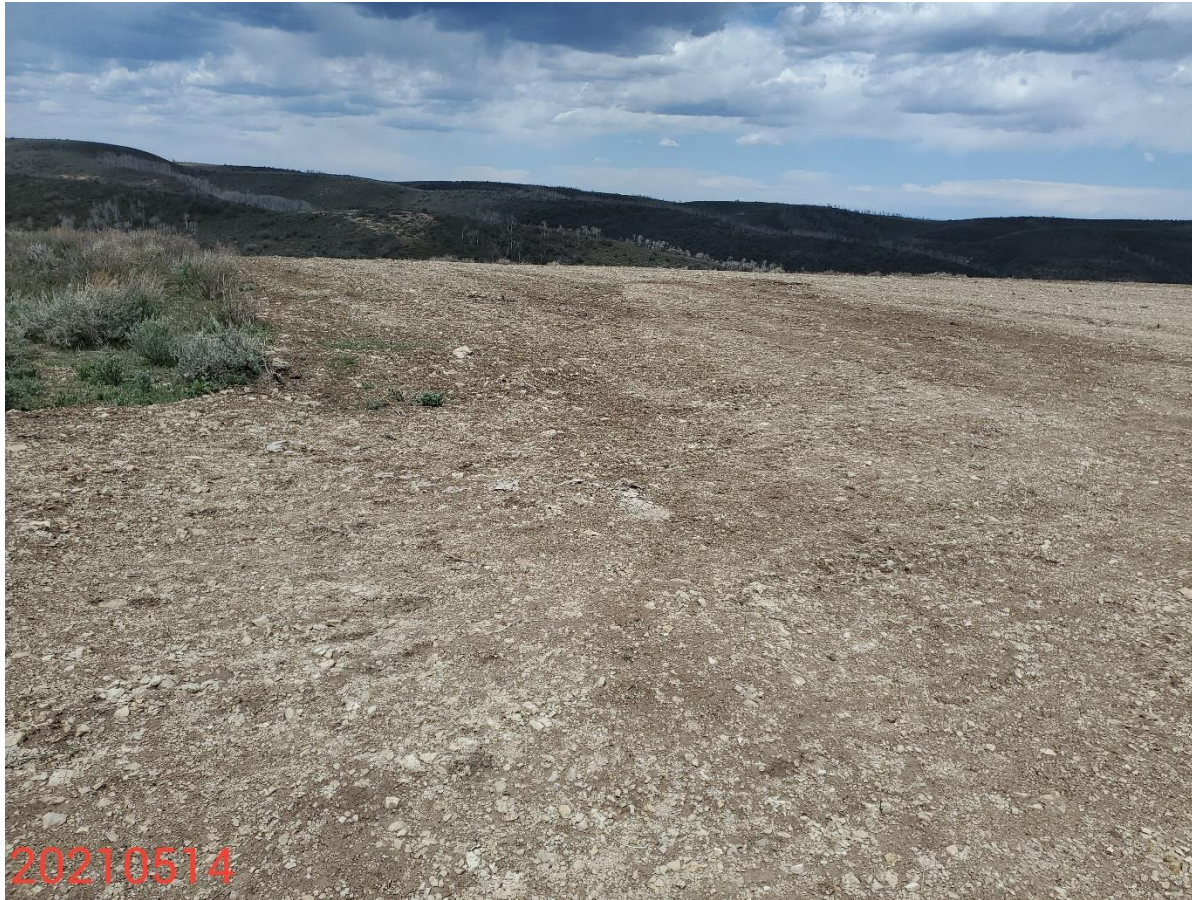
**Photo 1:** Photo taken from the south end of the Location, facing west. Photos 1-3 provide an overview of the Location from west, north to east. Operator appears to have conducted final reclamation activities on the well site, however very little desirable vegetative germination was observed.

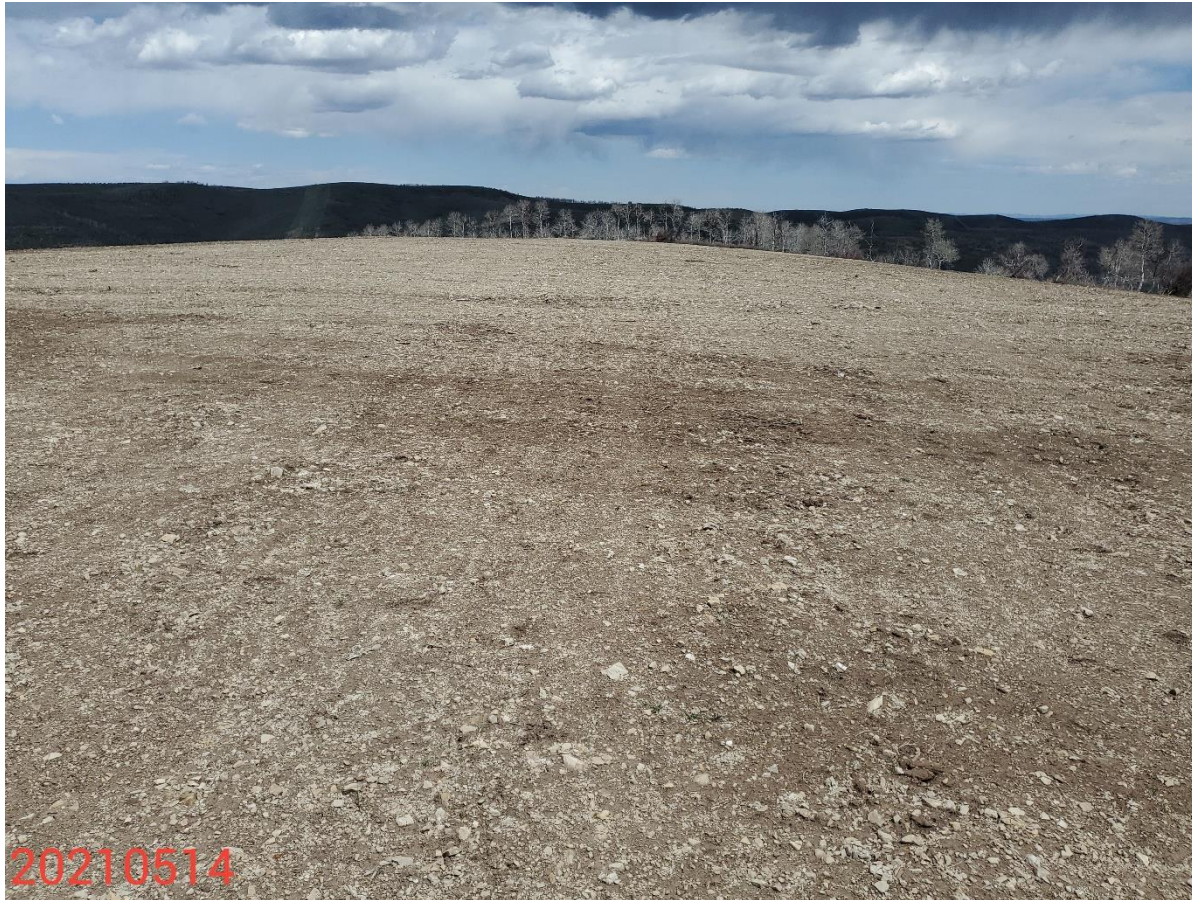
**Photo 2:** See comments under photo 1.

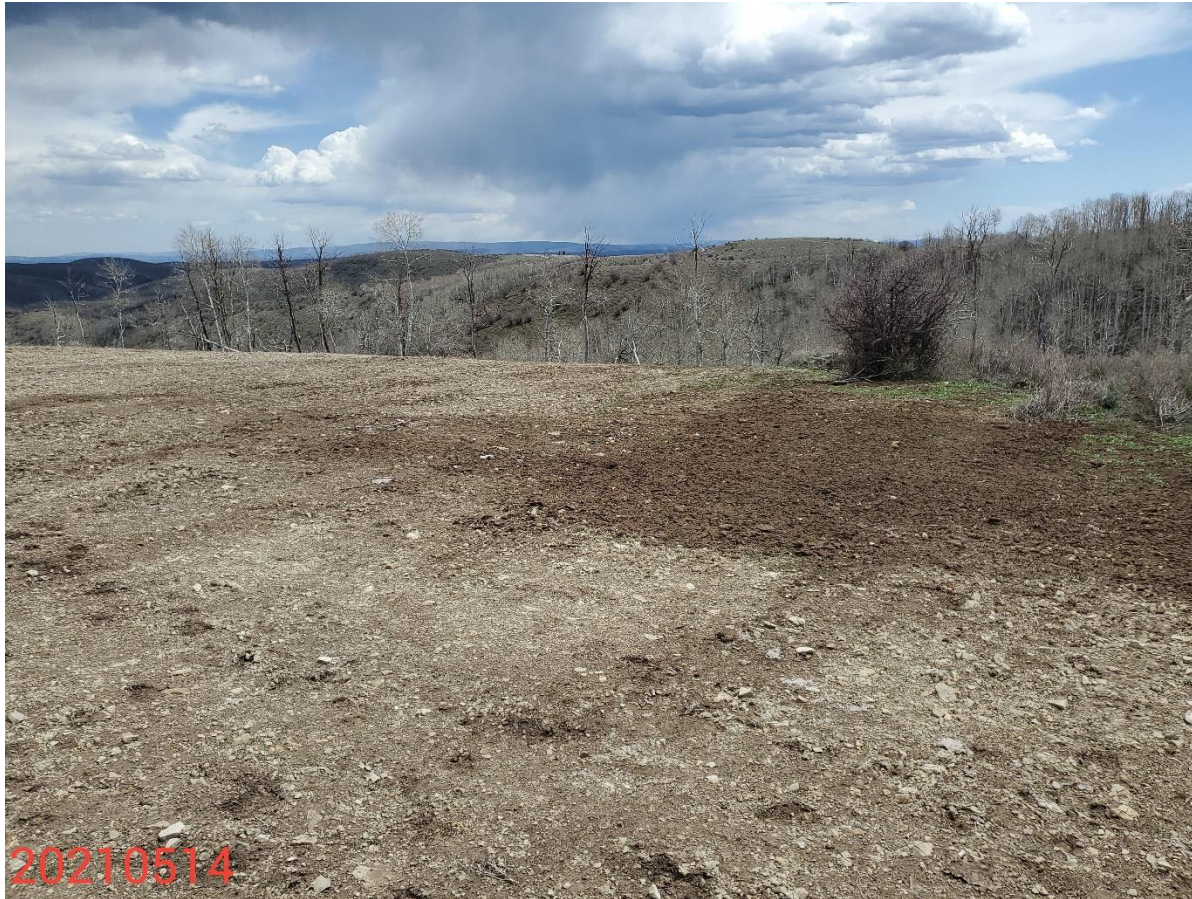
**Photo 3:** See comments under photo 1.

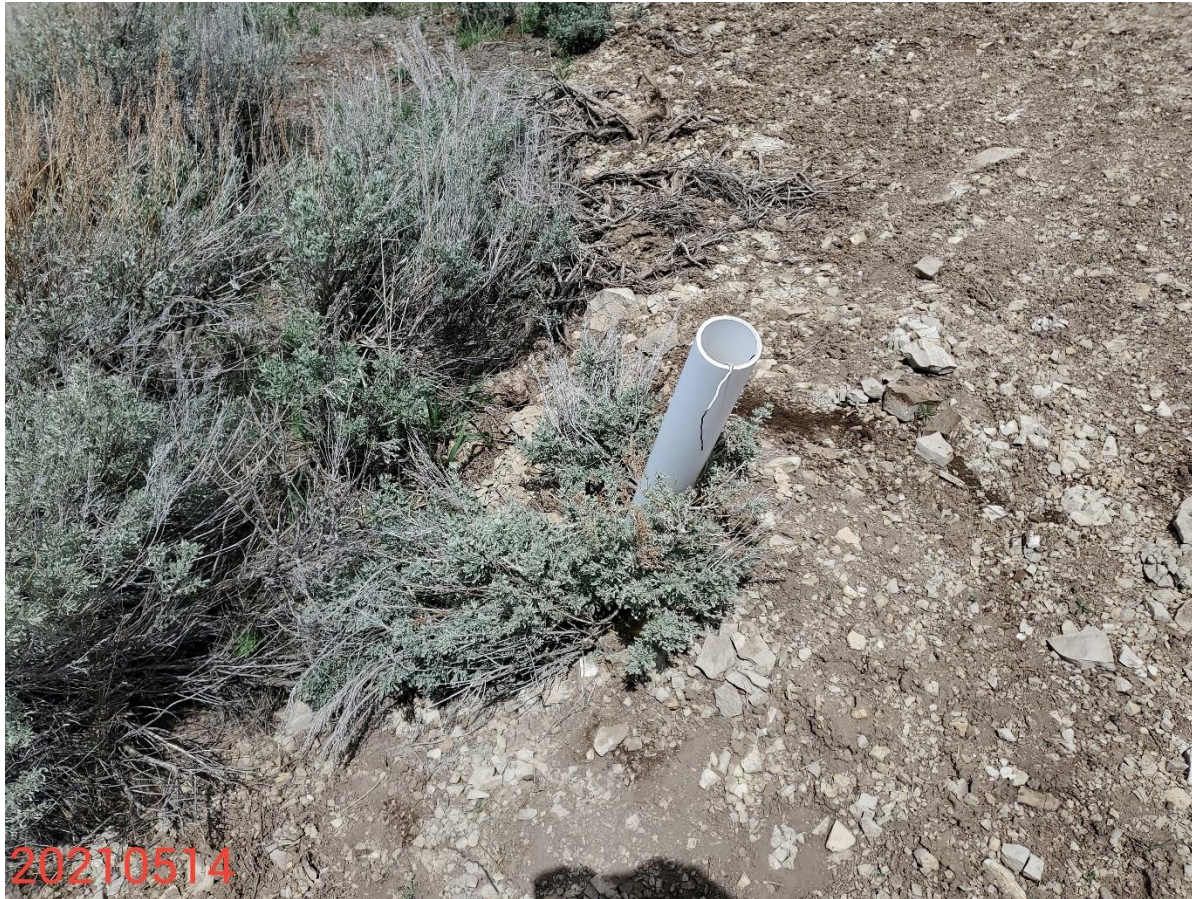
**Photo 4:** Photo taken from the Location entrance, on the south end of the site. Photo shows plastic pipe with wires observed within. Equipment requires removal.

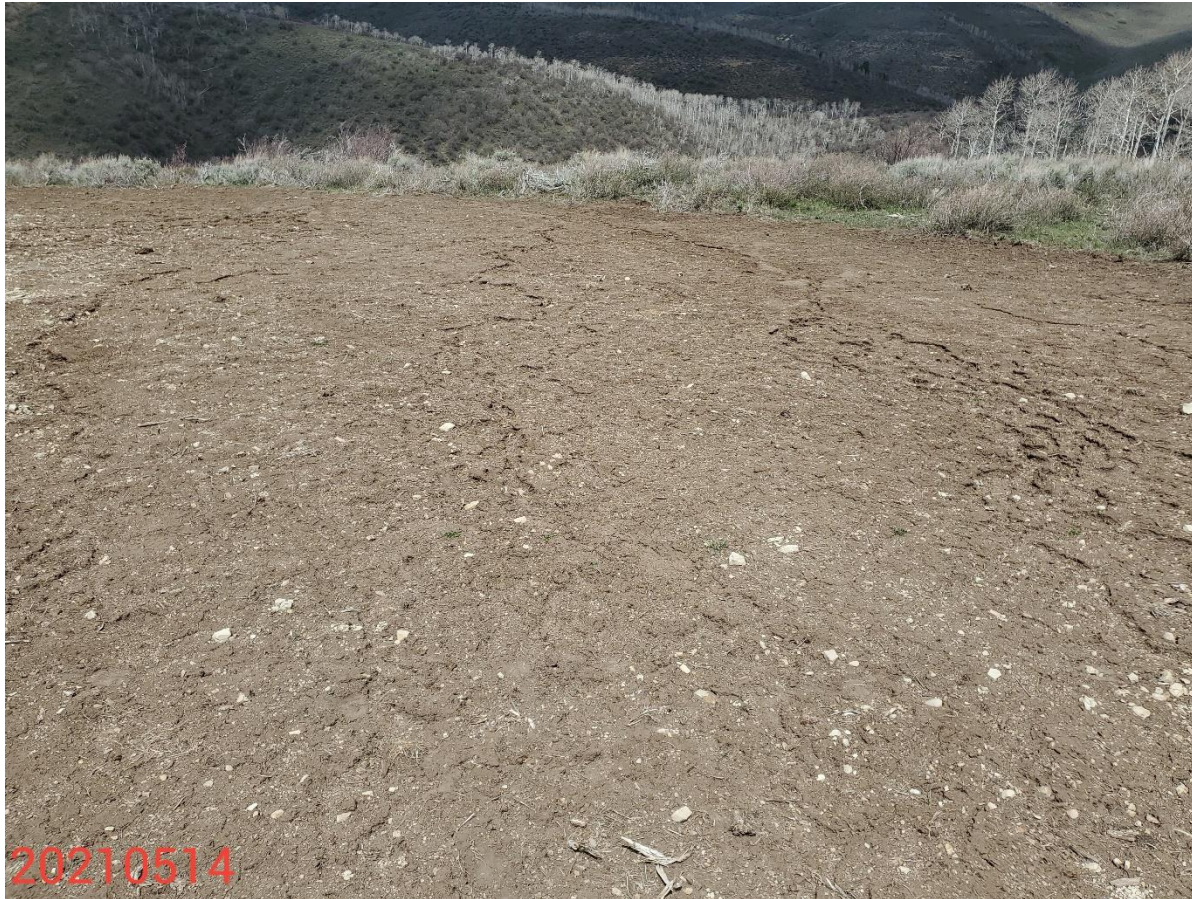
**Photo 5:** Photo taken from the northwest end of the Location, facing northwest. Photo shows control measures to stabilize the soils and manage stormwater runoff is missing or insufficient; erosion degradation evident.

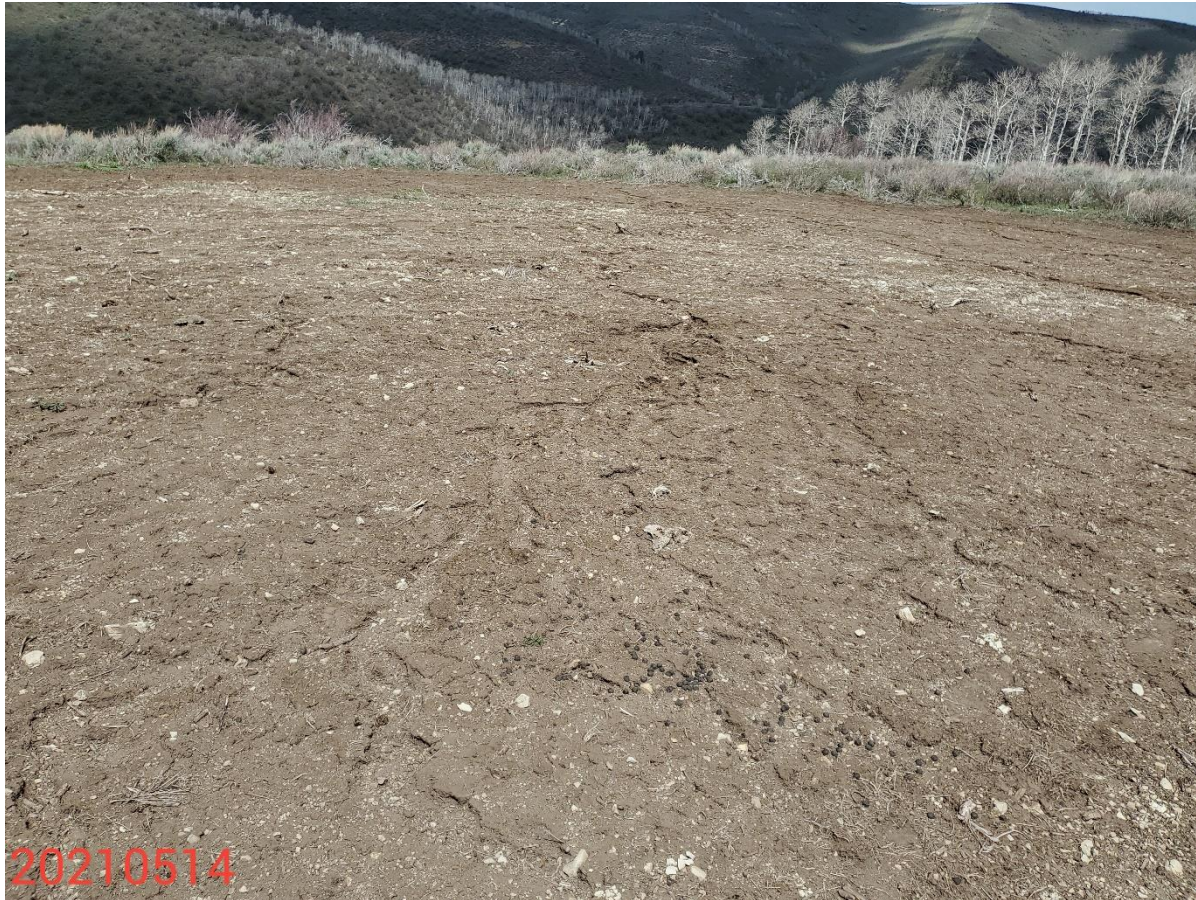
**Photo 6:** Photo taken from the northwest end of the Location, facing northwest. Photo shows control measures to stabilize the soils and manage stormwater runoff is missing or insufficient; erosion degradation evident. .

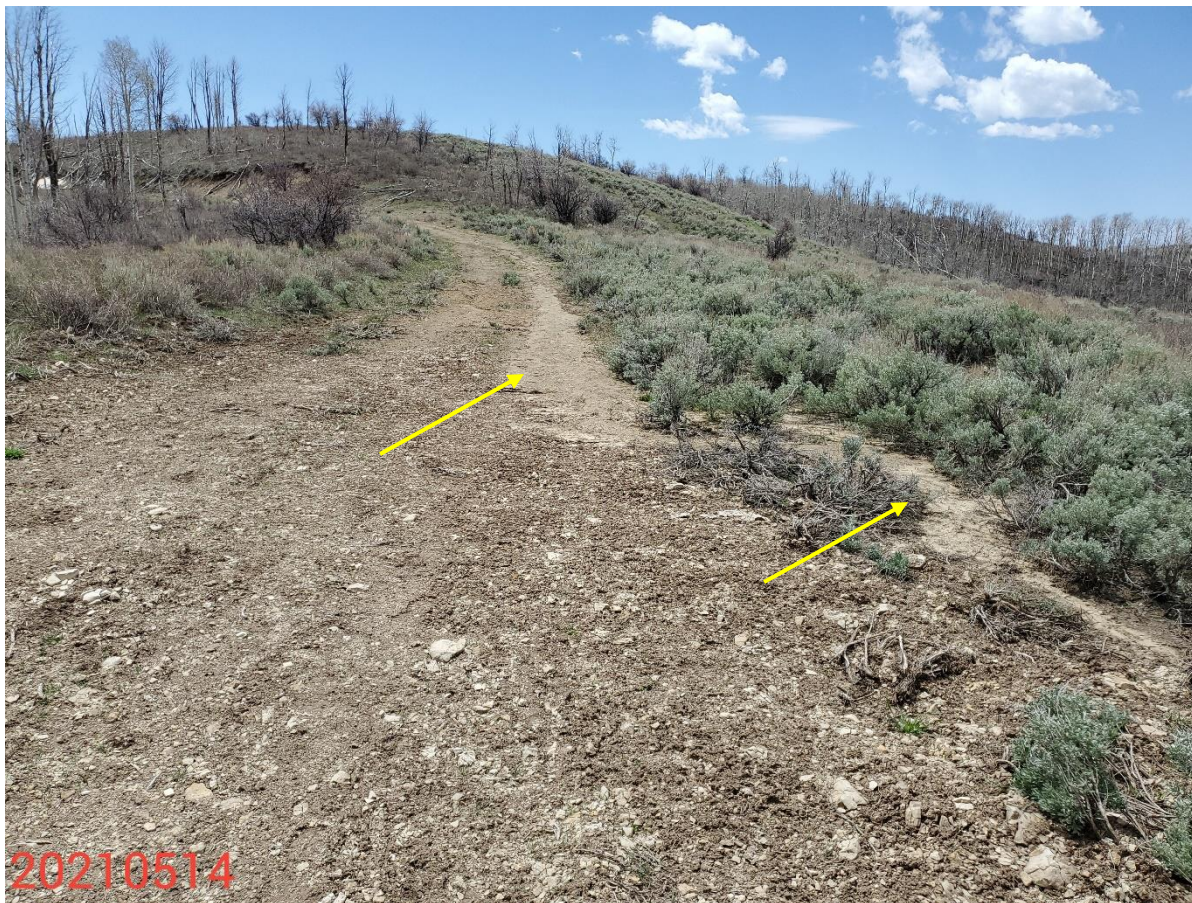
**Photo 7:** Photo taken from the access road, south of the Location, facing south. Photo shows erosion degradation due to stormwater runoff on the access road; arrow shows sediment deposition on and off the road. Stormwater BMPs missing or insufficient on the access road. Photo also shows access road has not been reclaimed in accordance with 1004 Rules.

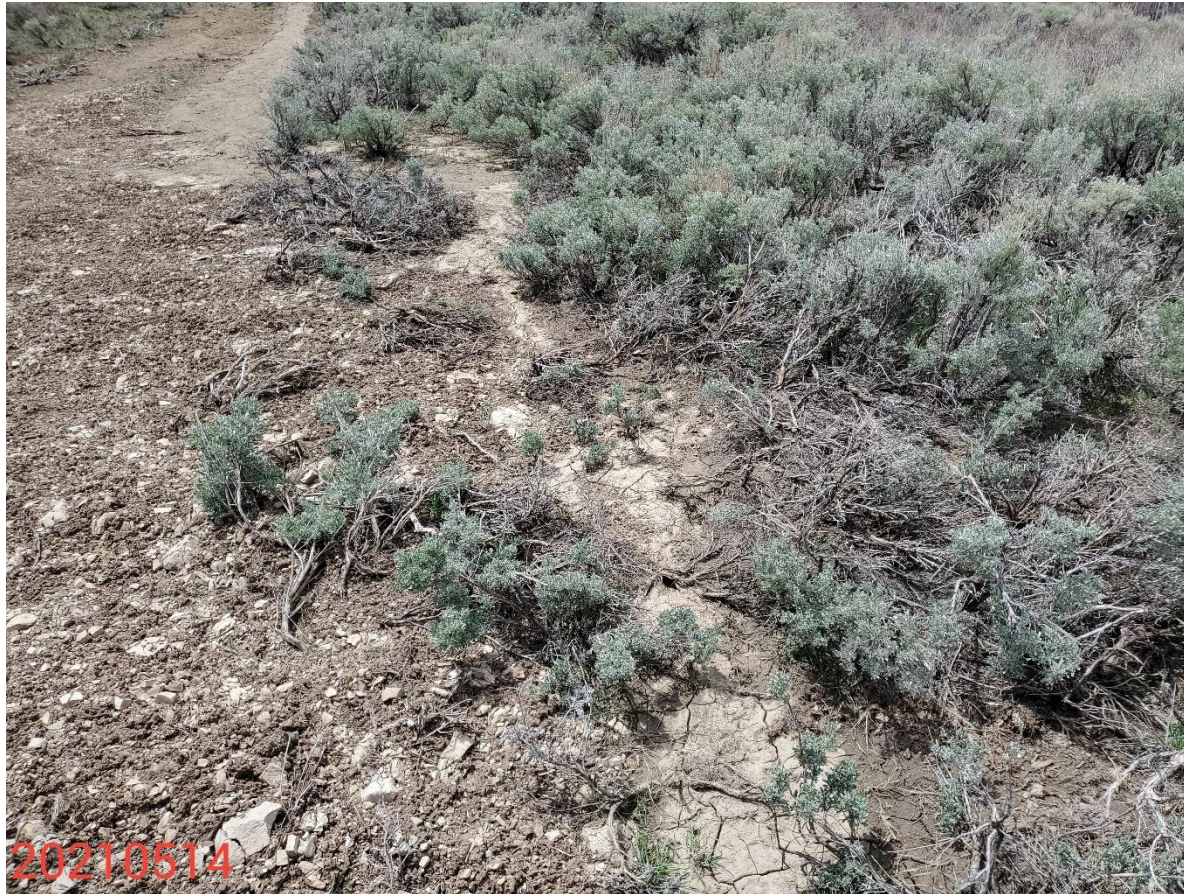
**Photo 8:** Continued from photo 7. Photo shows erosion degradation and sediment deposition occurring at the access road.

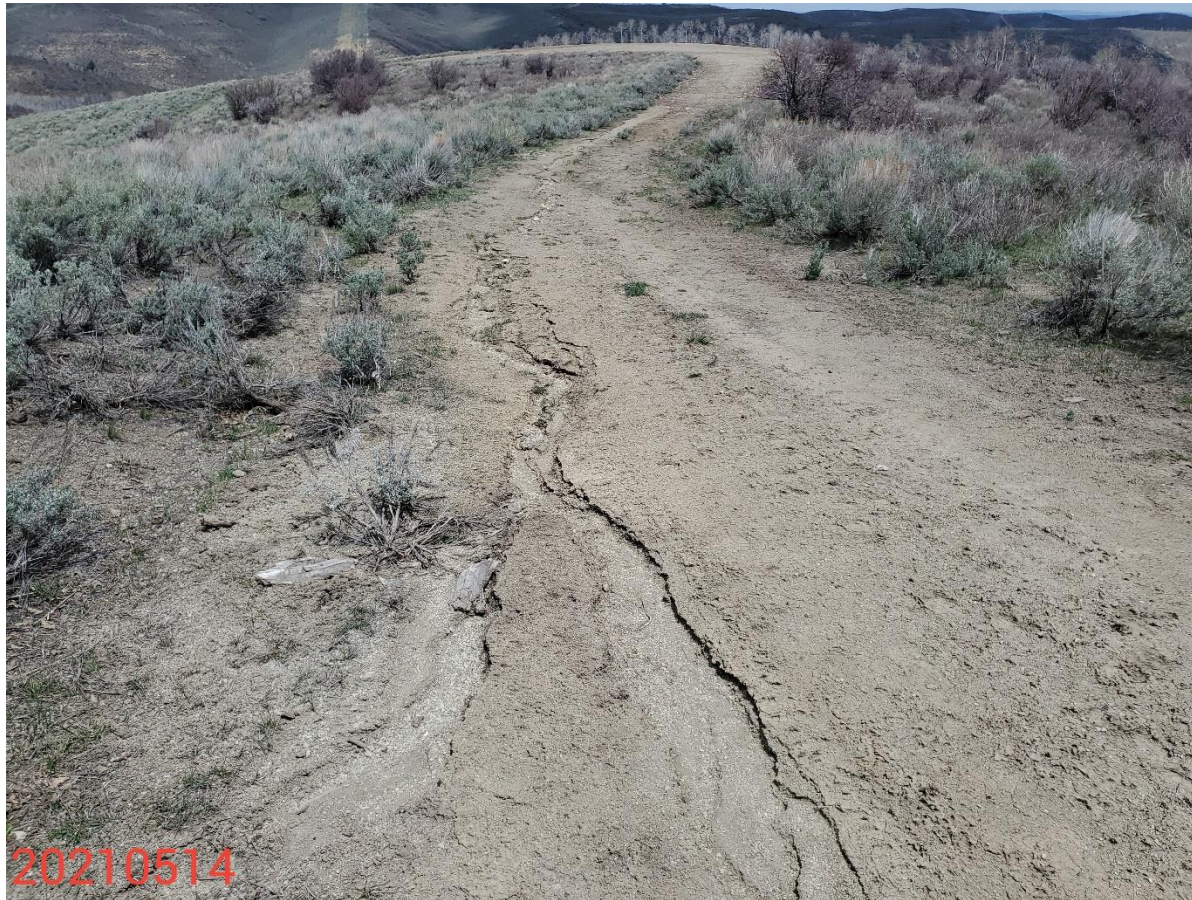
**Photo 9:** See comments under photo 7,

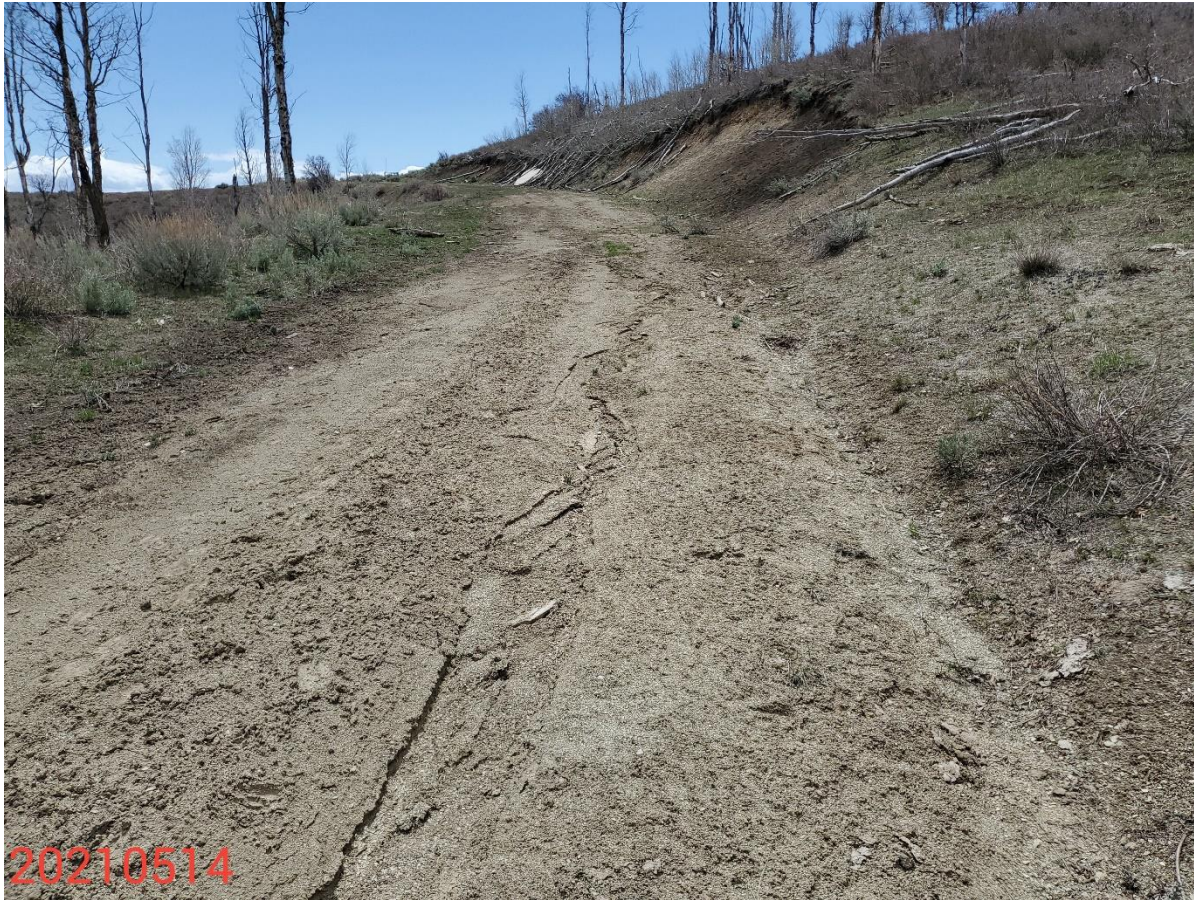
**Photo 10:** Photo taken from the former cut slope on the west end of the Location, facing northeast. Surface roughening (tracking) observed on western slopes of the Location.

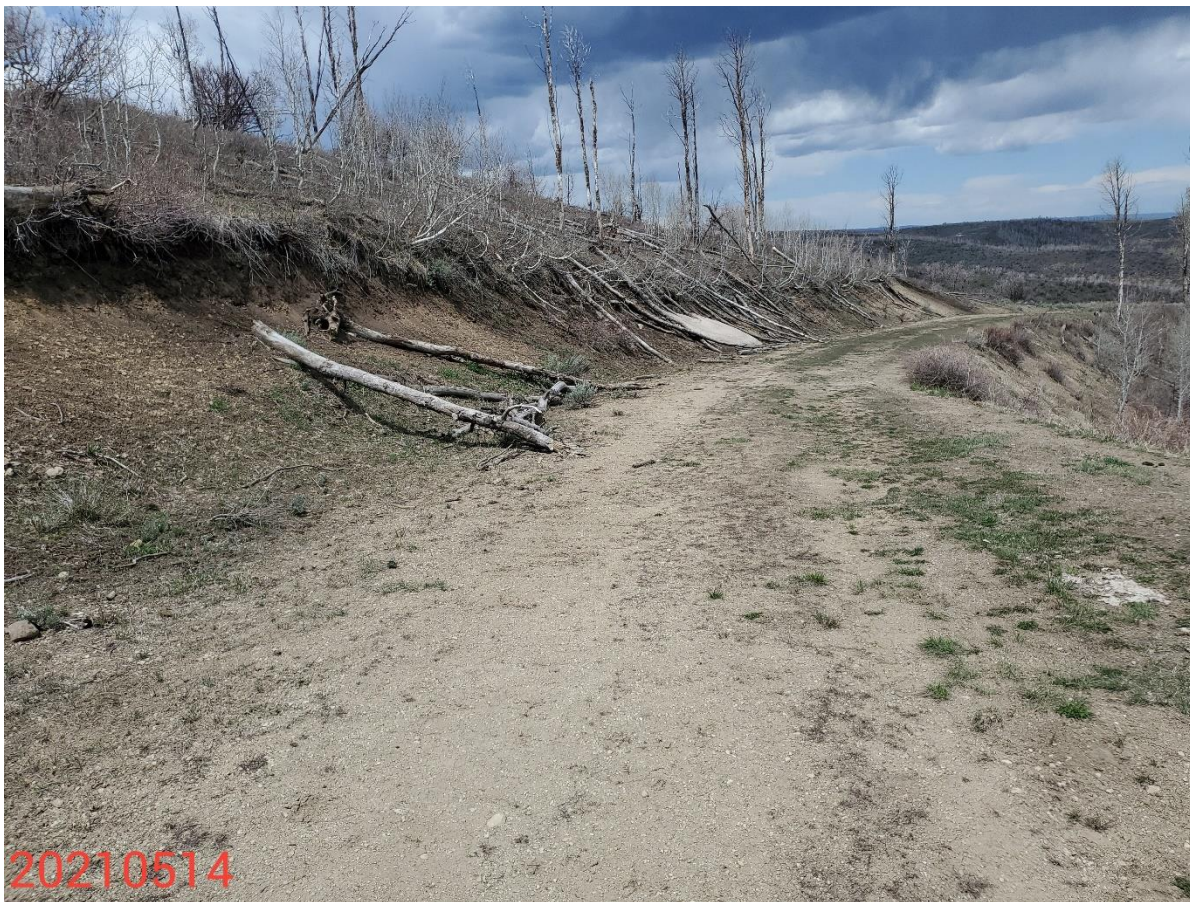
**Photo 11:** Photo taken from the access road, facing northwest. Photo shows access road has not been reclaimed in accordance with 1004 Rules; Access road requires, at a minimum, compaction alleviation, recontouring/regrading and revegetation activities.
