Inspection Photos
Operator: XTO
API: 067-07683
Date: 5/17/2021

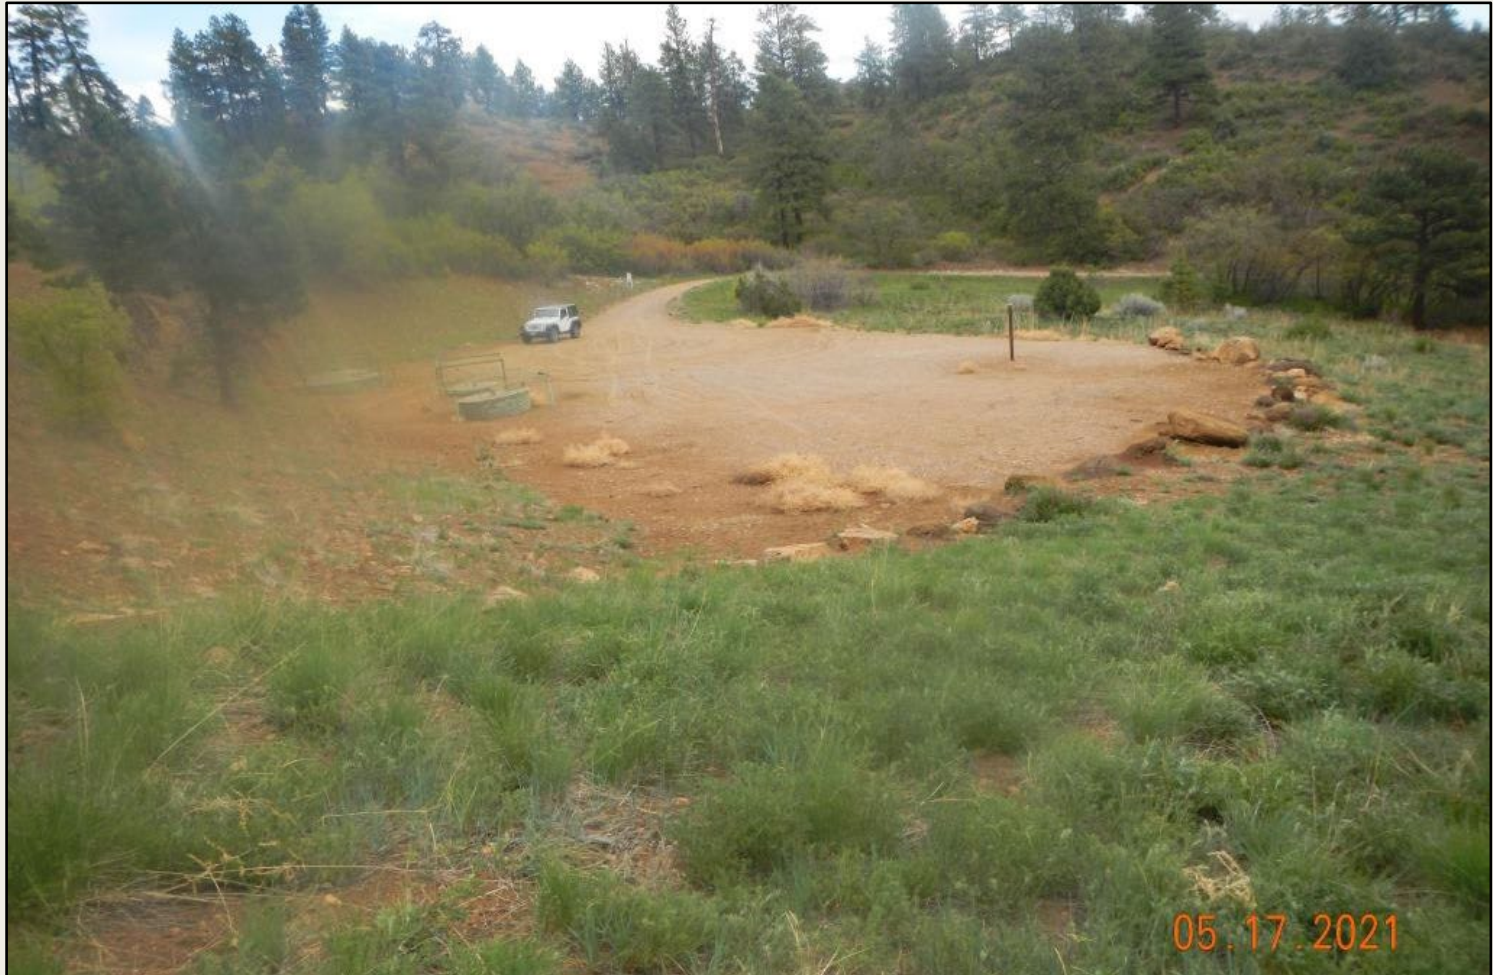
Photo 1. View of project area from southwestern corner facing center.

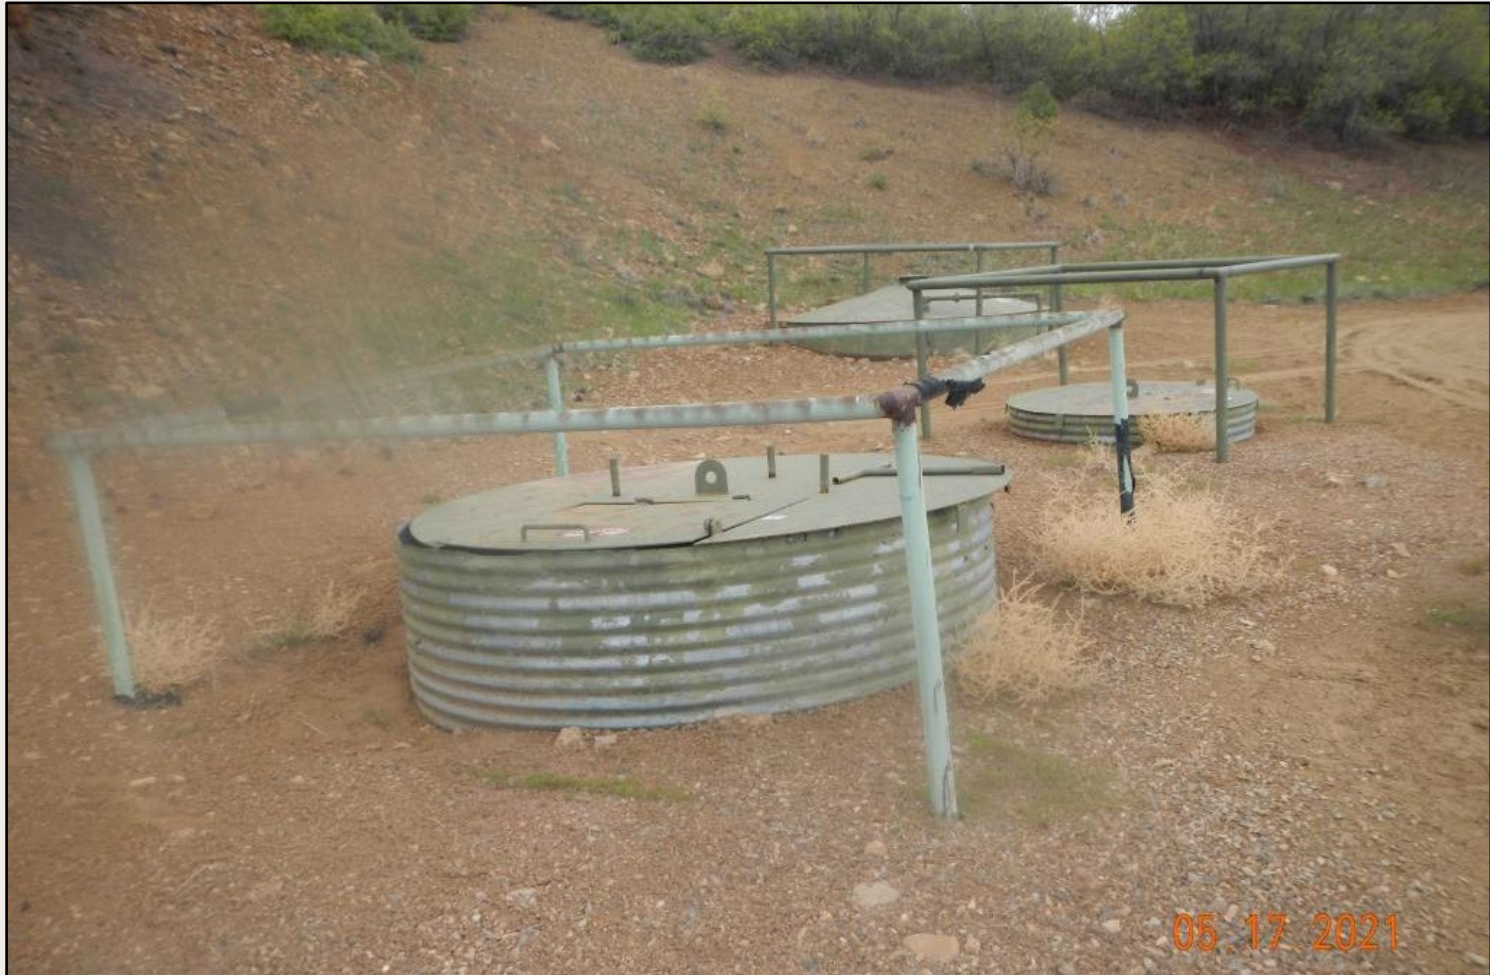
Photo 2. View of tanks and equipment needs to be removed.

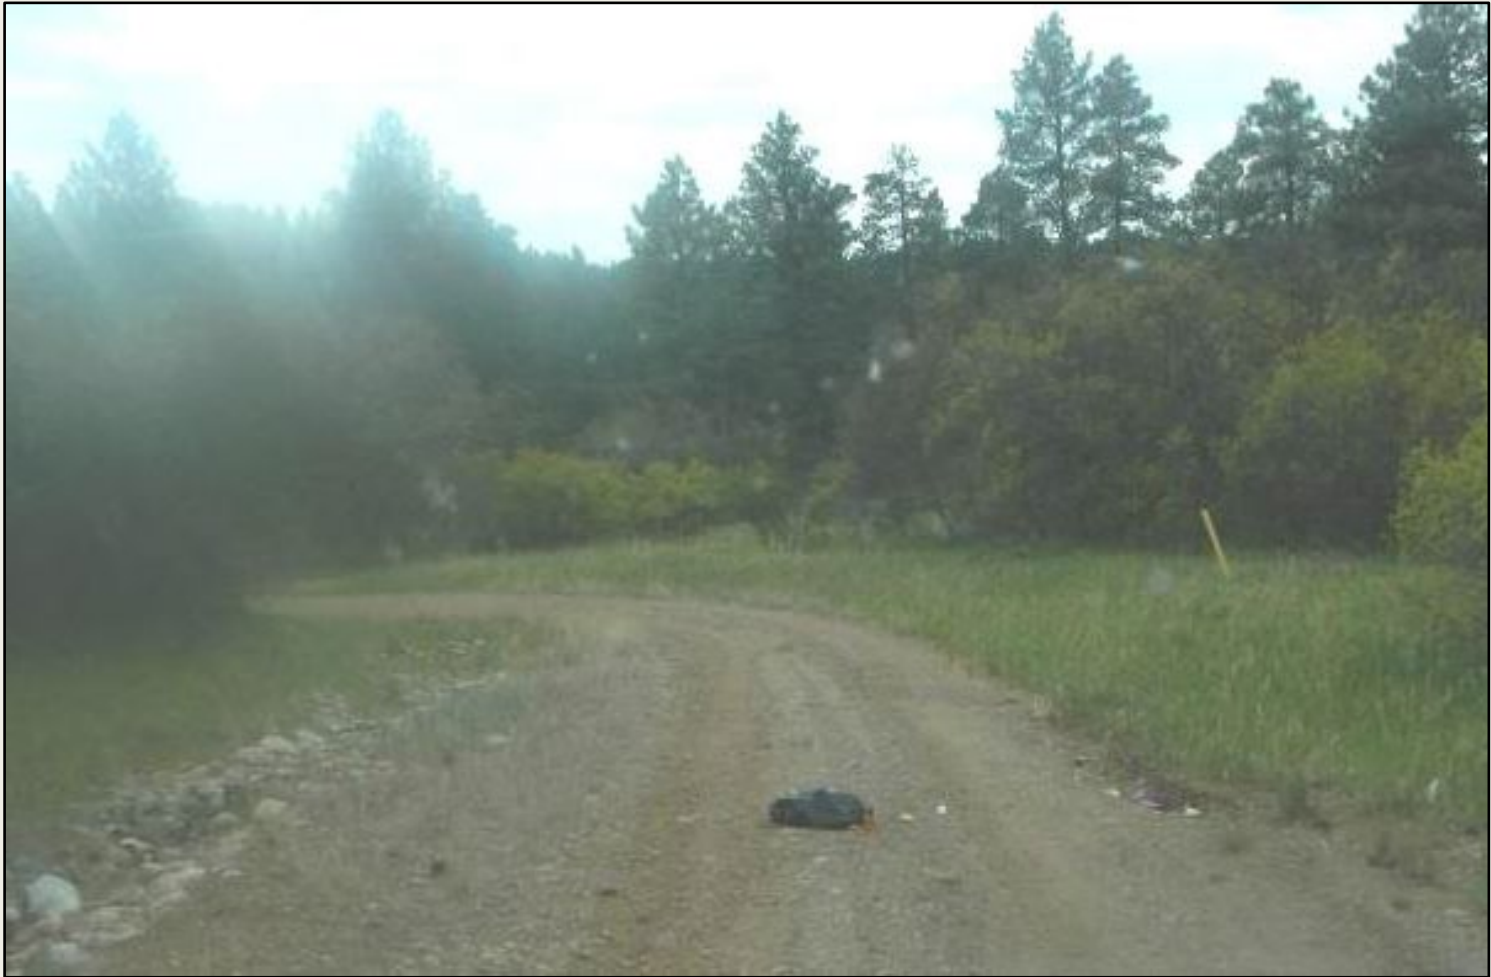
Photo 3. View of access road needs to be reclaimed. Black bag and trash need to be removed. Open site is providing access for trash dumping.

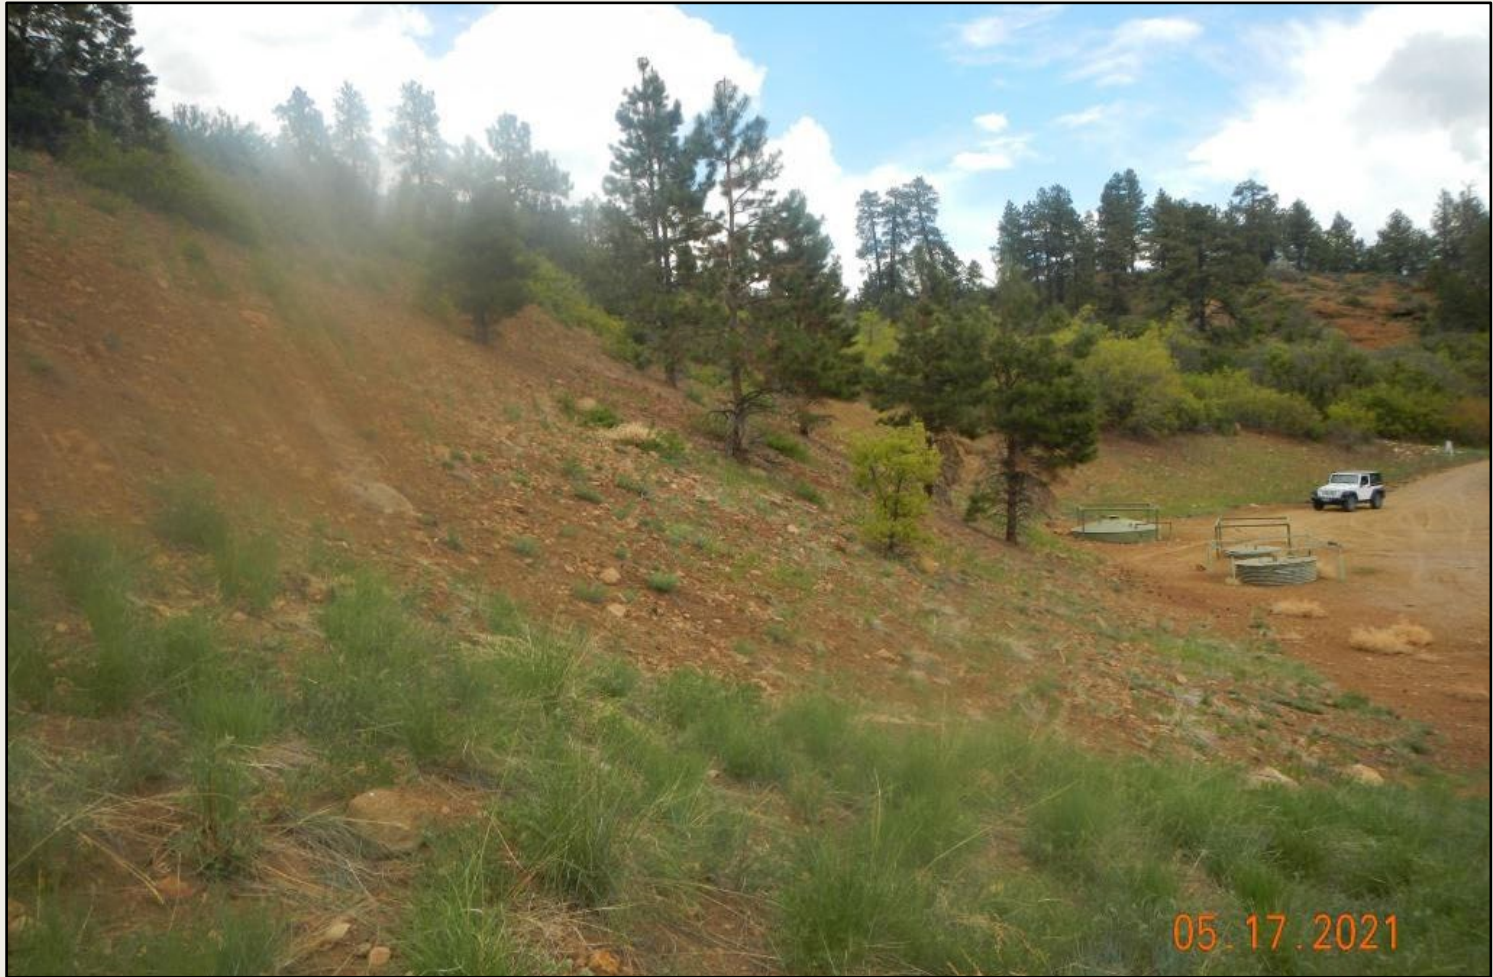
Photo 4. View of the western cut slope facing southward from the southwestern corner.

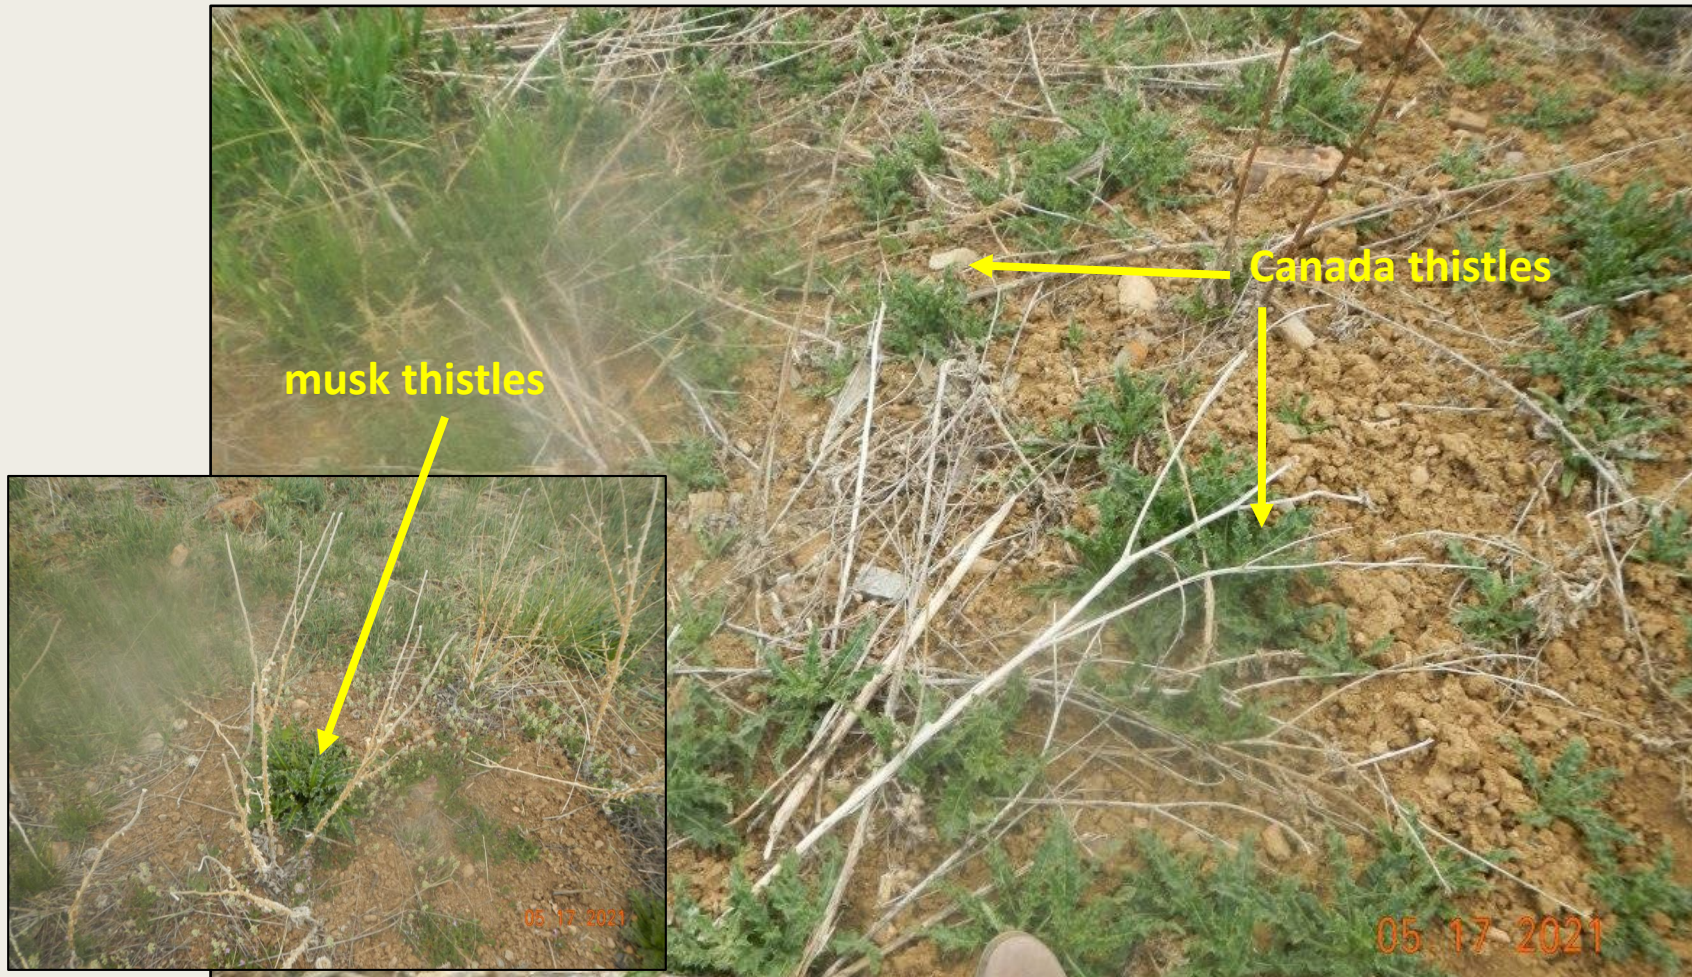
Photo 5. View of dense musk thistles and Canada thistles observed within the project area. Approximately 1000 Canada thistles and 500 musk thistles observed.

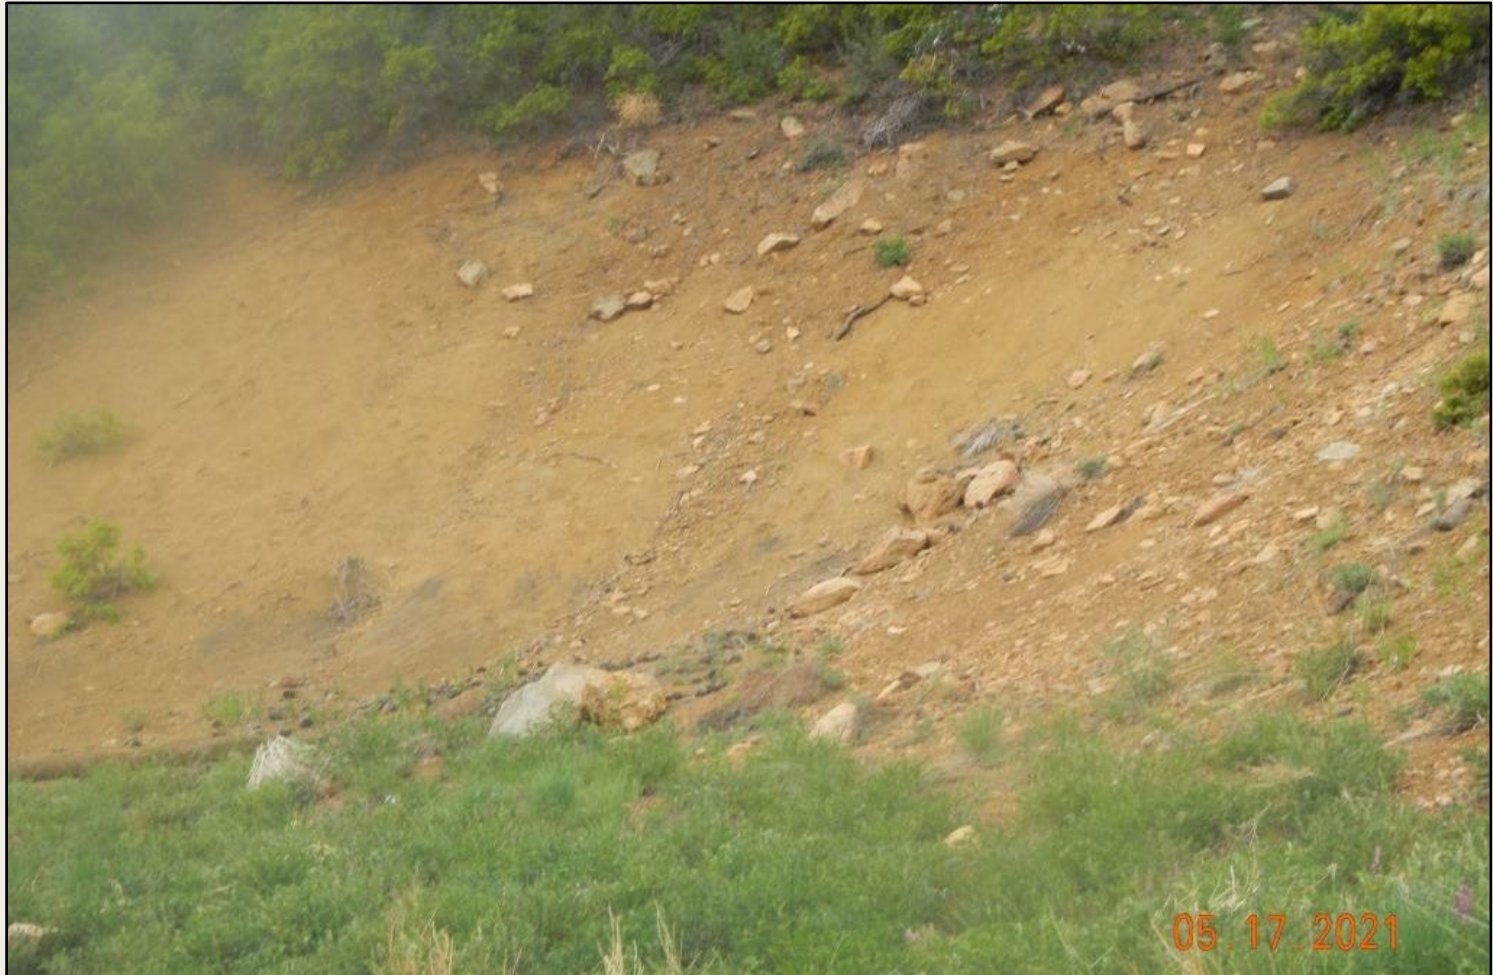
Photo 6. View of cut-slope within the southwestern project area, approximately 30 feet high. Bare soils and little vegetation observed on slope needing recontouring, slope reduction, and stabilization.

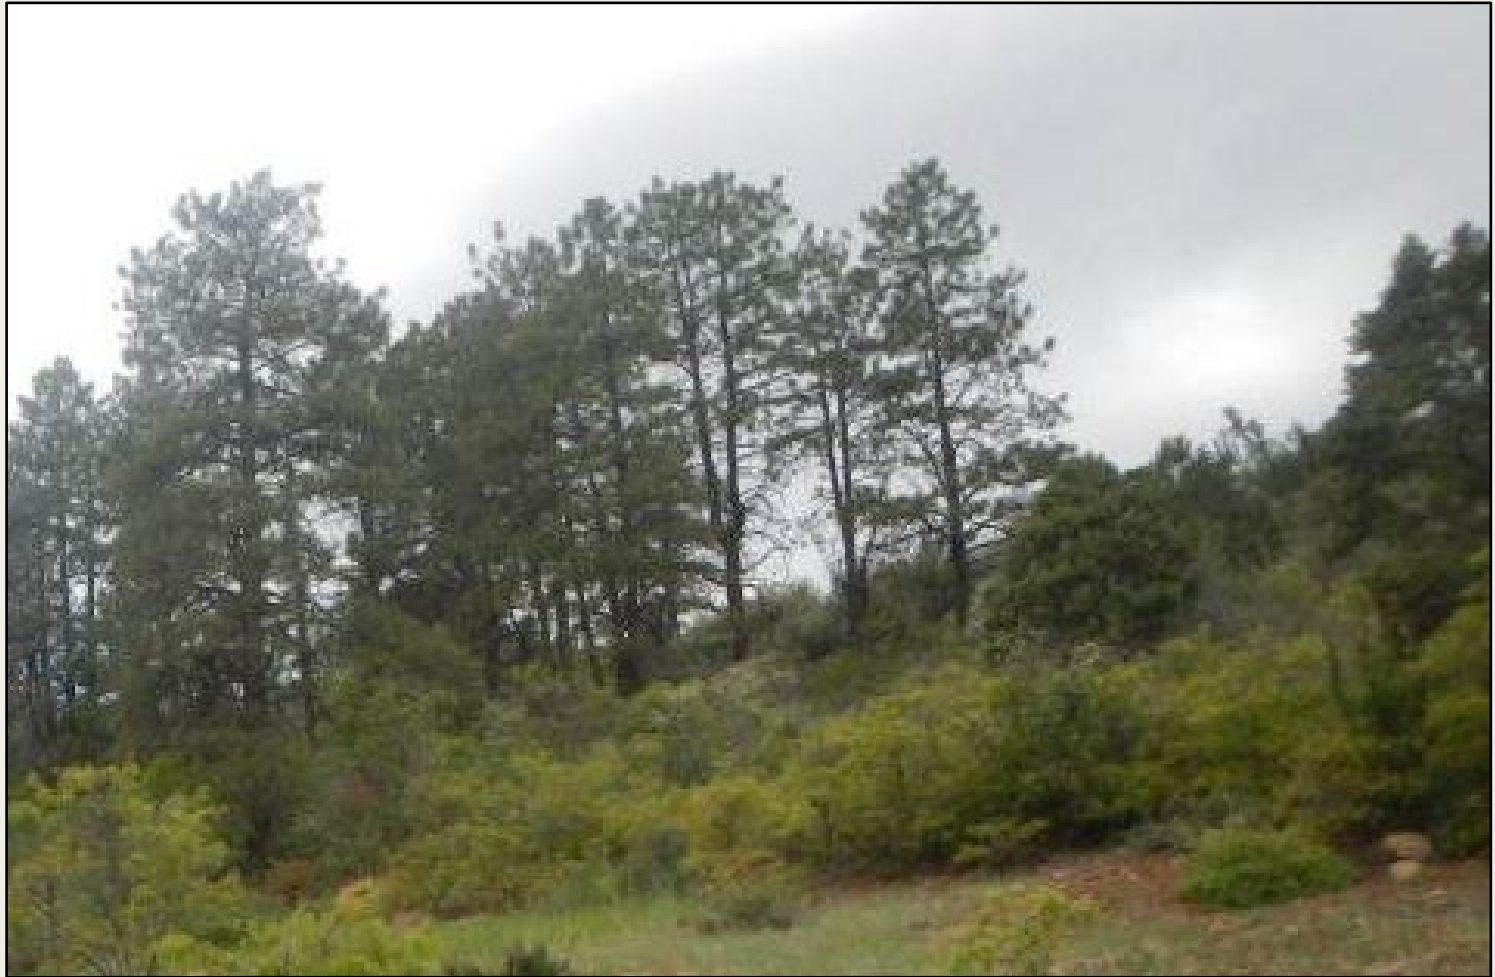
Photo 7. View of the reference area comprised of ponderosa pine woodland with understory of gambel oak, western wheatgrass, muttongrass, serviceberry, and mountain mahogany
