Inspection Photos
Operator: Hilcorp
API: 067-07814
Date: 5/17/2021

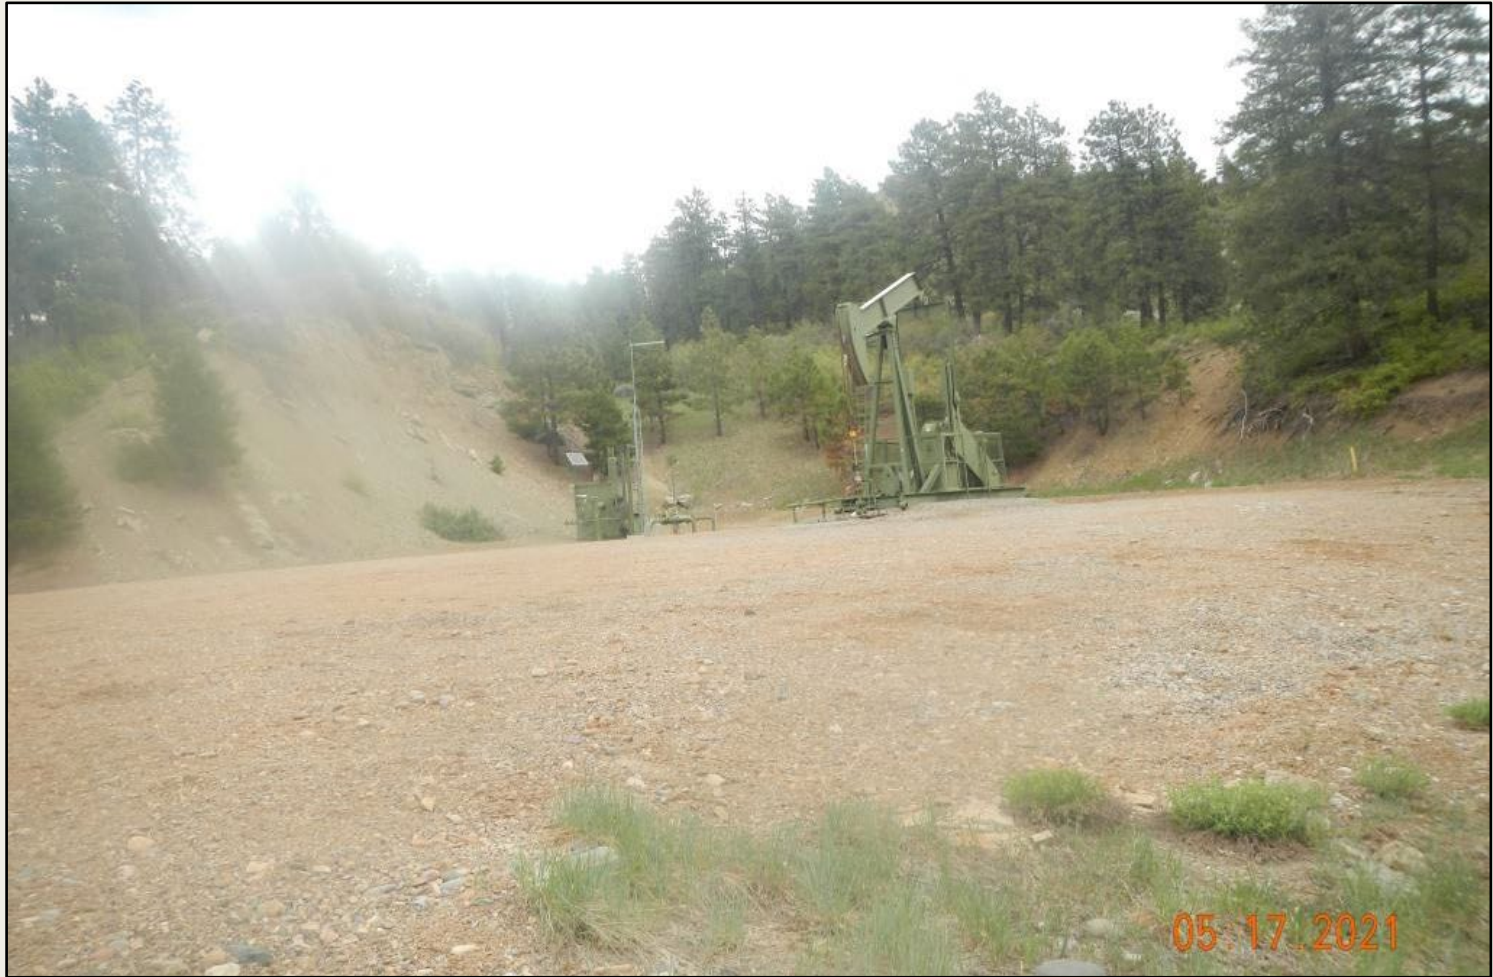
Photo 1. View of project area from northwestern corner facing center.

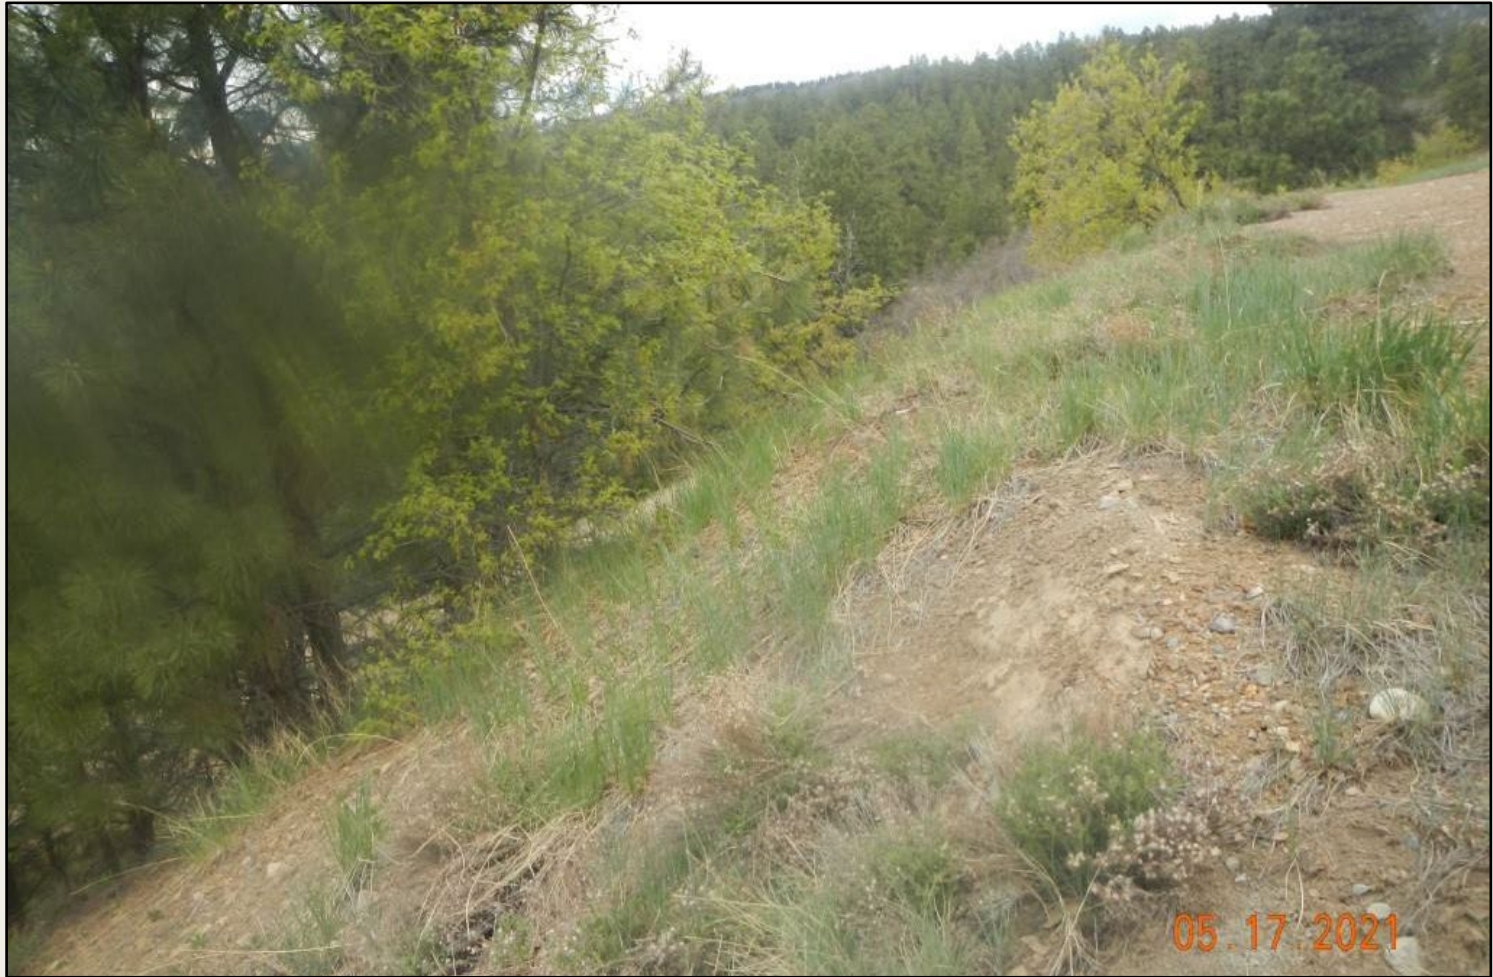
Photo 2. View of the western fill slope from the southwestern corner facing northward. Revegetation is progressing with western wheatgrass, smooth brome, and goldenaster.

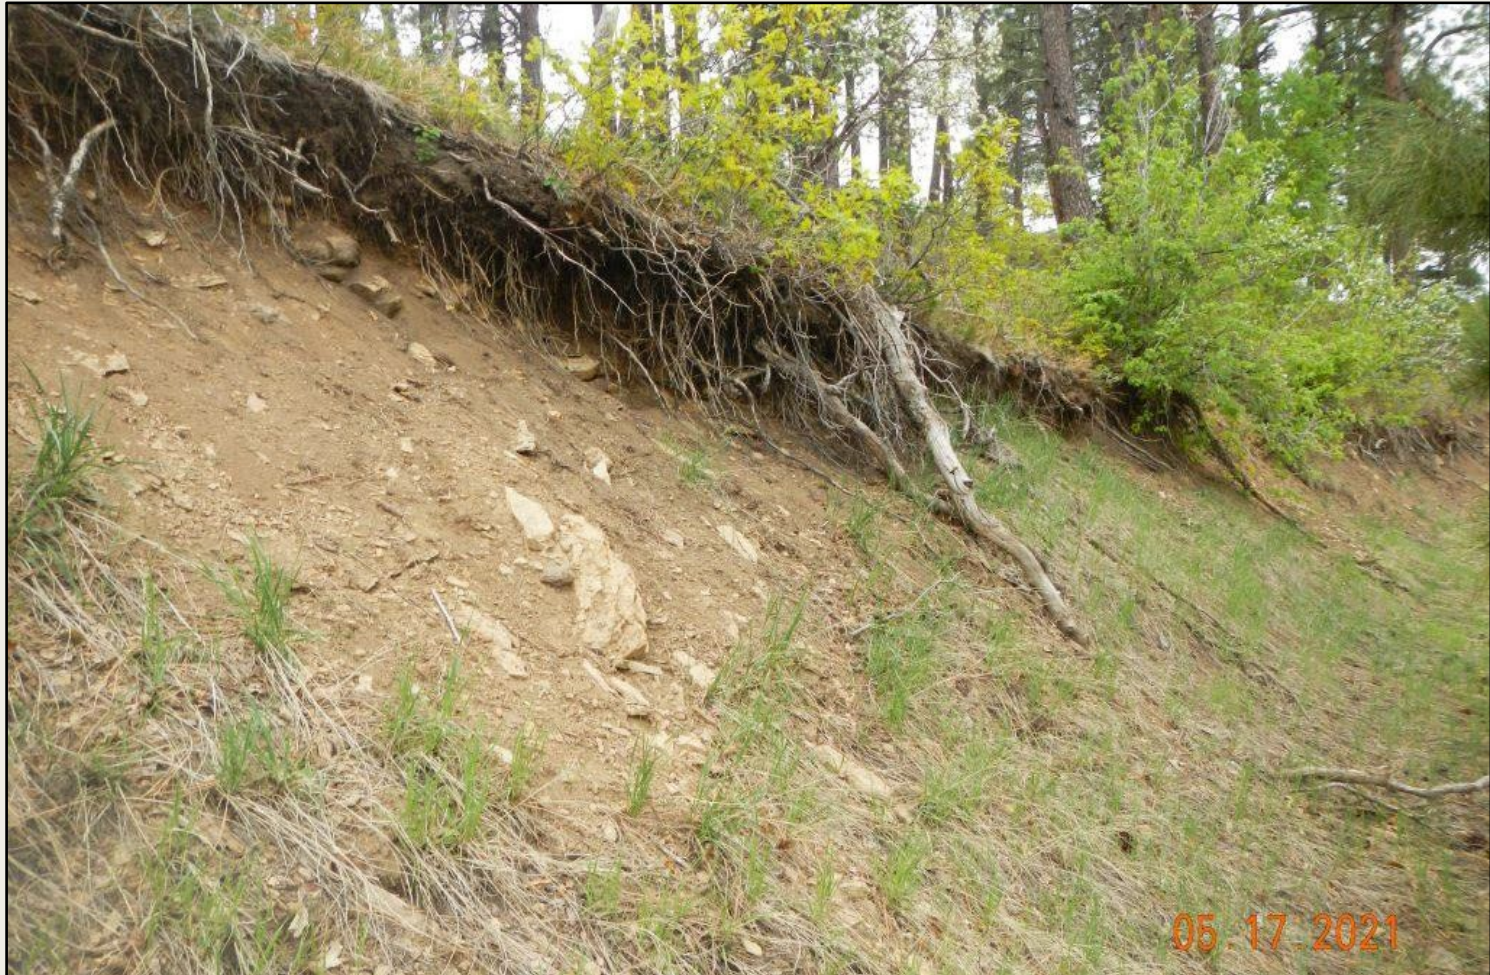
Photo 3. View of erosional downcutting at the top of the eastern cut slope facing. Exposed roots demonstrate lack of stabilization at the top of the cut-slope.

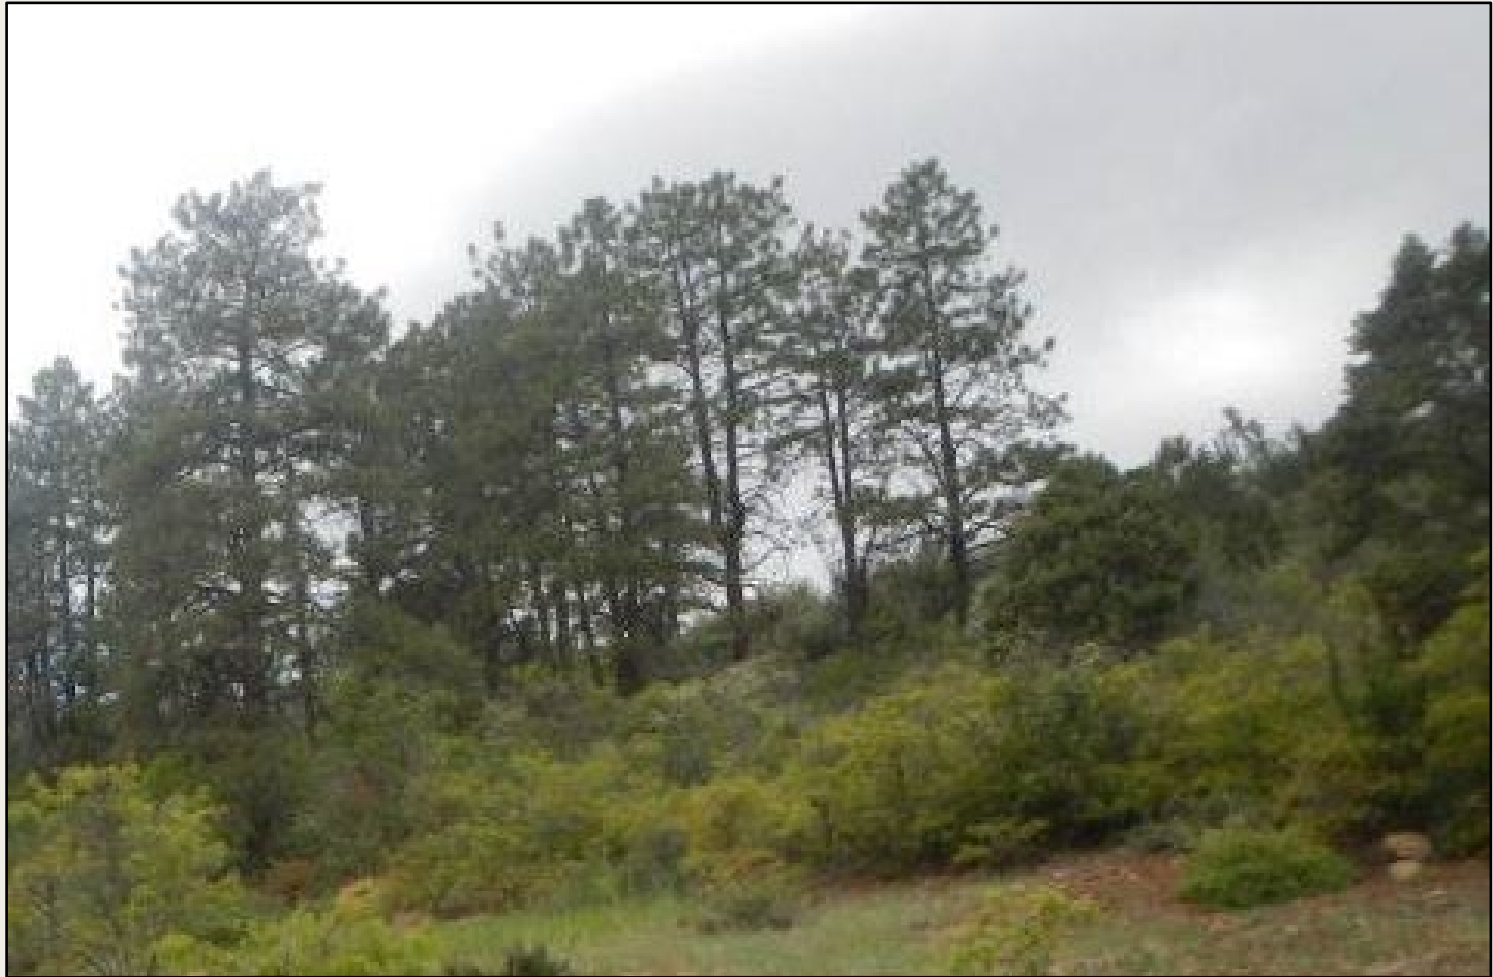
Photo 4. View of the reference area comprised of ponderosa pine woodland with understory of gambel oak, western wheatgrass, muttongrass, serviceberry, and mountain mahogany
