Inspection Photos  
Operator: Simcoe  
API: 067-07860  
Date: 5/19/2021

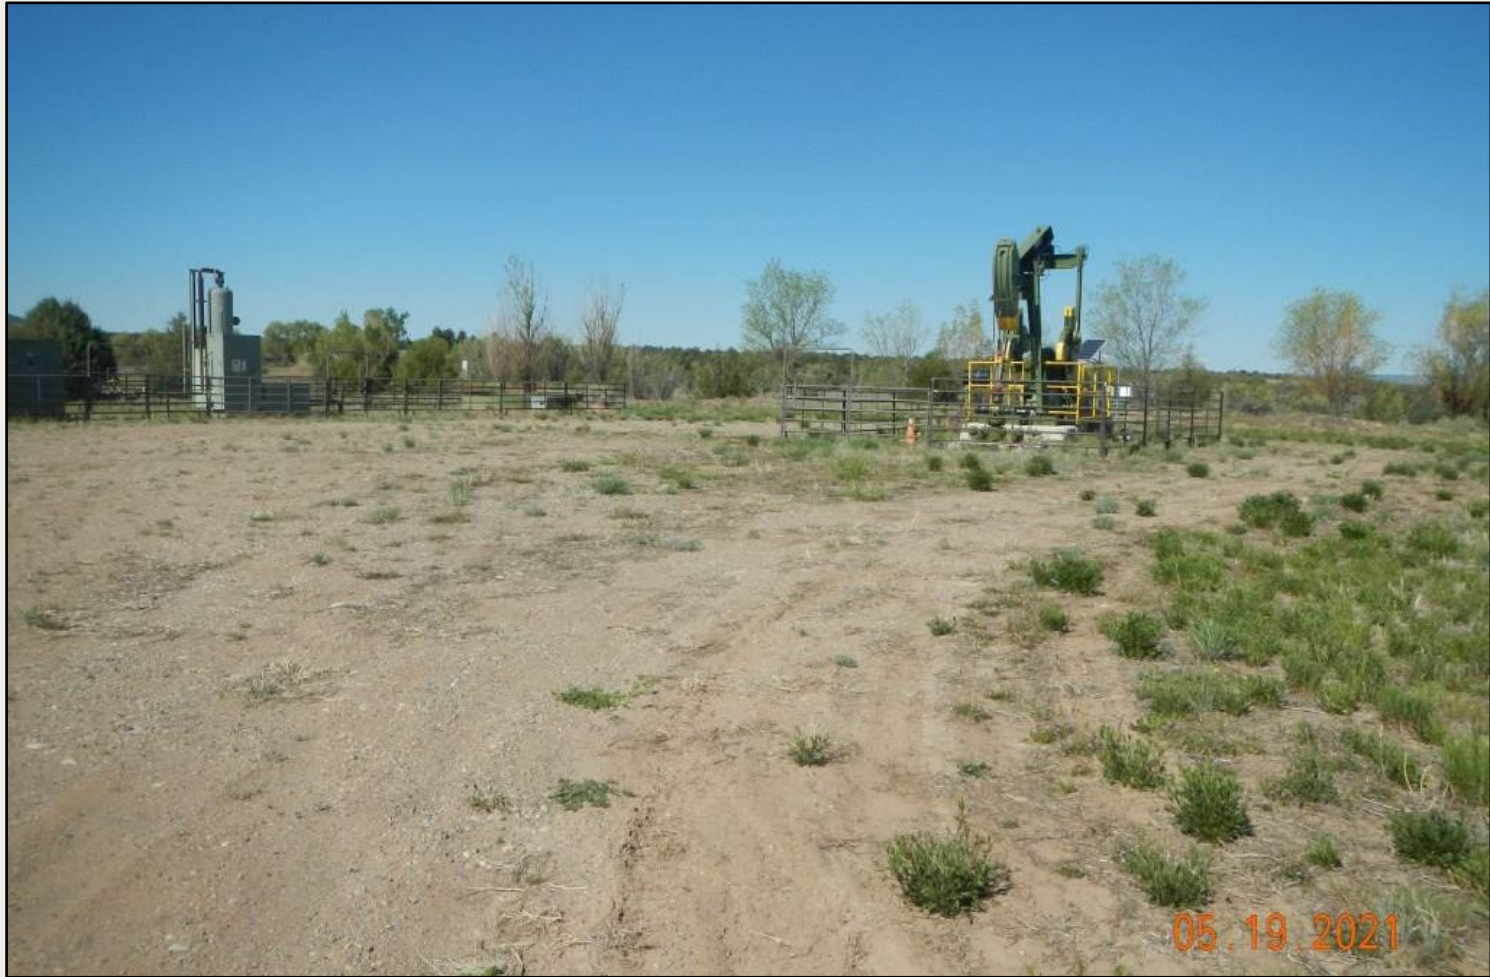
Photo 1. View of project area from the well pad entrance facing center.

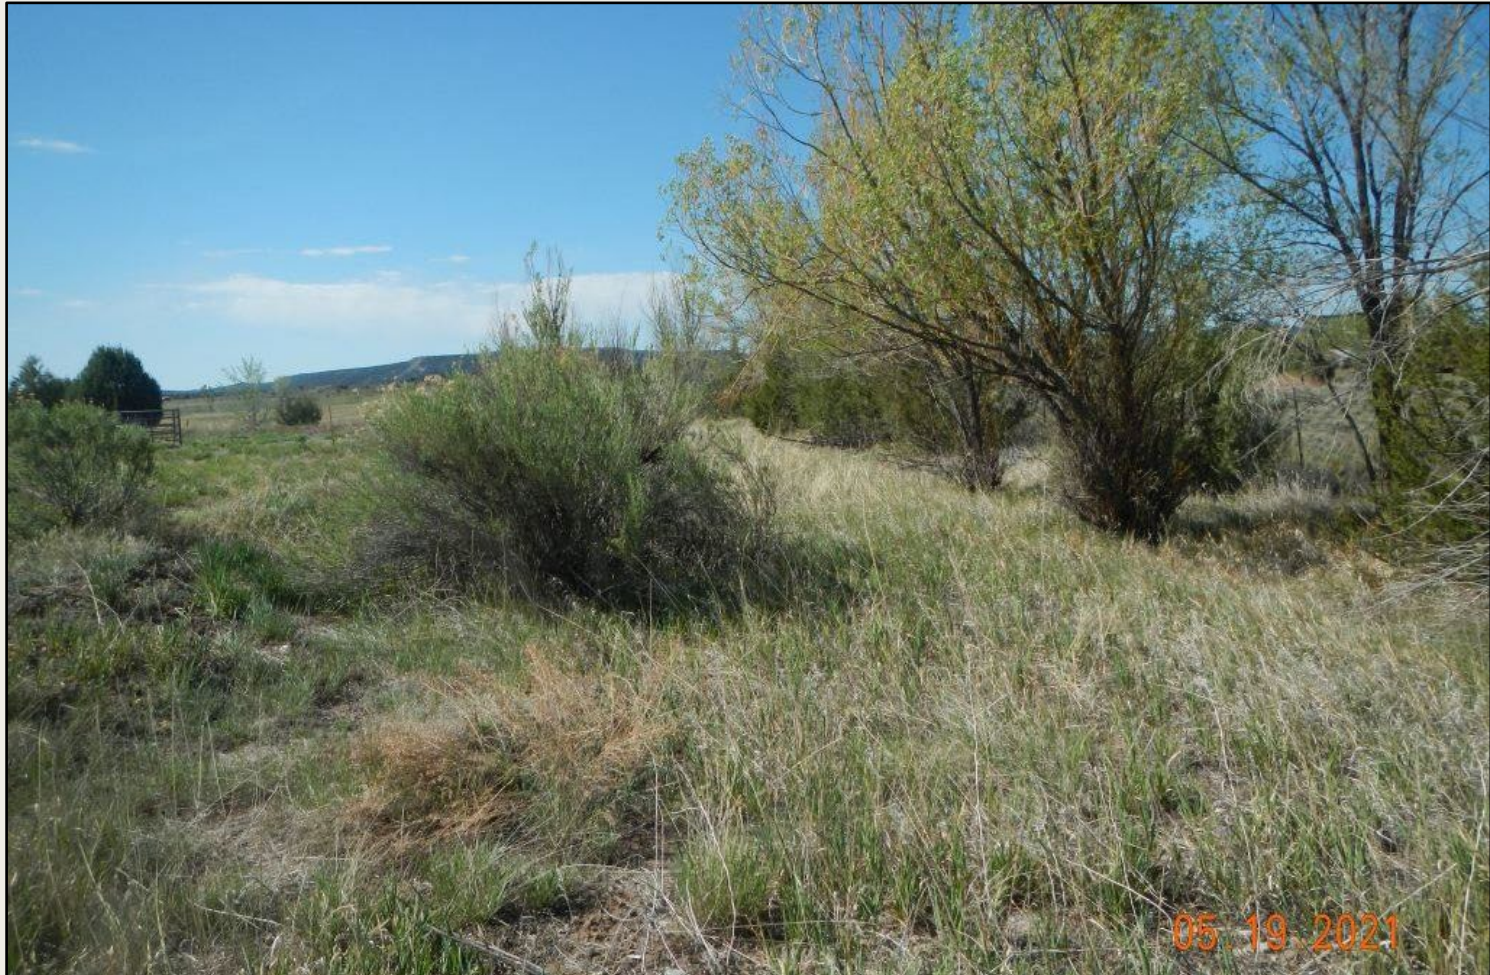
Photo 2. View of the western project area from the northwestern corner facing southward. Revegetation is progressing with western wheatgrass, smooth brome, willows, and rubber rabbitbrush.

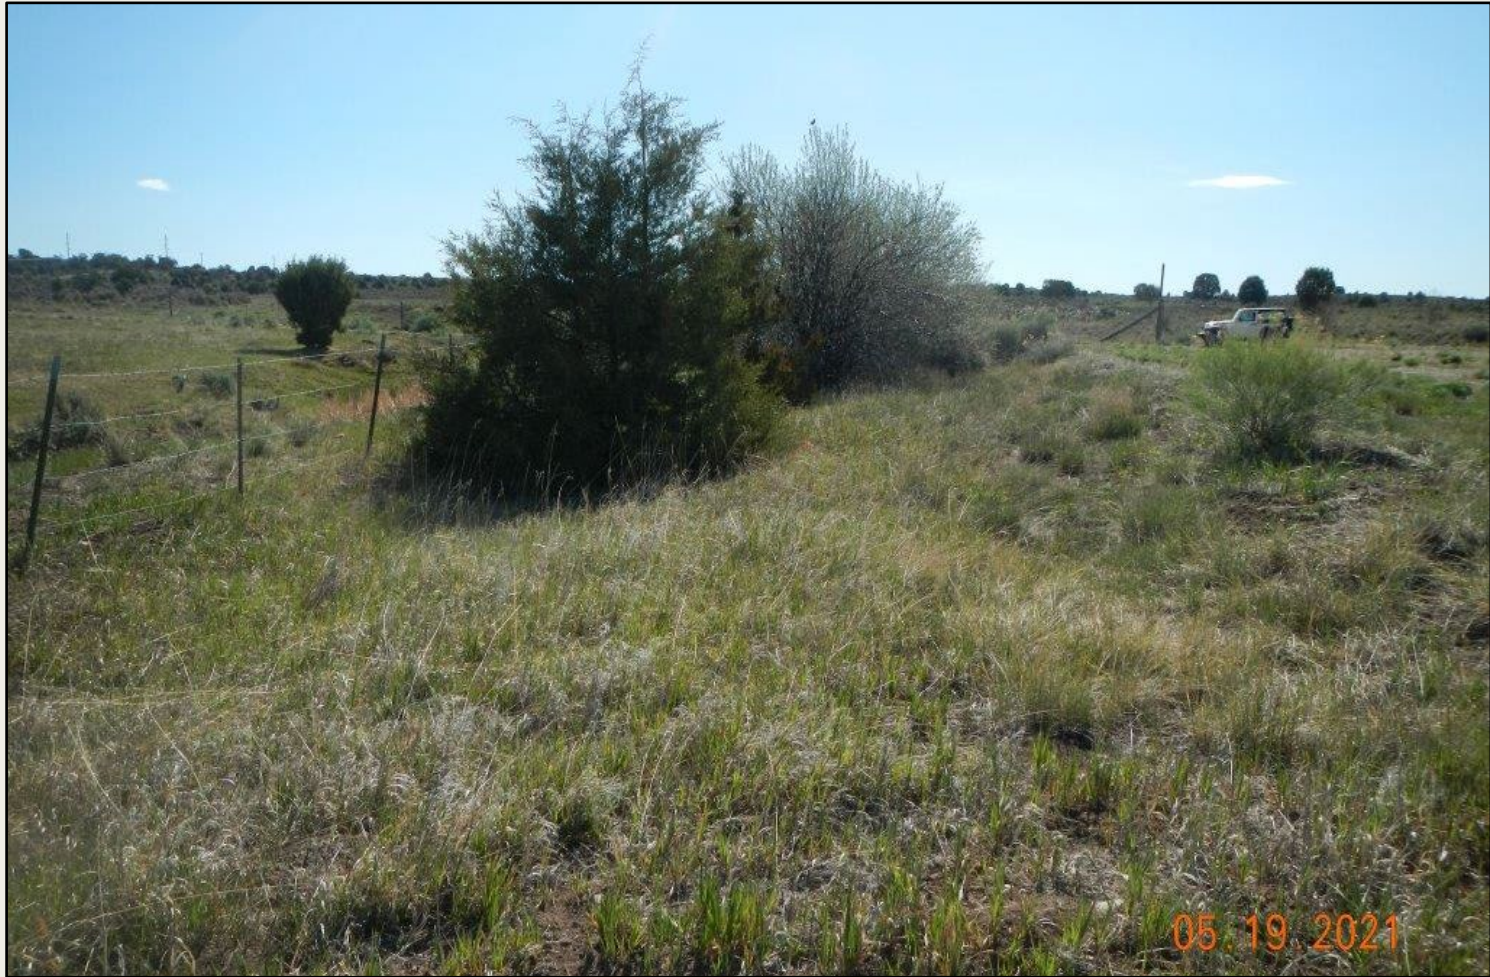
Photo 3. View of the northern project area from the northwestern corner facing eastward.

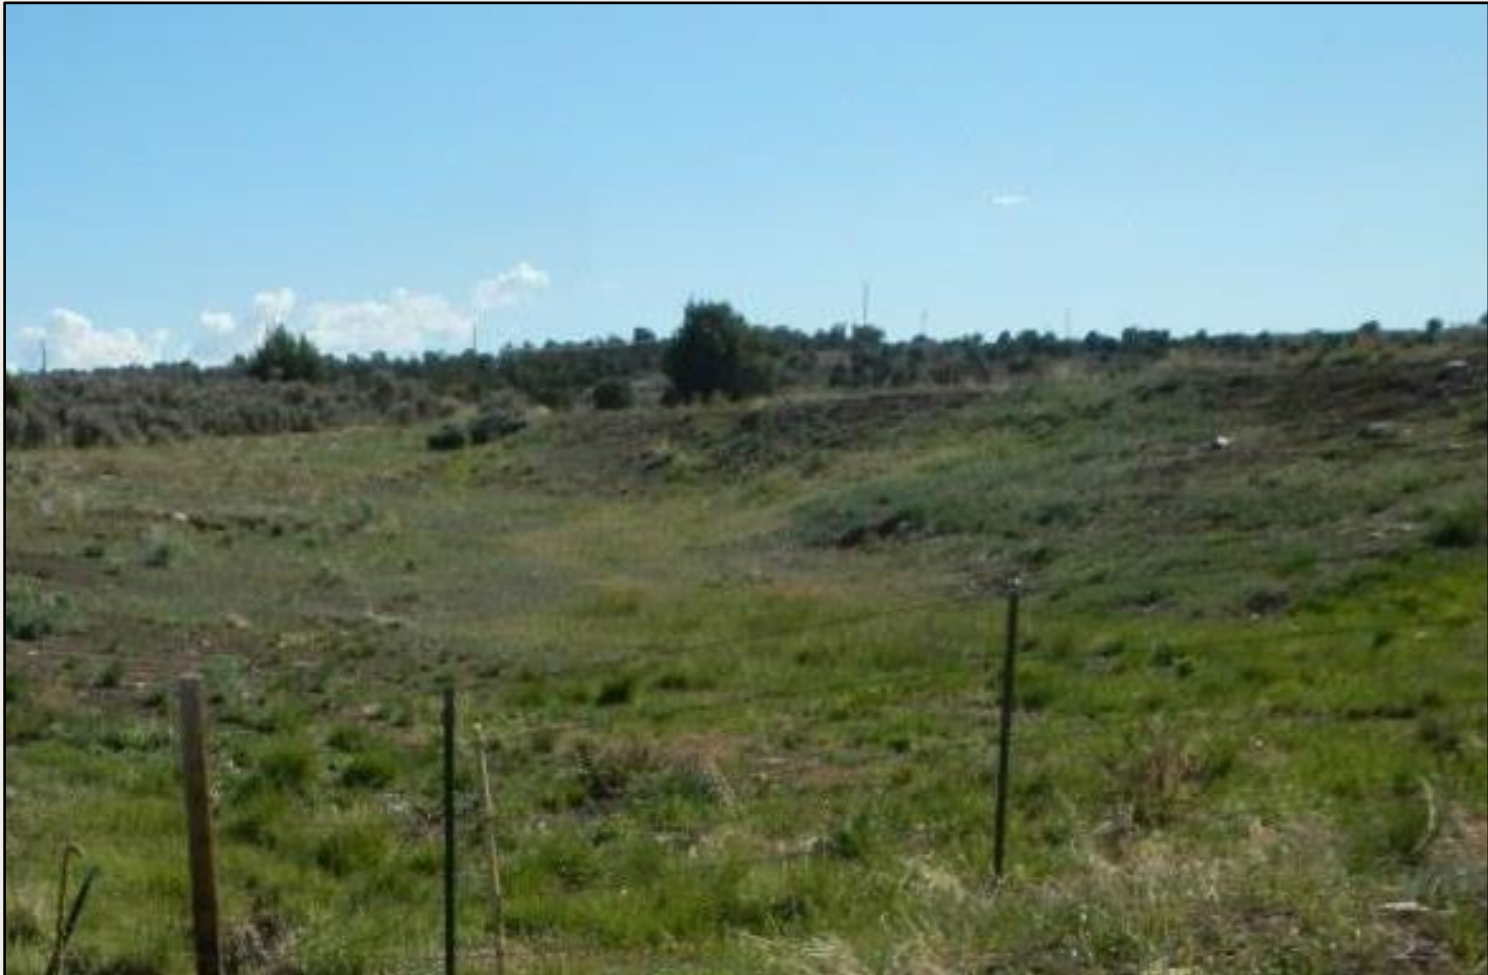
Photo 4. View of the reference area comprised of sagebrush shrubland and irrigated grassland mosaic with big sagebrush, western wheatgrass, smooth brome, and scattered juniper trees observed.

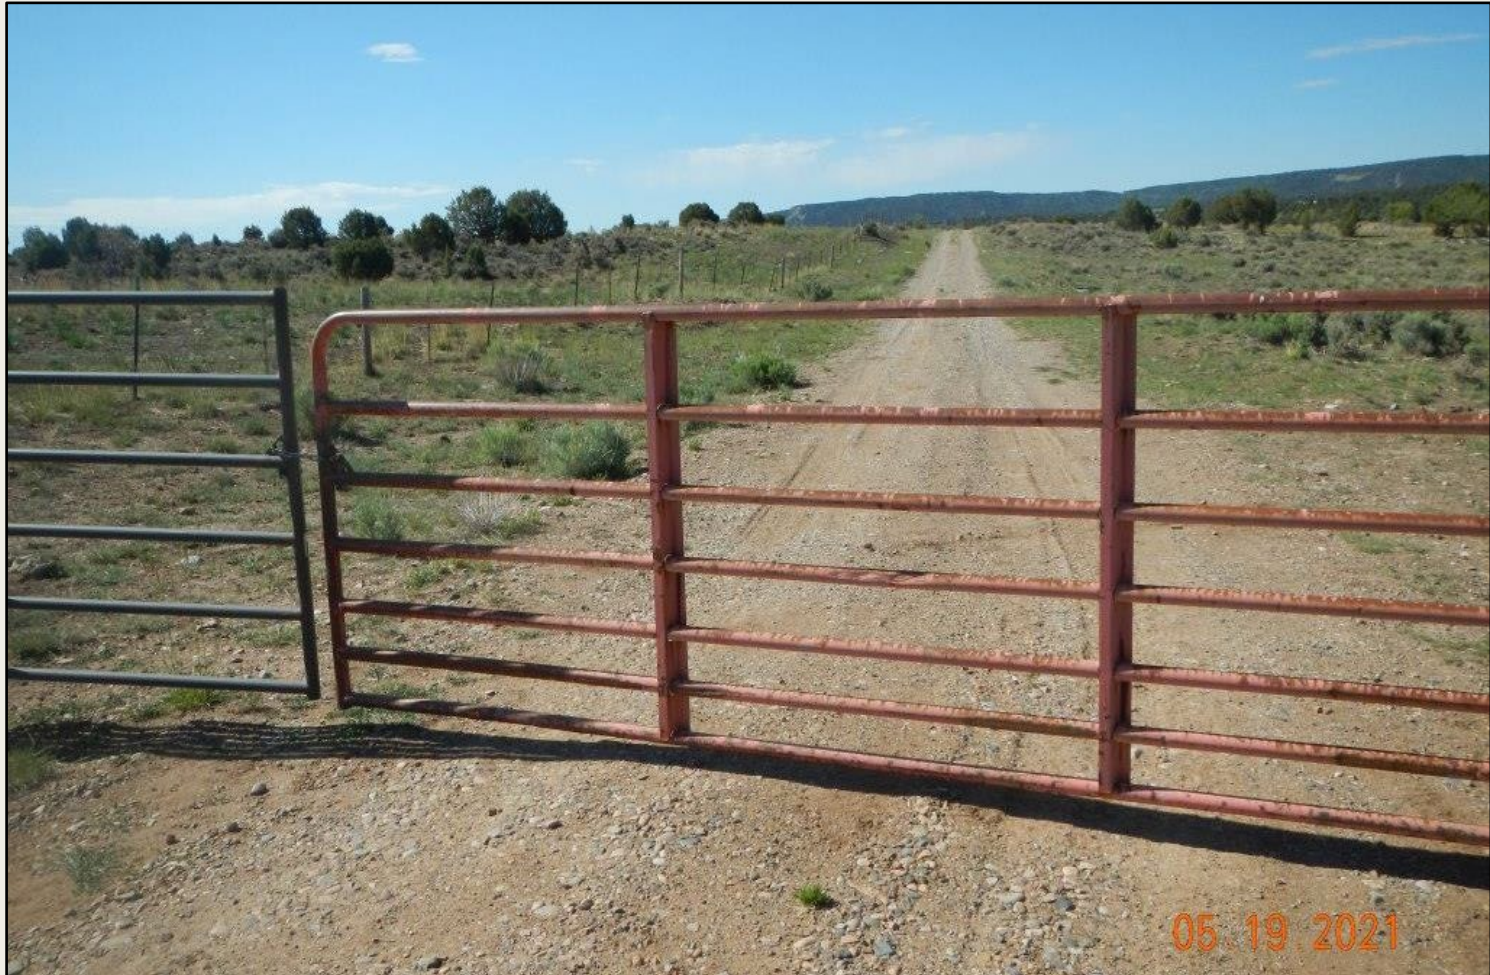
Photo 5. View of closed gate at entrance to access road after leaving location.
