Inspection Photos  
Operator: Simcoe  
API: 067-06339  
Date: 5/19/2021

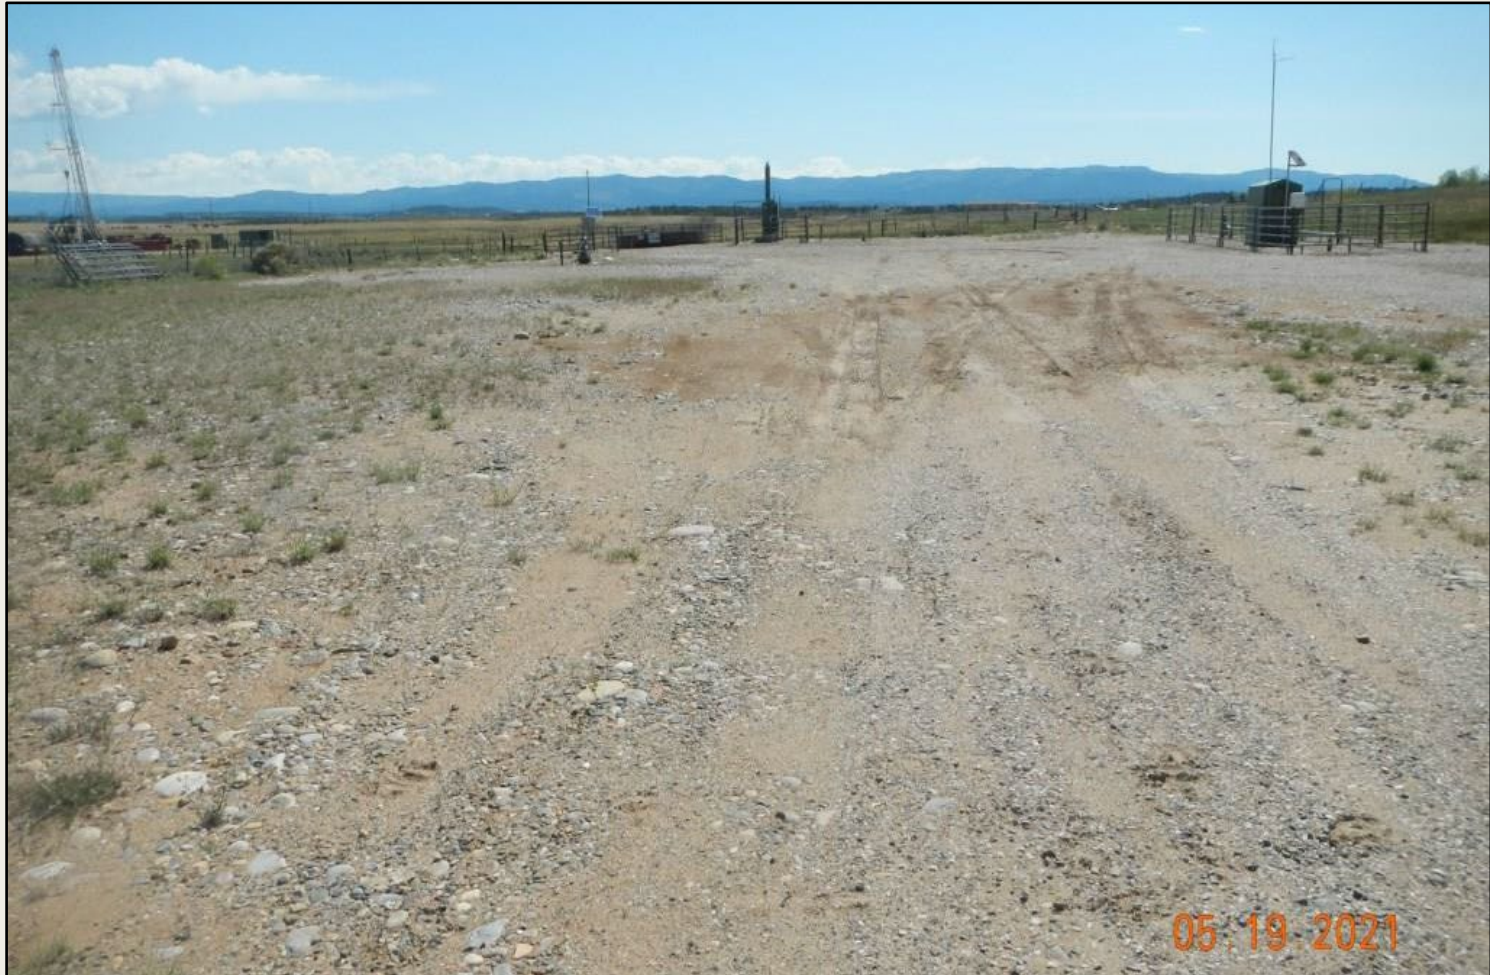
Photo 1. View of project area from well pad entrance facing center.

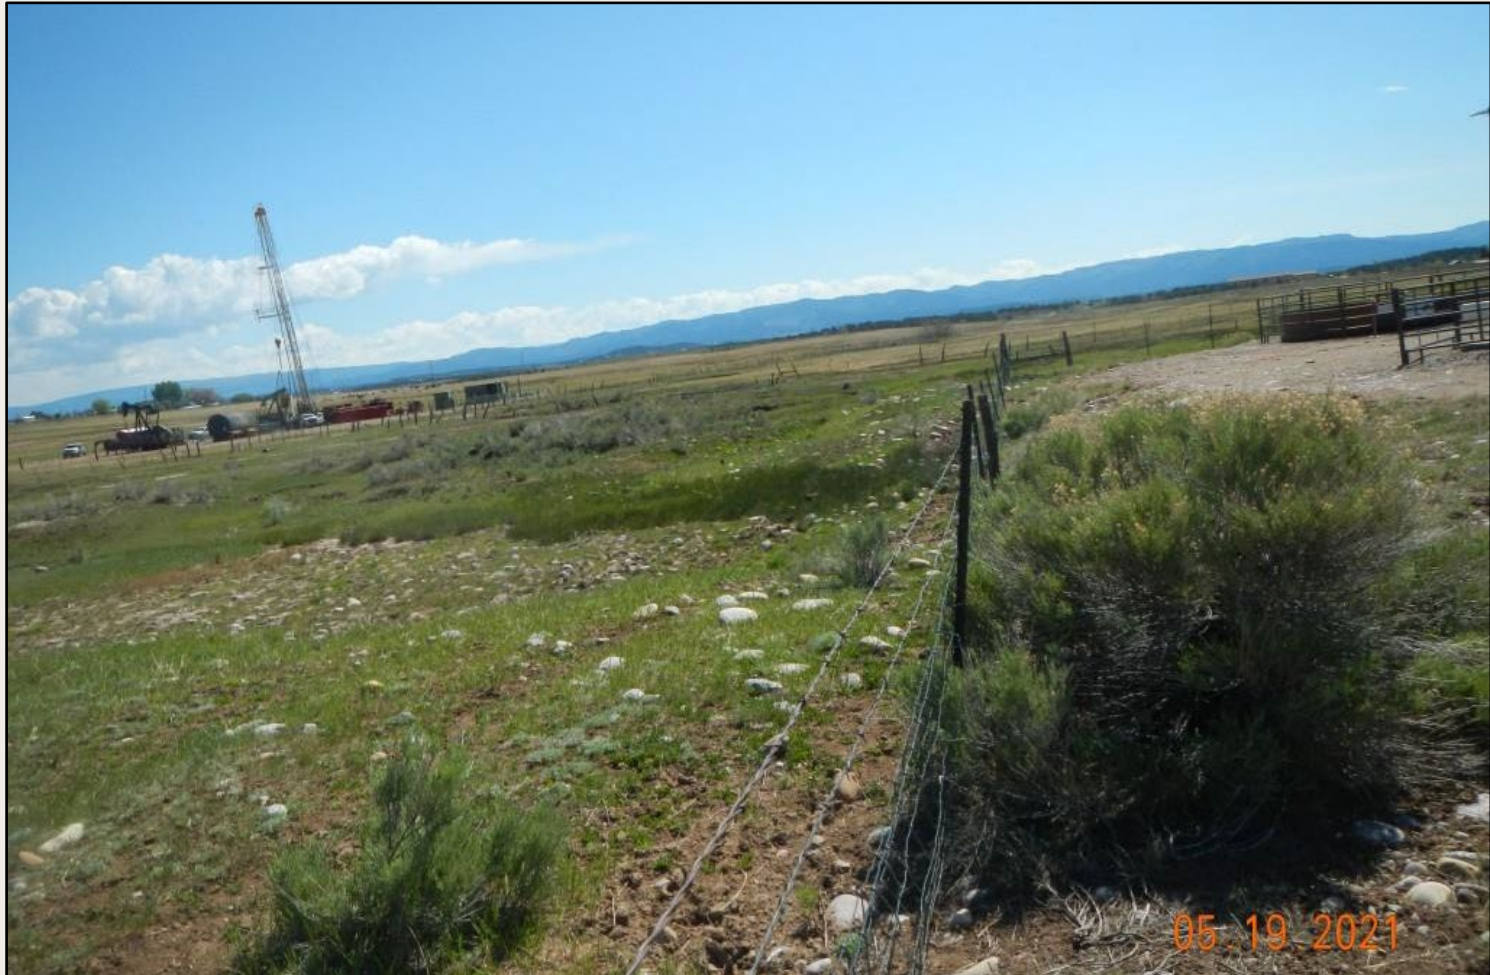
Photo 2. View of the northern project area from the northwestern corner facing eastward. Revegetation is progressing outside of fenced working area with grazed grasses and sedges largely in a grazed and early season vegetative condition similar to surrounding reference area vegetation.

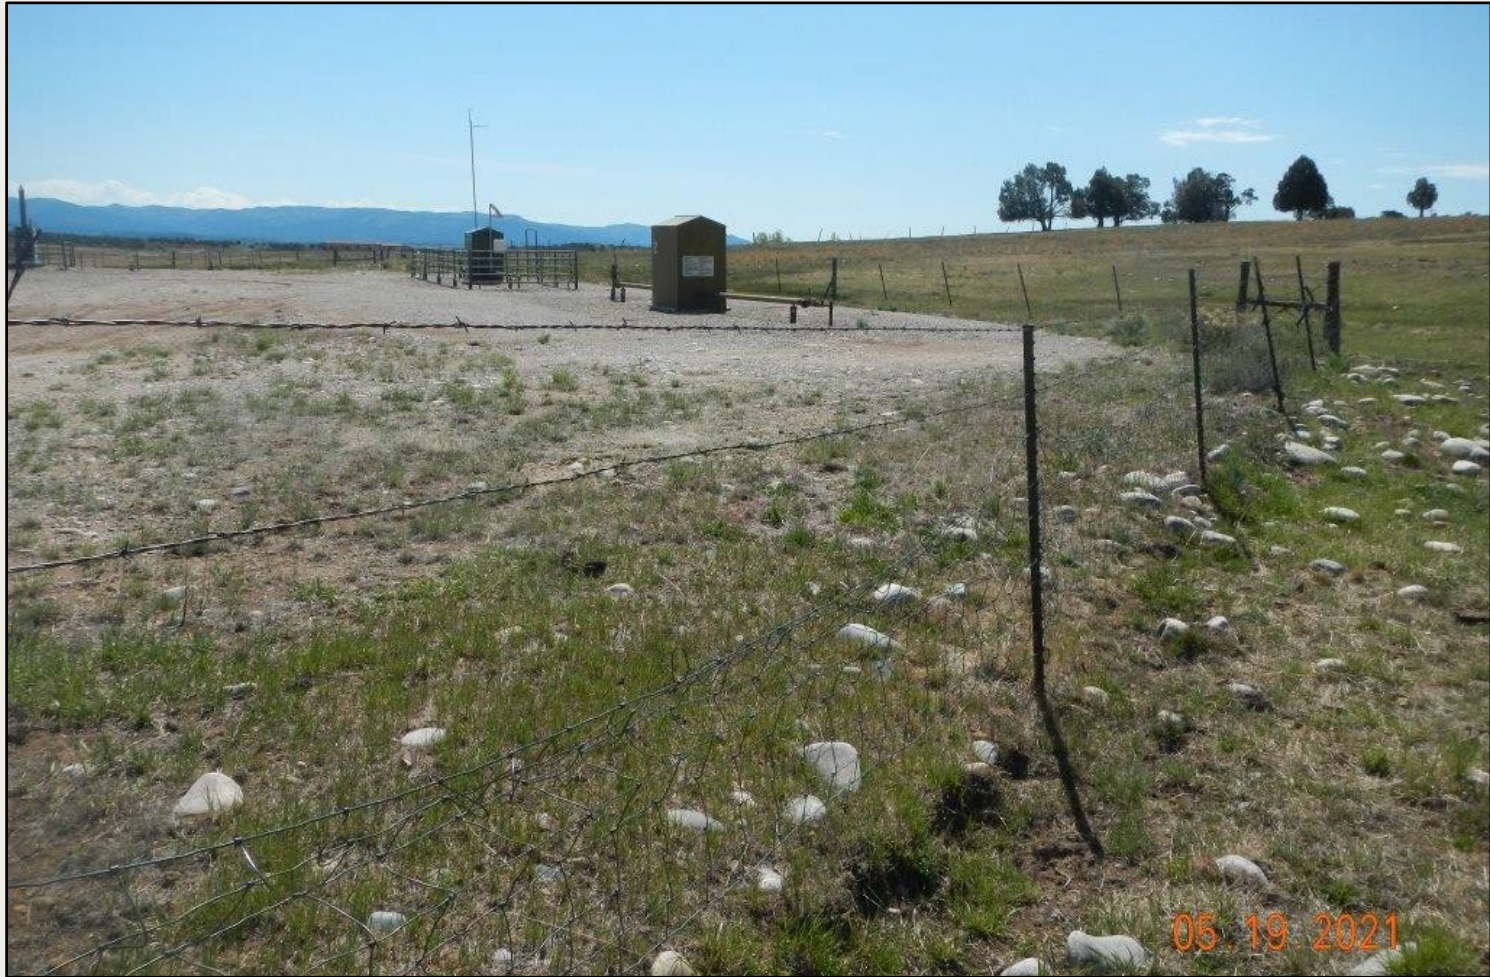
Photo 3. View of the southern project area from the southwestern corner facing eastward.

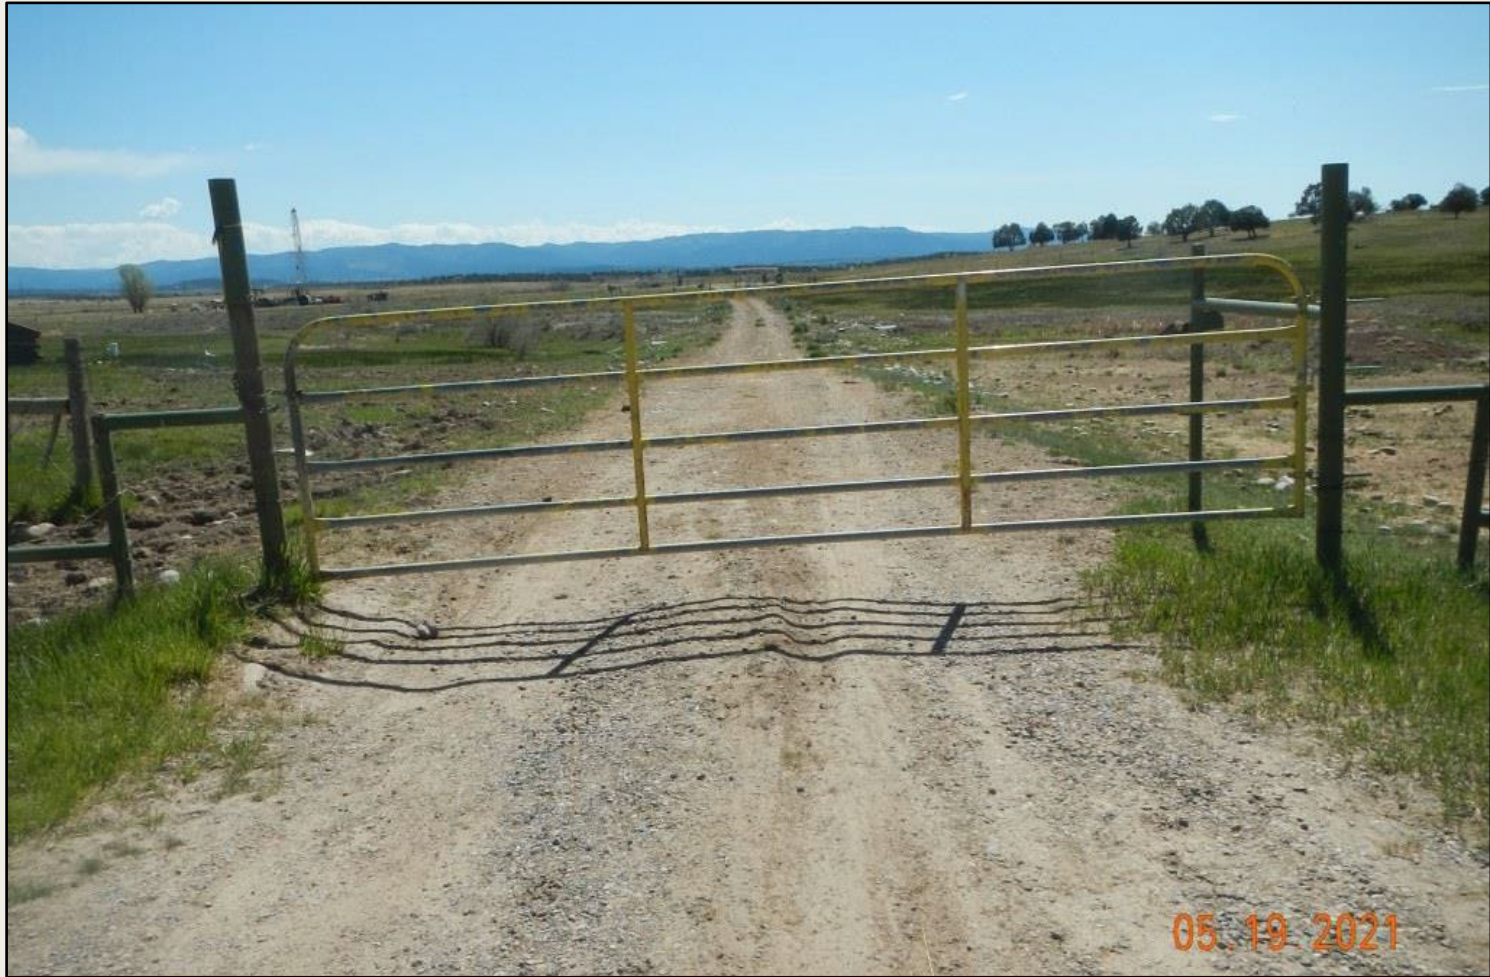
Photo 5. View of closed gates at after leaving location.
