Inspection Photos
Operator: Simcoe
API: 067-09822
Date: 5/19/2021

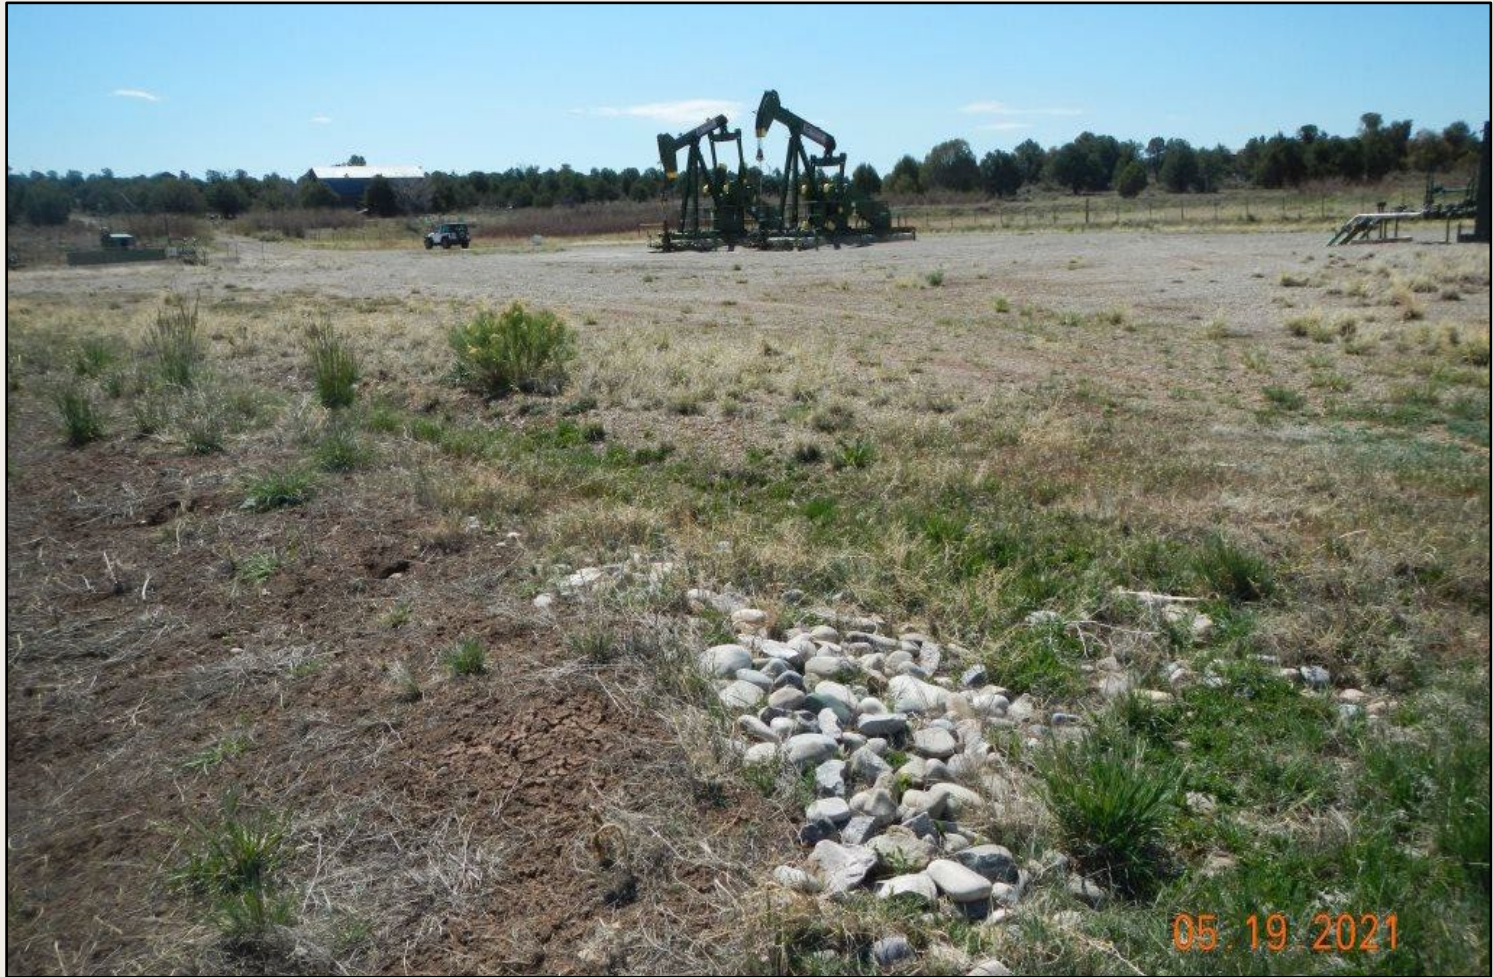
Photo 1. View of project area from well pad northwestern corner facing center.

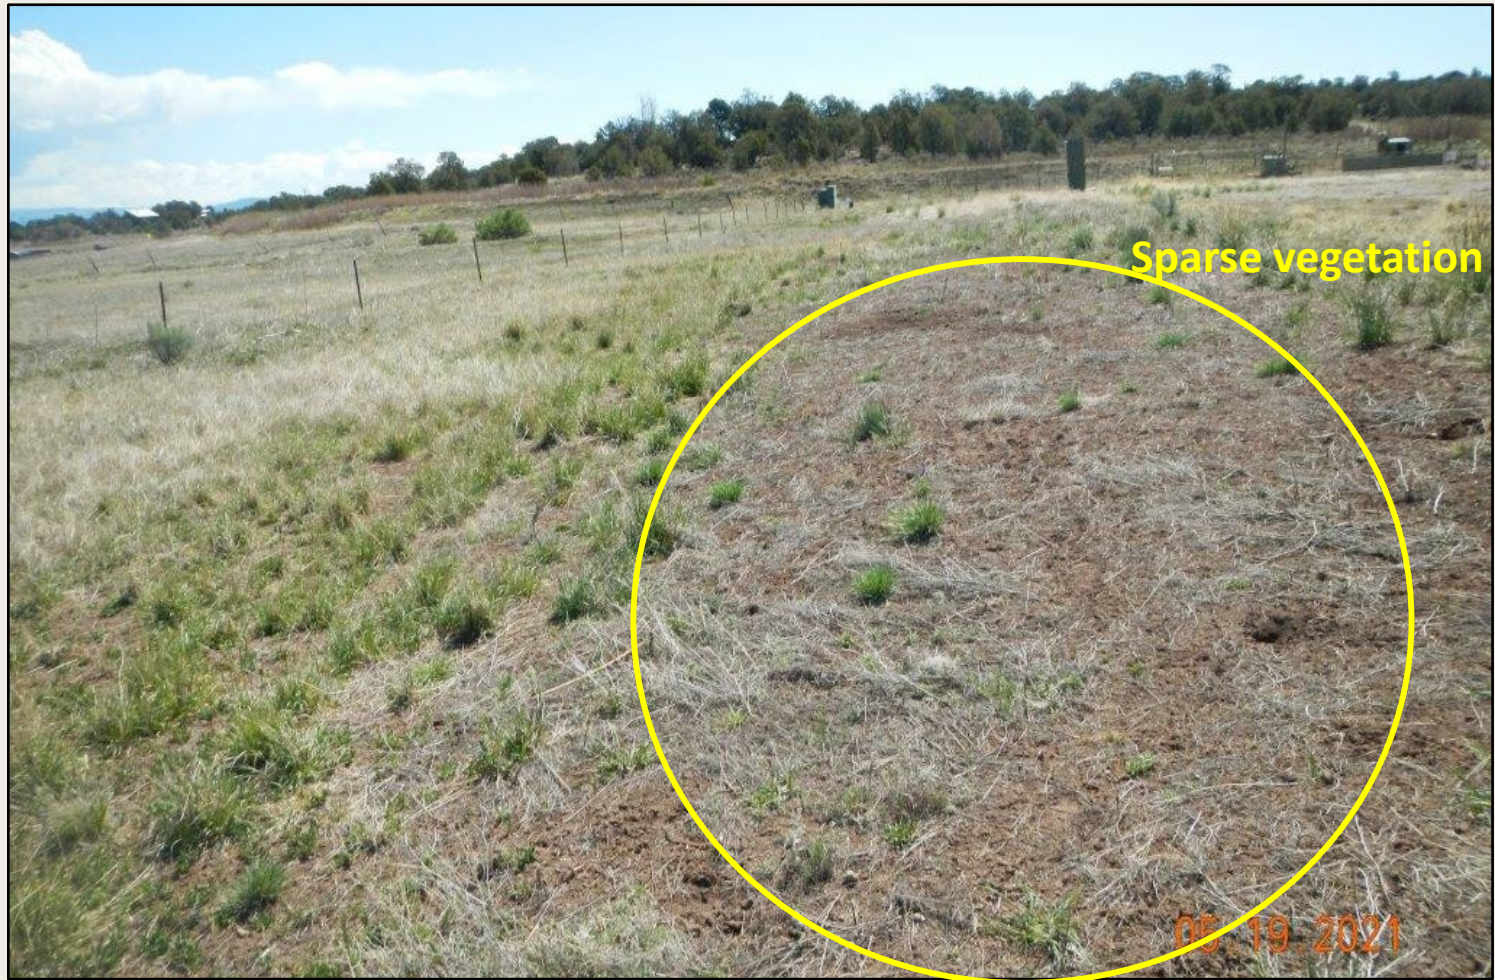
Photo 2. View of the northern project area from the northwestern corner facing eastward. Revegetation is sparse and weedy within the majority of the northern project area. Spot seeding is needed.

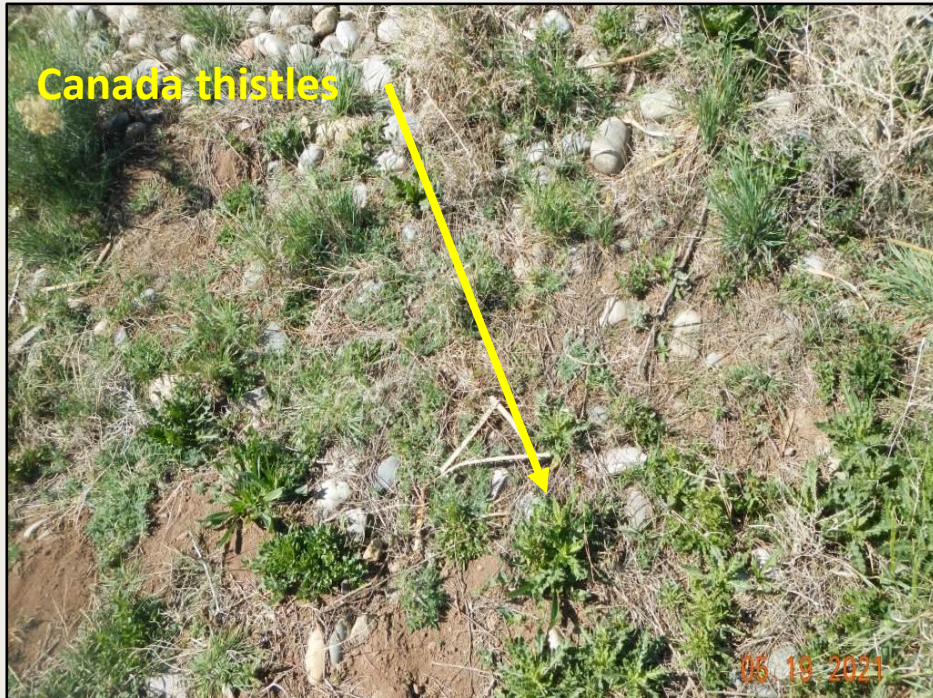
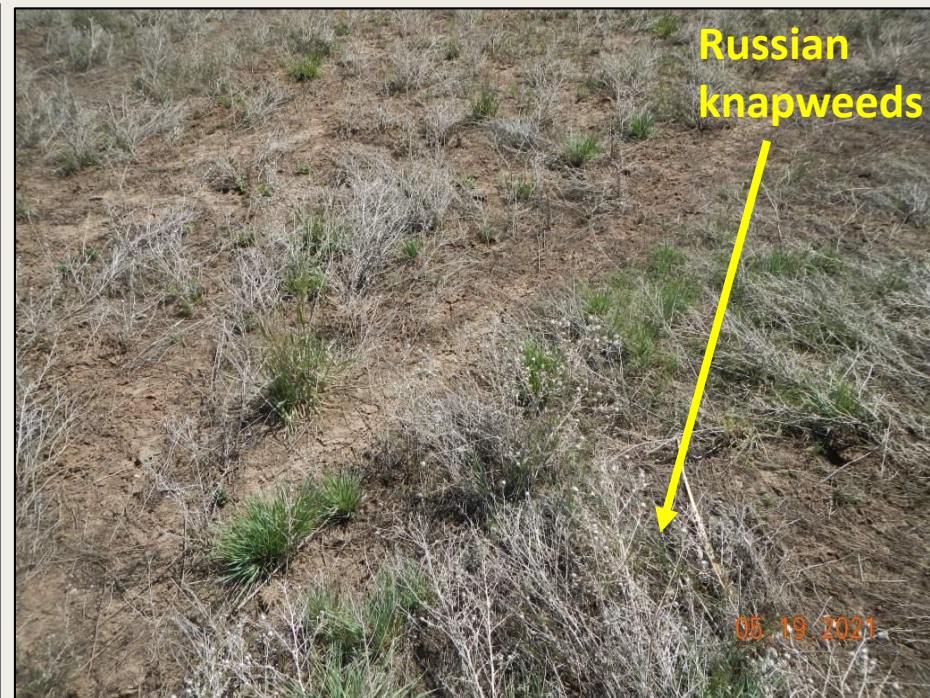
Photo 3. View of Canada thistles (approx. 200) and Russian knapweeds (approx. 300) observed within the project area.

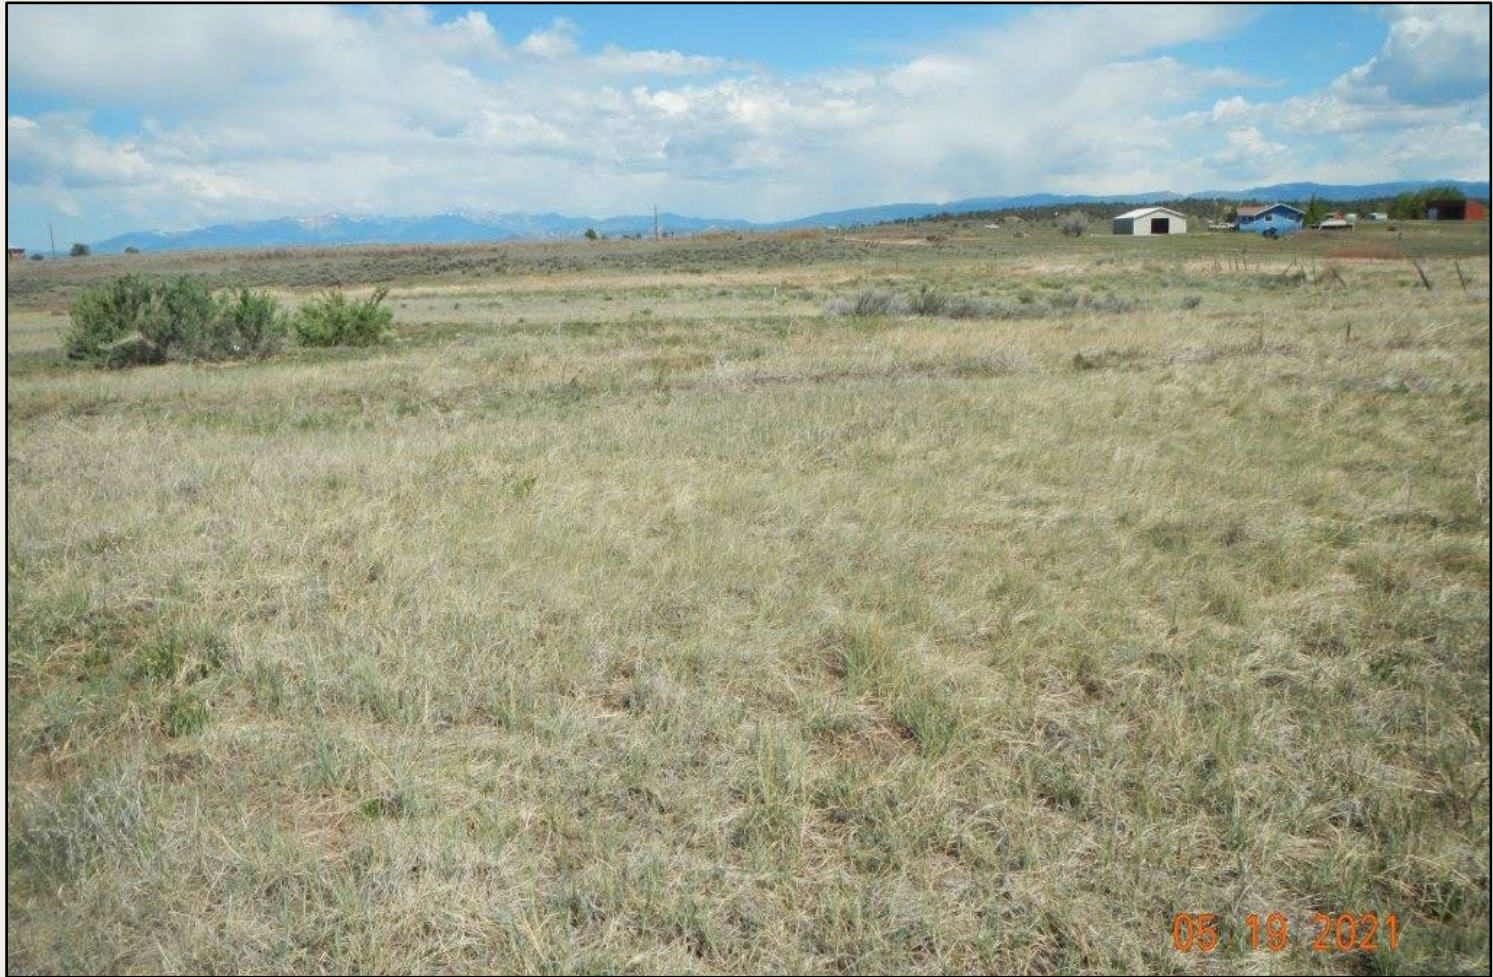
Photo 4. View of the reference area comprised of irrigated grass field with grasses such as western wheatgrass and smooth brome.
