Stormwater Inspection Report

Operator:	Laramie Energy, LLC
Project:	Cascade Creek
Location:	CC 604-41-32 Pad
Date:	Friday, May 21, 2021
Weather:	Rain Showers, Light Wind, 73°, Lo 51°

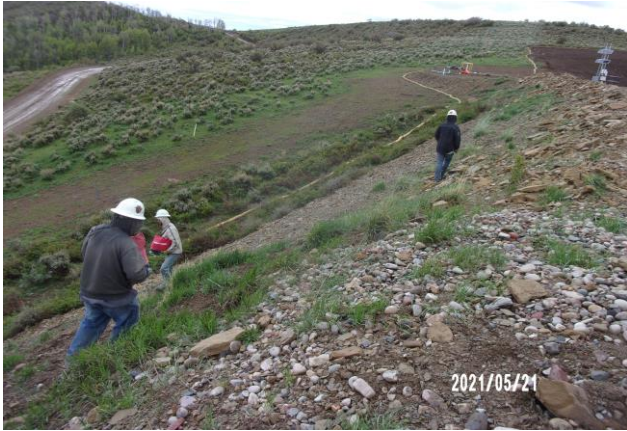
Photo 1

Broadcasting Seed on the CC 604-41-32 Pad

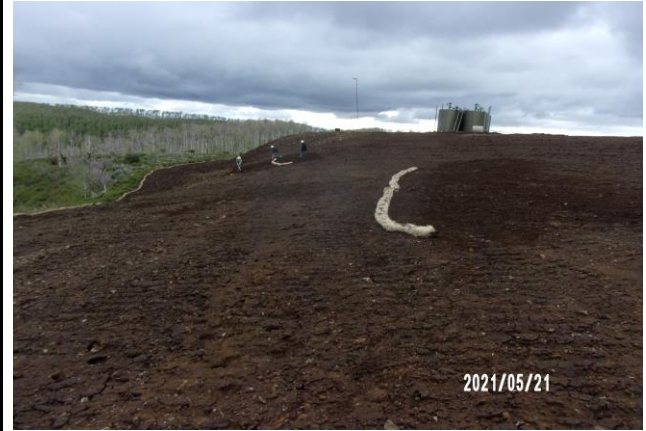
Photo 2

Wattle Installed below Minor Erosion

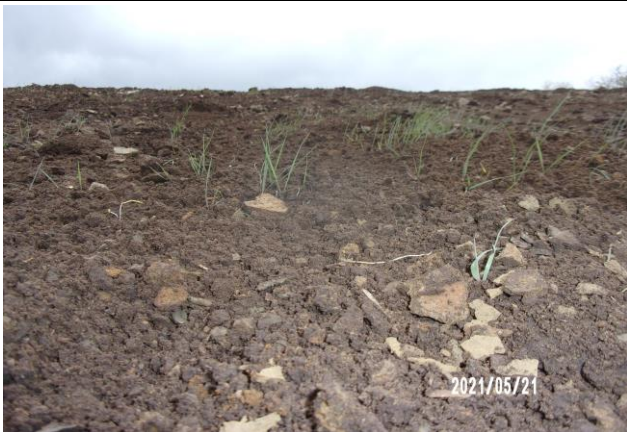
Photo 3

Seed Germinating on the CC 604-41-32 Pad

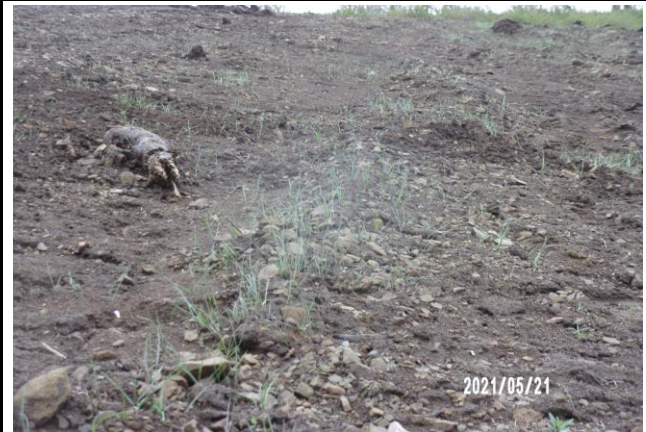
Photo 4

Seed Germinating on the CC 604-41-32 Pad
