# Inspection Photos

5/21/2021

Operator: GUNNISON ENERGY LLC # 10515

Location ID: 453805

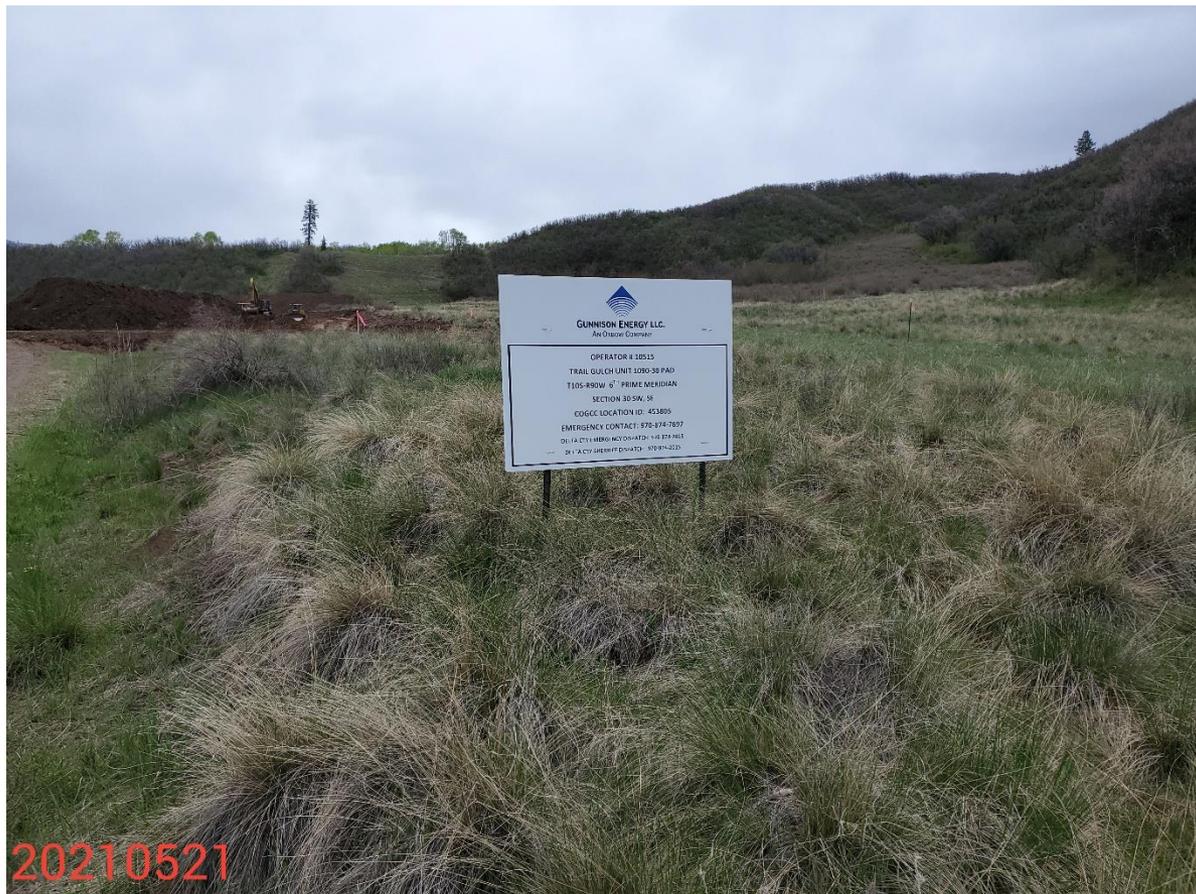
**Photo 1:** Photo taken from the Location entrance, facing northwest. Photo shows signage.

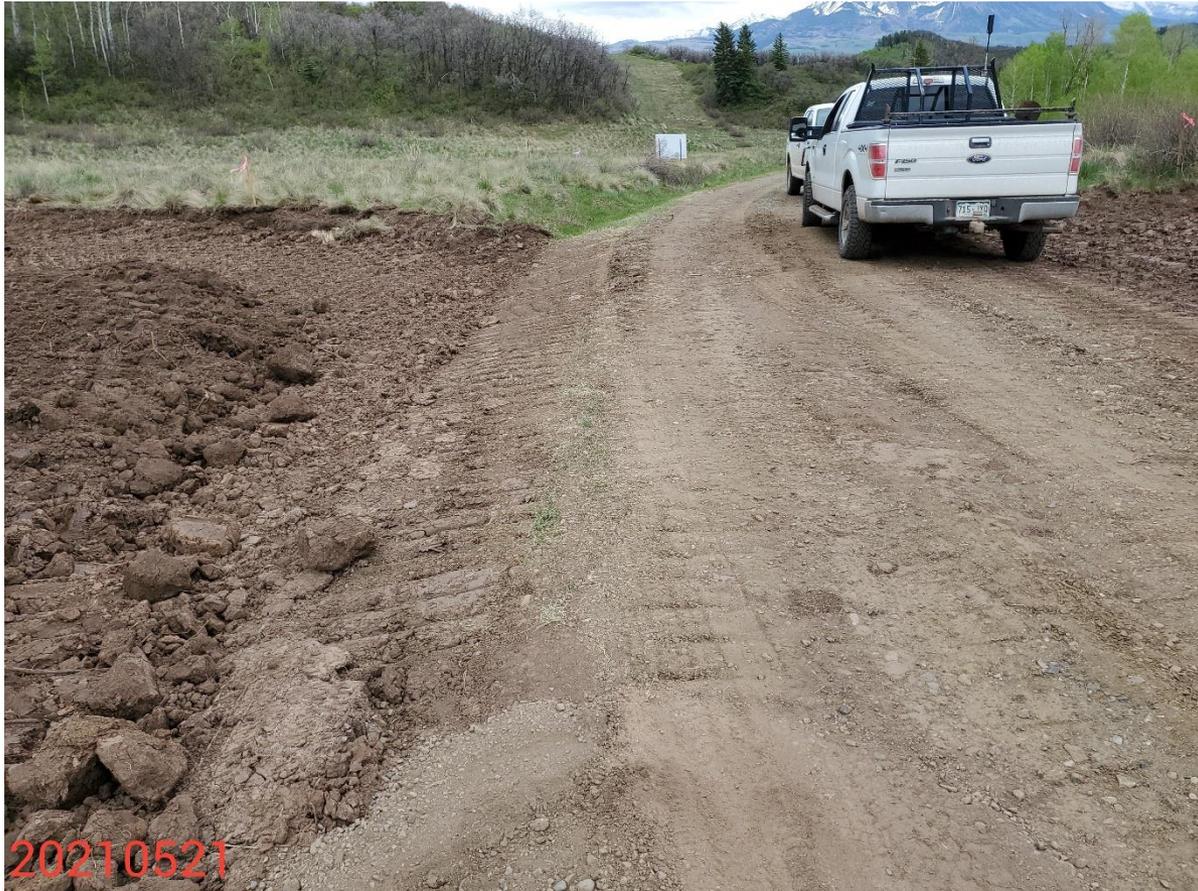
**Photo 2:** Photo taken from the east end of the Location, facing southeast. Photo shows Location entrance. Though off-site sediment transport concerns were not observed, photo shows that control measures to prevent vehicle sediment tracking are missing. Advise implementing control measures to mitigate/minimize off-site sediment transport prior to tracking issues.

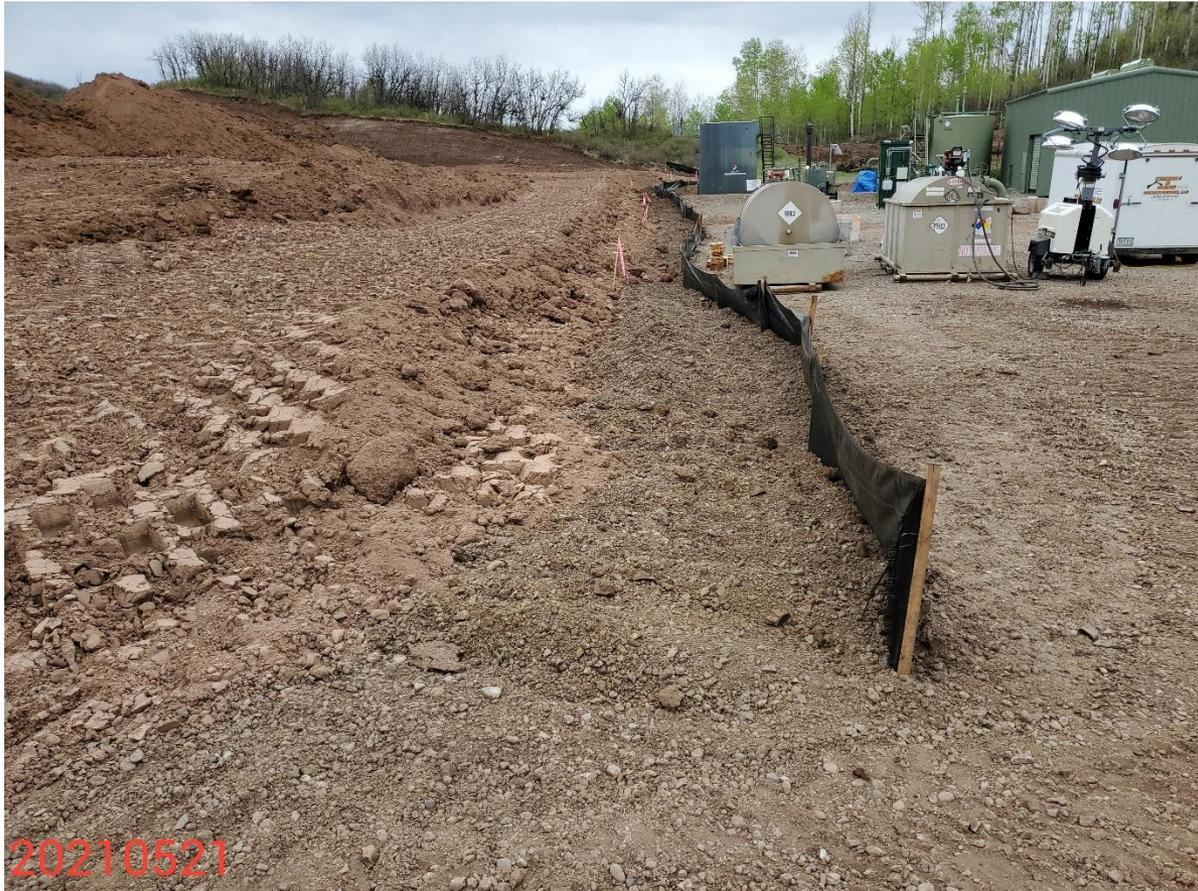
**Photo 3:** Photo shows silt fence constructed along the southern and western perimeters of the Location.

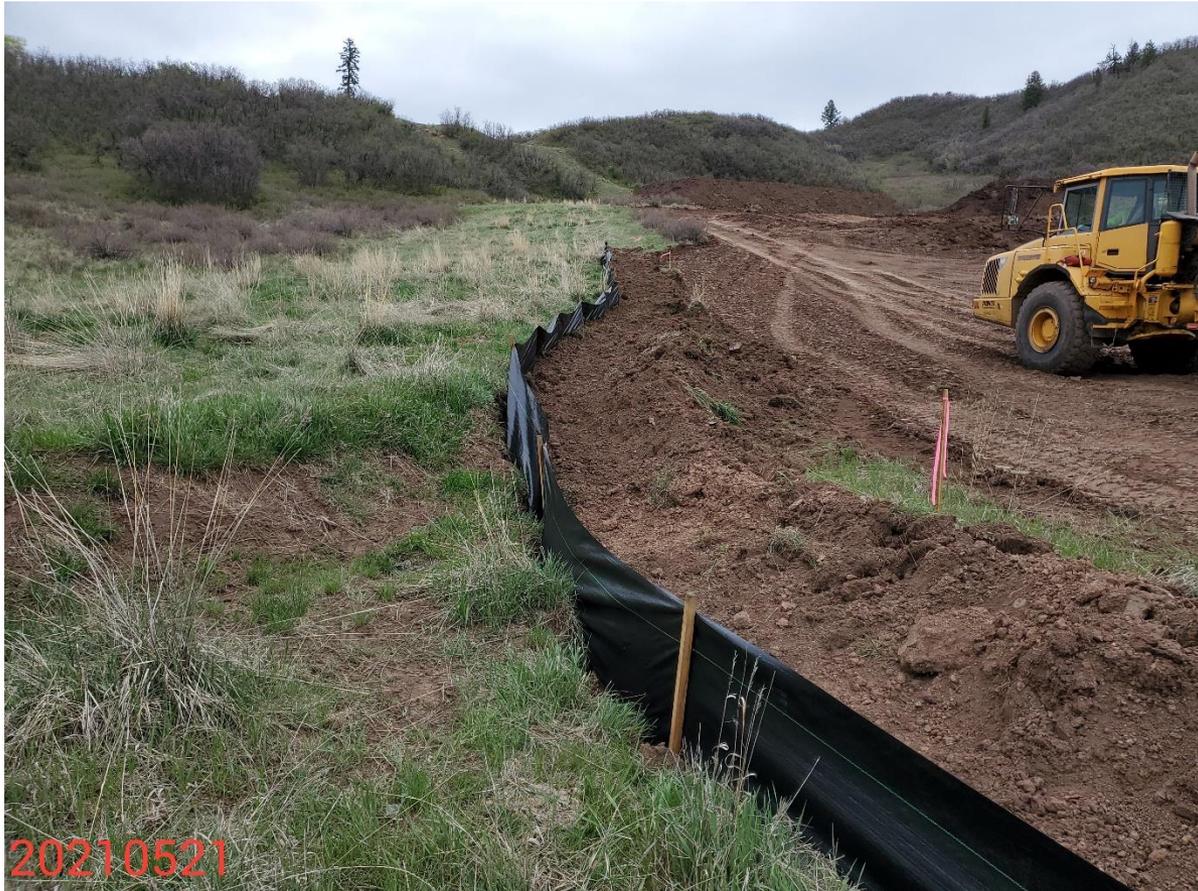
**Photo 4:** Photo shows silt fence constructed along the southern and western perimeters of the Location.

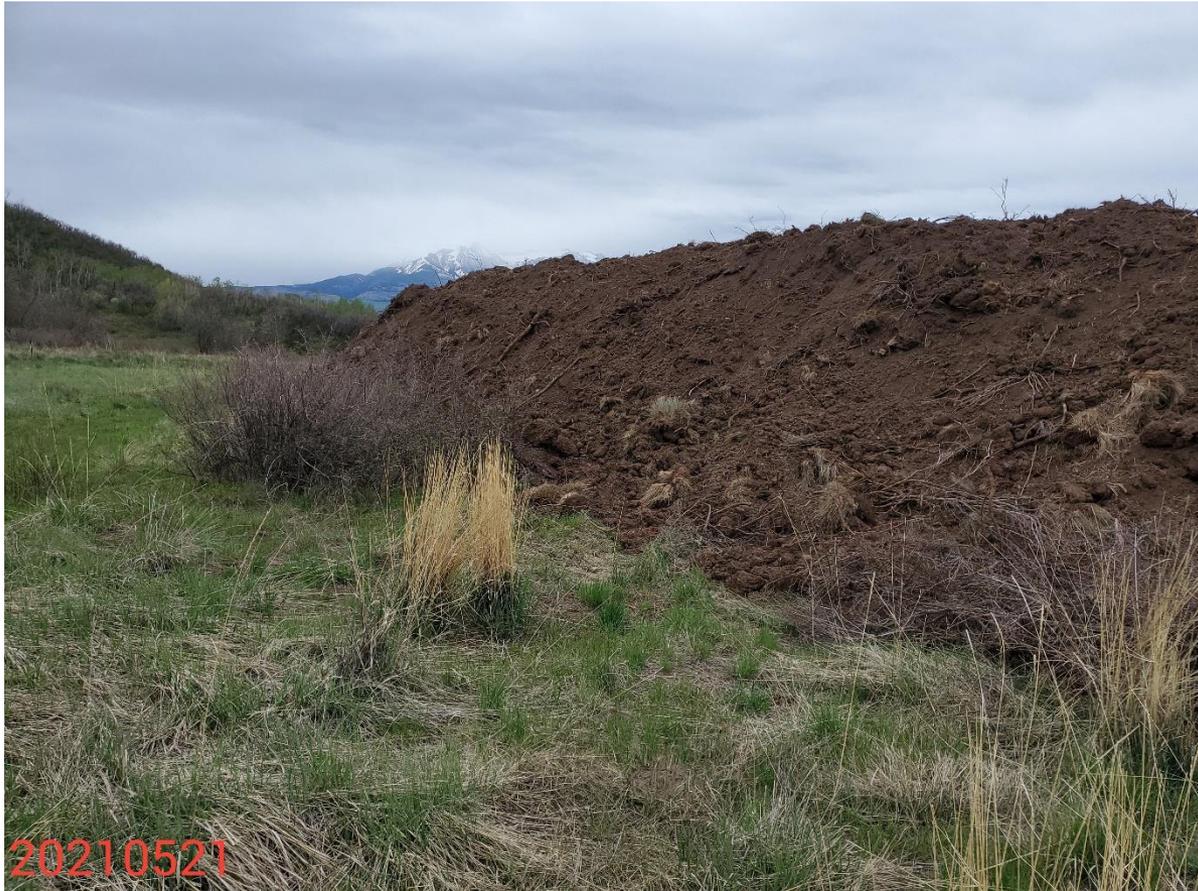
**Photo 5:** Photo taken from the topsoil stockpile on the north end of the Location. Photo shows stormwater BMPs at the soil stockpile to prevent offsite sediment transport are missing or insufficient.

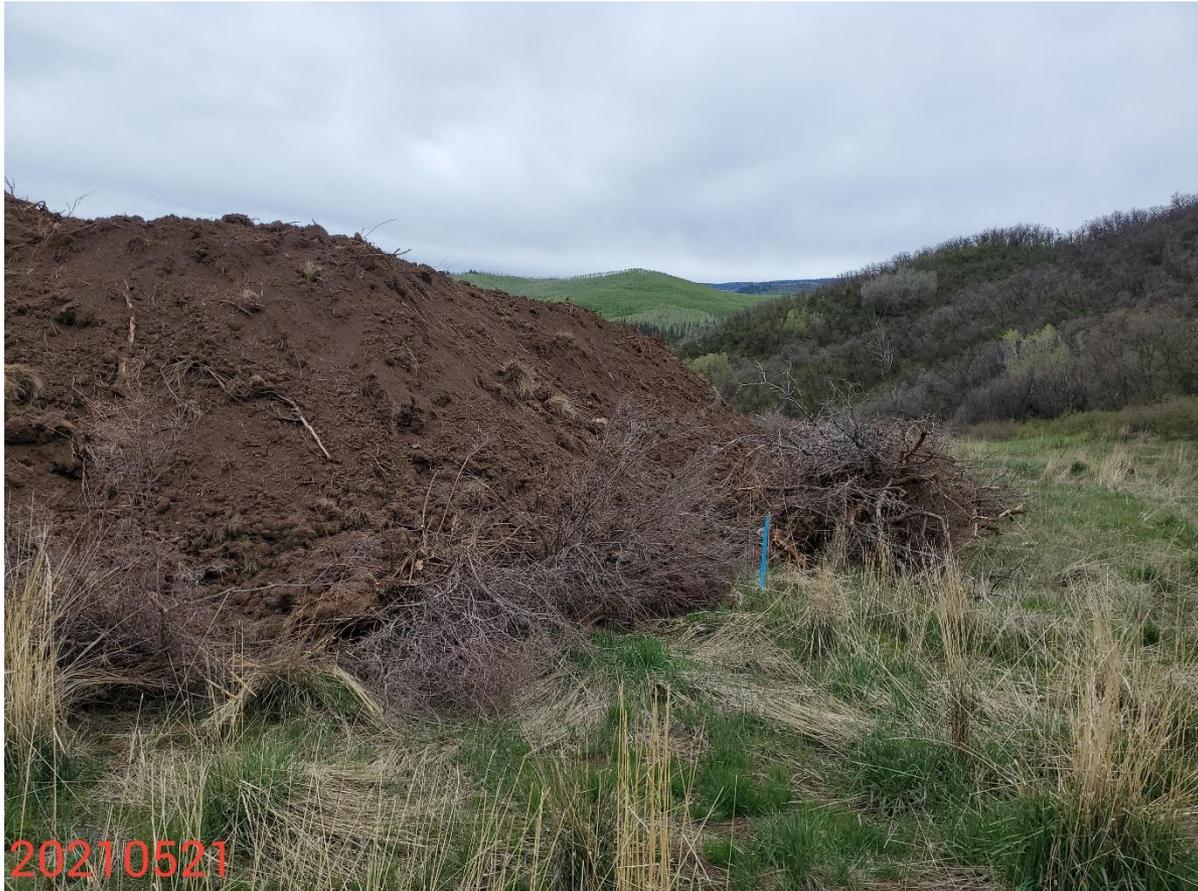
**Photo 6:** Photo taken from the topsoil stockpile on the north end of the Location. Photo shows stormwater BMPs at the soil stockpile to prevent offsite sediment transport are missing or insufficient.

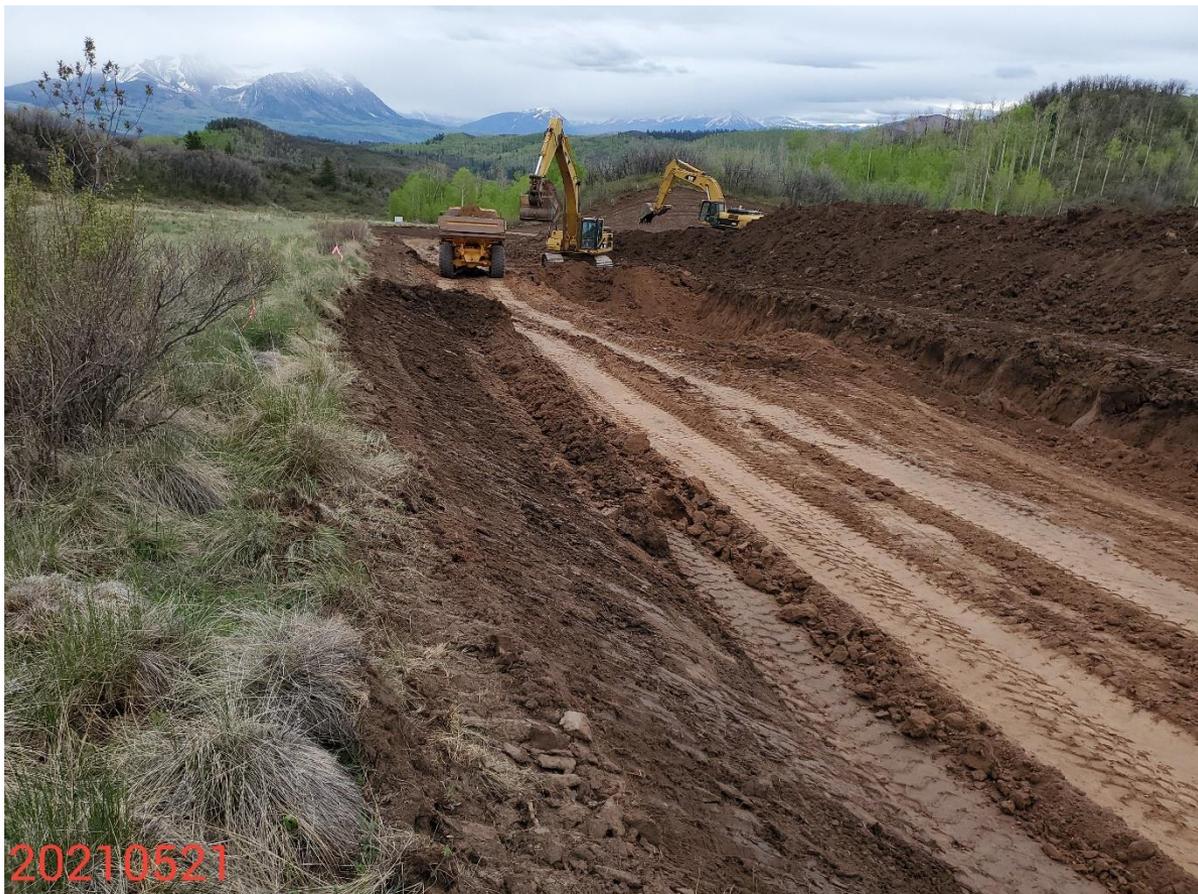
**Photo 7:** Photo taken from the north end of the Location, facing southeast. Photo shows location construction, and soil salvage/segregation activities in process.

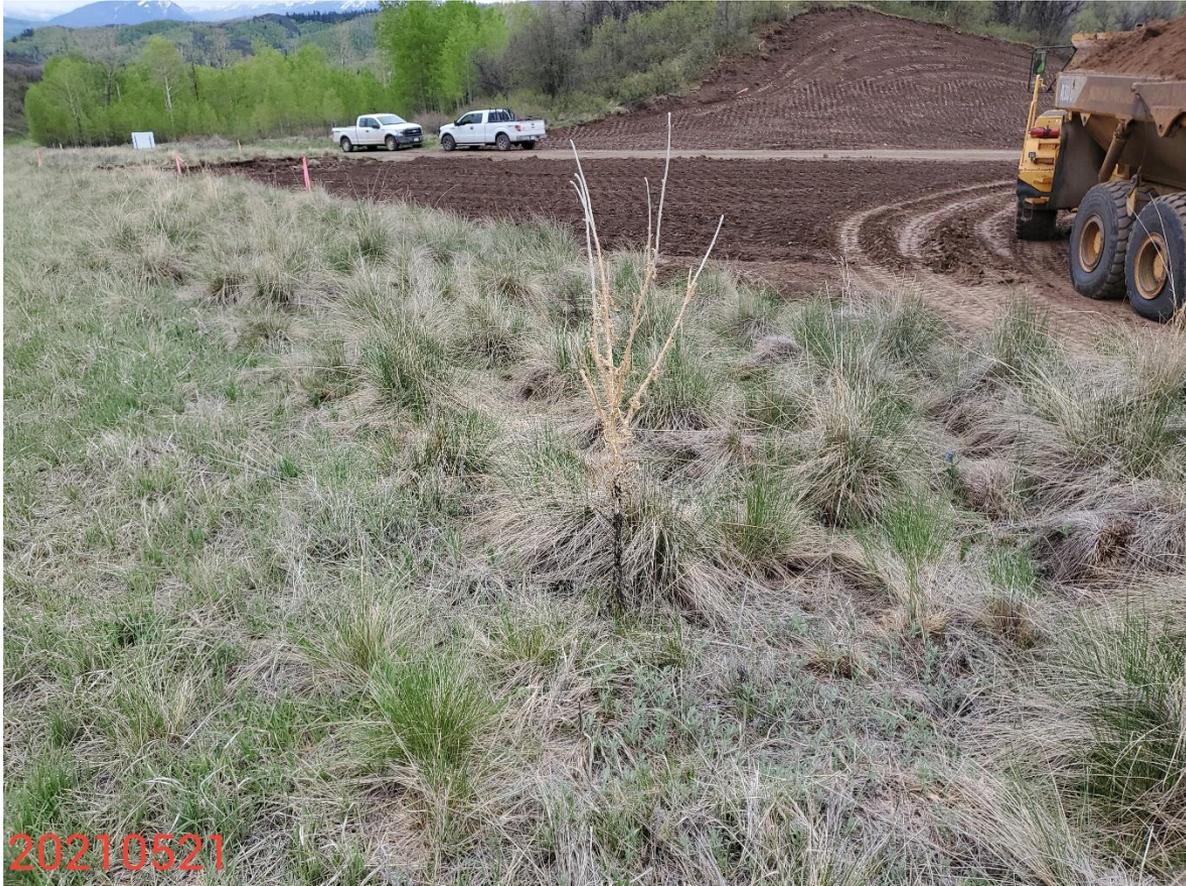
**Photo 8:** Photo shows musk thistle remnant from the 2020 growing season. Due to the disturbance activities from construction, noxious weeds on the location may become an ongoing issue without vigilant monitoring and management.

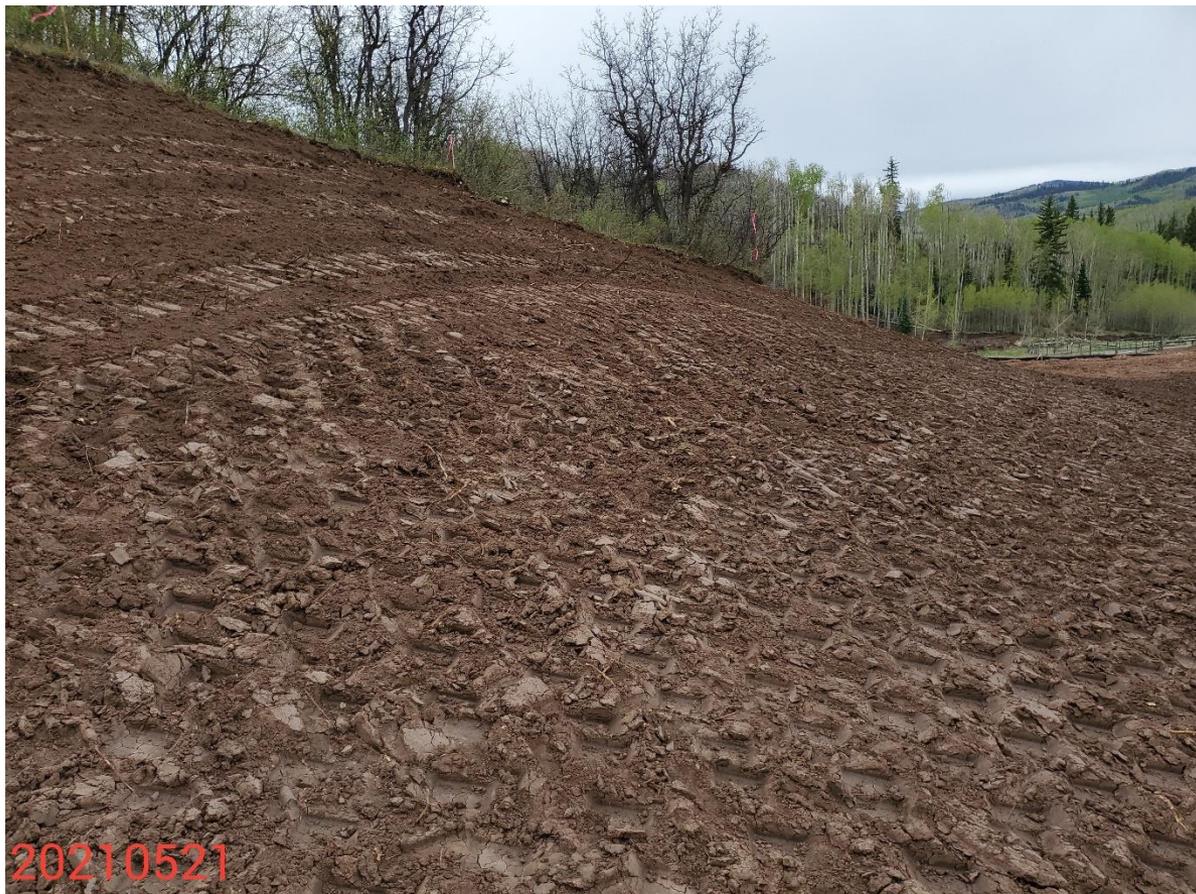
**Photo 9:** Photo of the cut slope on the east end of the cut slope. Photo shows surface roughening to stabilize soils on the slope.

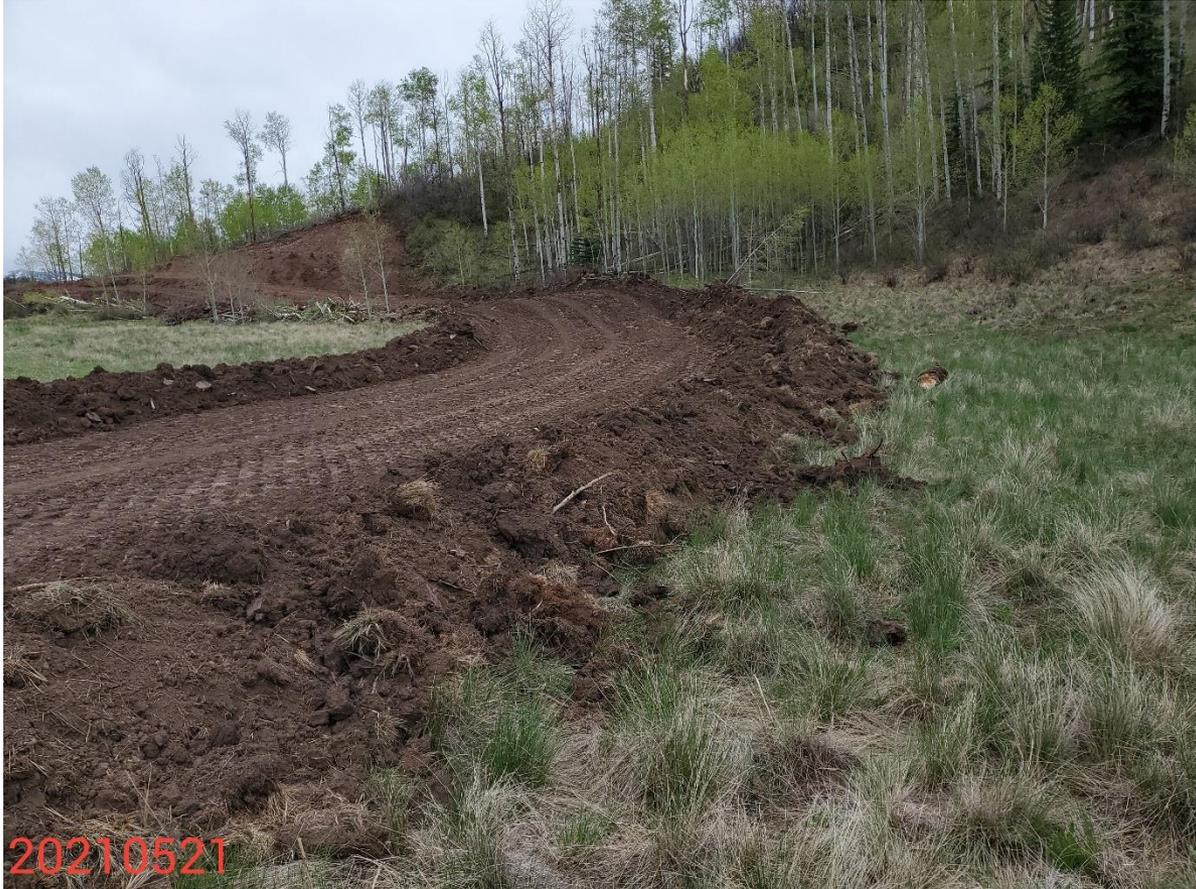
**Photo 10:** Photo taken from the newly constructed access road south of the Location, facing northeast. Photo shows stormwater and erosion control measures along the access road are missing or insufficient.

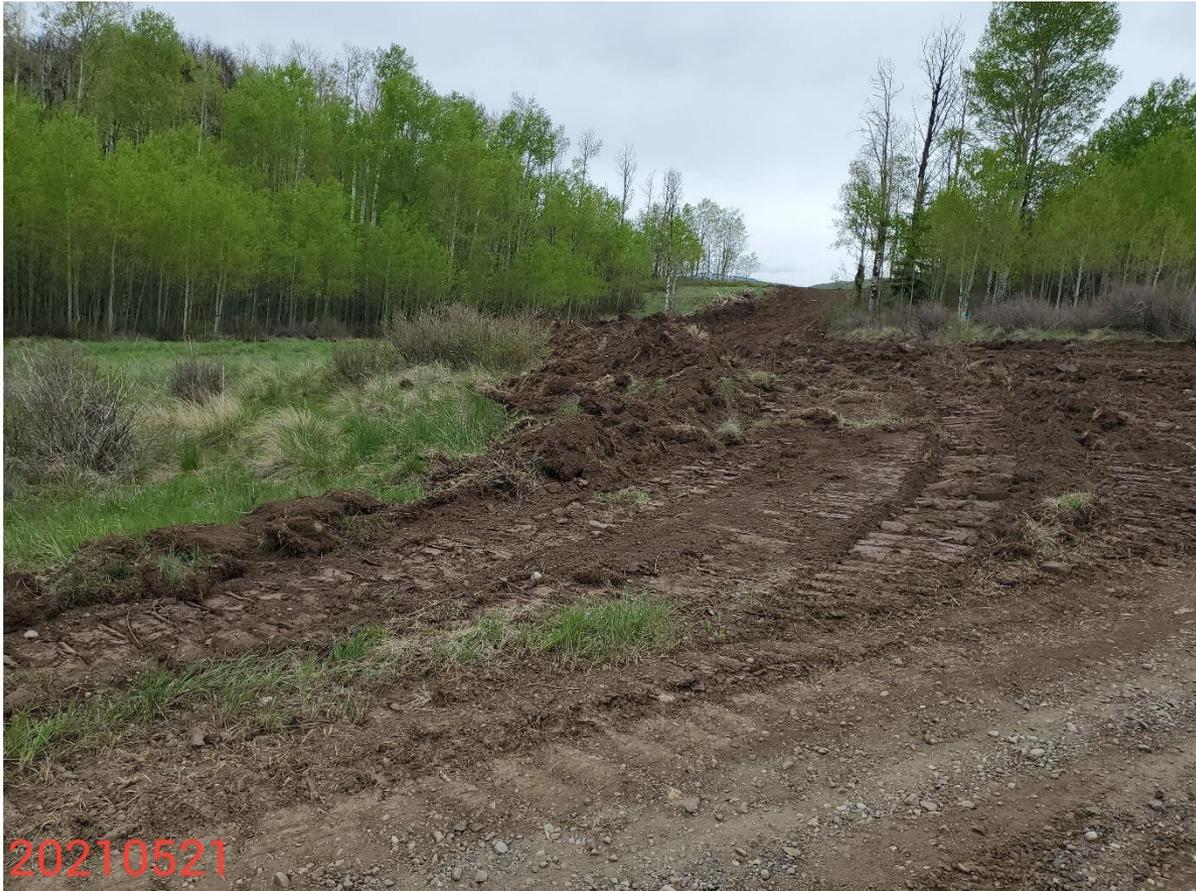
**Photo 11:** Photo taken from the newly constructed access road east of the Location, facing southwest. Photo shows stormwater and erosion control measures along the access road are missing or insufficient.
