TEP
Miller 5
Location # 417475

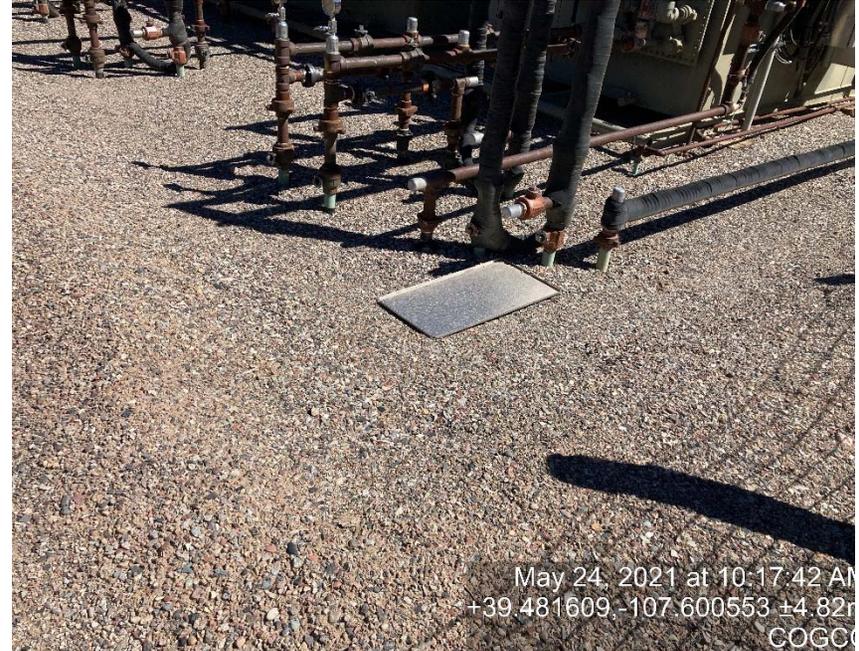
Debris

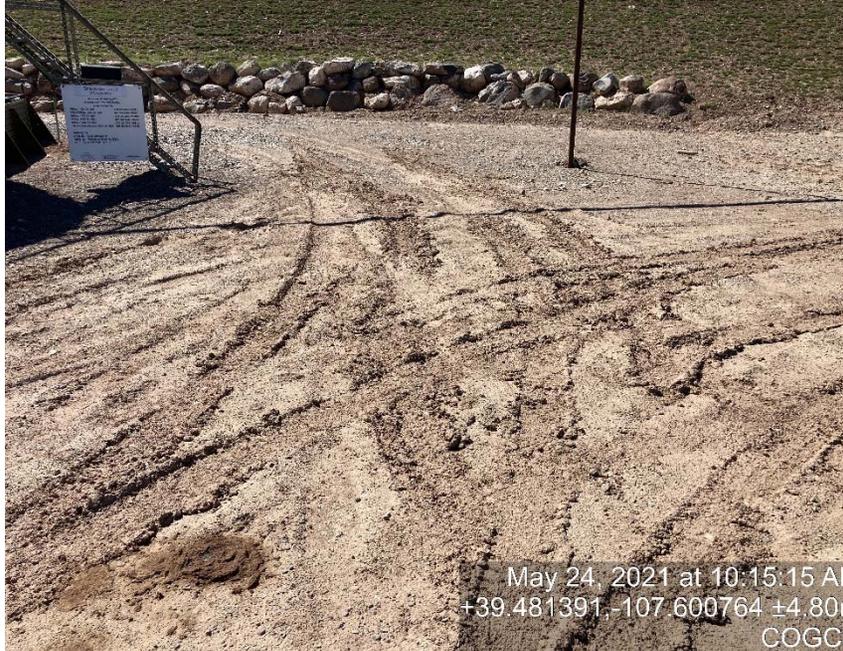
Lack of stabilization/compaction

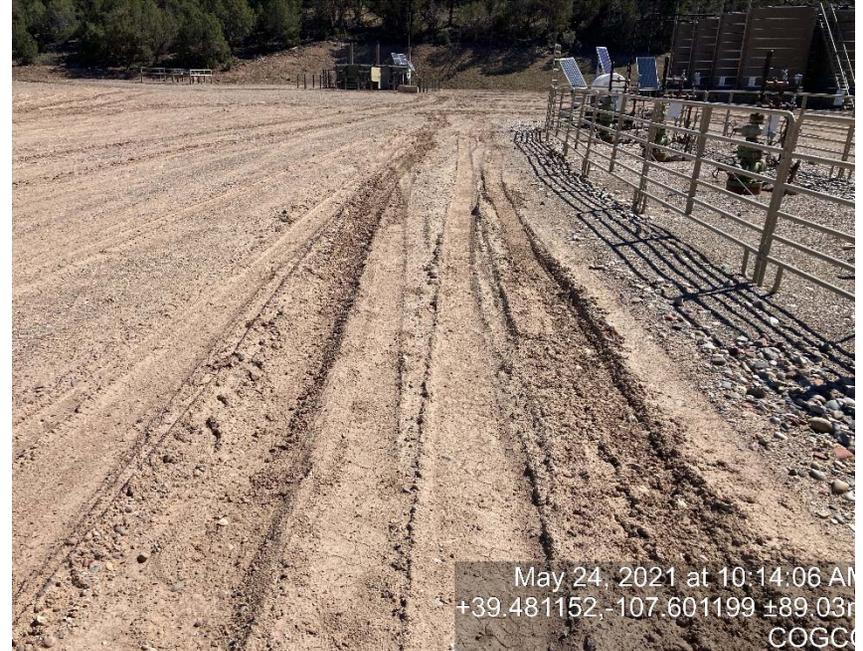
Lack of stabilization/compaction

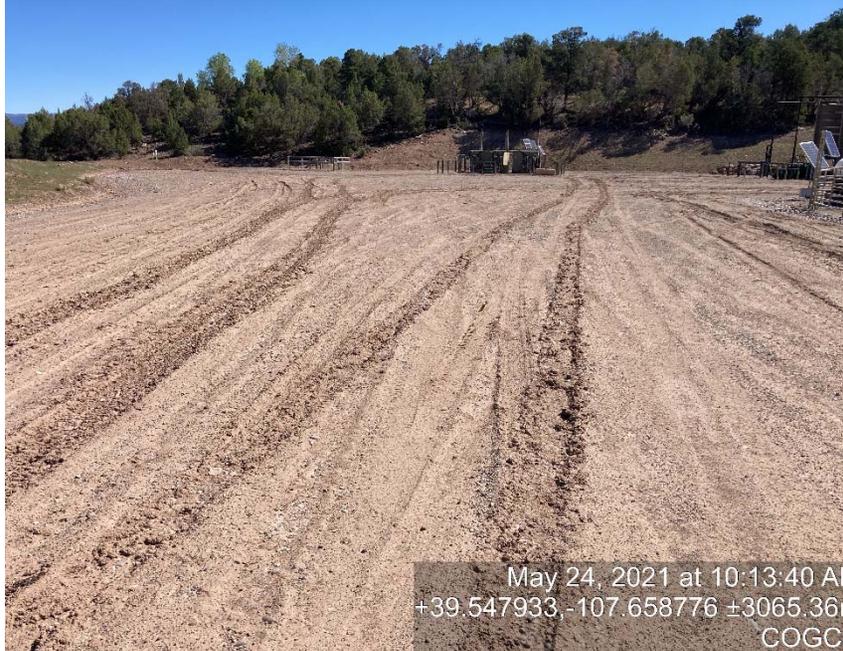
Lack of stabilization/compaction looking north into pad

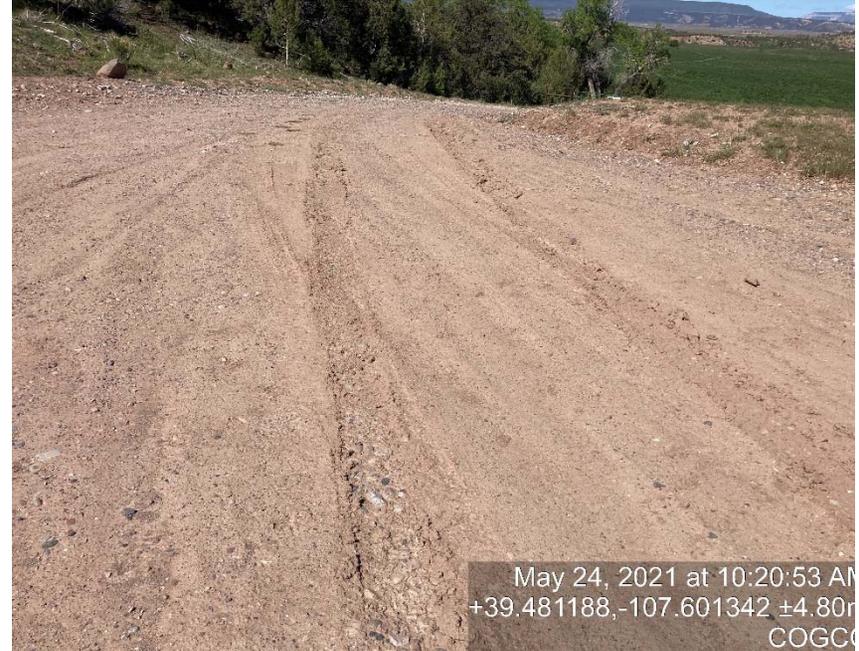
Lack of stabilization/compaction looking South/west leaving pad
