Inspection Photos

API: 071-08840

Operator: EVERGREEN NATURAL RESOURCES

Inspection Date: 5/24/2021

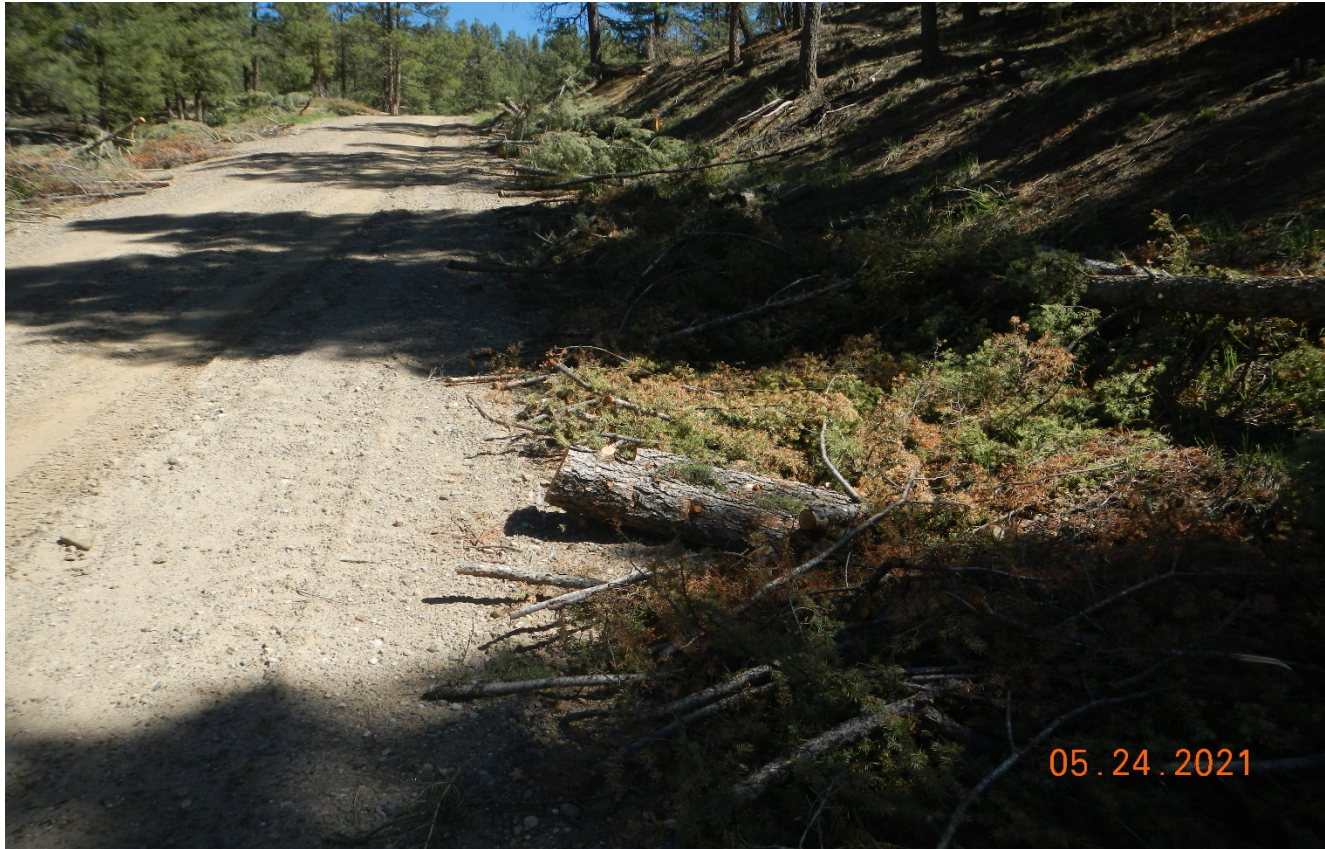
Photo 1. It was observed that branches and logs are being piled along the side of the road. It is a concern that braches and logs will obstruct stormwater flow and direct stormwater onto the road.

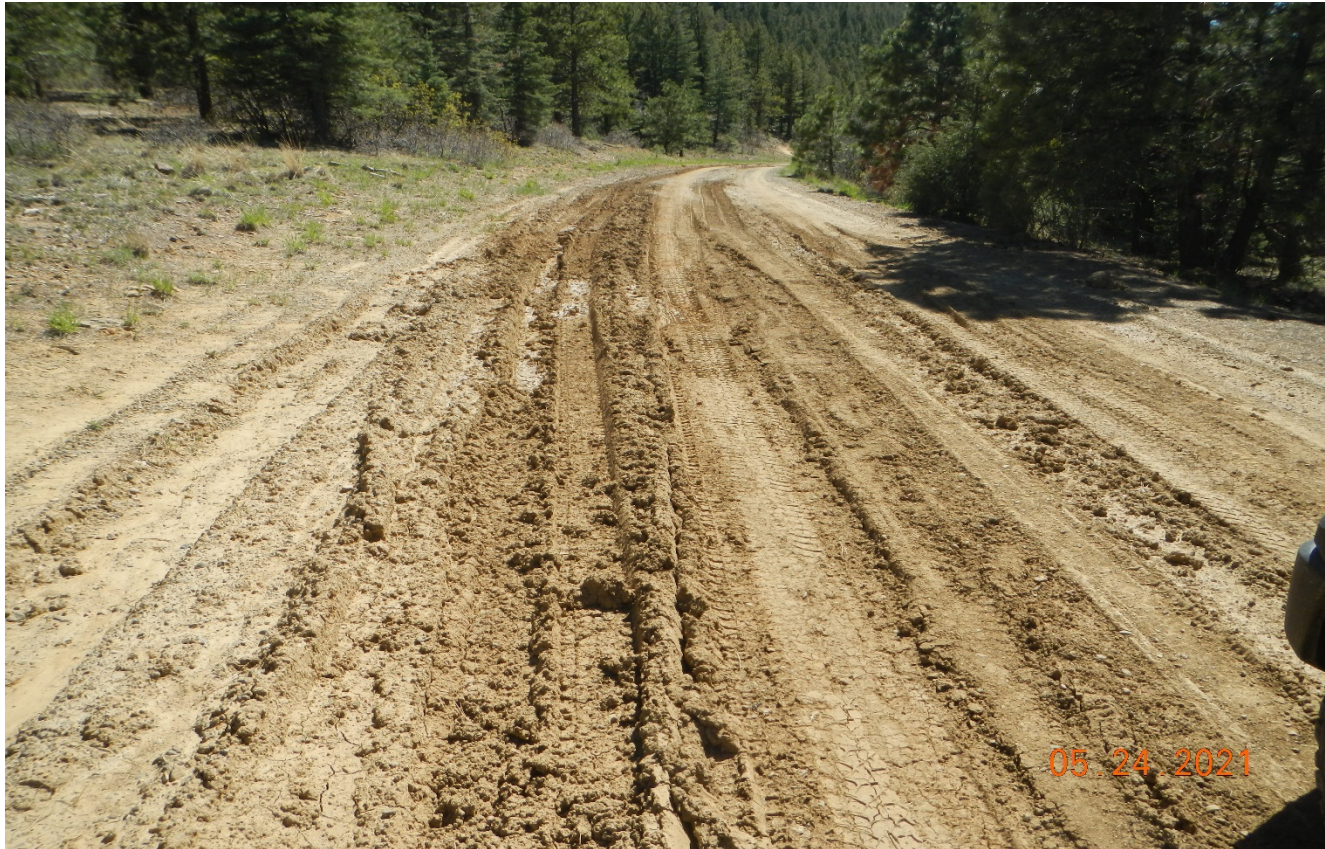
Photo 2. Facing west along the main access road. There are areas along the road that have vehicle rutting and erosion.

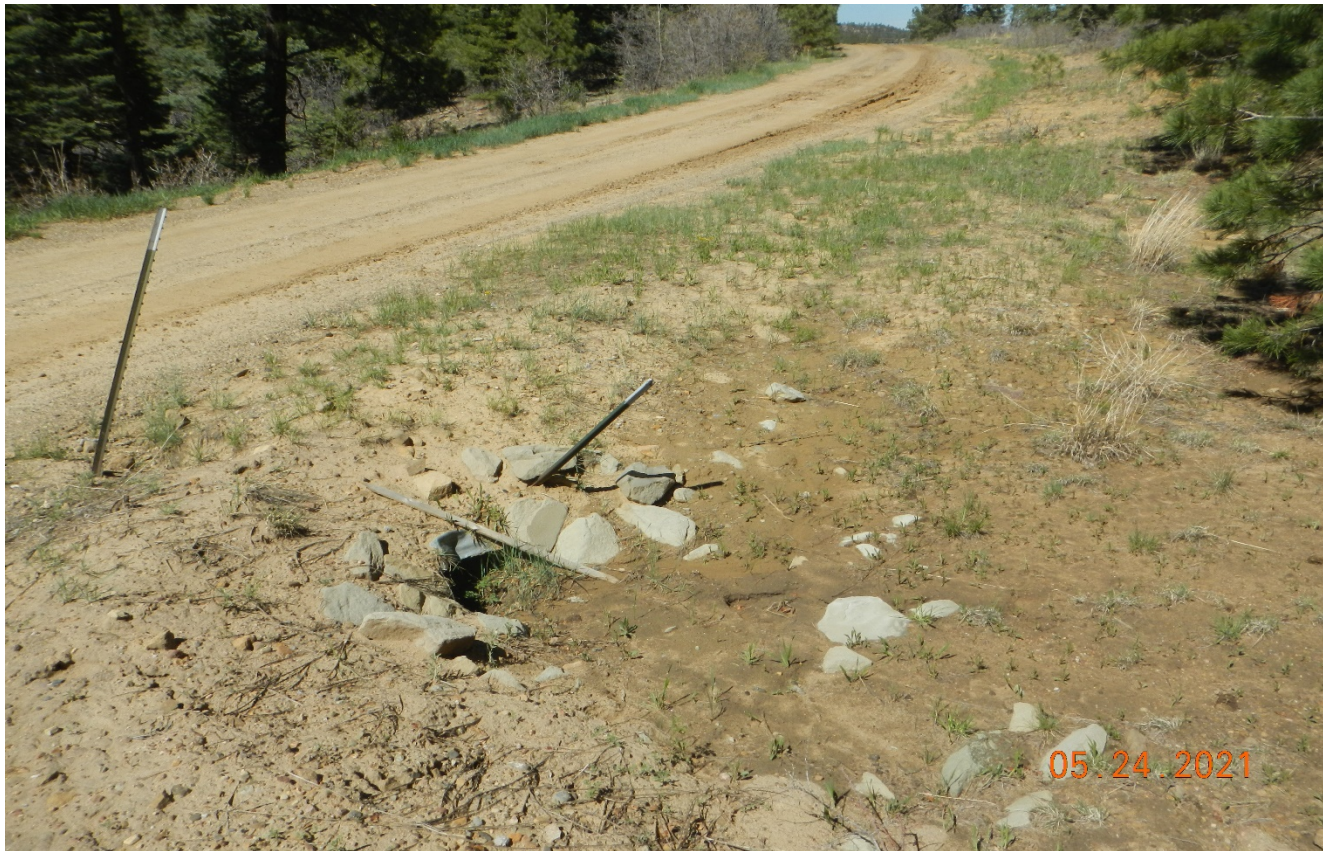
Photo 3. This culvert is partially filled in with sediment at Lat/Long:37.2112, - 104.9298.

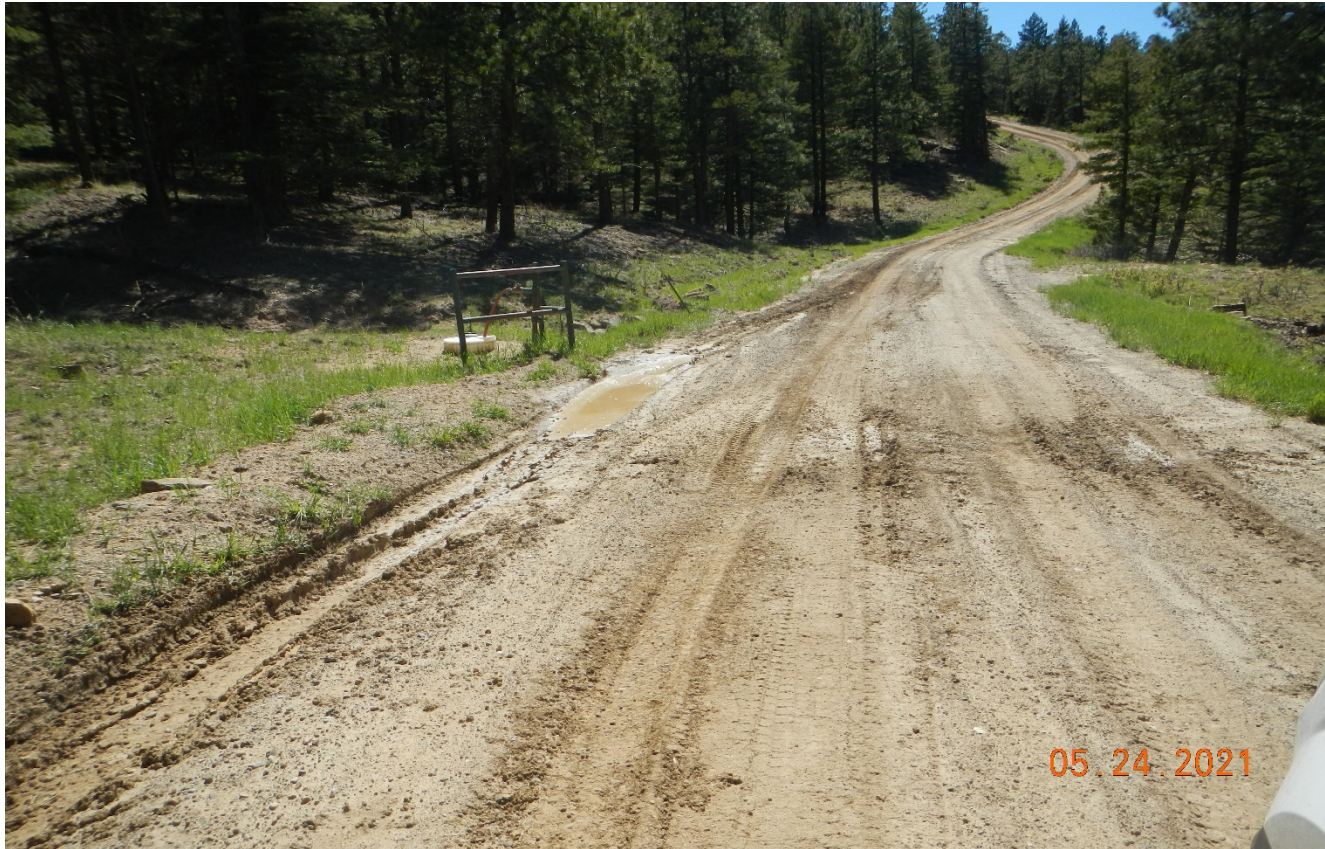
Photo 4. Stormwater is not properly directed toward the culvert and there is gravel obstructing the culvert.

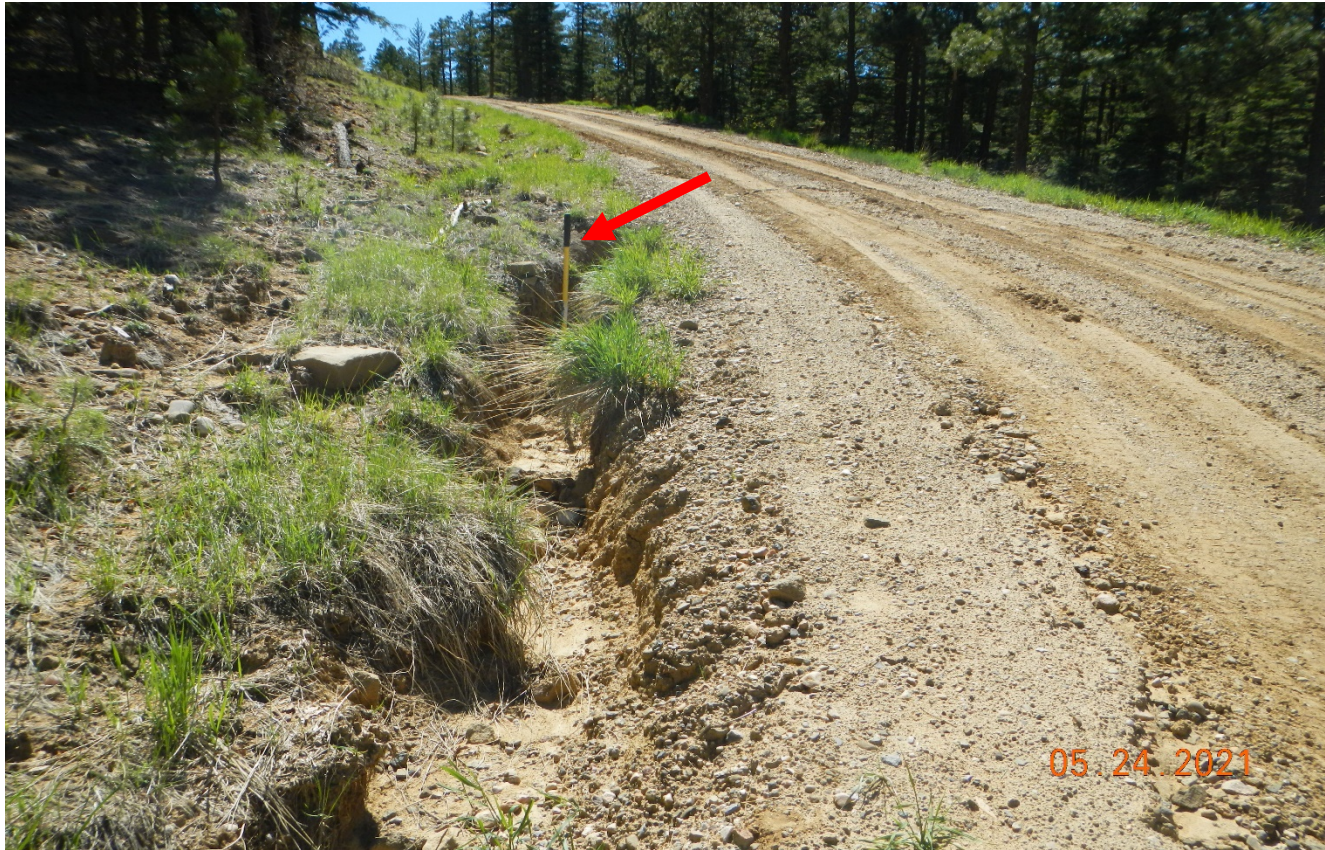
Photo 5. There is an erosion channel along the side of the road. Arrow points to 4.5 ft. shovel to show depth of erosion.

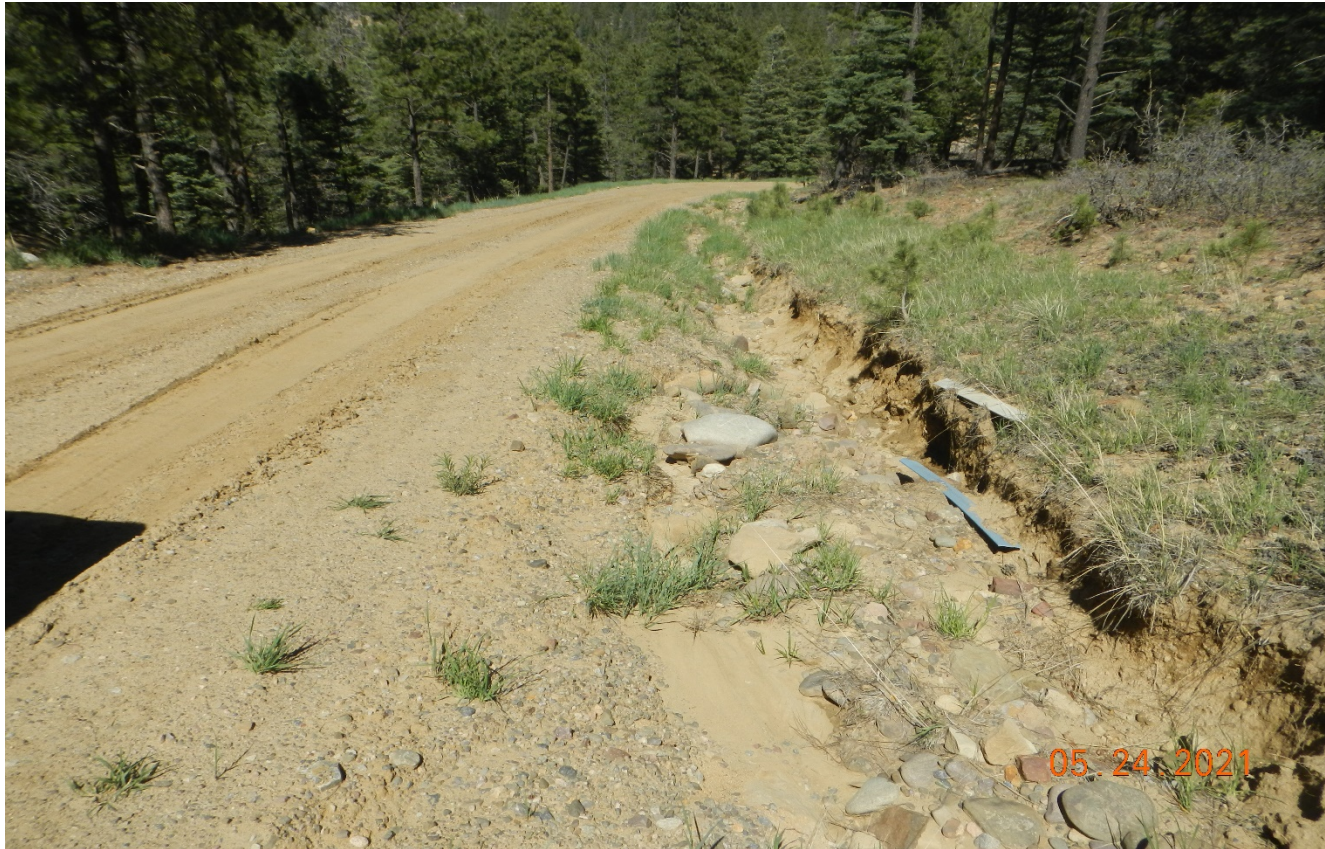
Photo 6. BMP's need to be installed along the side of the road to prevent erosion at this area, Lat/Long:37.20905,-104.9369.

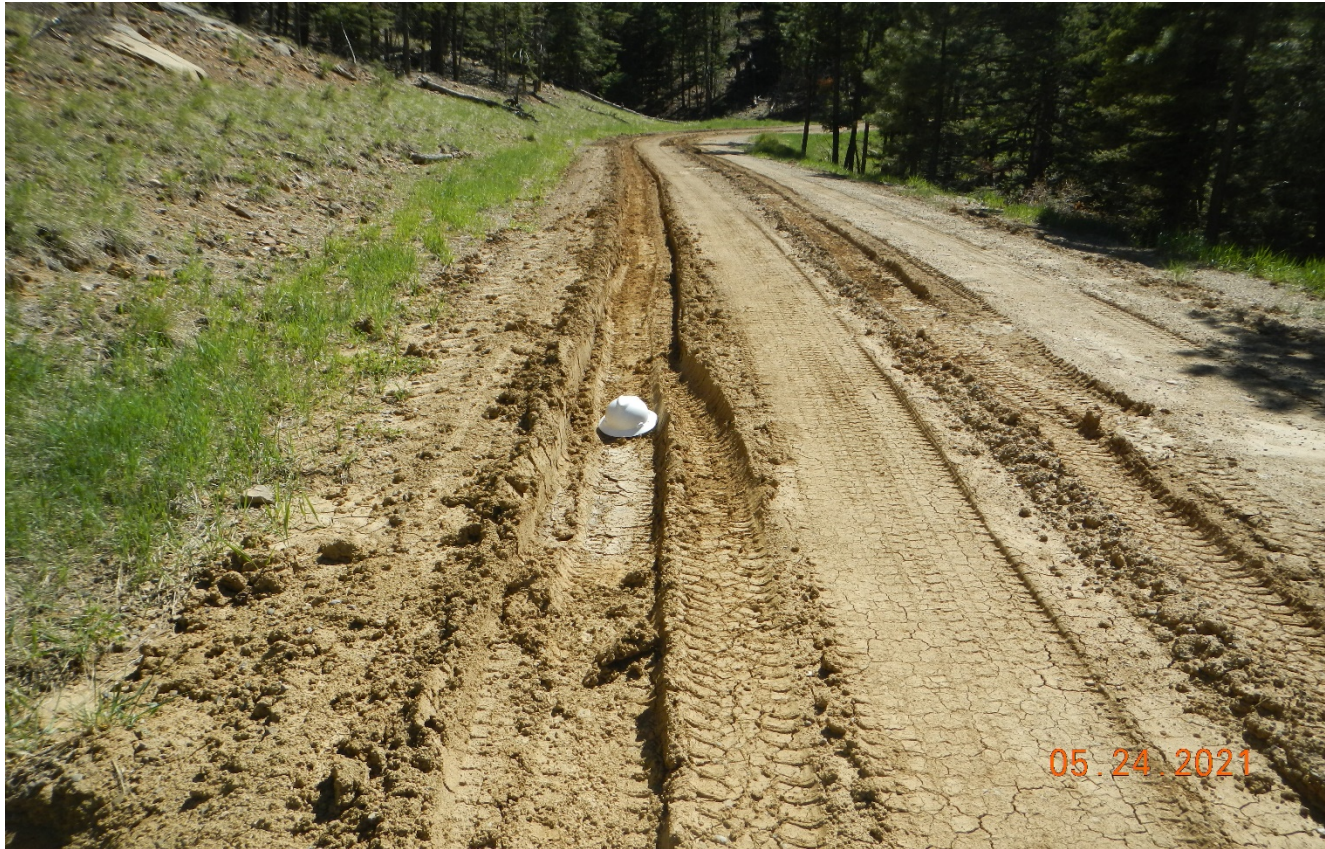
Photo 7. Facing west along the main access road. There are areas along the road that have vehicle rutting and erosion. The road needs to be maintained and stabilized.

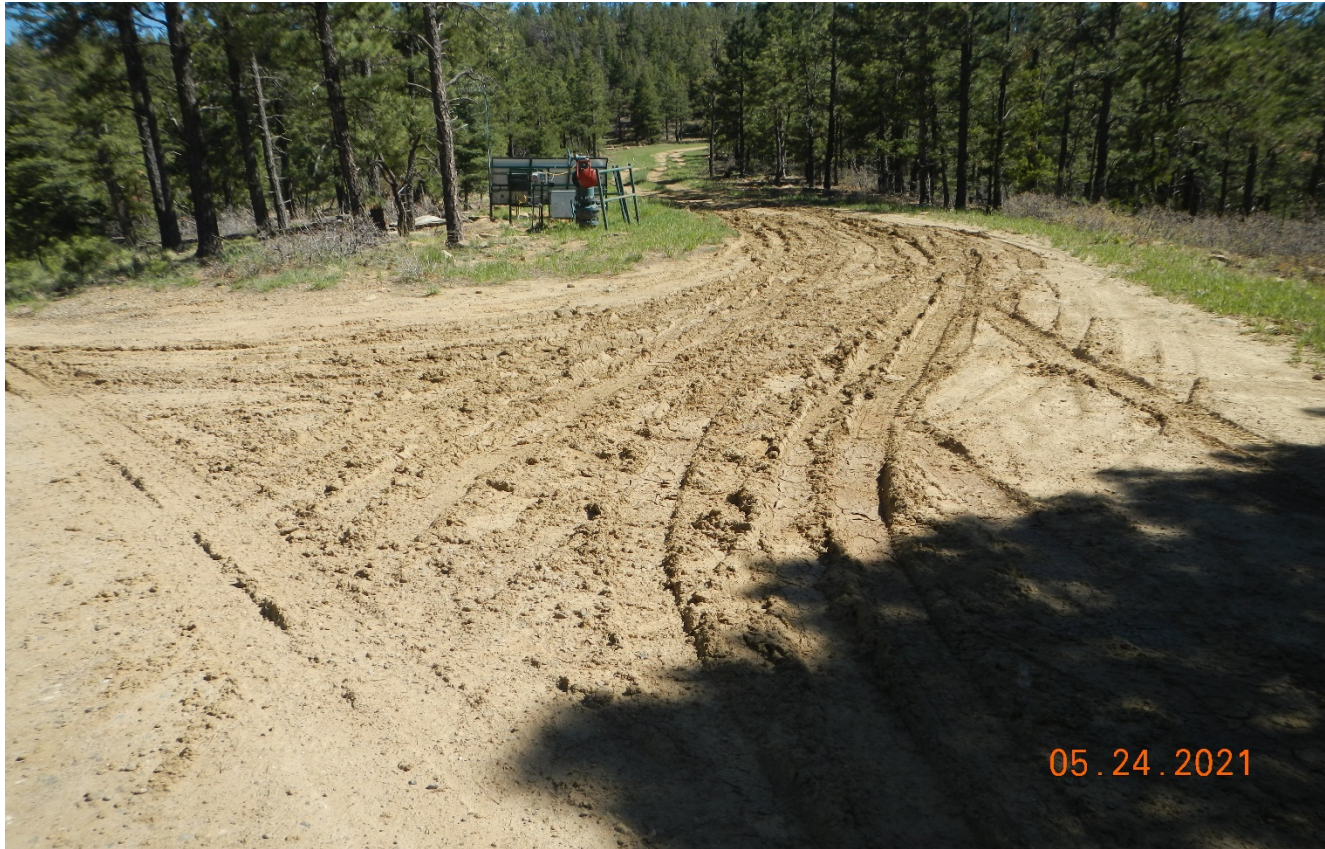
Photo 8. There is vehicle rutting where trucks are backing into the receiver/launcher.

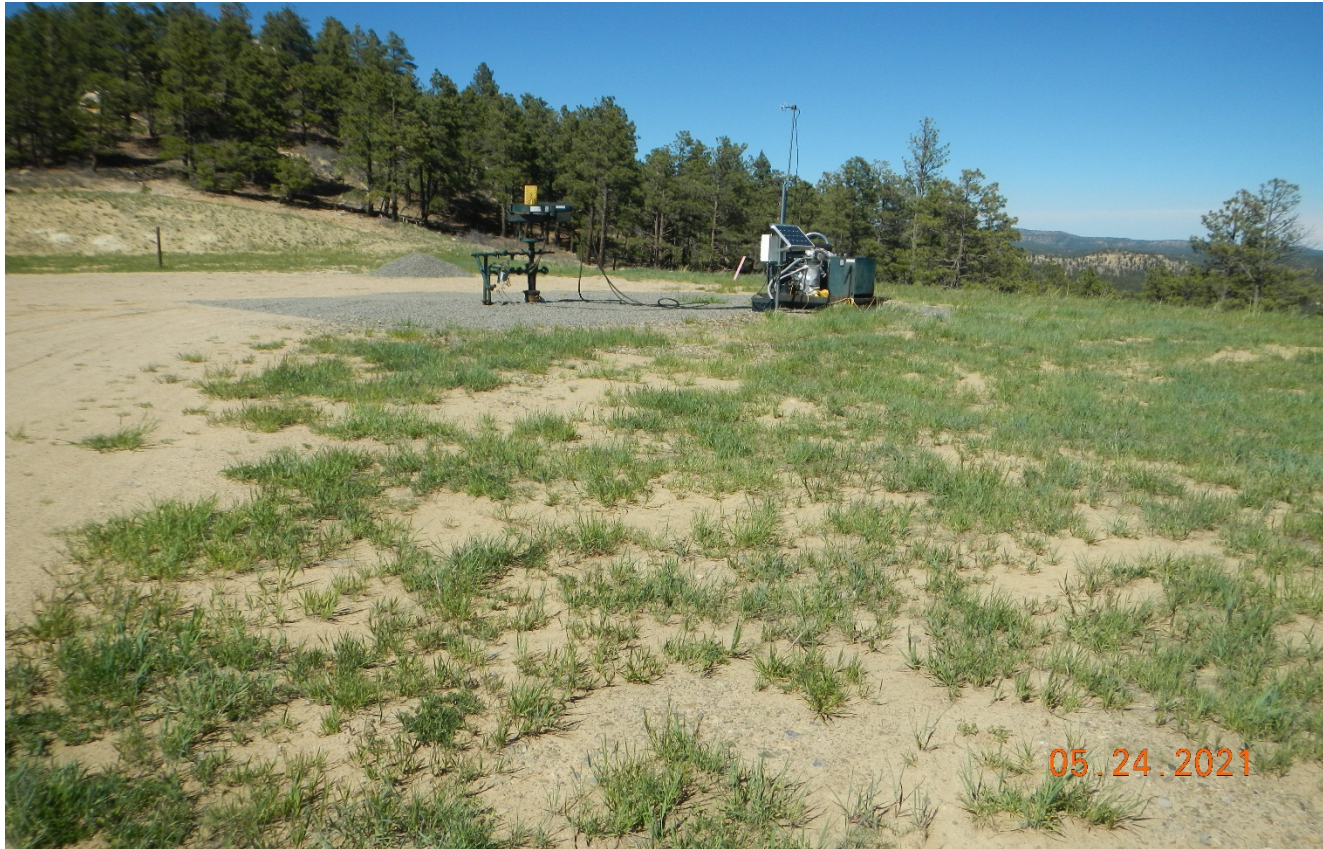
Photo 9. Facing northeast toward the location. Vegetation is established in the interim area and the location is stabilized.

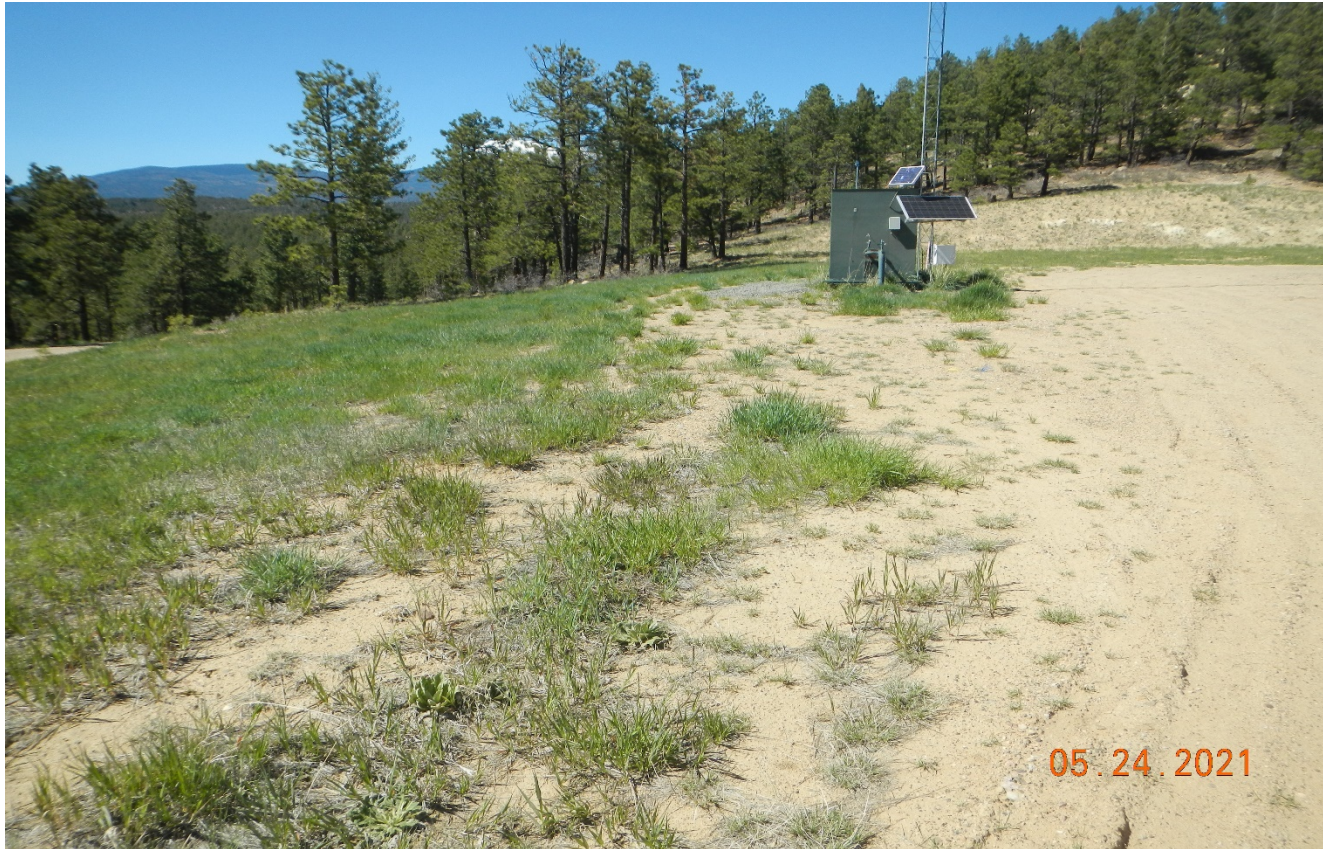
Photo 10. Facing north toward the location. Vegetation is established in the interim area and the location is stabilized.
