Inspection Photos

5/21/2021

Operator: SG INTERESTS I LTD - 77330

Location ID: 414132

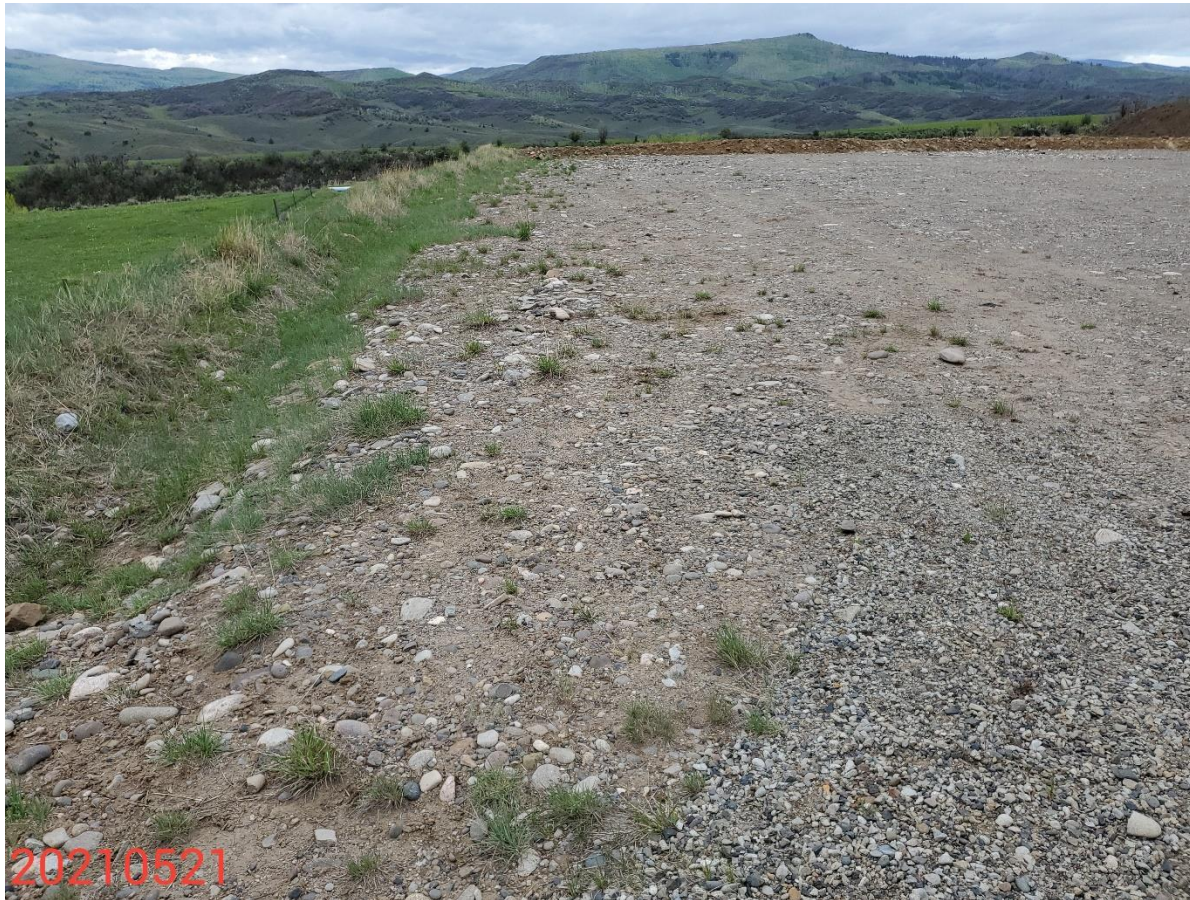
Photo 1: Photo taken from the southeast end of the Location, facing west. Photos 1-3 provide an overview of the Location from west, northwest to north. Photos show reclamation of unused areas not needed for production has not been performed in accordance with 1003 Rules.

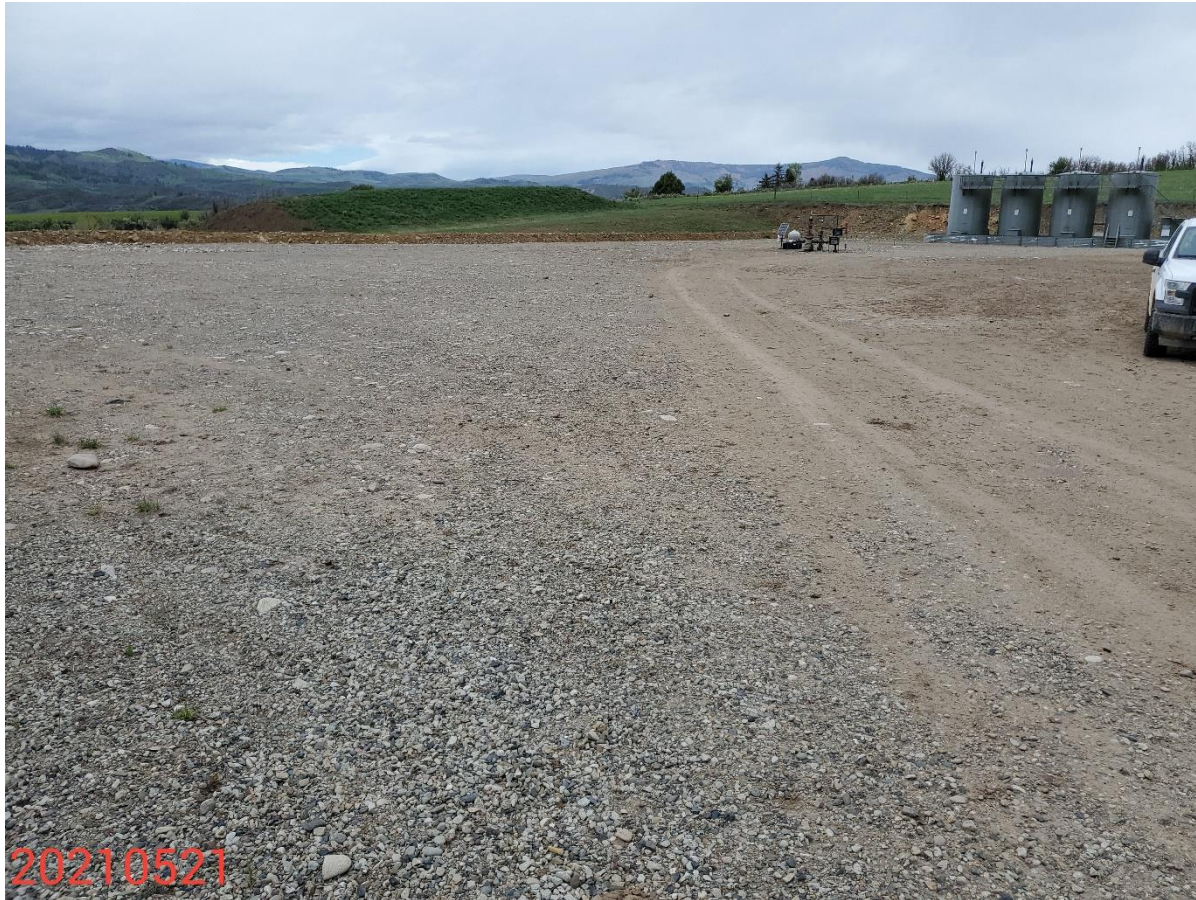
Photo 2: See comments under photo 1.

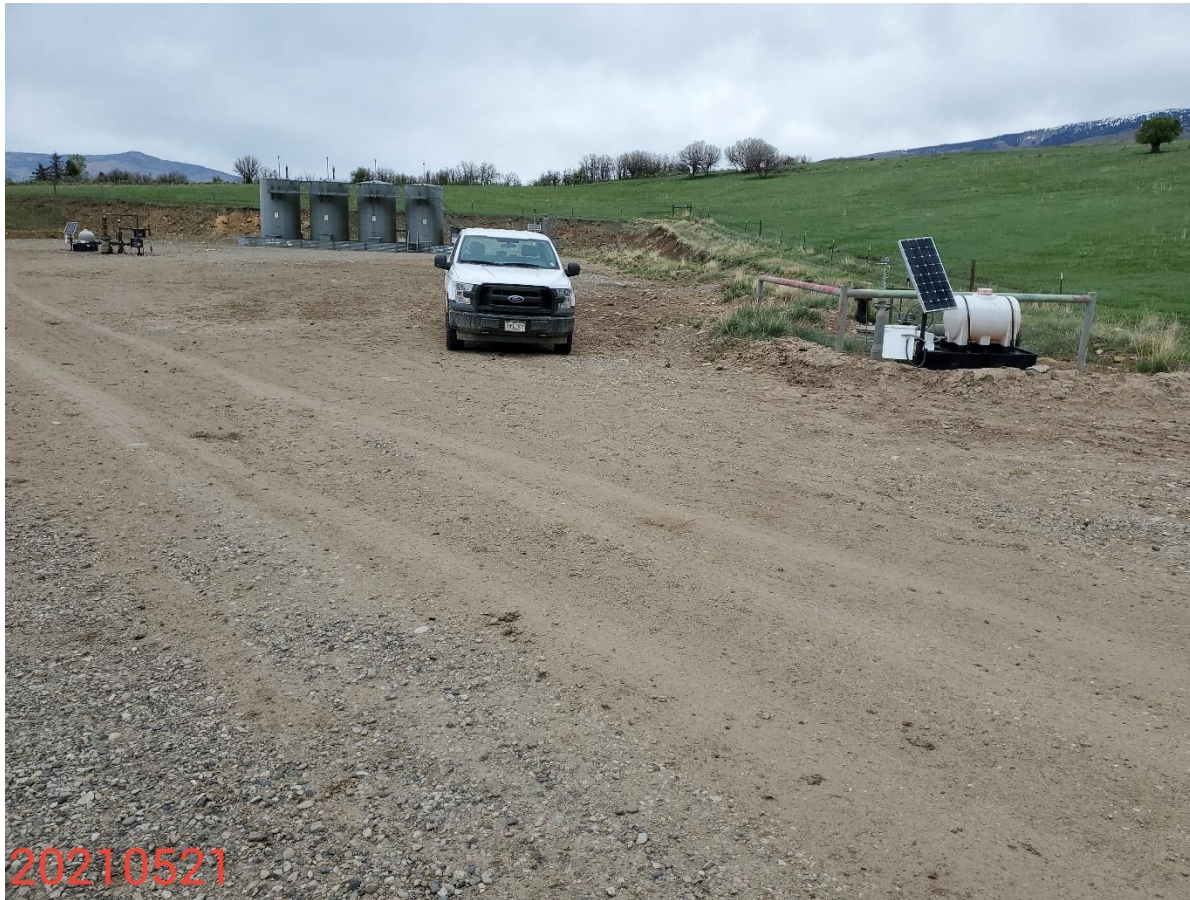
Photo 3: See comments under photo 1.

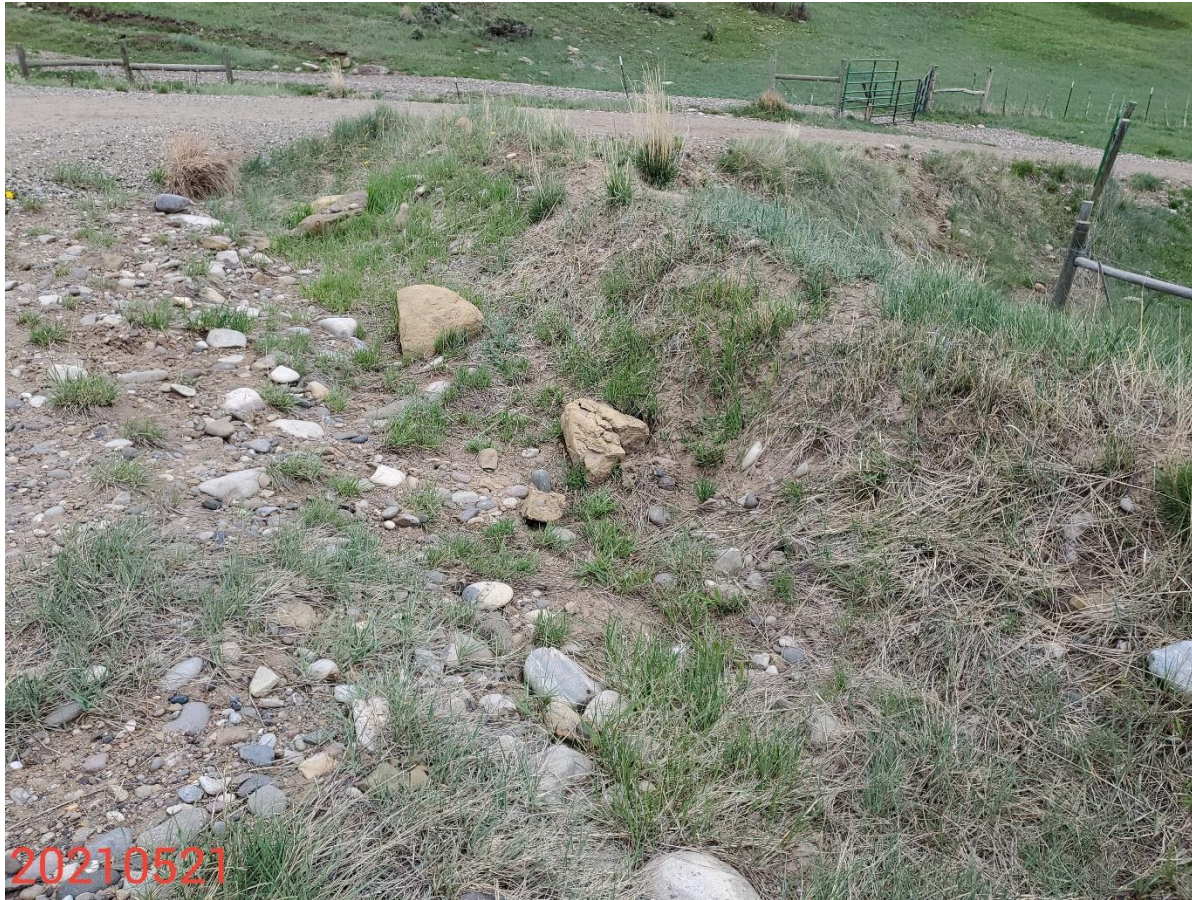
Photo 4: Photo taken from the southeast corner of the Location. Previous inspections observed that the Slope drone has not been maintained in proper functioning condition; inlet filled with sediment. Photo shows inlet of the slope drain remains filled with sediment.

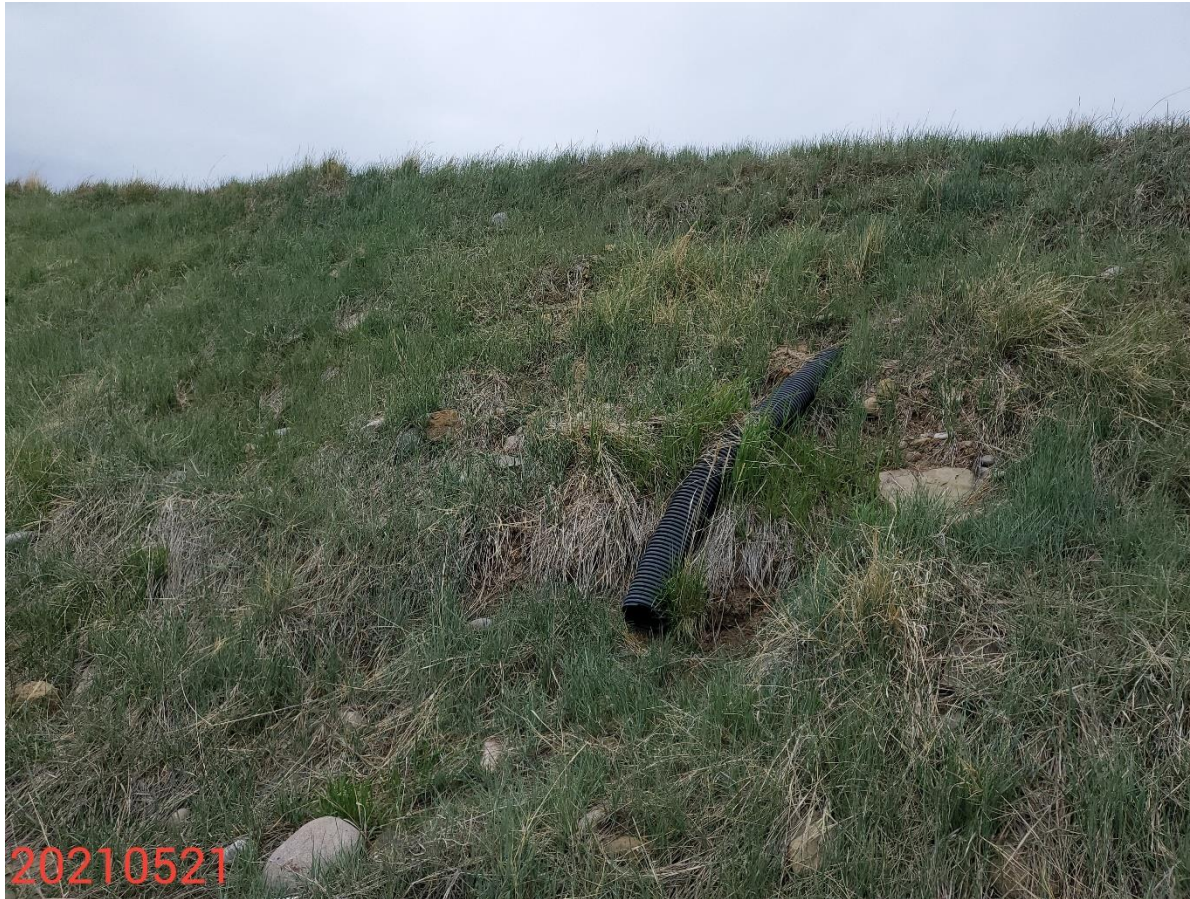
Photo 5: Photo taken from the southeast corner of the Location. Photo shows slope drain. Previous inspections documented that the slope drain was not constructed with an appropriate outlet per good engineering practices. Photo shows slope drain has not been constructed with an appropriate outlet.

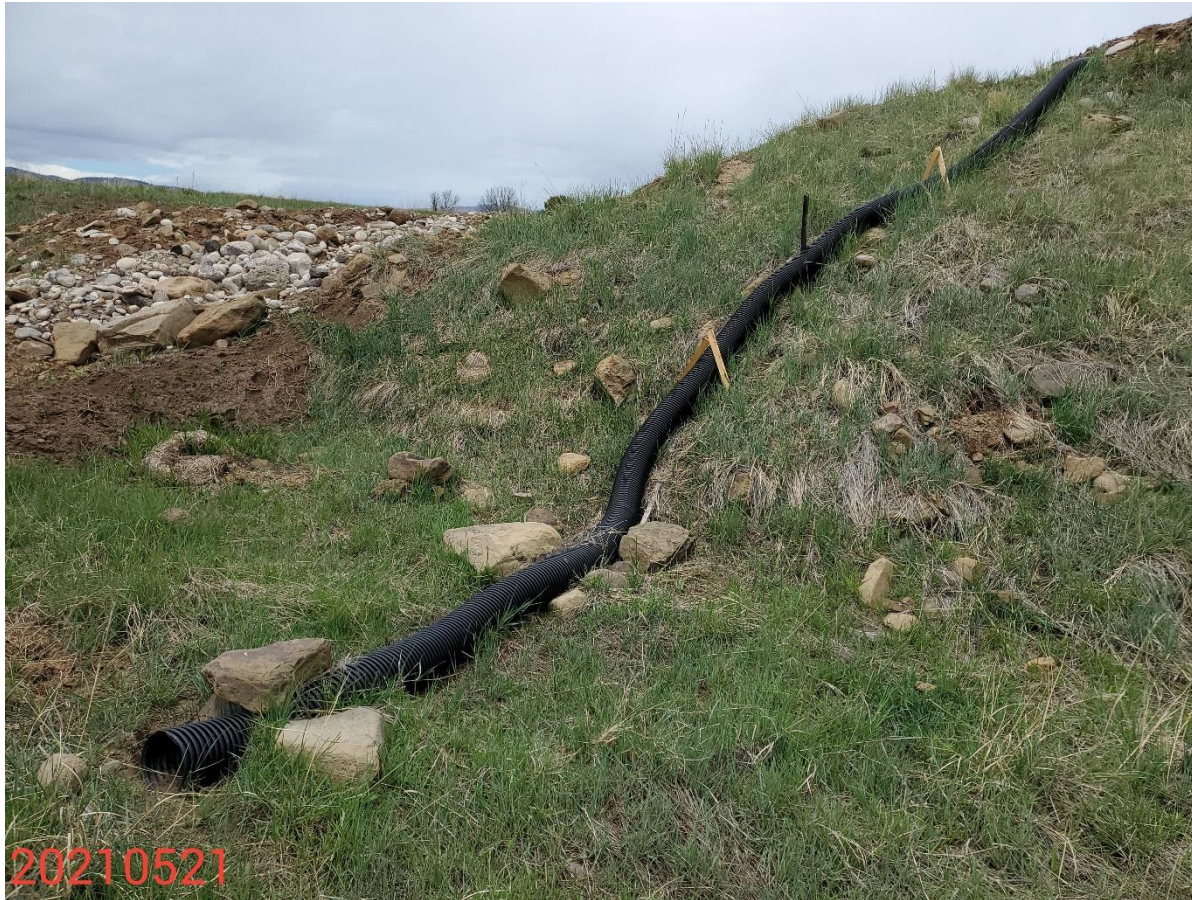
Photo 6: Photo taken from the southwest corner of the Location. Photo shows slope drain. Previous inspections documented that the slope drain has not been constructed with an appropriate outlet per good engineering practices. Photo shows slope drain remains improperly constructed with an appropriate outlet per good engineering practices.

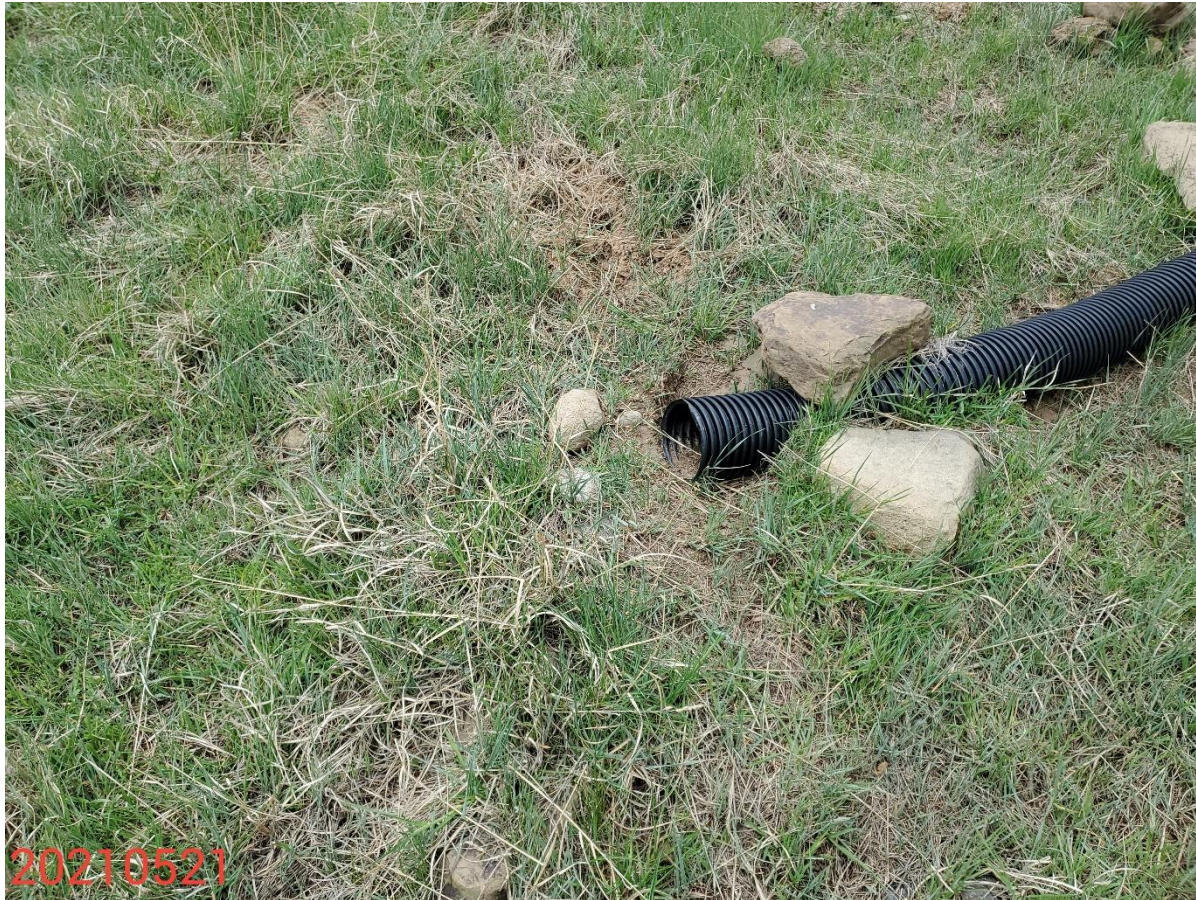
Photo 7: Continued from photo 6. Photo shows slope drain has not constructed with an appropriate outlet per good engineering practices.

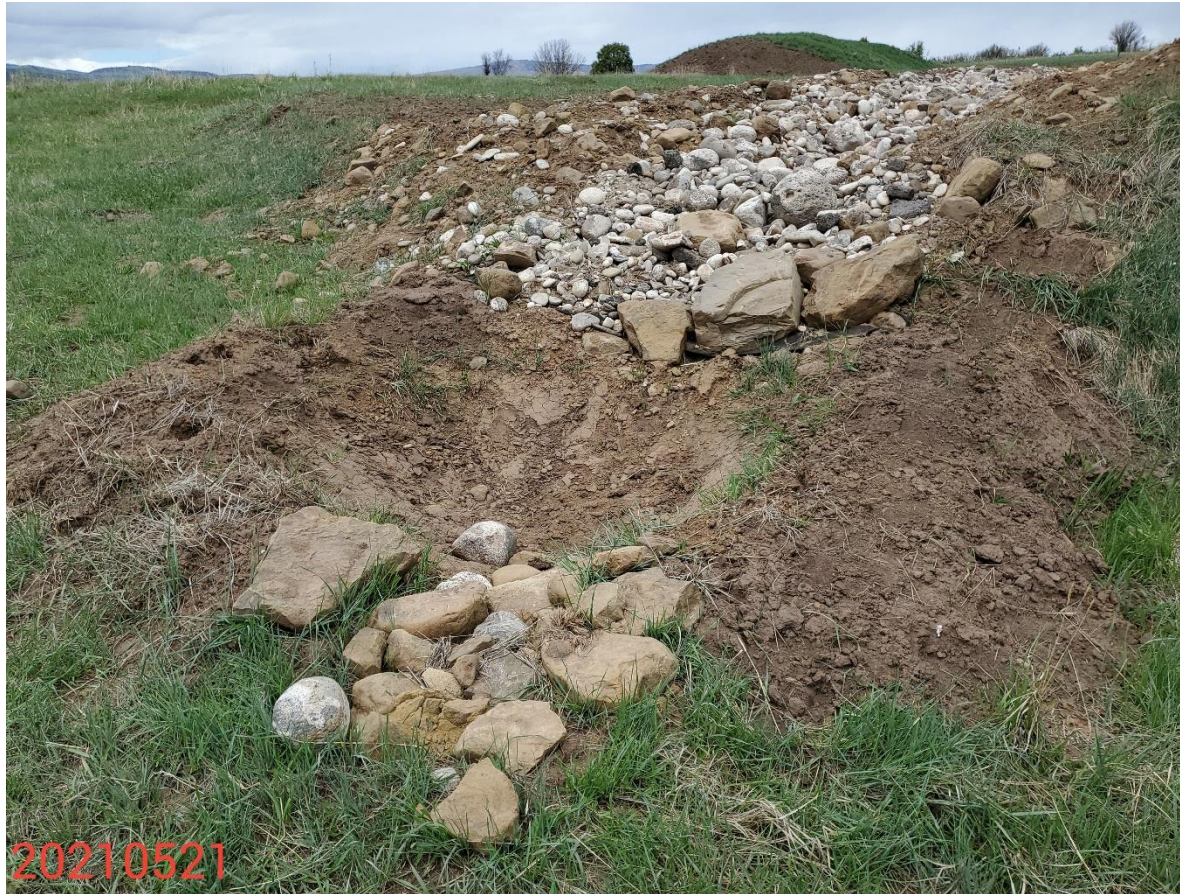
Photo 8: Photo taken from the southwest corner of the Location. Photo shows sediment trap. Precious inspections documented that the sediment trap has not been constructed with an appropriate outlet per good engineering practices. Photo shows outlet has not been not constructed in accordance with good engineering practices; outlet missing geotextile lining; scouring/degradation becoming evident around riprap at outlet. Trap also does not appear to be appropriate in size.

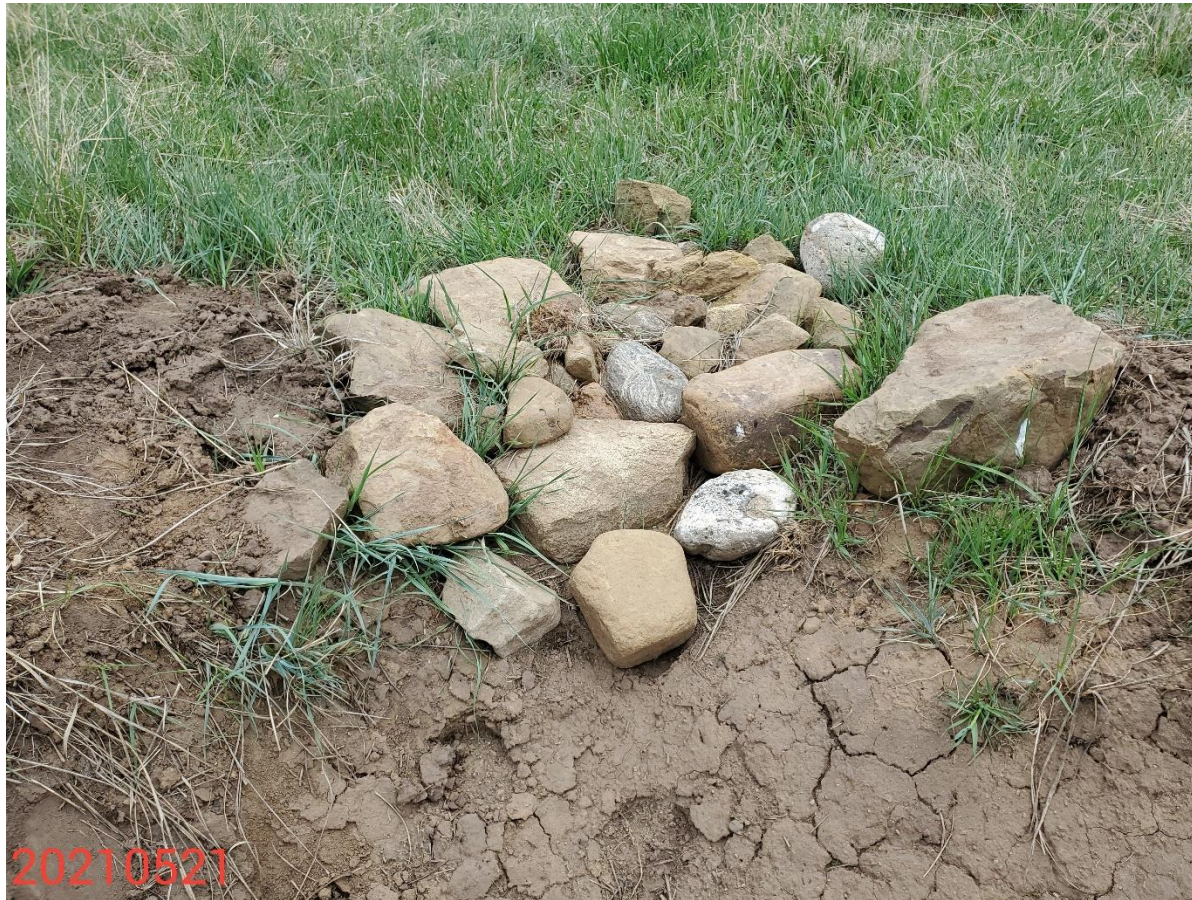
Photo 9: See comments under photo 8. Photo shows outlet missing geotextile lining per good engineering practices; scouring/degradation becoming evident around riprap at outlet

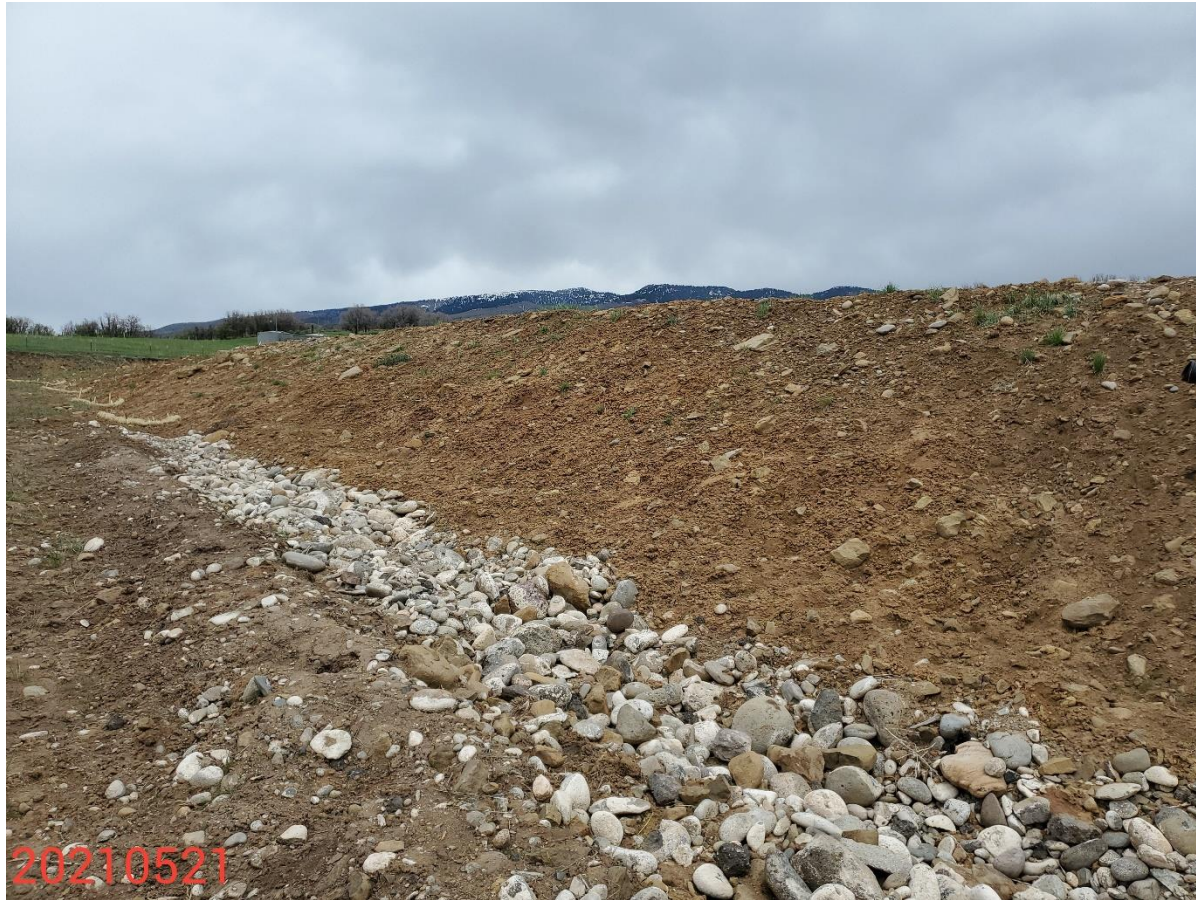
Photo 10: Photo taken from the slopes on the west end of the Location. Previous inspections documented that control measures to protect/stabilize slopes on the Location were missing or insufficient. Photo shows control measures to protect/stabilize slopes on the Location remain missing or insufficient.

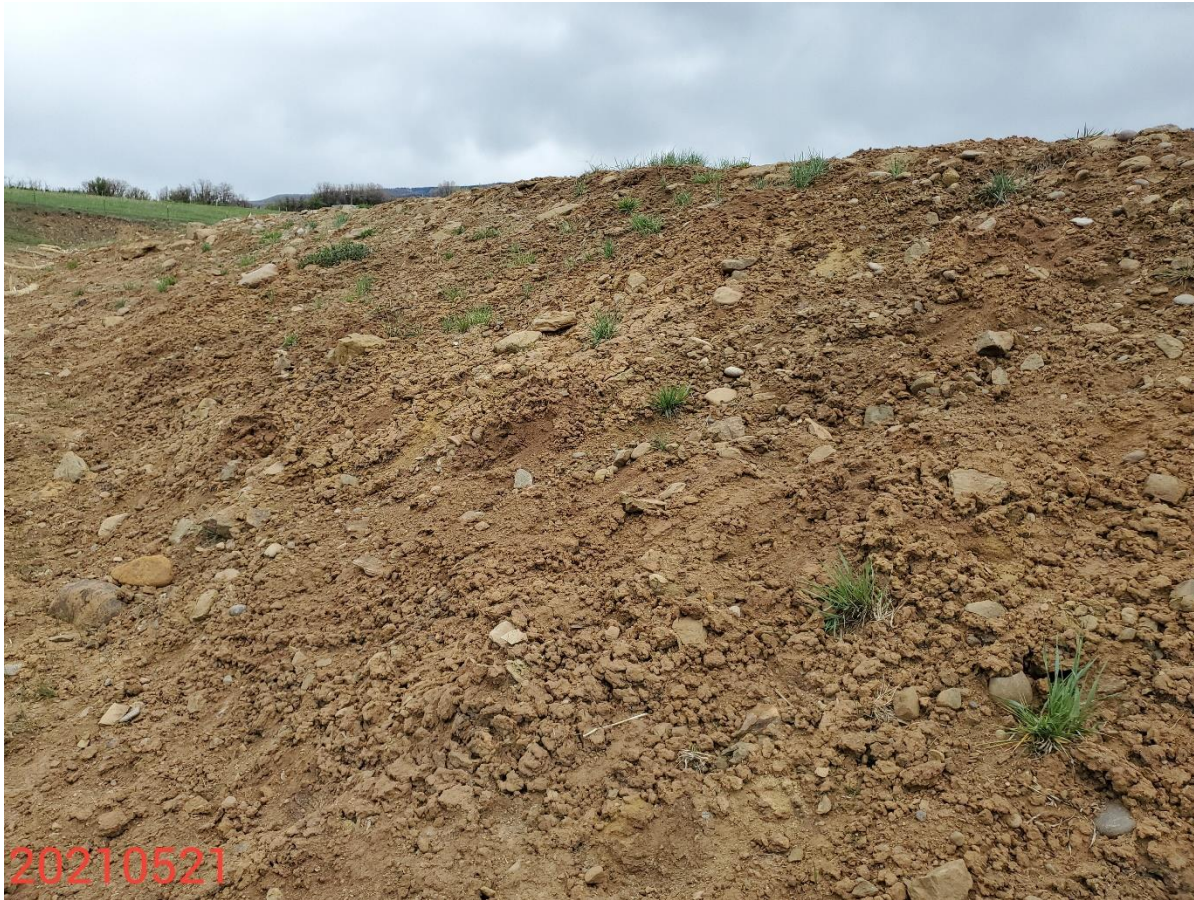
Photo 11: See comments under photo 10.

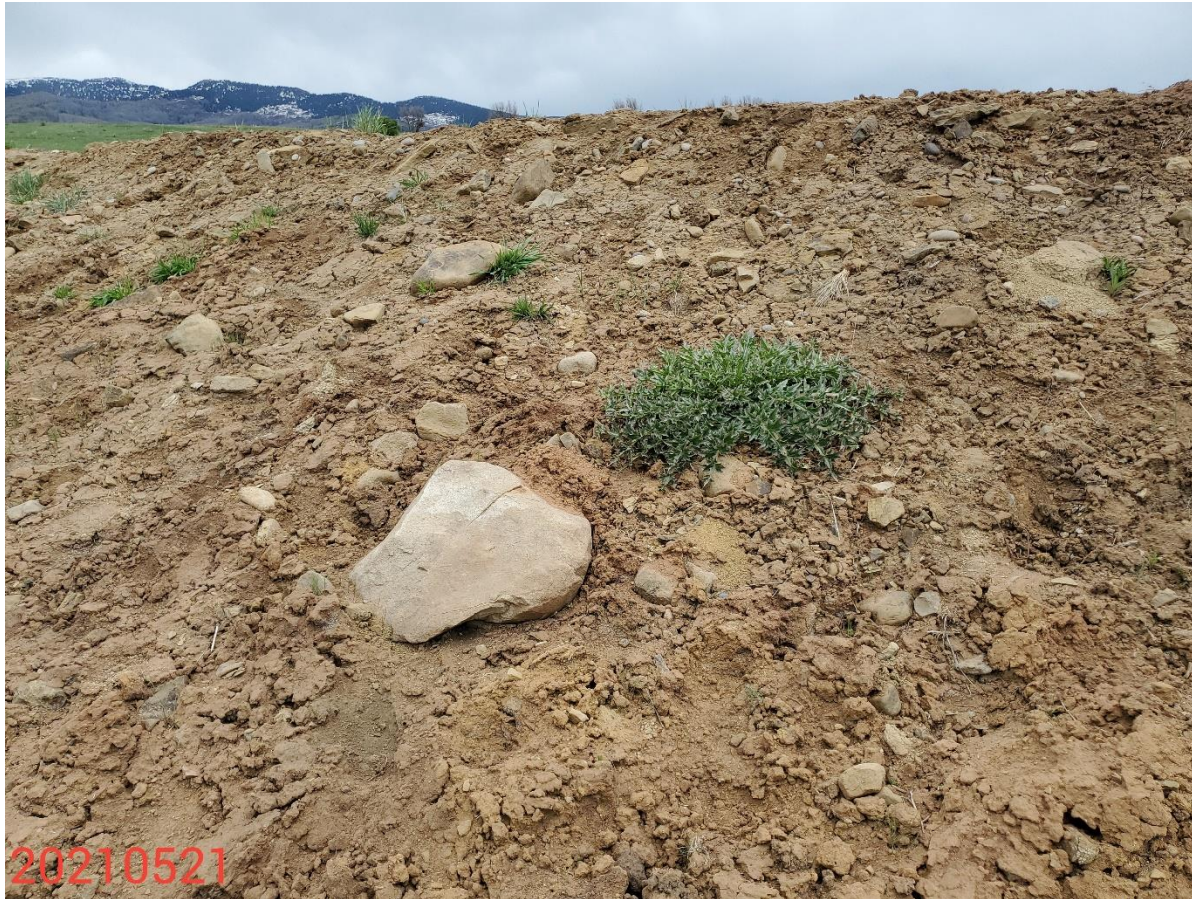
Photo 12: Photo shows noxious weed rosette observed on the western slopes of the Location.

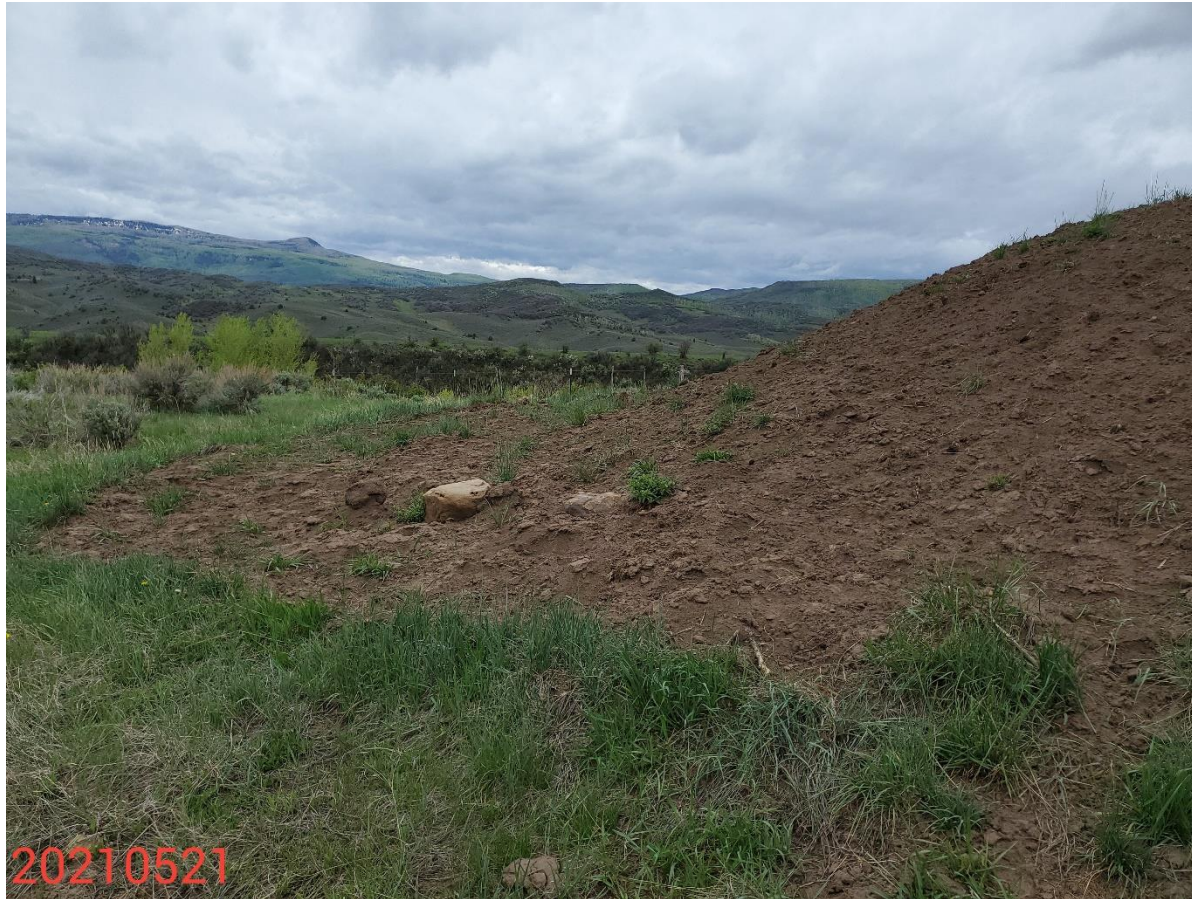
Photo 13: Photo taken from the topsoil stockpile on the west end of the Location. Previous inspections documented that control measures to protect/stabilize slopes on the Location were missing or insufficient. Photo shows control measures to protect/stabilize slopes on the Location remain missing or insufficient.

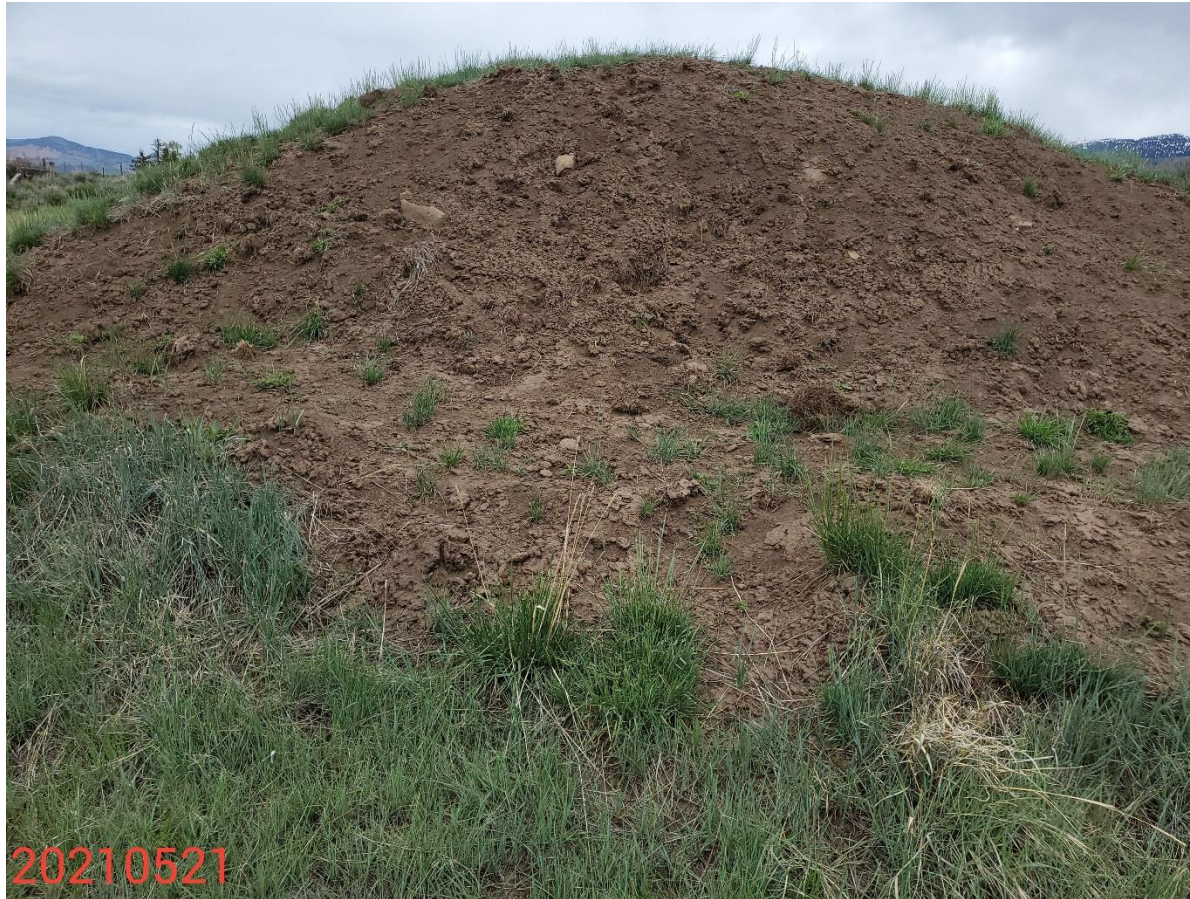
Photo 14: See comments under photo 13.

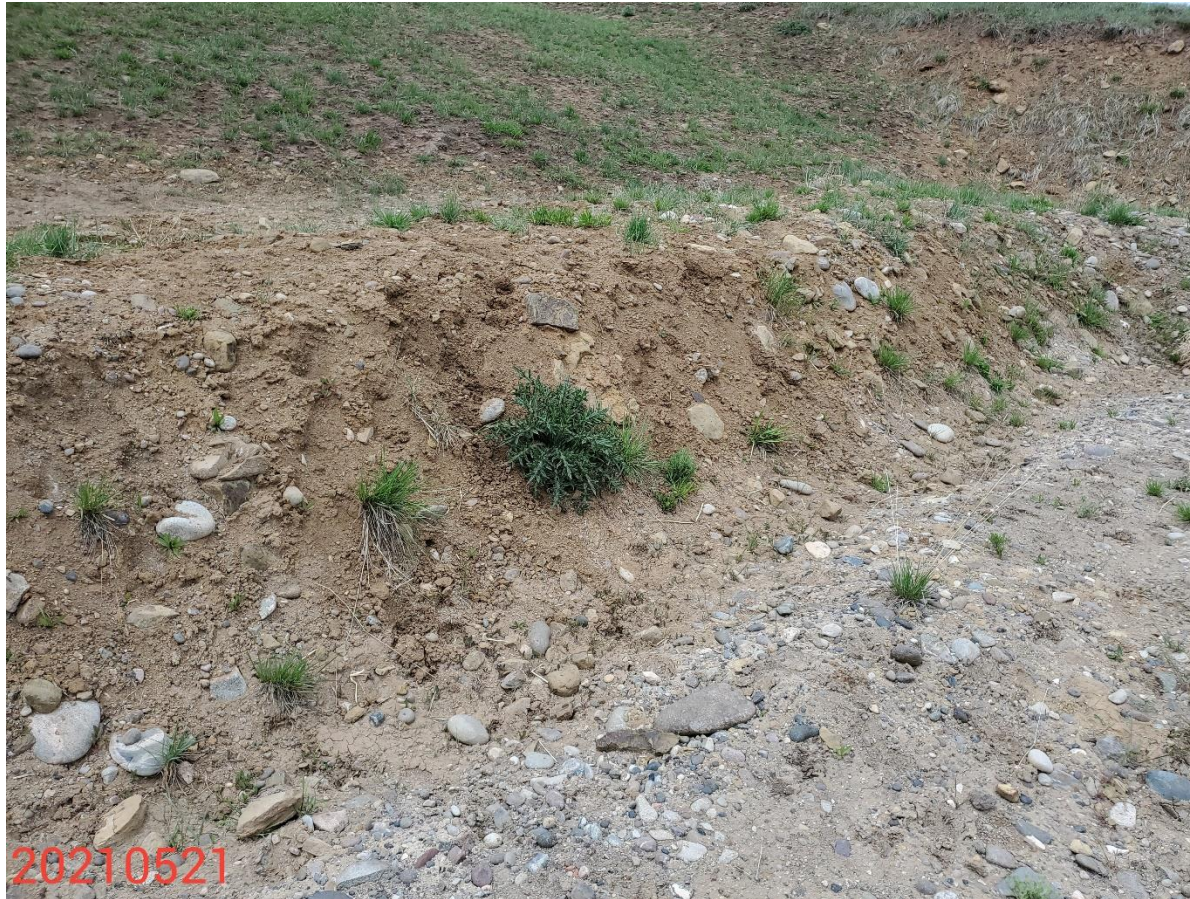
Photo 15: Photo shows noxious weed rosette observed on the berm along the northwest end of the Location.

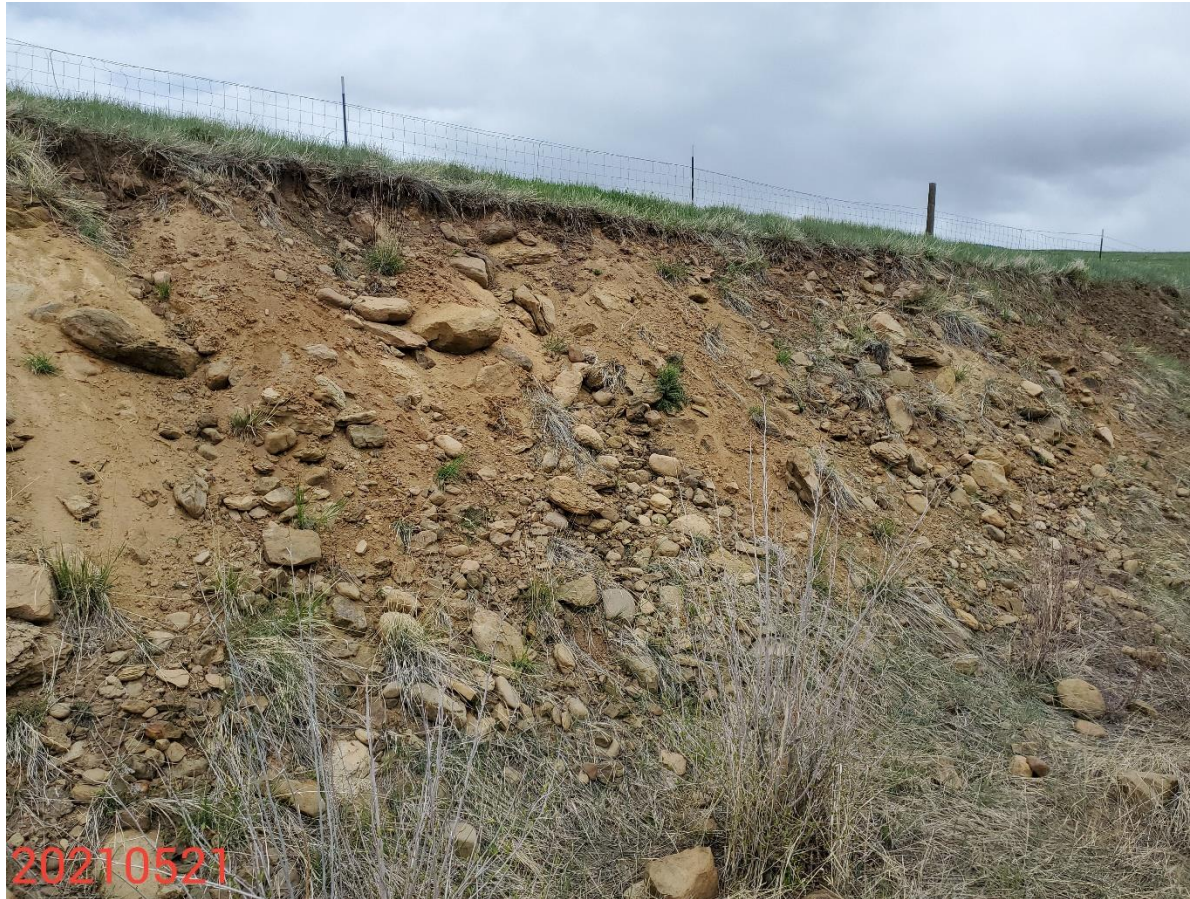
Photo 16: Photo taken from the north end of the Location. Previous inspections documented that control measures to protect/stabilize slopes on the Location were missing or insufficient. Photo shows control measures to protect/stabilize slopes on the Location remain missing or insufficient.

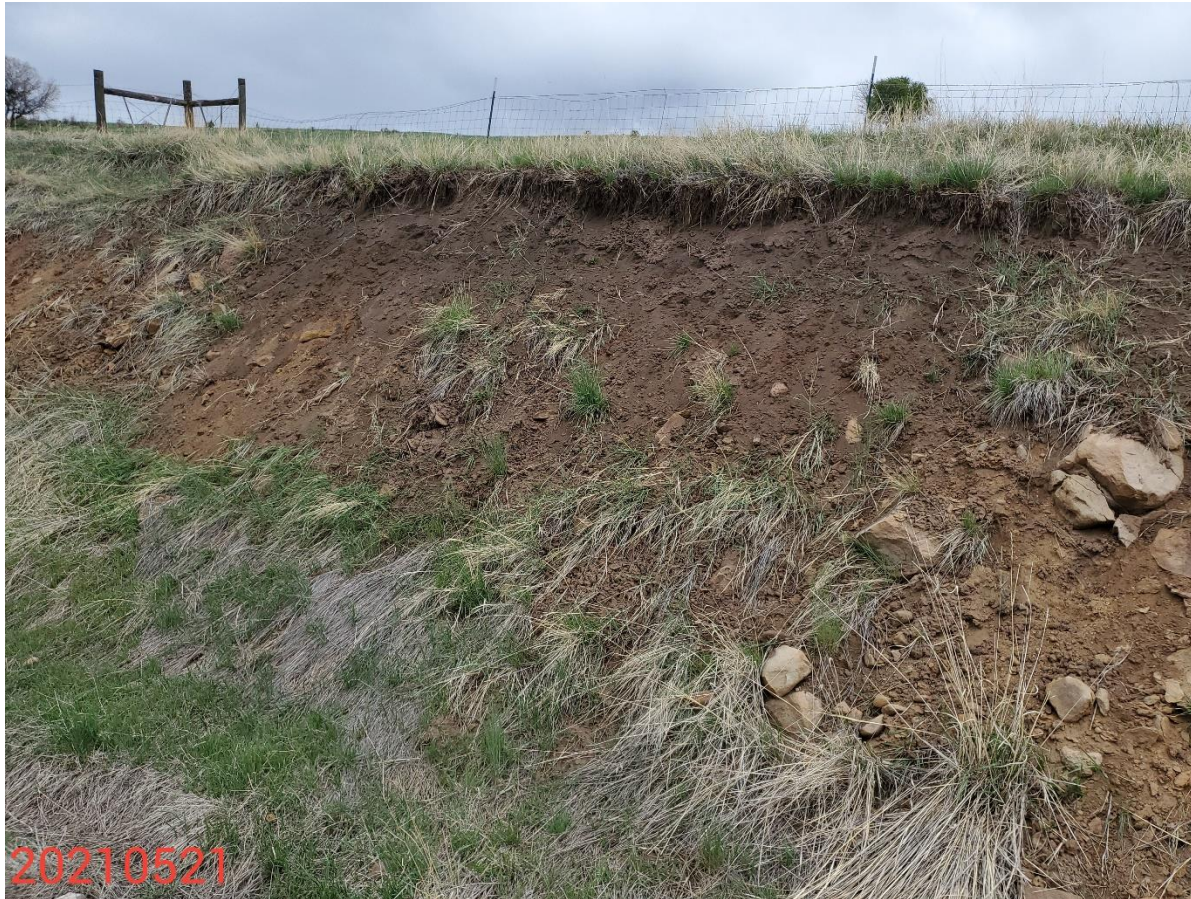
Photo 17: See comments under photo 16.

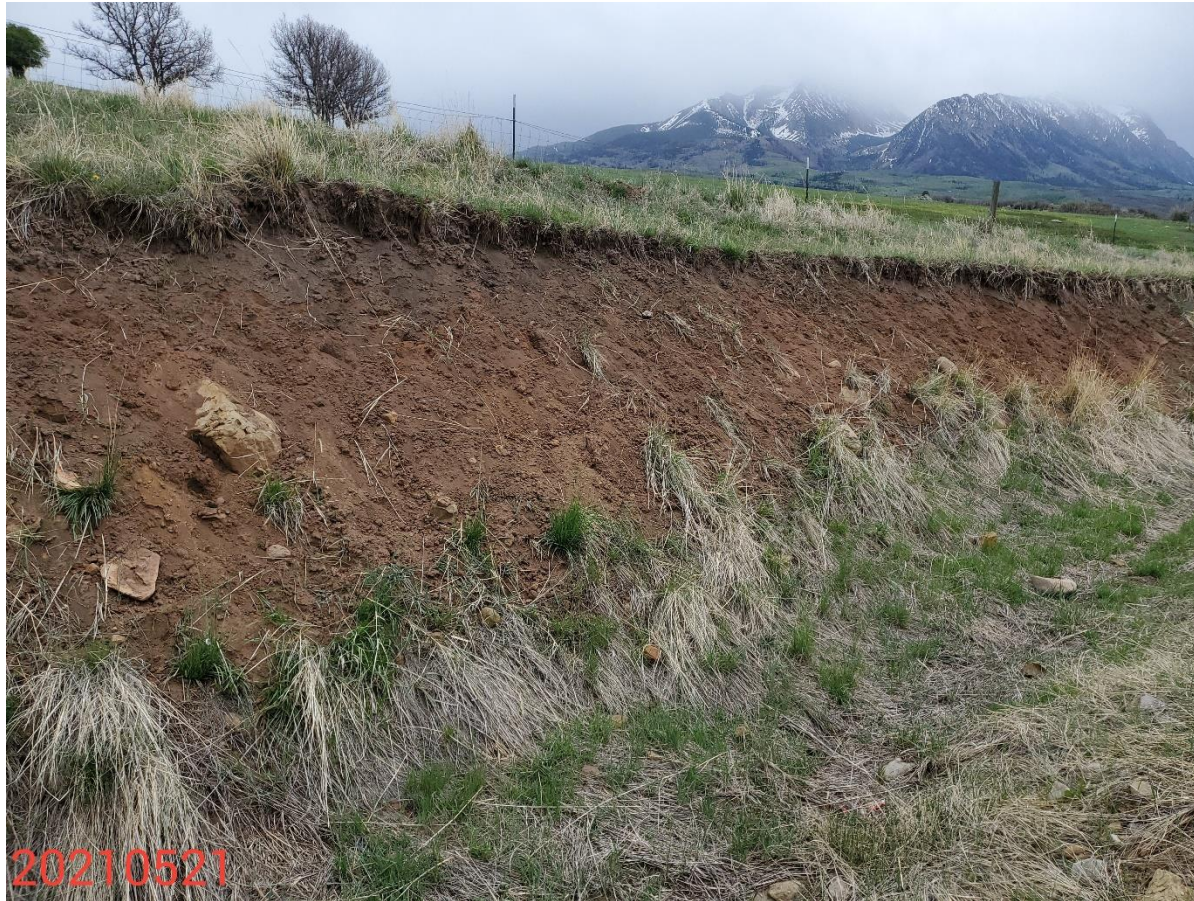
Photo 18: See comments under photo 16
