# Inspection Photos

5/21/2021

Operator: SG INTERESTS I LTD - 77330

Location ID: 418697

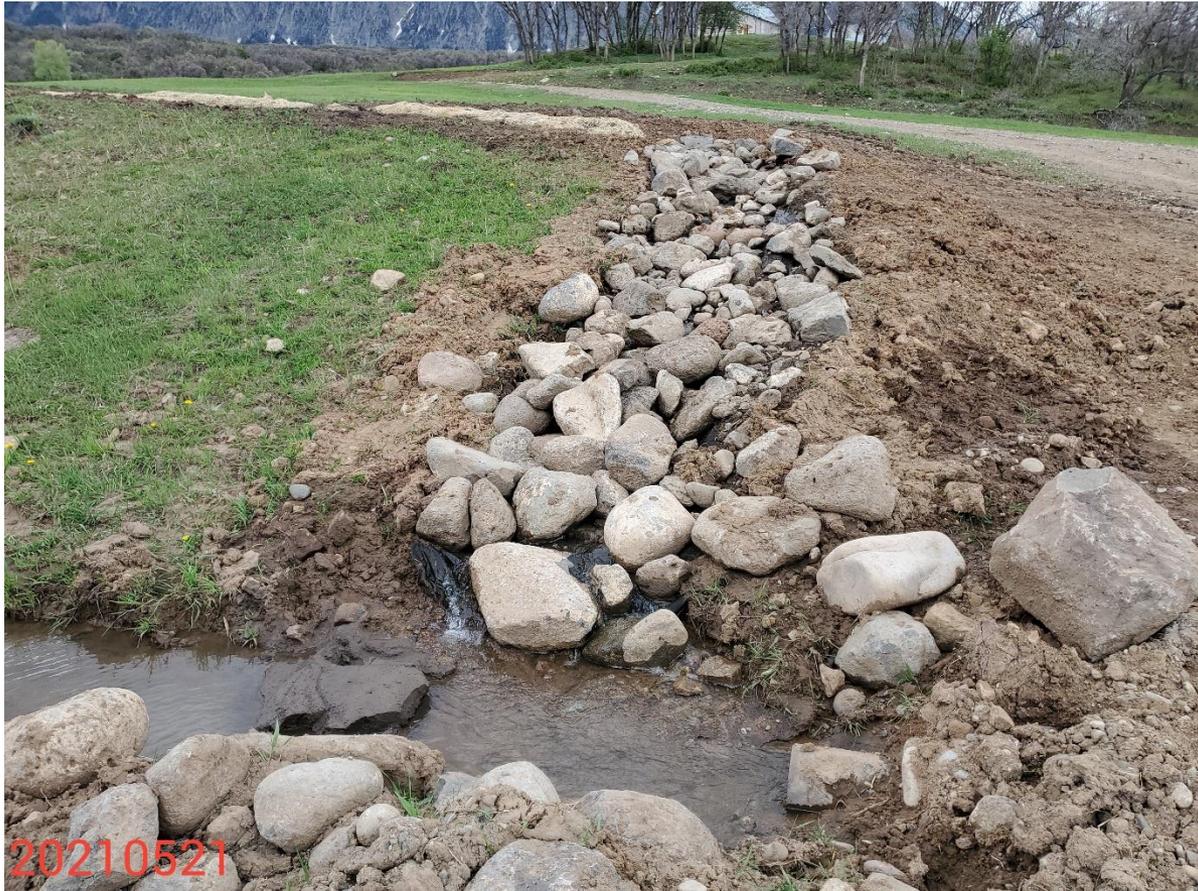
**Photo 1:** Photo taken from the east end of the Location, facing east. Photo shows section of the Location's perimeter stormwater diversion ditch armored with geotextile lining and rip-rap.

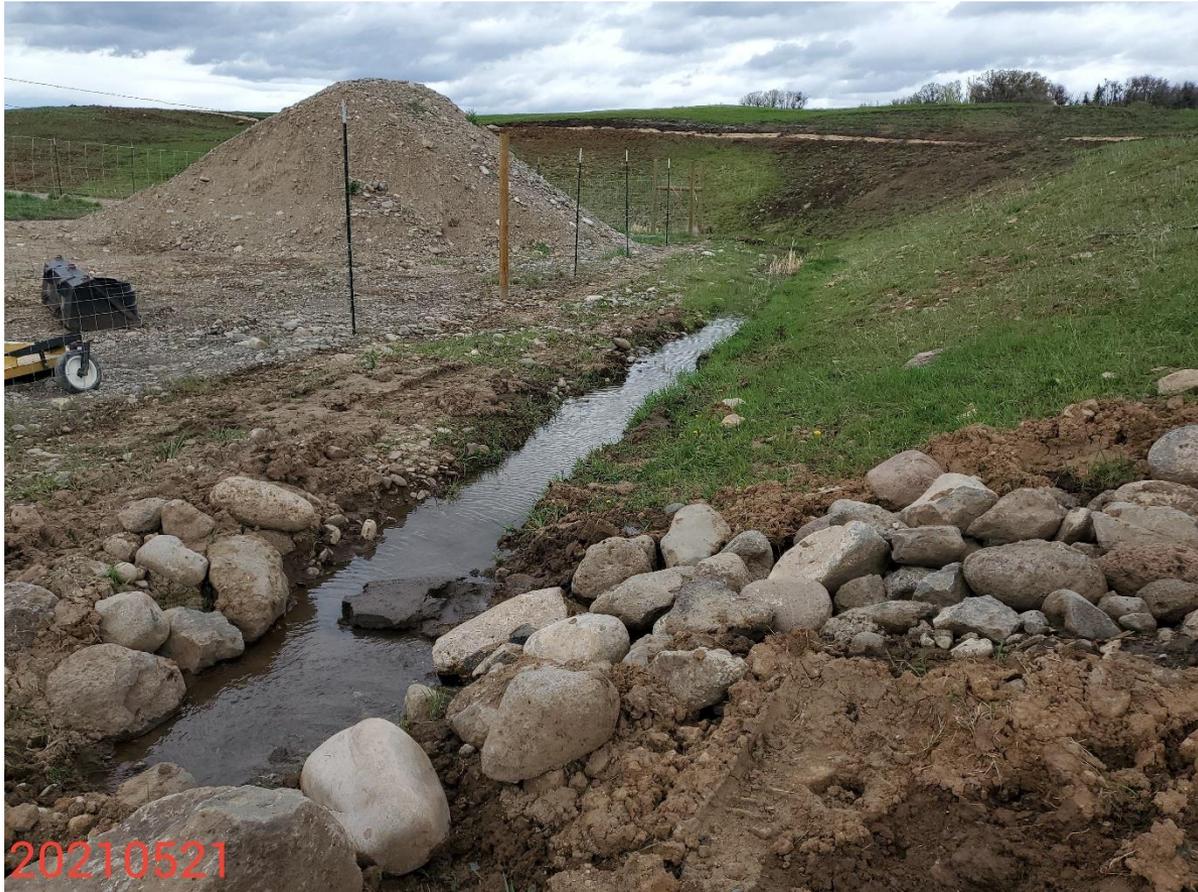
**Photo 2:** Photo taken from the east end of the Location, facing north. Photo shows the 2<sup>nd</sup> stormwater diversion ditch around perimeter of the pad.

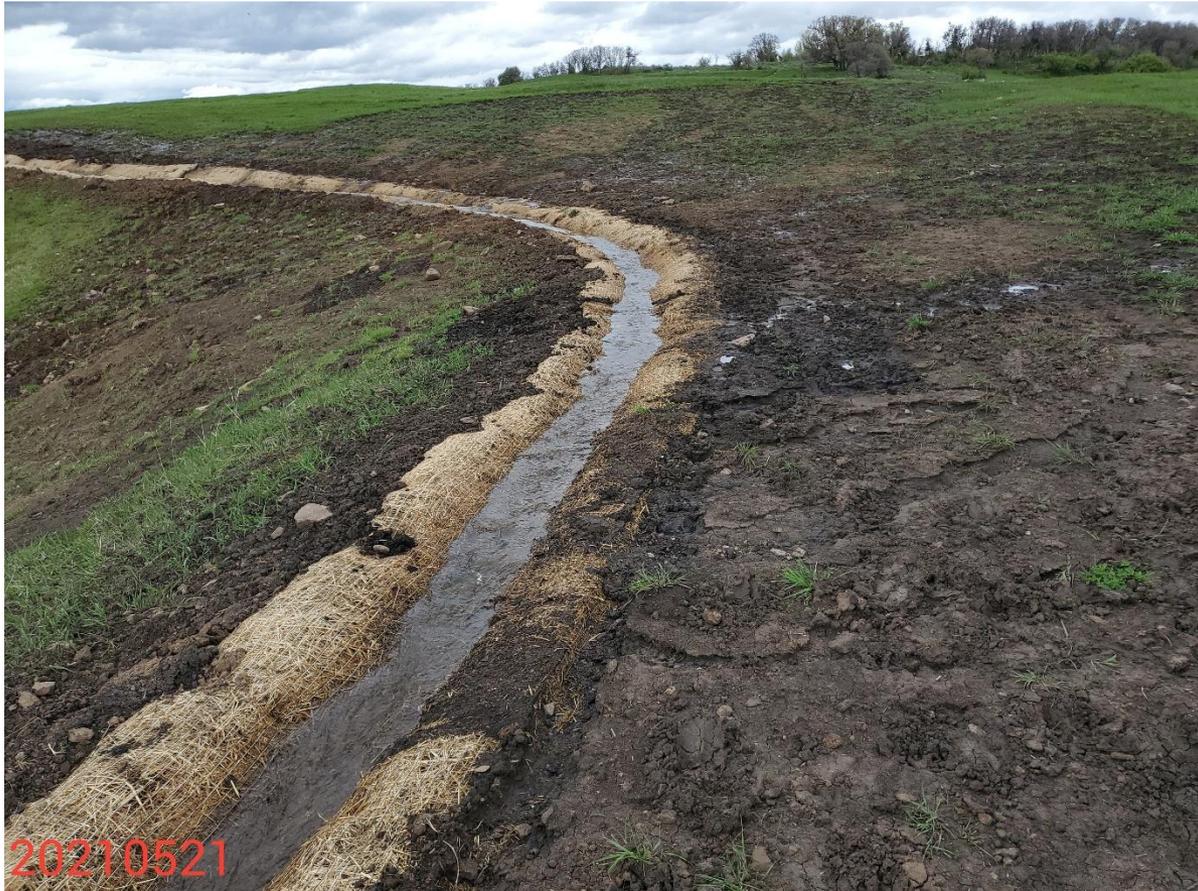
**Photo 3:** Photo taken from the east end of the Location, facing north. Photo shows the perimeter stormwater diversion ditch. Photo also shows control measures to protect/stabilize slopes and disturbed areas of the Location remain missing or insufficient. Unable to find evidence that revegetation activities were performed, and BMPs to stabilize seeded soils implemented. Erosion degradation evident.

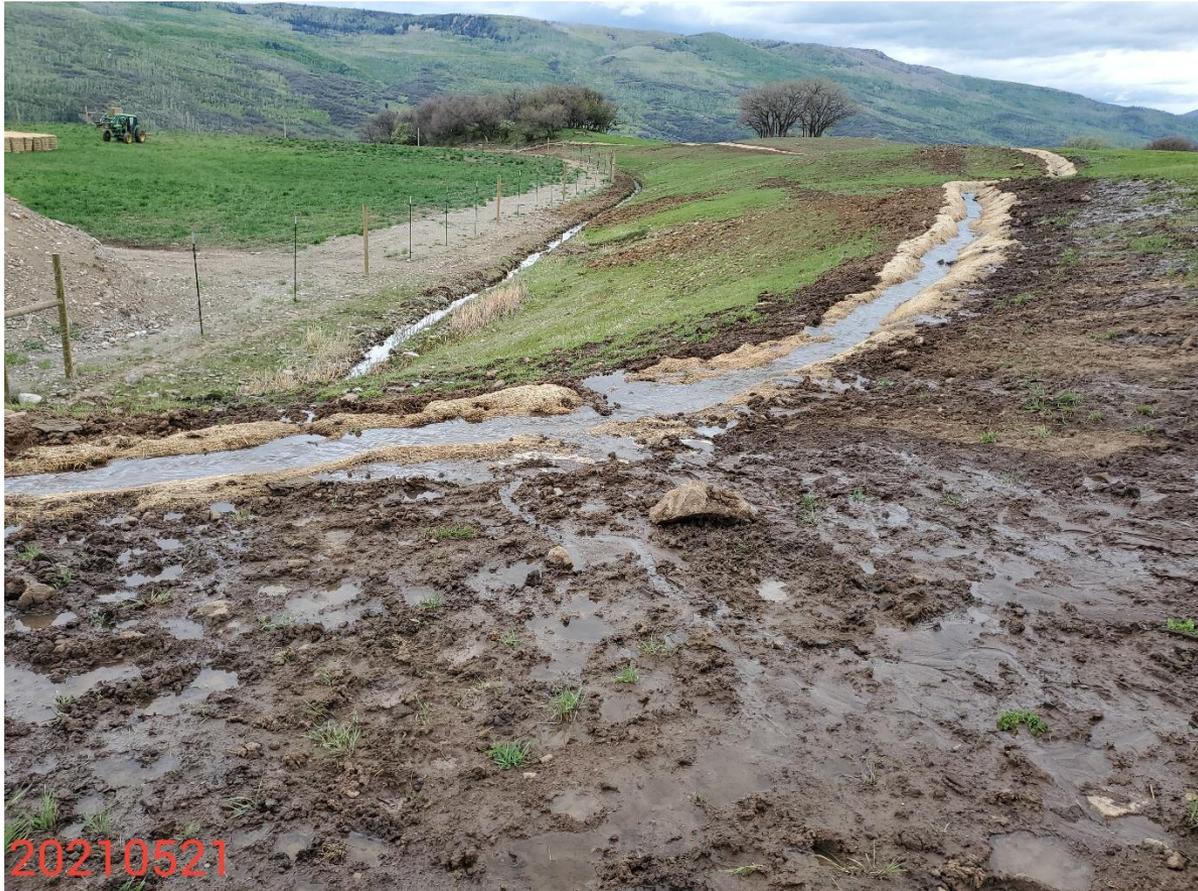
**Photo 4:** Photo taken from the northeast corner of the Location, facing southwest. Photo shows perimeter stormwater diversion ditch installed on Location is inadequate/insufficient for the site's conditions; diversion ditch not in proper functioning condition.

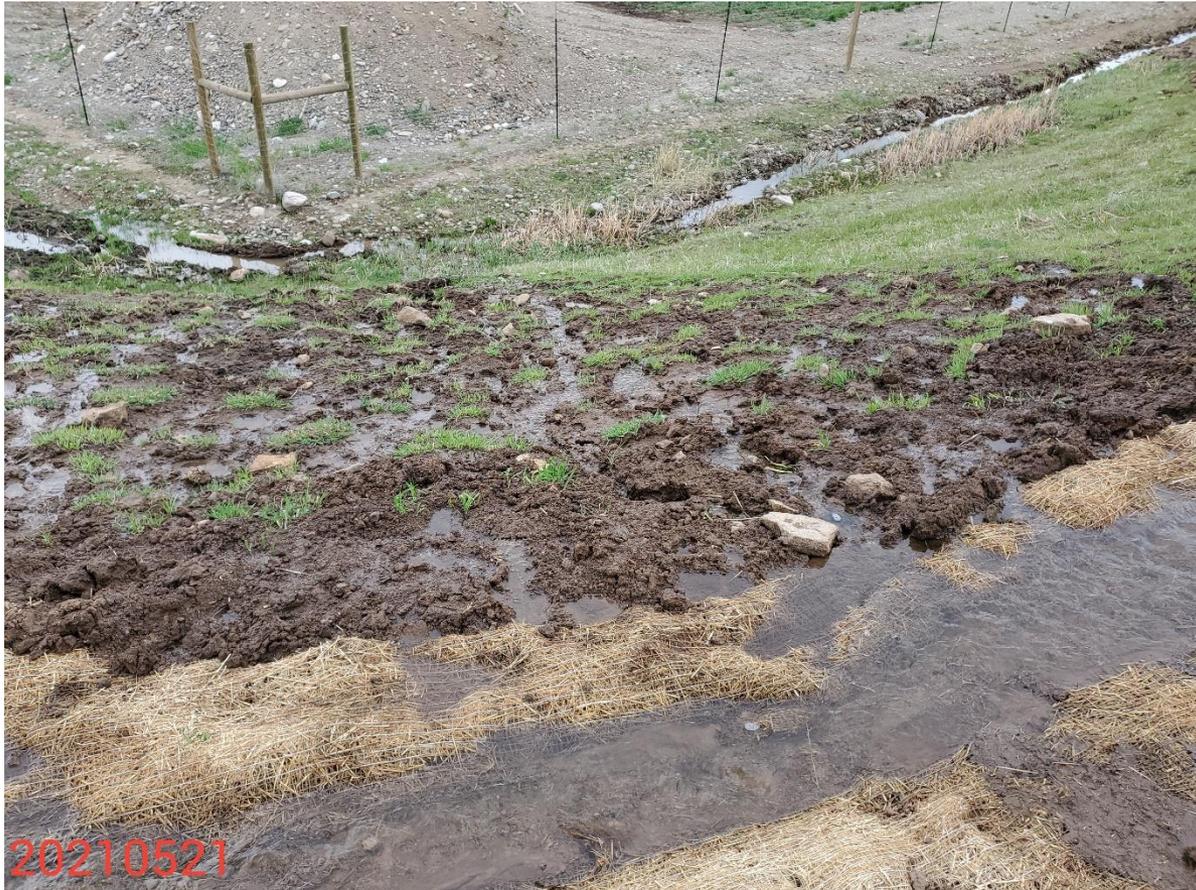
**Photo 5:** Continued from photo 4. Photo shows perimeter stormwater diversion ditch installed on Location is inadequate/insufficient for the site's conditions; ditch not in proper functioning condition. Photo also shows control measures to protect/stabilize slopes of the Location remain missing or insufficient.

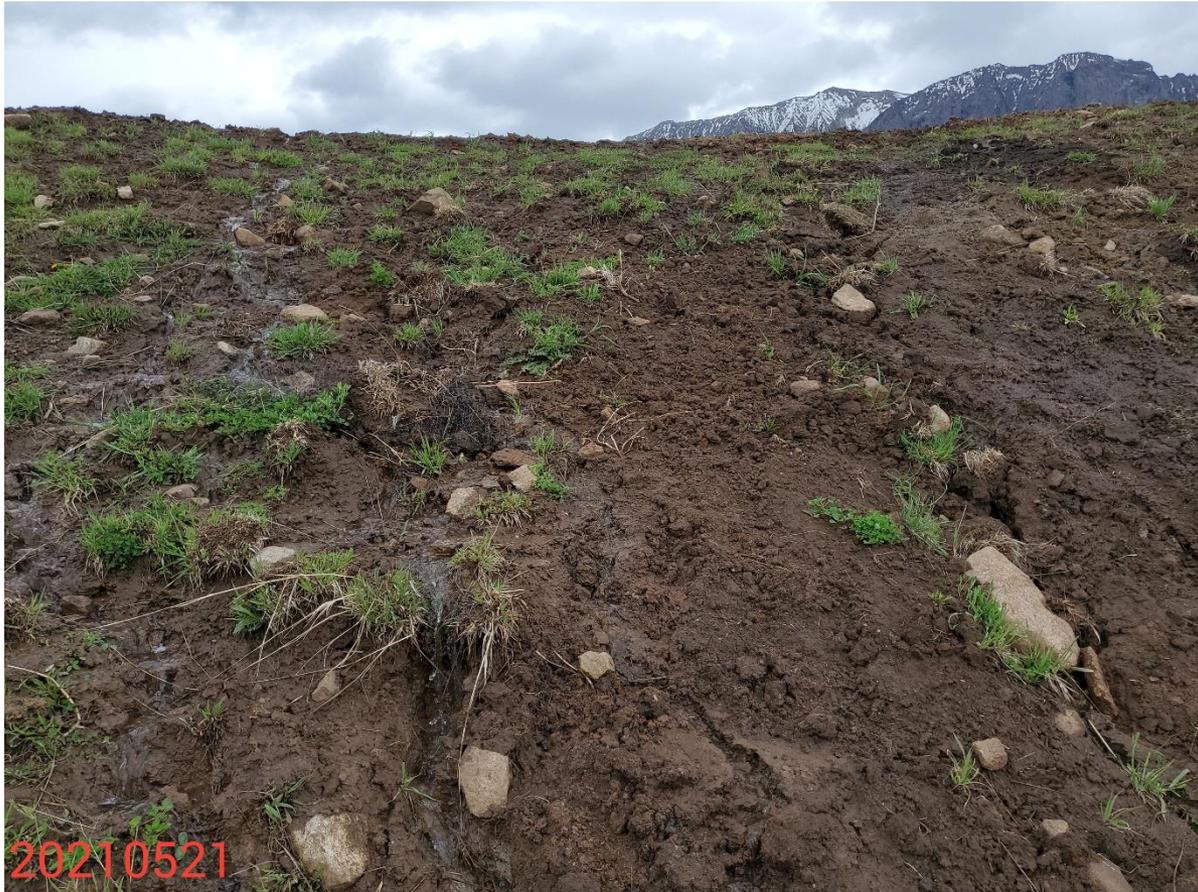
**Photo 6:** Continued from photo 5. Photo shows cut slopes on the Northeast end of the Location. Photo shows runoff causing erosion degradation on the slopes. Control measures to protect/stabilize slopes and disturbed areas of the Location remain missing or insufficient. Unable to find evidence that revegetation activities were performed, and BMPs to stabilize seeded soils implemented.

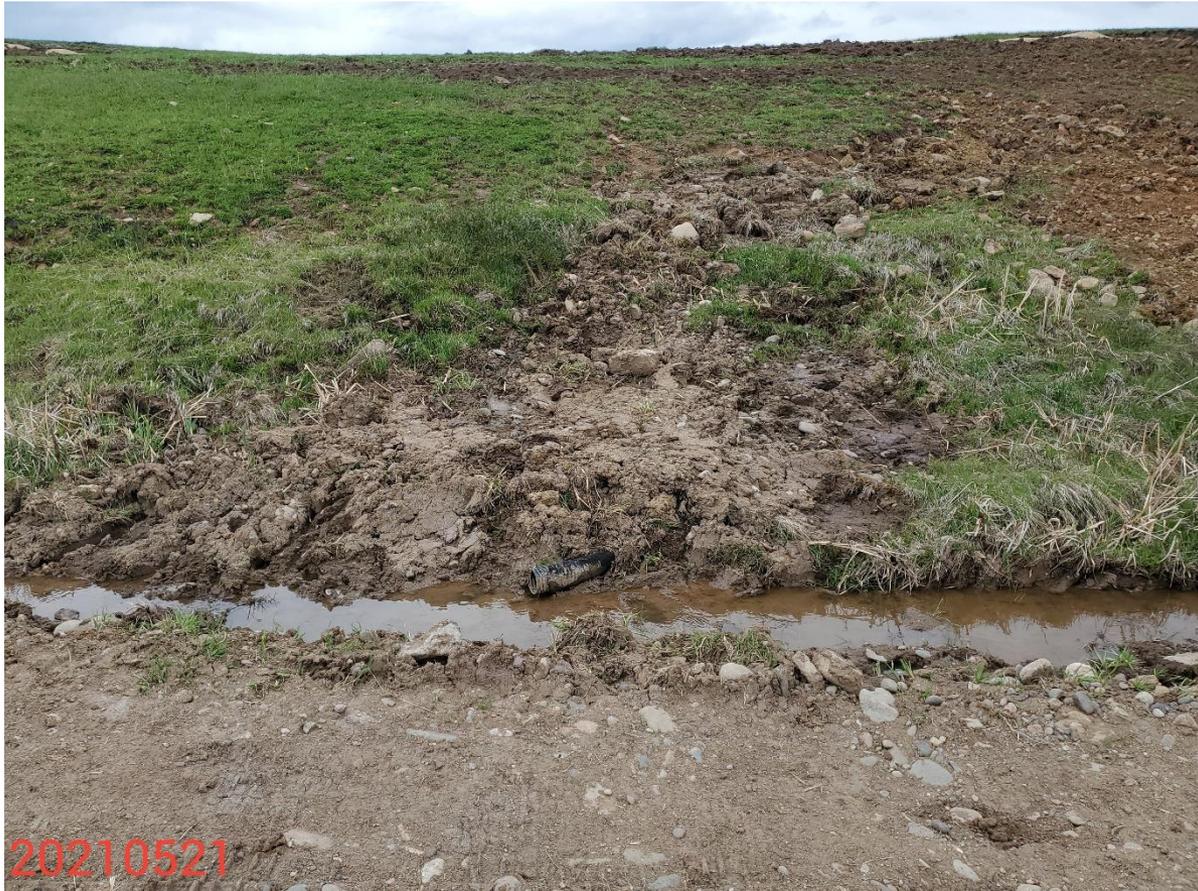
**Photo 7:** Photo taken from the north end of the Location, facing north. Photo shows control measures to protect/stabilize slopes and disturbed areas of the Location remain missing or insufficient. Unable to find evidence that revegetation activities were performed, and BMPs to stabilize seeded soils implemented.

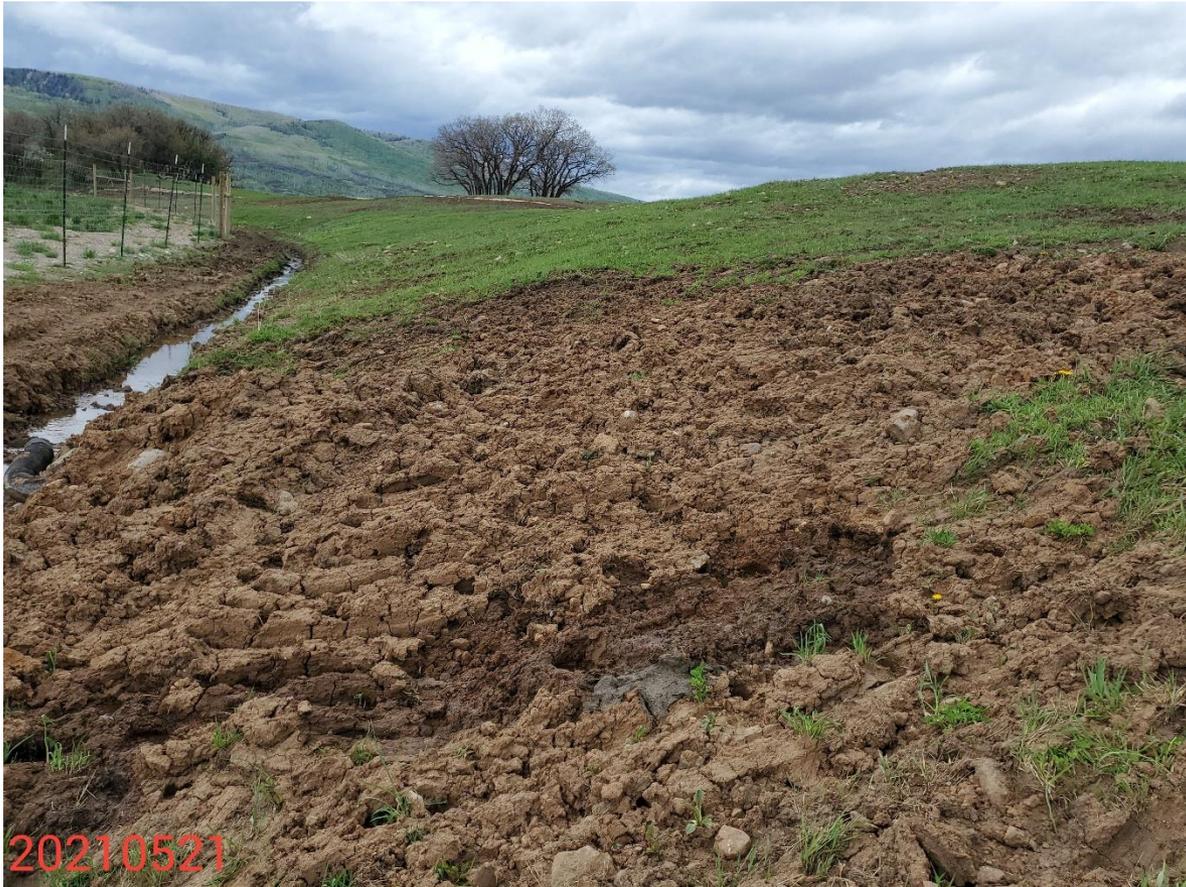
**Photo 8:** Photo taken from the north end of the Location, facing west. Photo shows control measures to protect/stabilize slopes and disturbed areas of the Location remain missing or insufficient. Unable to find evidence that revegetation activities were performed, and BMPs to stabilize seeded soils implemented.

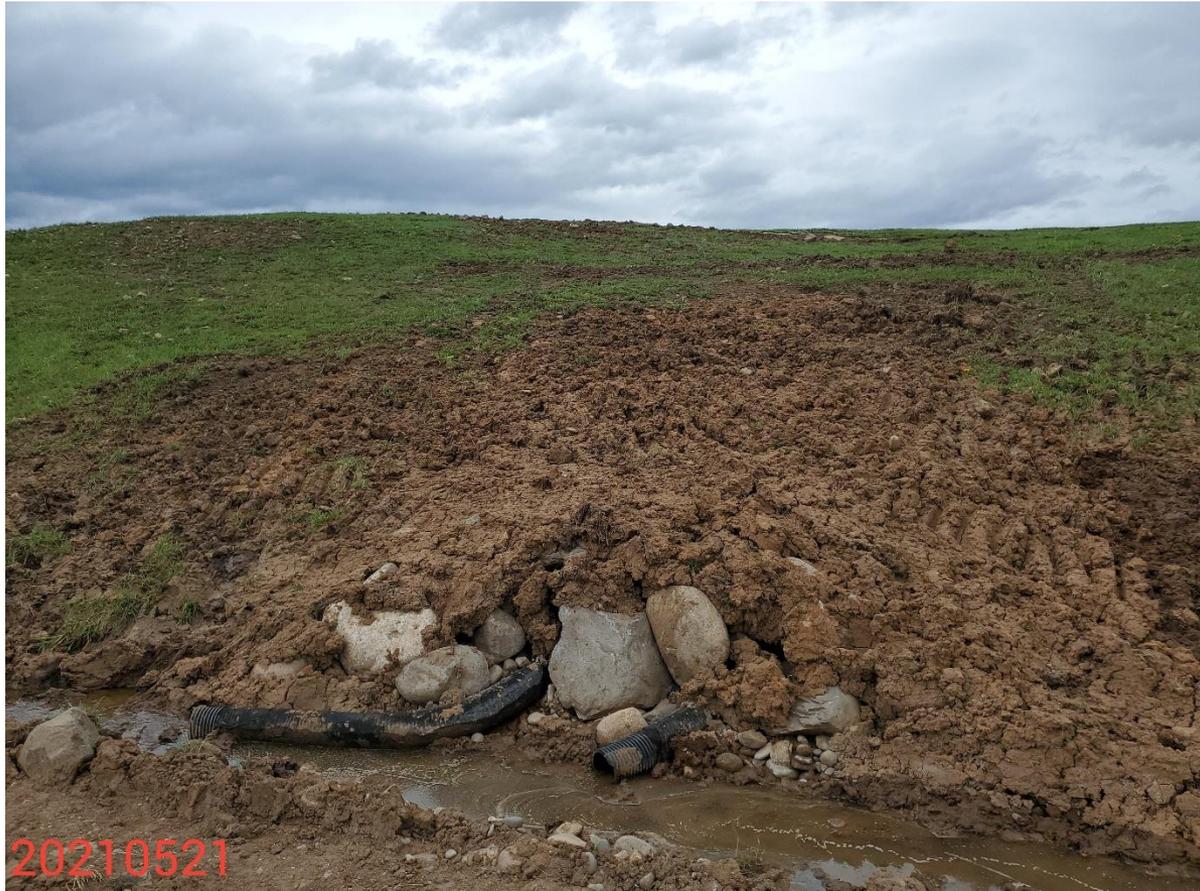
**Photo 9:** Photo taken from the north end of the Location, facing north. Photo shows control measures to protect/stabilize slopes and disturbed areas of the Location remain missing or insufficient. Unable to find evidence that revegetation activities were performed, and BMPs to stabilize seeded soils implemented.

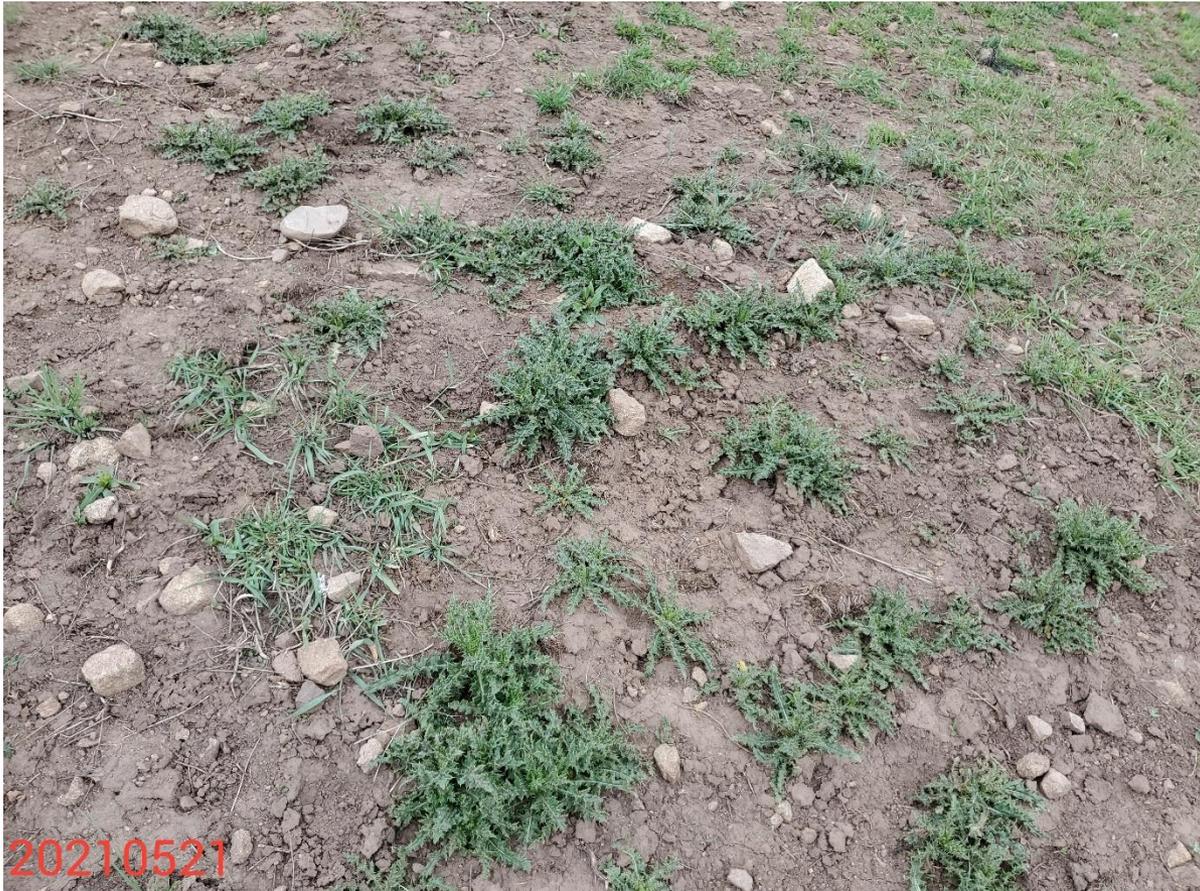
**Photo 10:** Photo taken from the north end of the Location. Photo show example of Canada thistle rosettes observed on the Location.

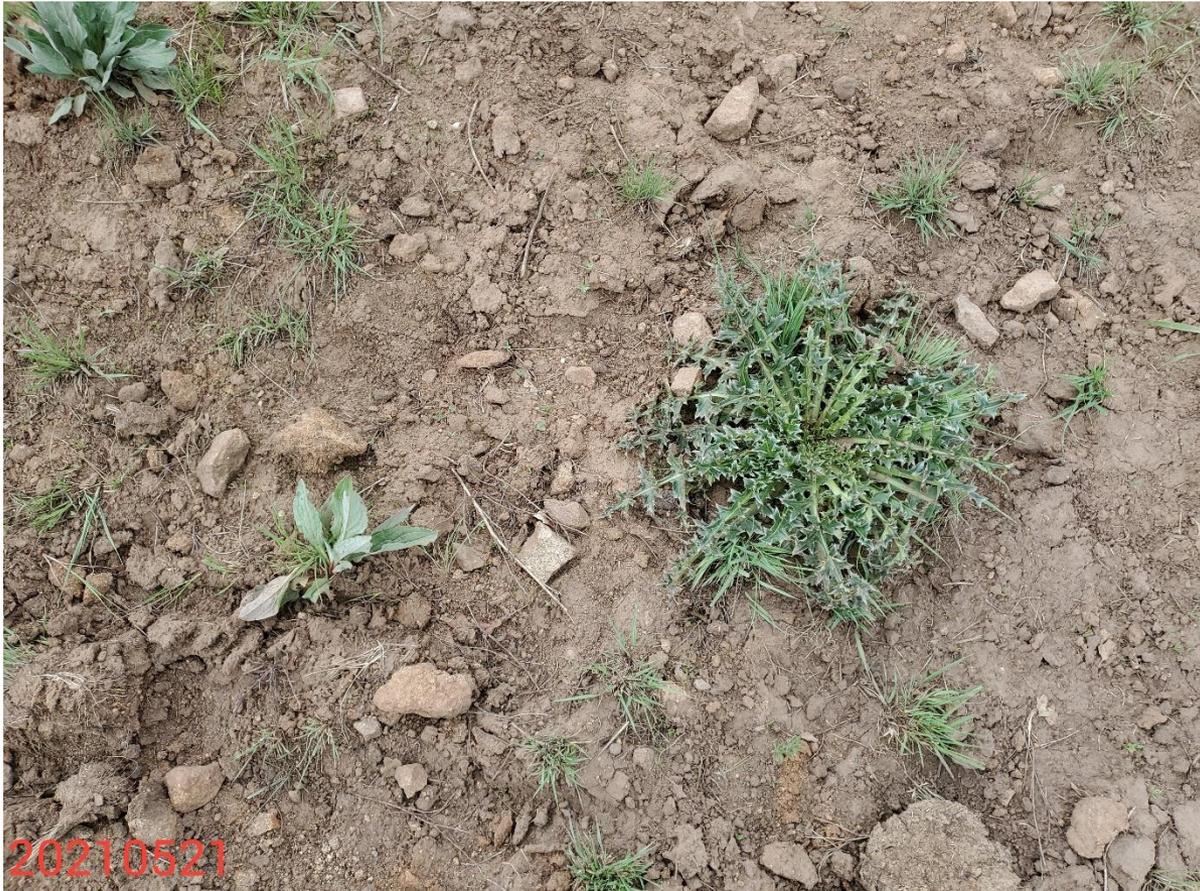
**Photo 11:** Photo taken from the north end of the Location. Photo show example of Houndstongue, and what appears to be Musk thistle rosettes observed on the Locaiton.

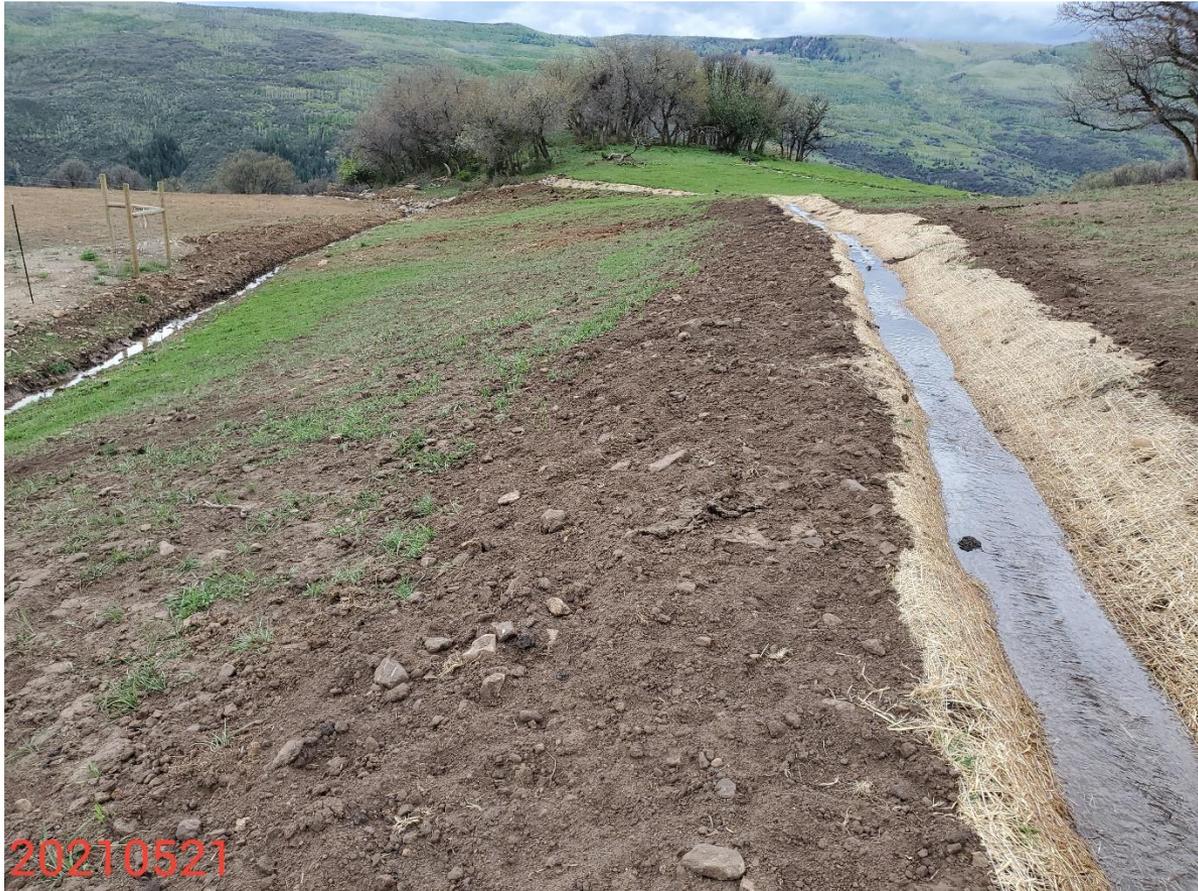
**Photo 12:** Photo taken from the north end of the Location, facing west. Photo shows stormwater diversion ditch constructed along perimeter of the Location.

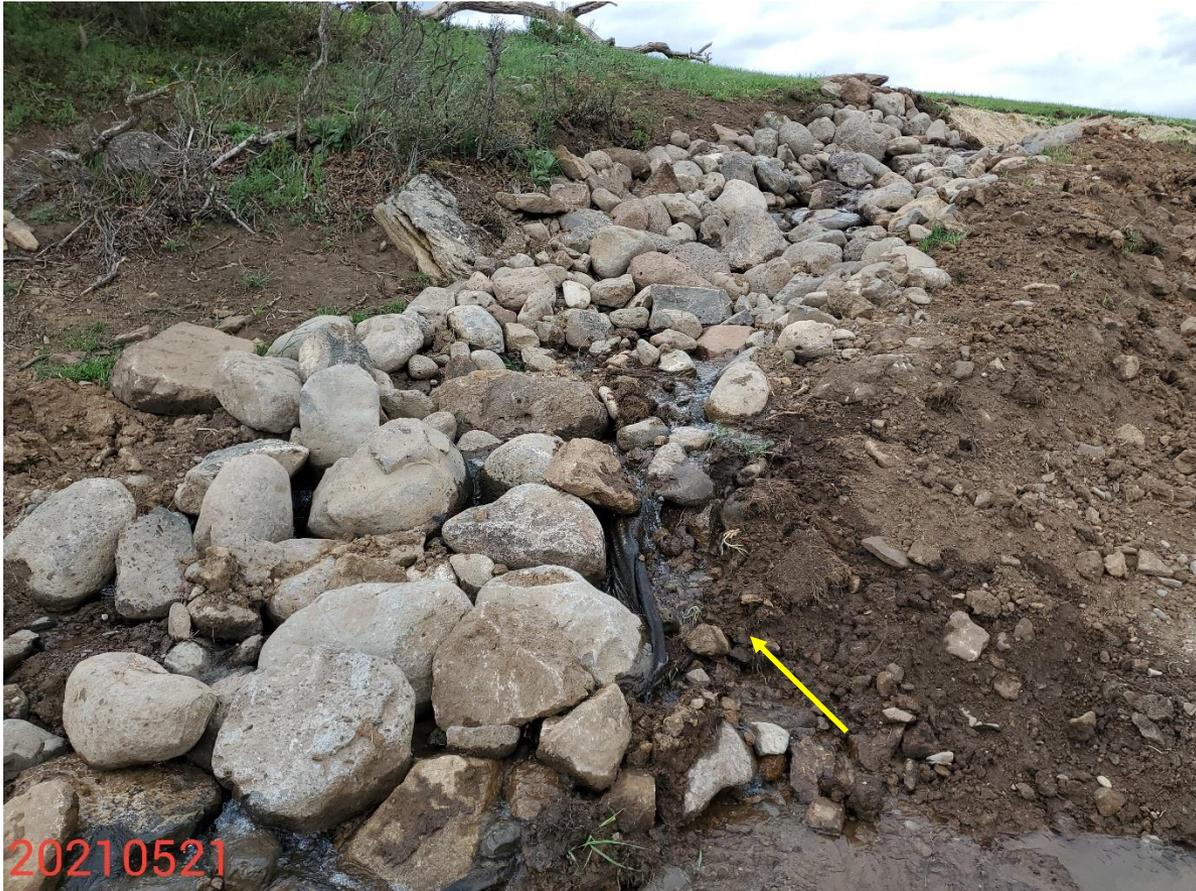
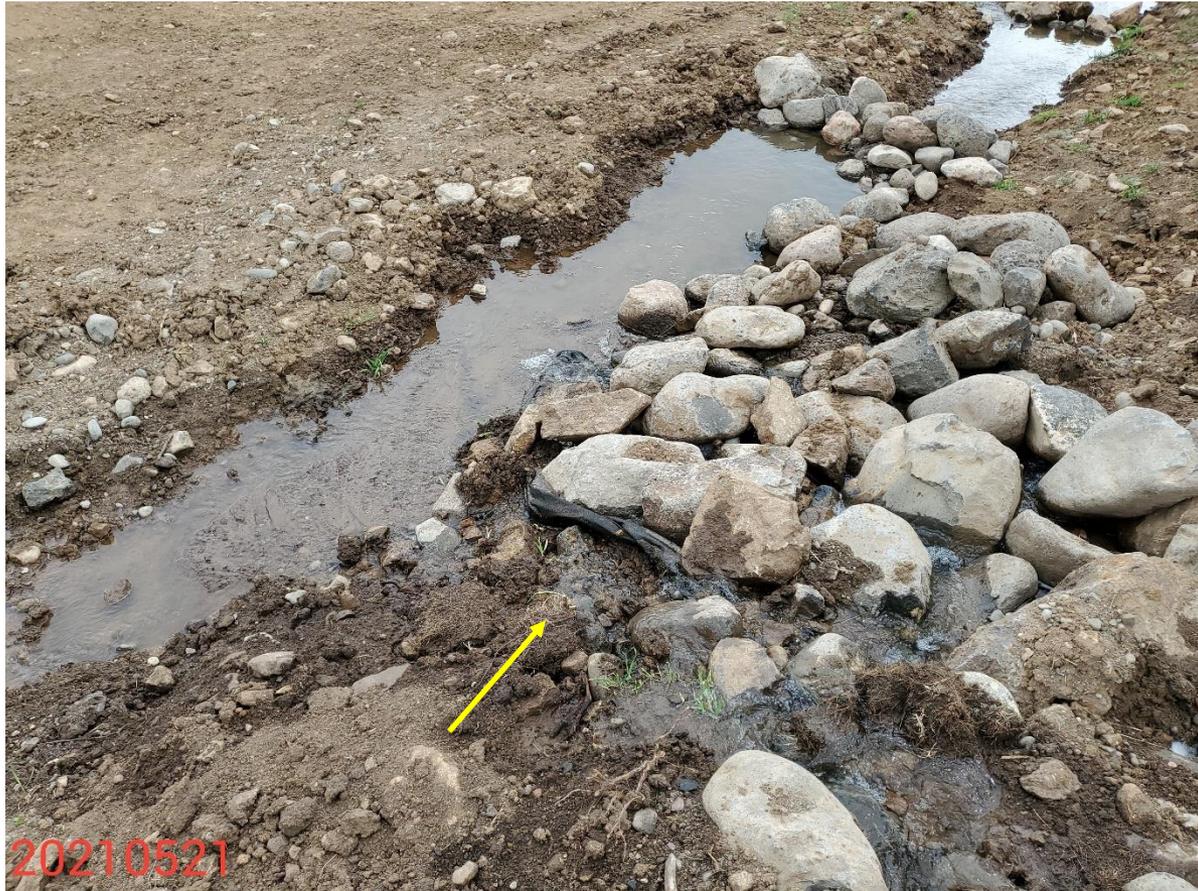
**Photo 13:** Photo taken from the northwest corner of the Location, facing north. Photo shows armored section of the Location's perimeter stormwater diversion; control measure inadequate/not in proper functioning condition; stormwater observed scouring/degrading around armor and geotextile lining.

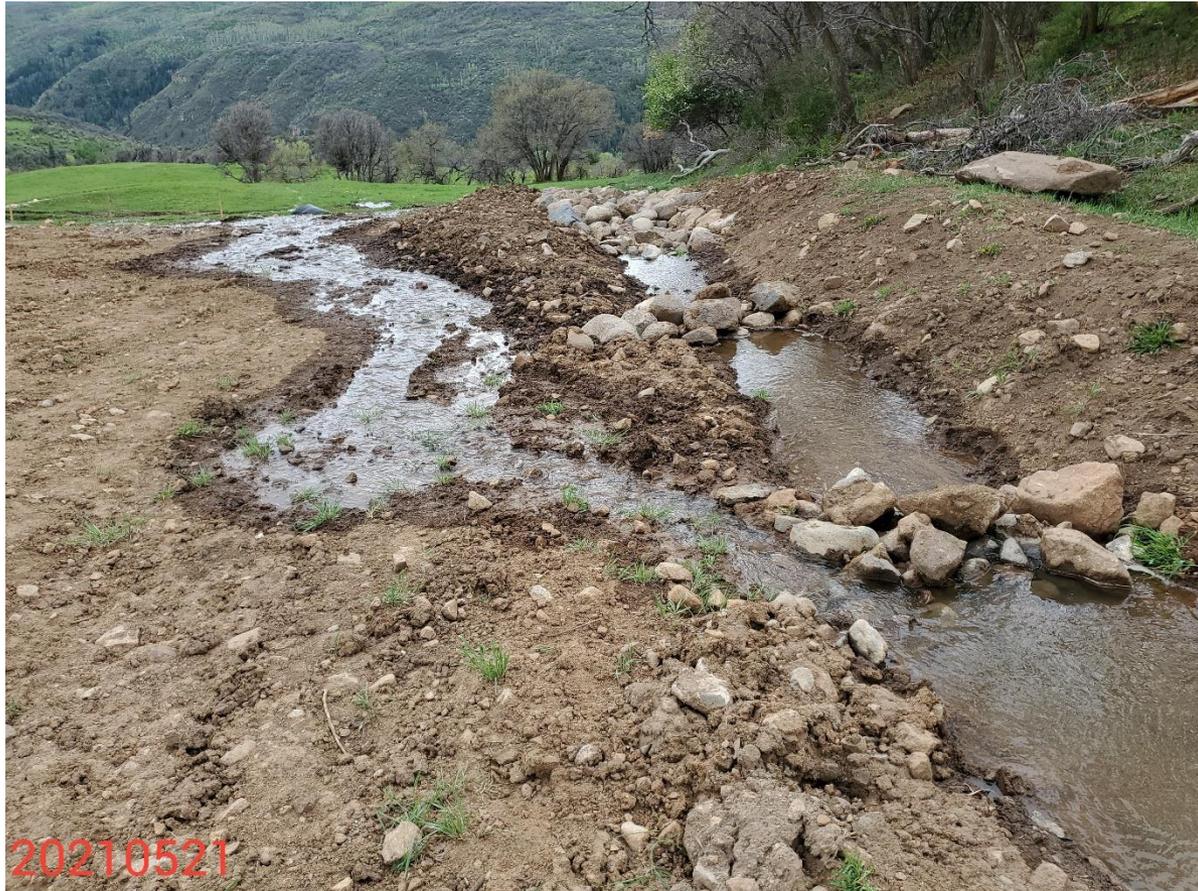
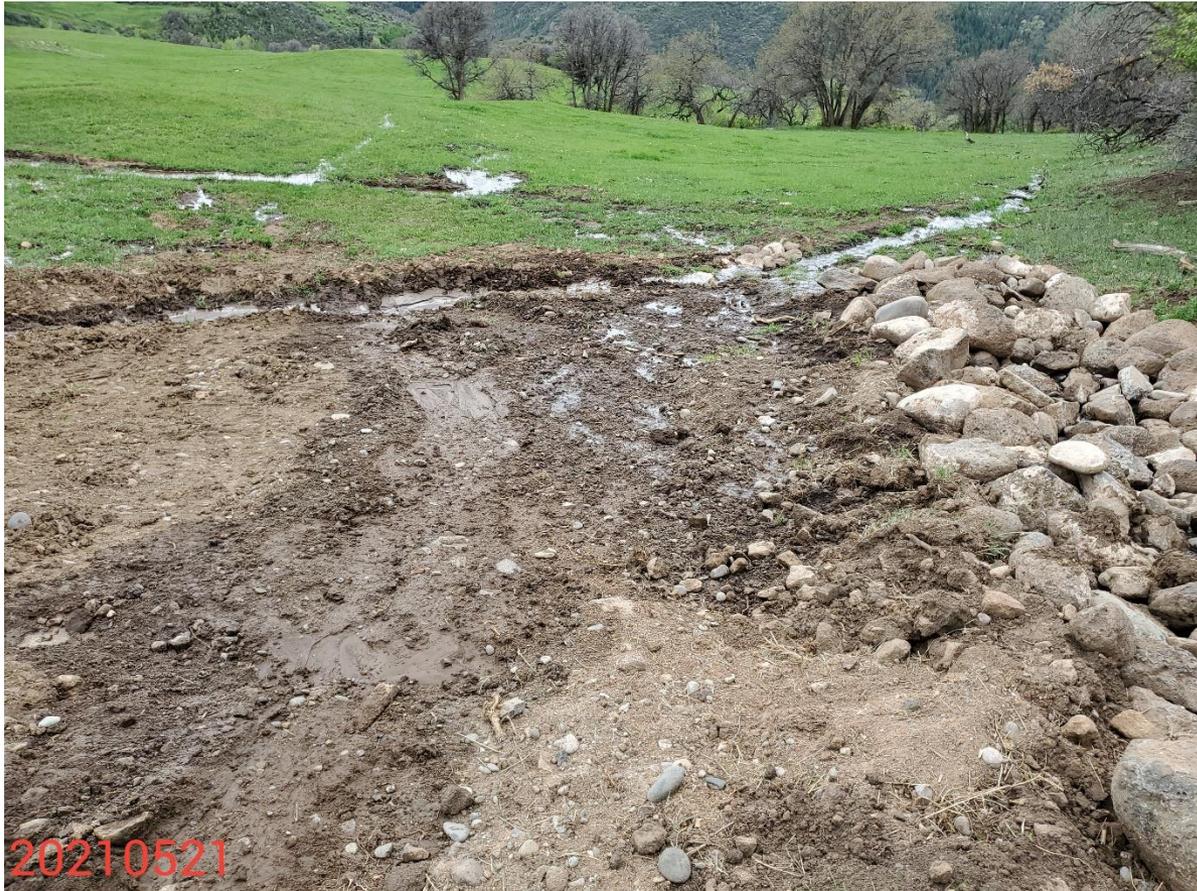
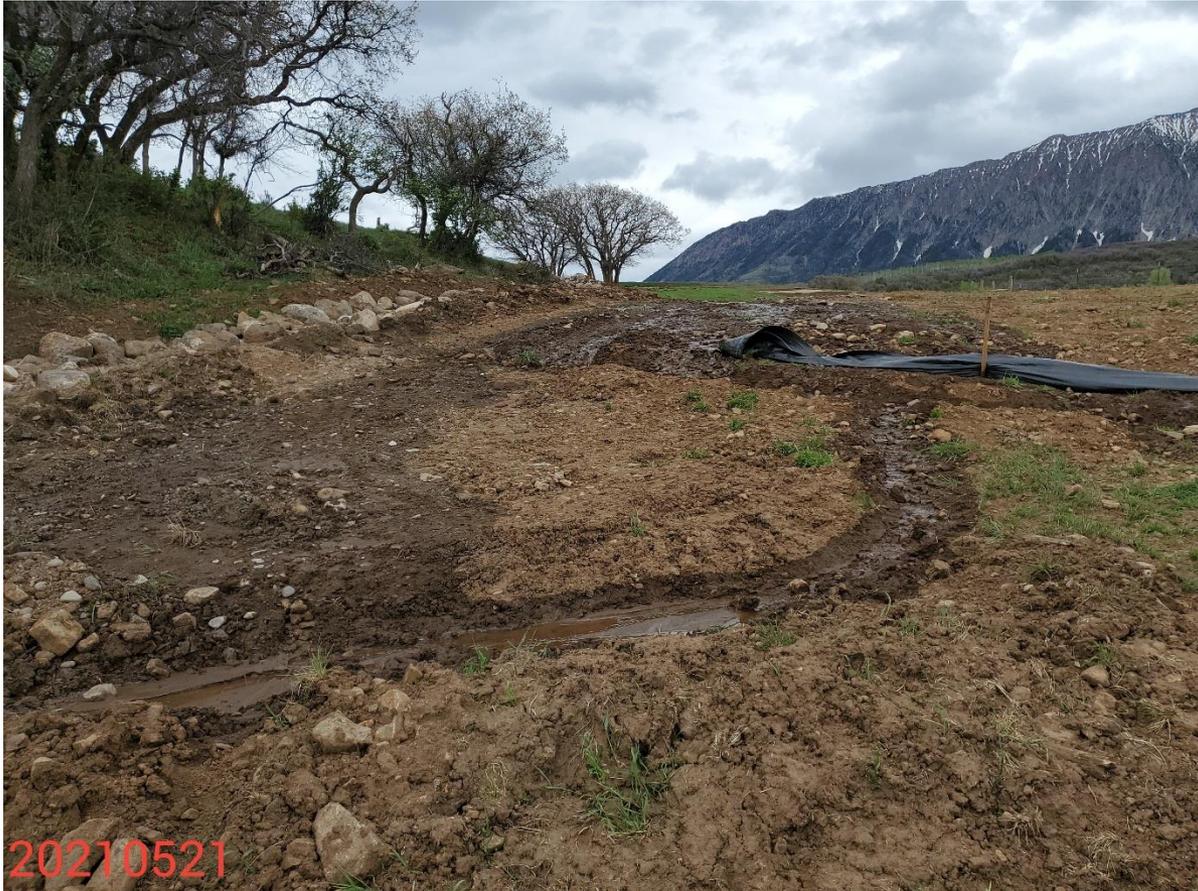
**Photo 15:** Photo taken from the stormwater diversion ditch on the northwest end of the Location, facing west. Photo shows perimeter stormwater diversion ditch installed on Location is inadequate/insufficient for the site's conditions; ditch not in proper functioning condition; stormwater has breached ditch resulting in additional stormwater erosion degradation.

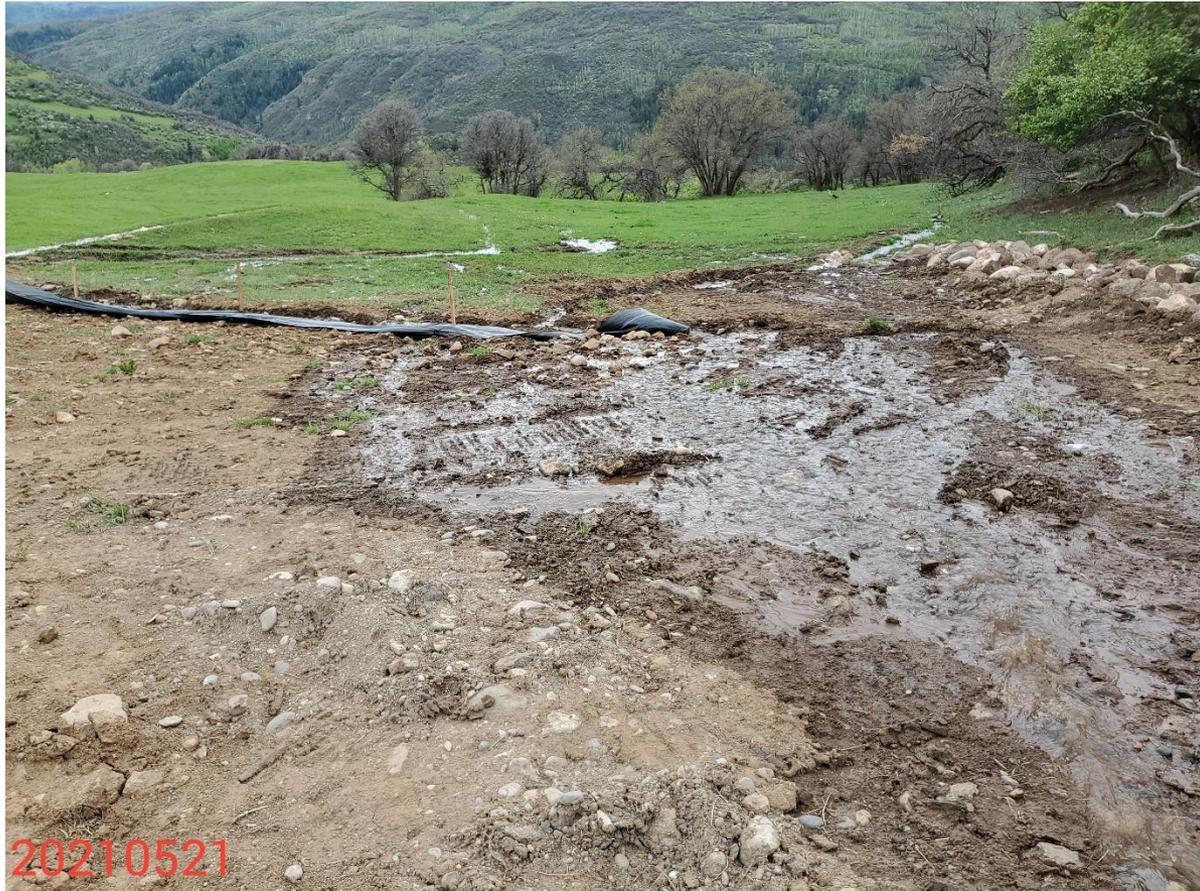
**Photo 16:** Continued from photo 15. Photo shows runoff from the ditch. Photo also shows silt fence along the western perimeter of the Location is inadequate and not in proper functioning condition.

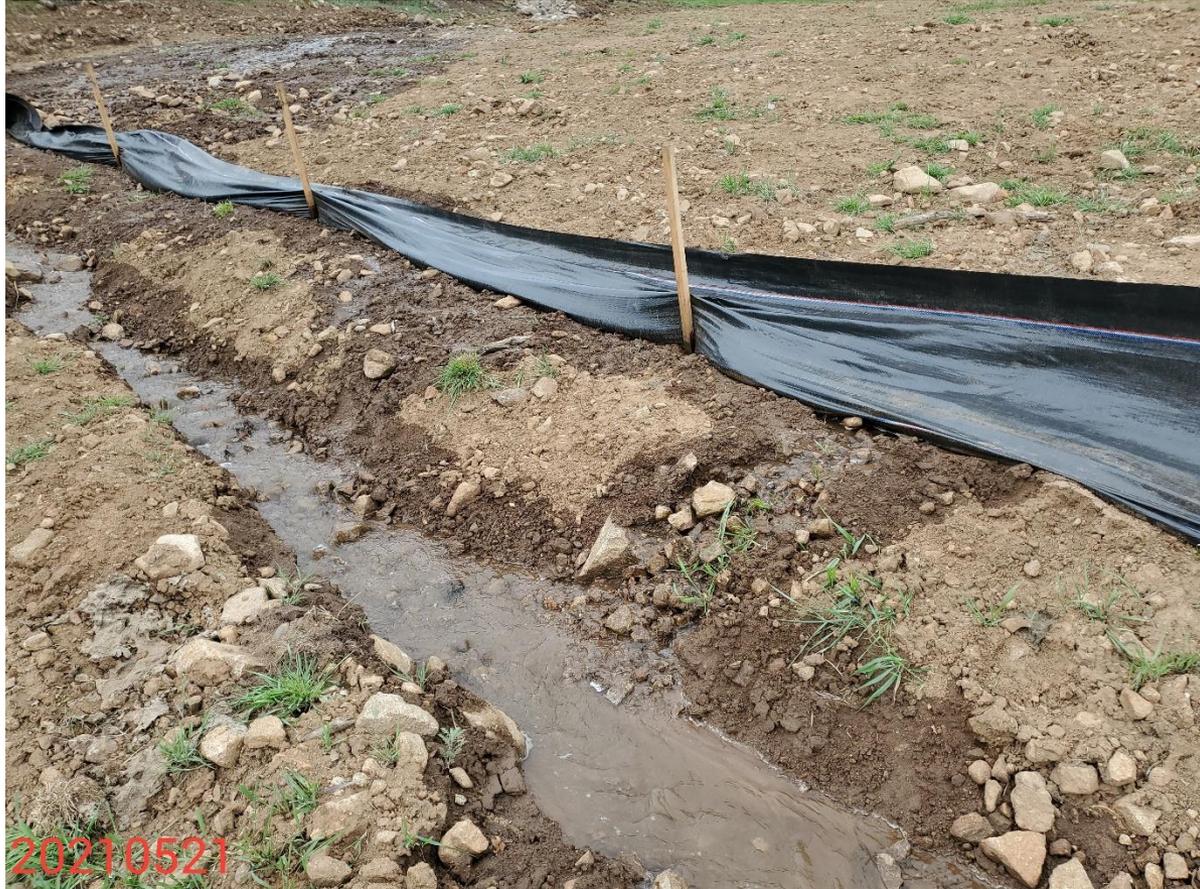
**Photo 19:** Photo shows silt fence along the western perimeter of the Location is inadequate and not in proper functioning condition.

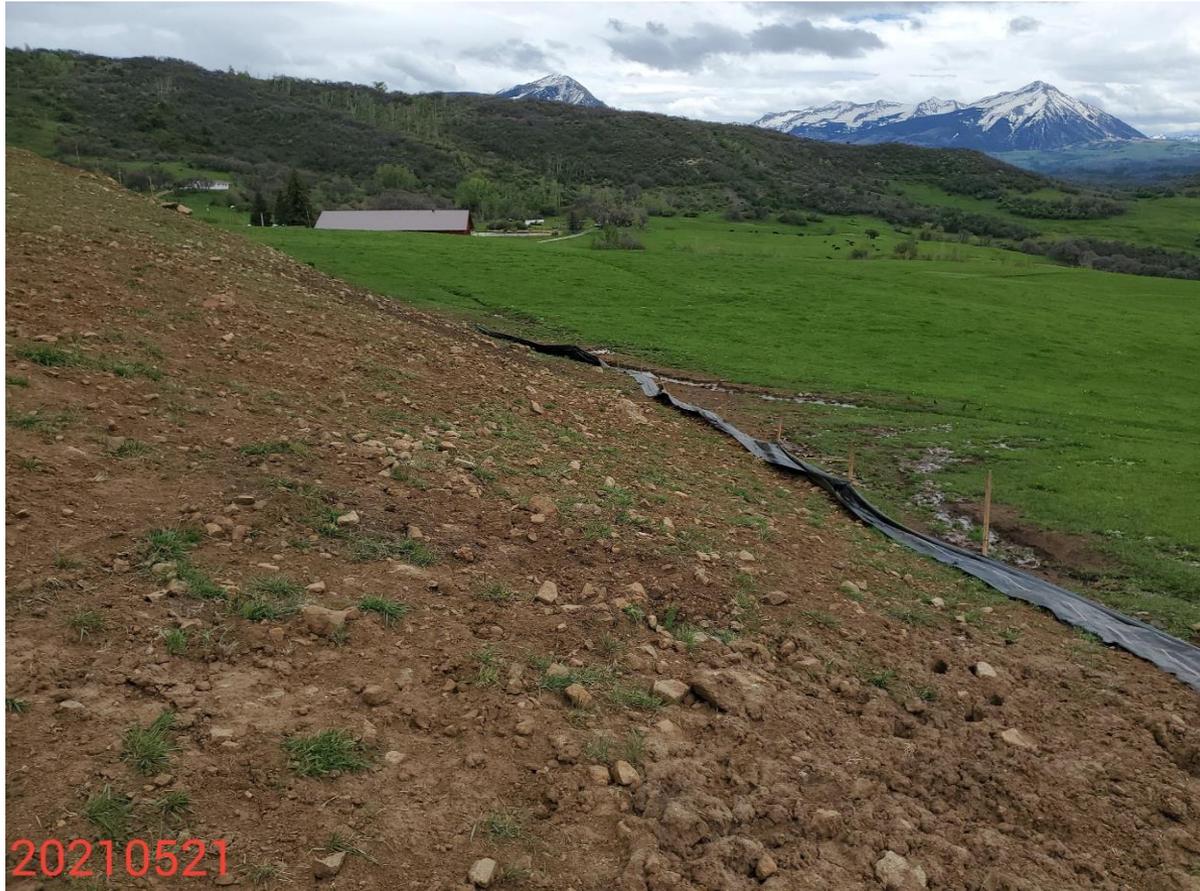
**Photo 20:** Photo shows silt fence along the western perimeter of the Location is inadequate and not in proper functioning condition.
