# Inspection Photos

5/21/2021

Operator: SG INTERESTS I LTD - 77330

Location ID: 418697

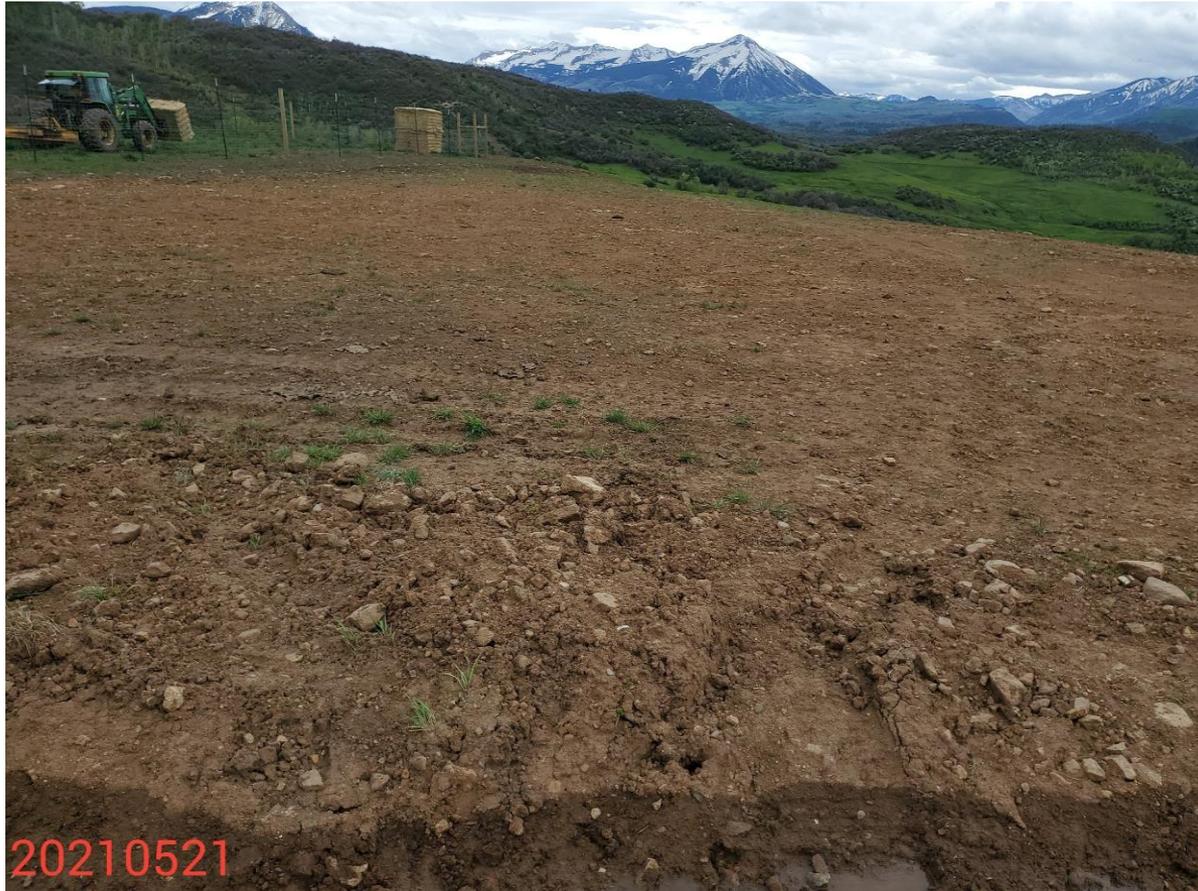
**Photo 21:** Photo taken northwest end of the Location, facing southeast. Photo shows control measures to protect/stabilize slopes and disturbed areas of the Location remain missing or insufficient; unable to find evidence that revegetation activities were performed, and BMPs to stabilize seeded soils implemented.

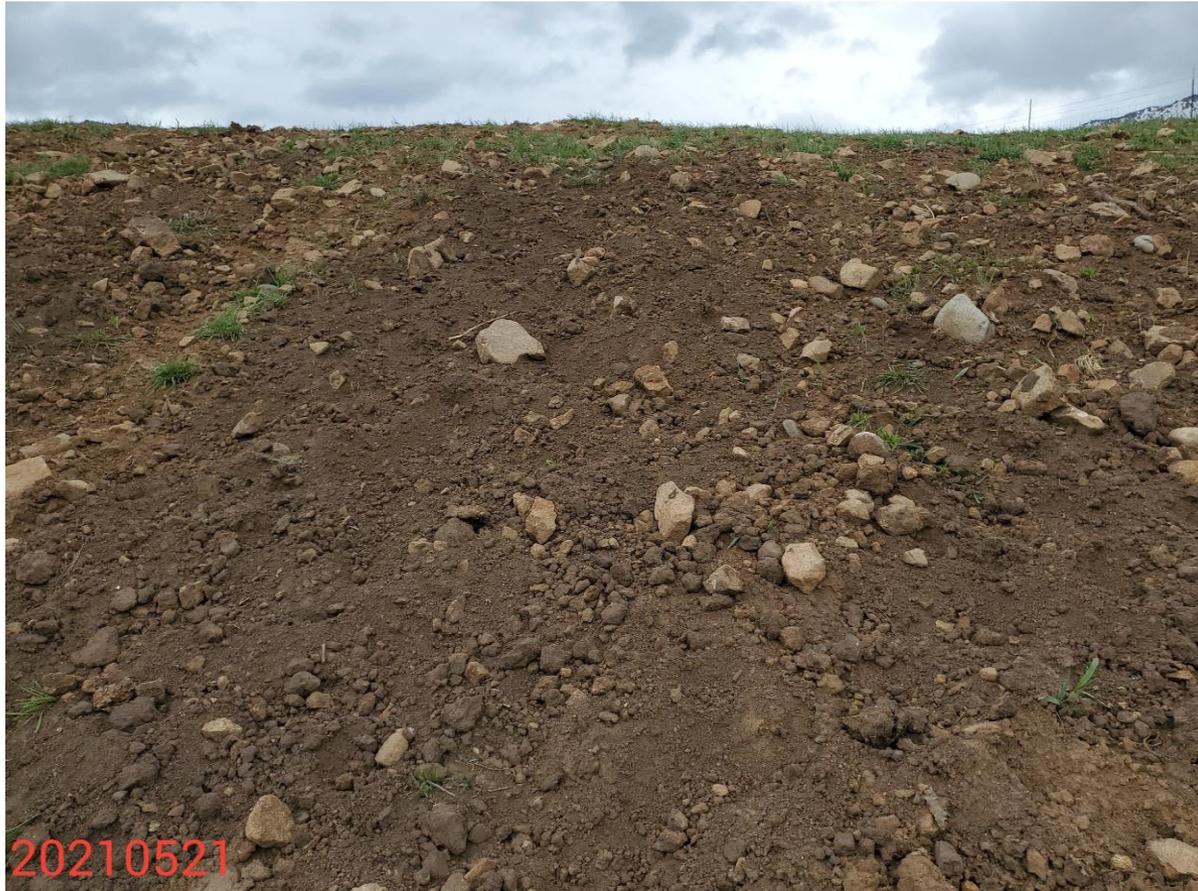
**Photo 22:** Photo taken from the slopes on the southwest end of the Location, facing north. Photo shows control measures to protect/stabilize slopes and disturbed areas of the Location remain missing or insufficient; unable to find evidence that revegetation activities were performed, and BMPs to stabilize seeded soils implemented.

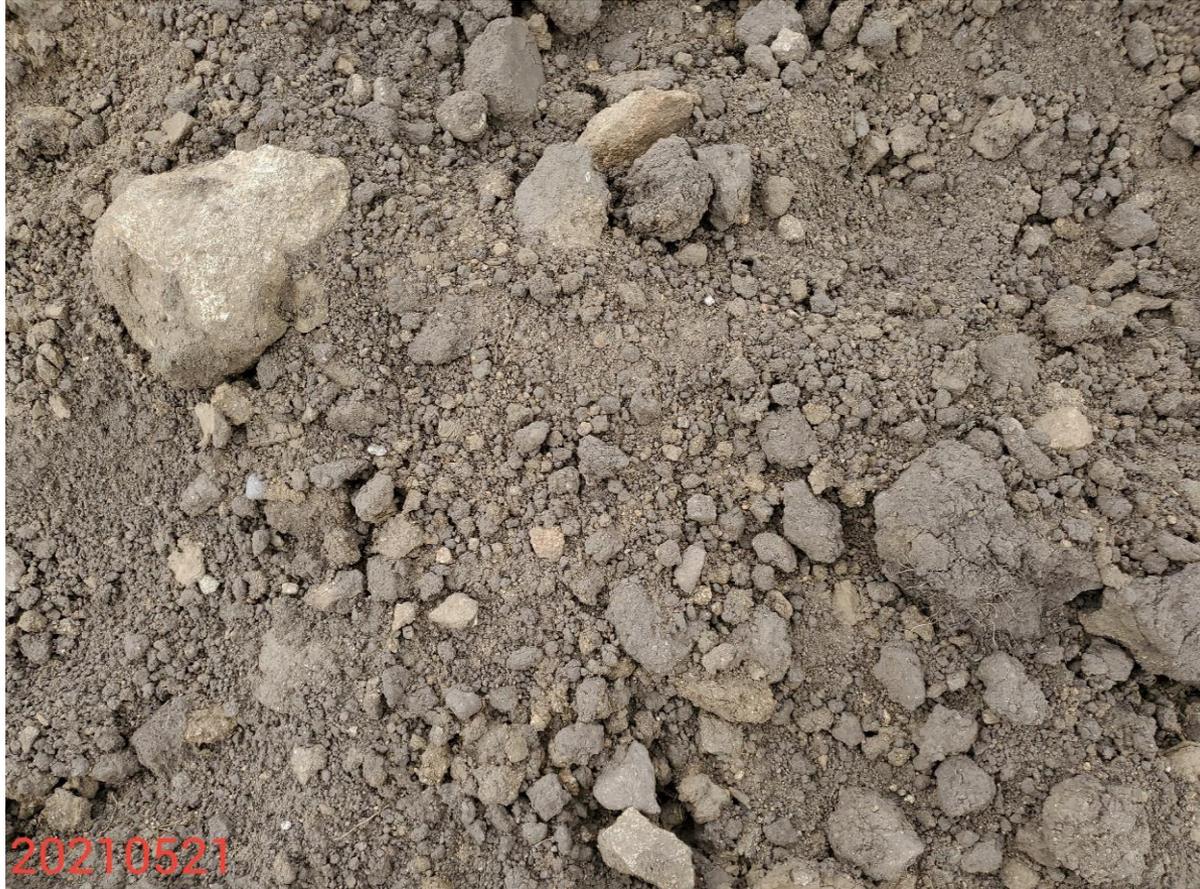
**Photo 23:** Photo taken from the west end of the Location. Photo shows Reclamation Specialist was unable to observe evidence that revegetation activities were performed, or BMPs to protect/stabilize the slopes/disturbed areas/seeded soils installed.

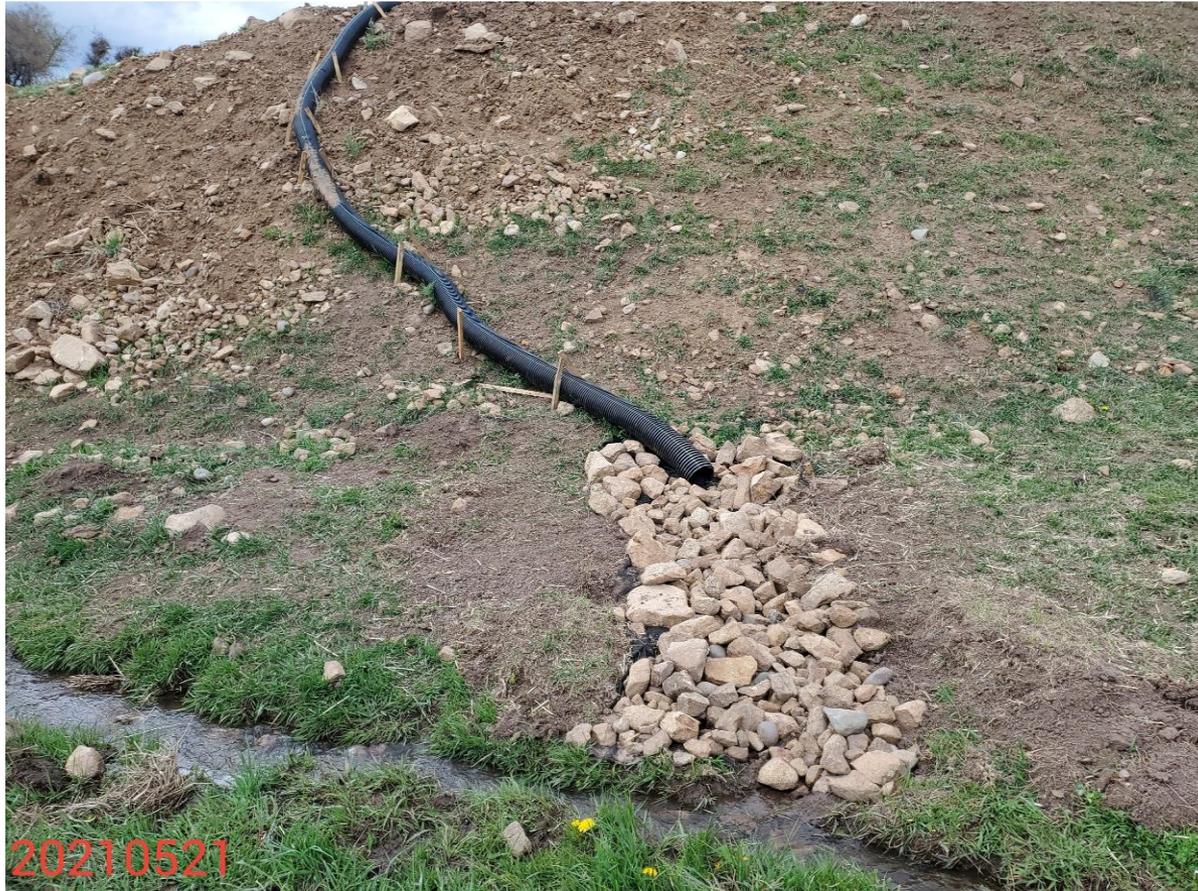
**Photo 24:** Photo taken from the southwest end of the Location, facing north. Photo shows slope drain; unclear if slope drain has been adequately secured. Outlet constructed with geotextile lining and rip-rap armor.

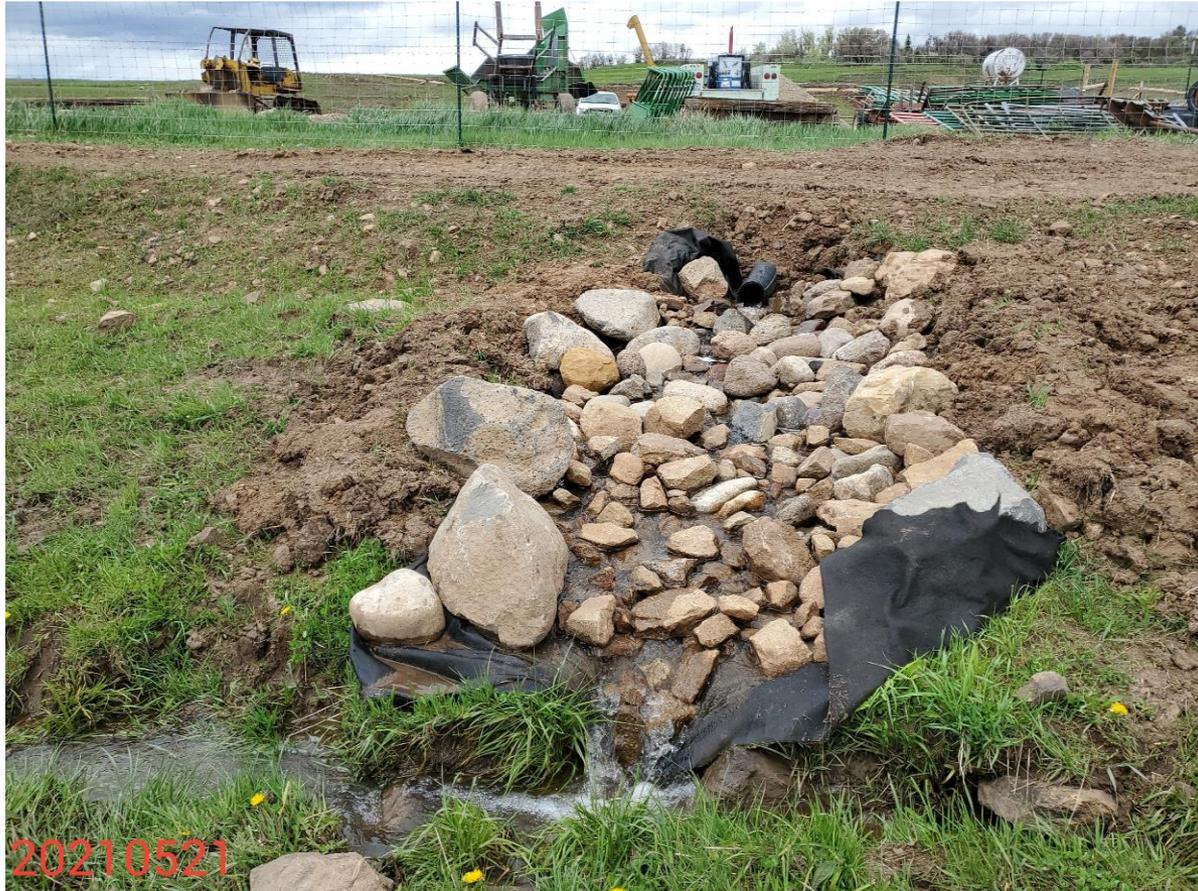
**Photo 25:** Photo taken from the ditch on the southeast end of the Location. Photo shows outlet protection of the stormwater diversion ditch has not been installed in accordance with good engineering practices; geotextile liner has been laid upon the soil rather than trenched in.
