Inspection Photos
Location Name: Spicer 3-32H
Location ID: 324754

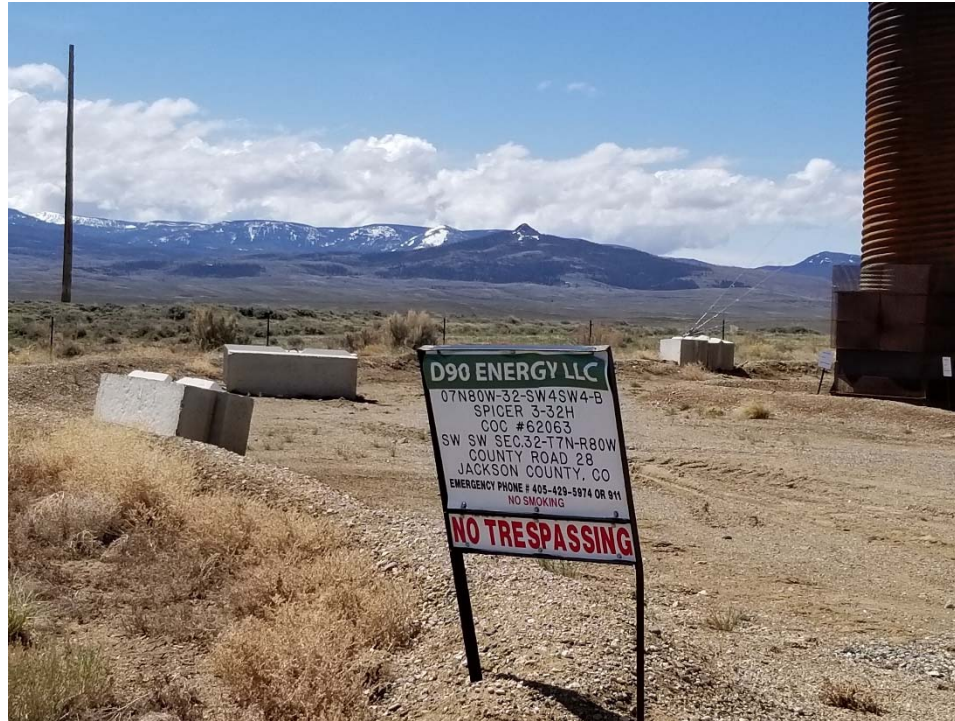
Photo 1. Battery sign at entrance incomplete.

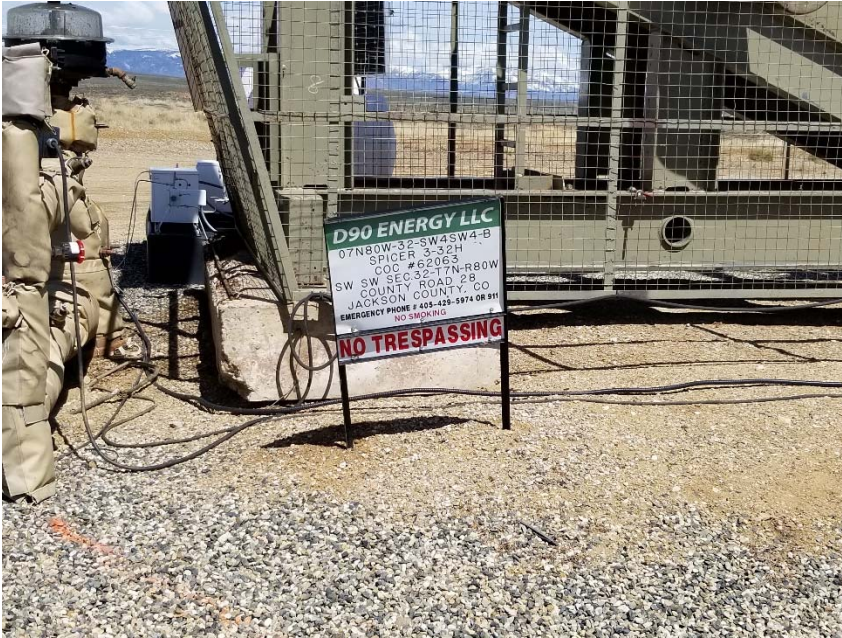
Photo 2. Wellhead sign incomplete/inaccurate.

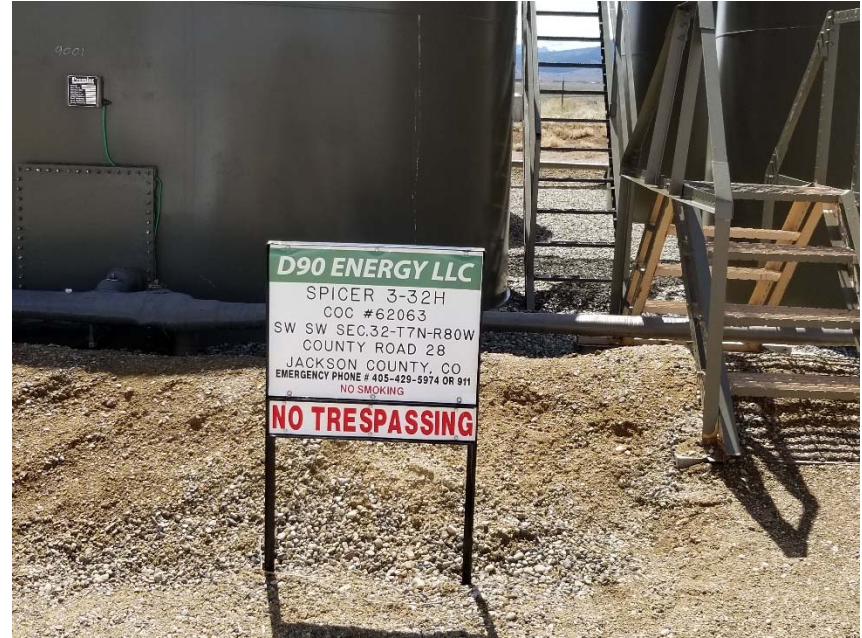
Photo 3. Tank battery sign at battery incomplete/inaccurate.

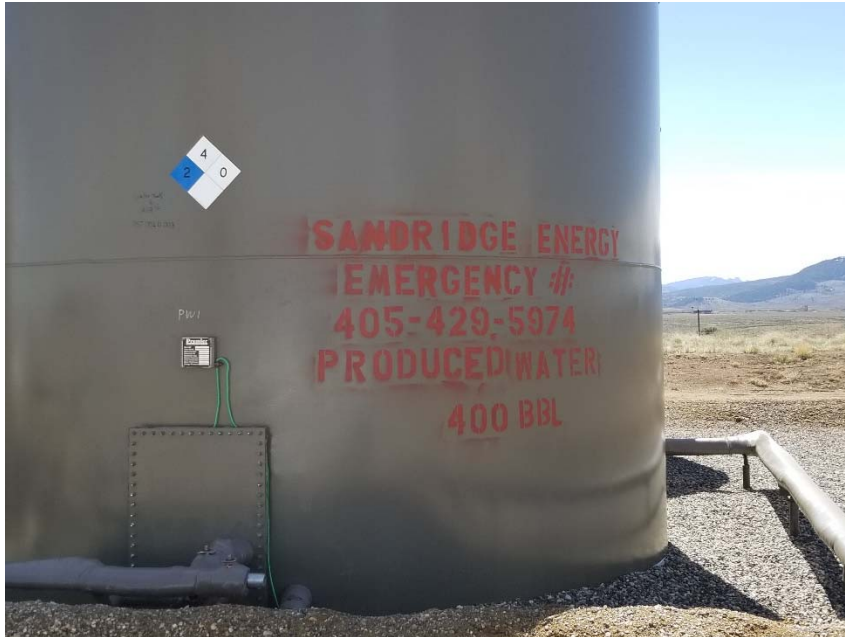
Photo 4. Tank label incomplete/inaccurate.

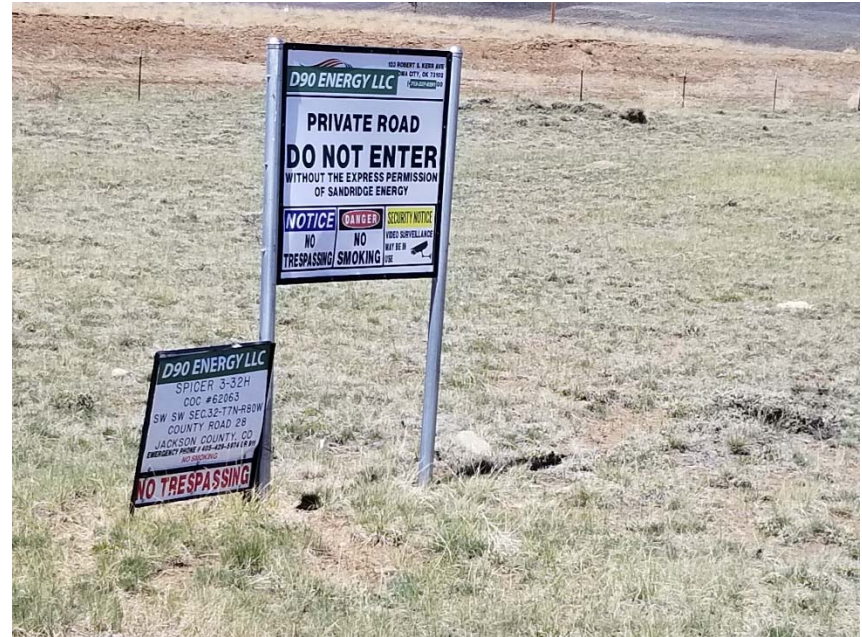
Photo 5. Sign at entrance incomplete/inaccurate.
