Inspection Photos
Location Name: Surprise Unit 0680 S9
Location ID: 445005

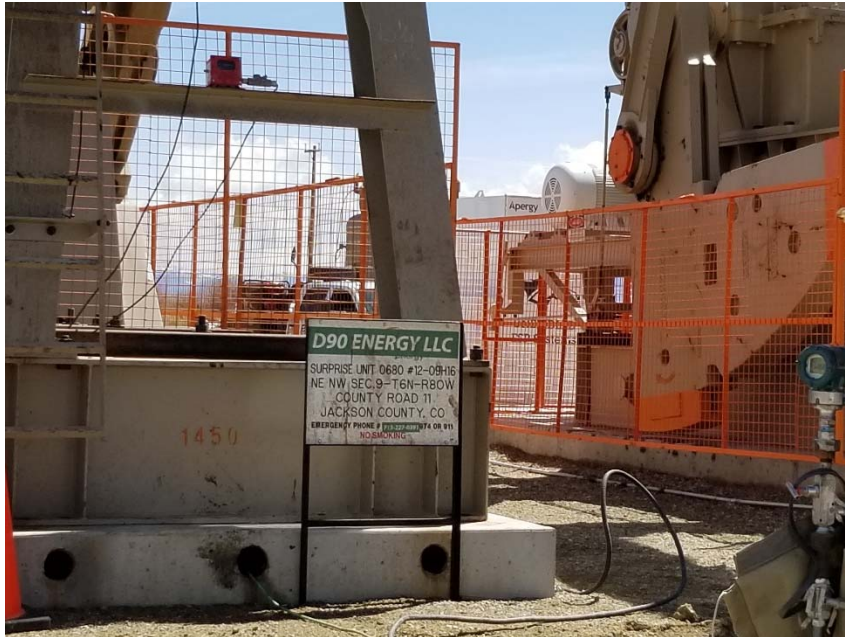
Photo 1. Wellhead sign incomplete/inaccurate.

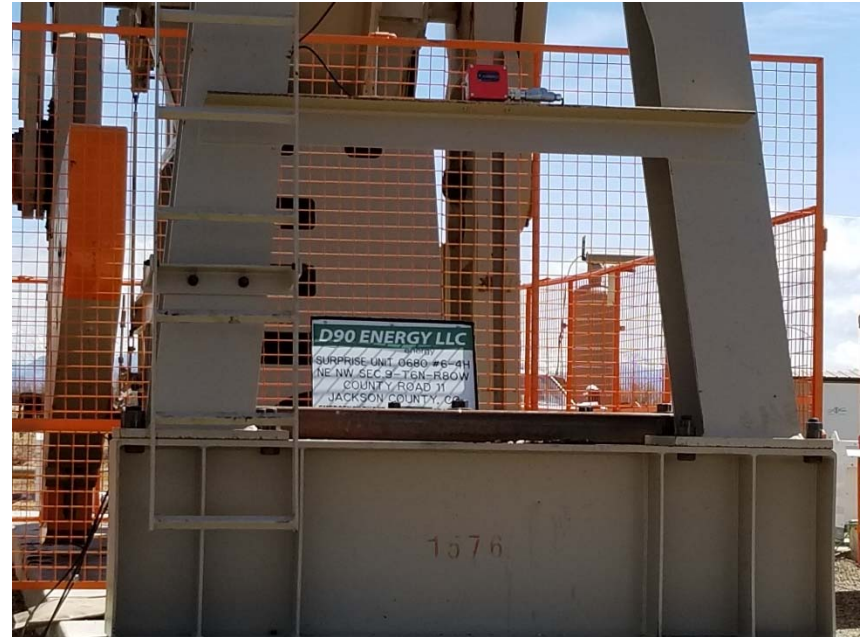
Photo 2. Wellhead sign incomplete/inaccurate.

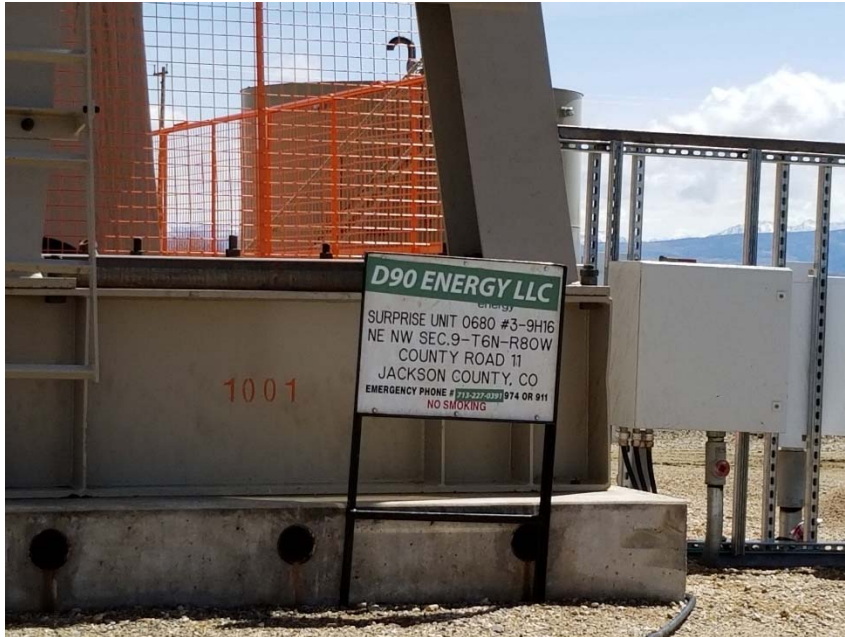
Photo 3. Wellhead sign incomplete/inaccurate.

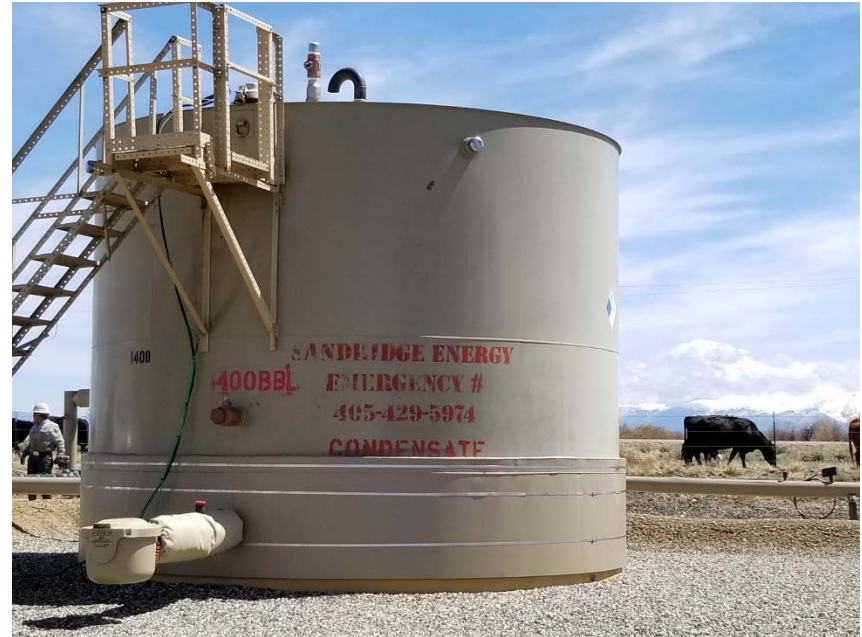
Photo 4. Tank label inaccurate.
