Inspection Photos
Location Name: Energy Minerals Unit B#1
Location ID: 318873

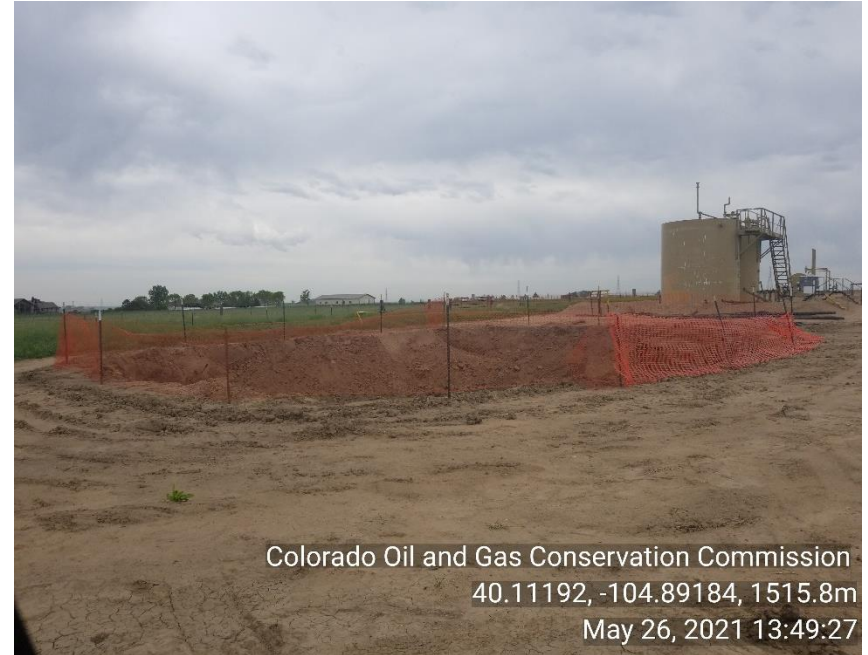
Photo 2 open spill remediation still open.
