Construction and Stormwater Inspection

May 19, 2021

Operator: GREAT WESTERN OPERATING COMPANY LLC- #10110

Location ID: 479193

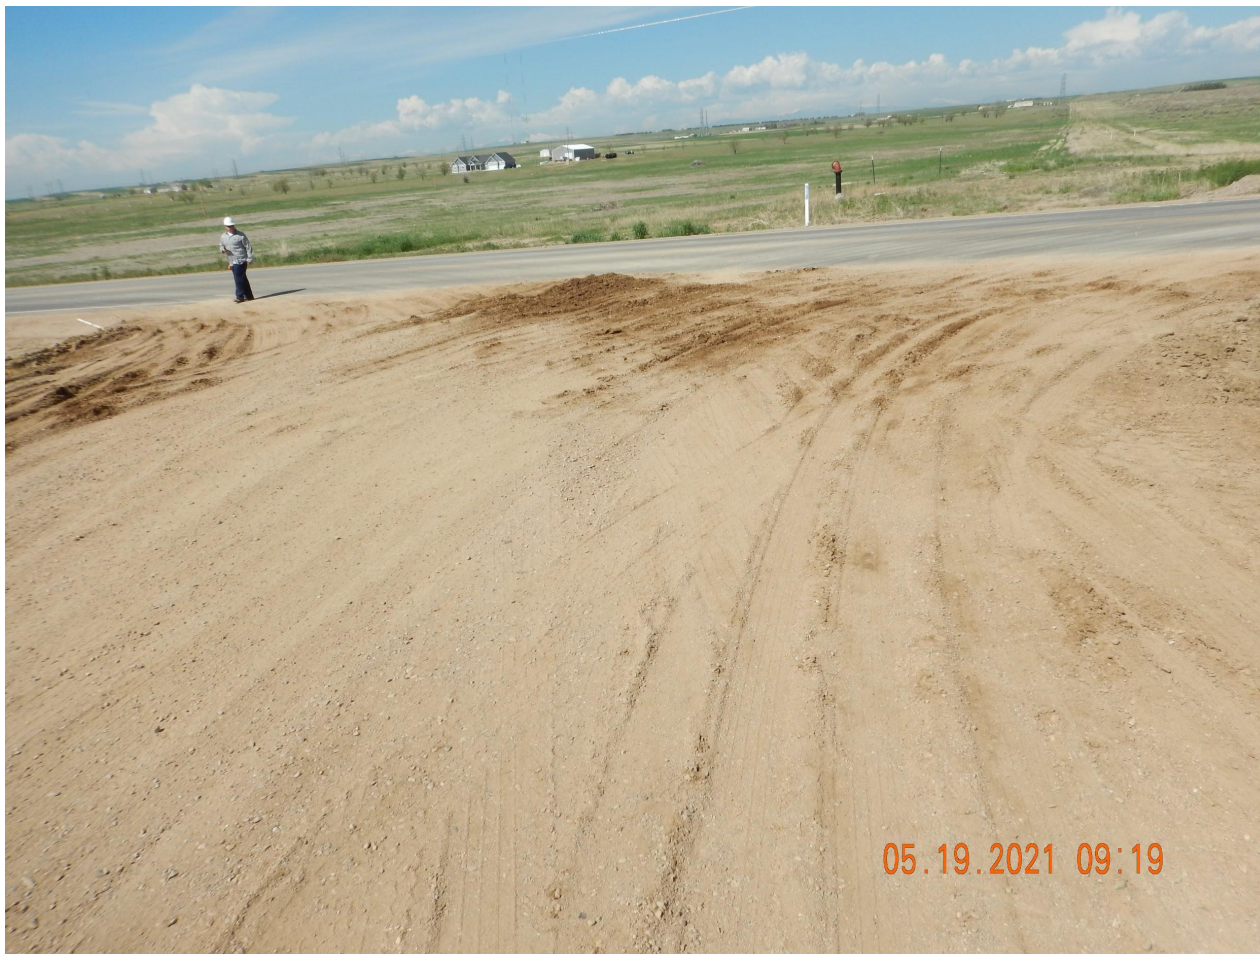
Photo 1. Photo taken from the entrance of location, facing West. Photo illustrates the major vehicle tracking device BMP has still not been installed.

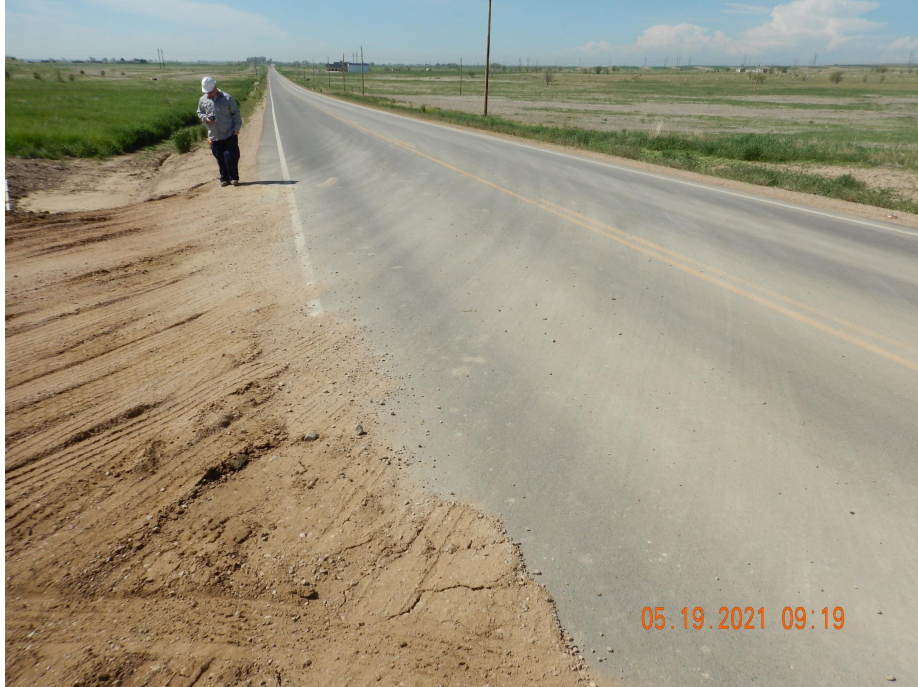
Photo 2. Photo taken from the entrance of location, facing South. Photo illustrates no vehicle track out was observed.

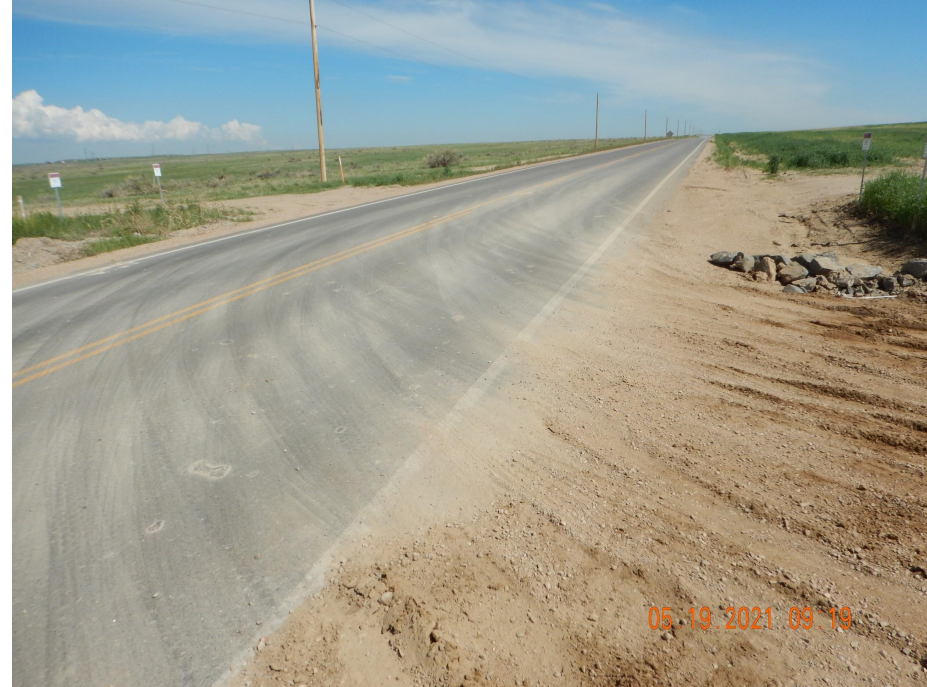
Photo 3. Photo taken from the entrance of location, facing North. See comments under Photo 2.

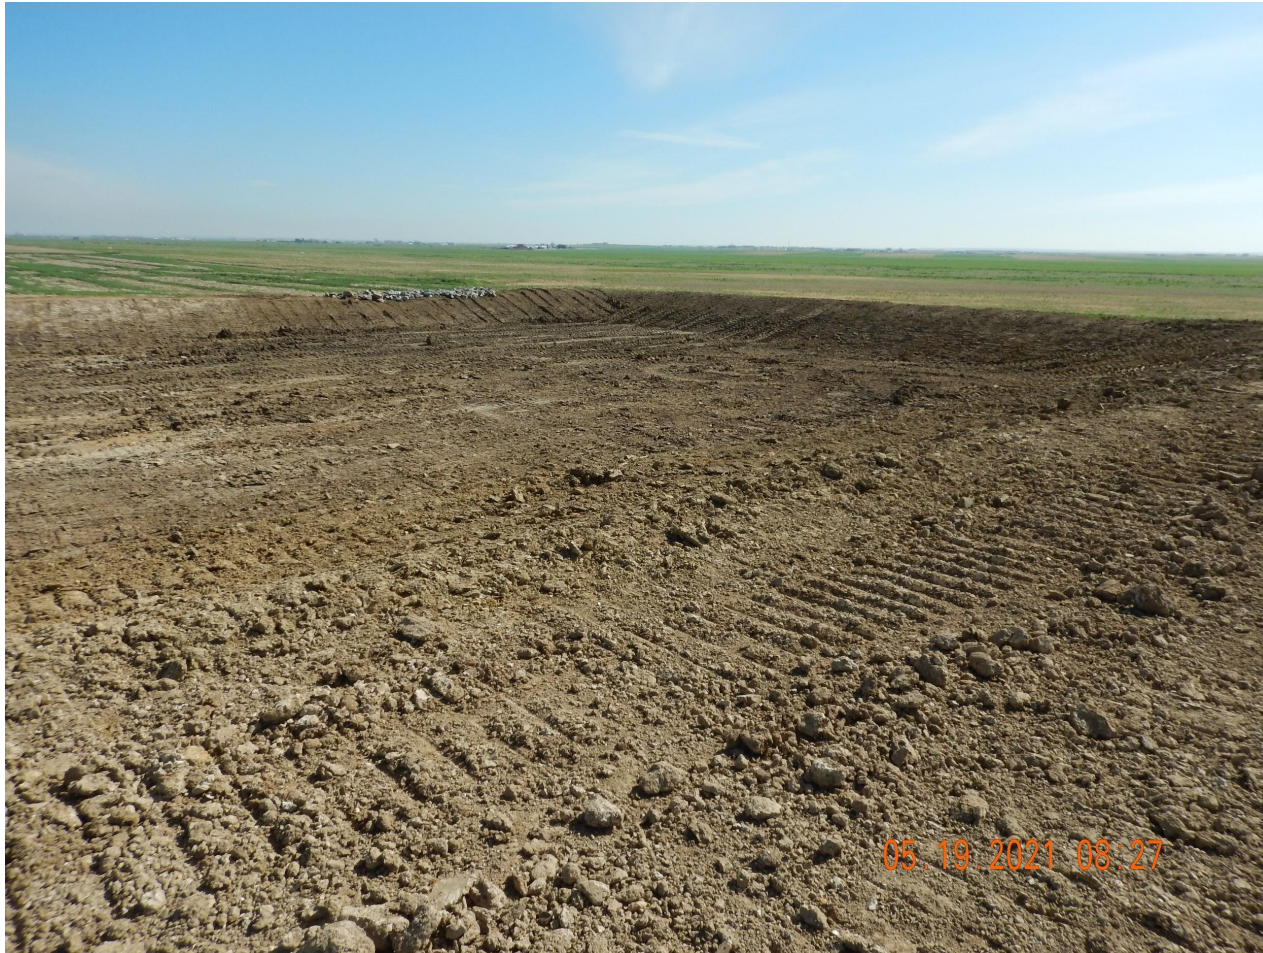
Photo 4. Photo taken from the northeastern location, facing Northeast. Photo illustrates the detention pond has been installed.

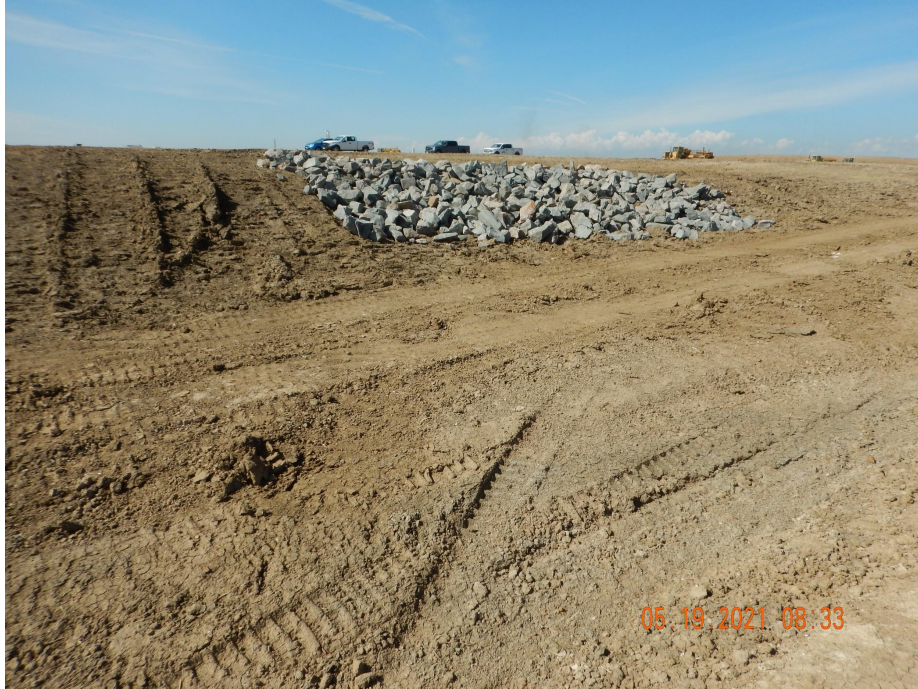
Photo 5. Photo taken from the stabilized outlet of the detention pond, facing Southwest.

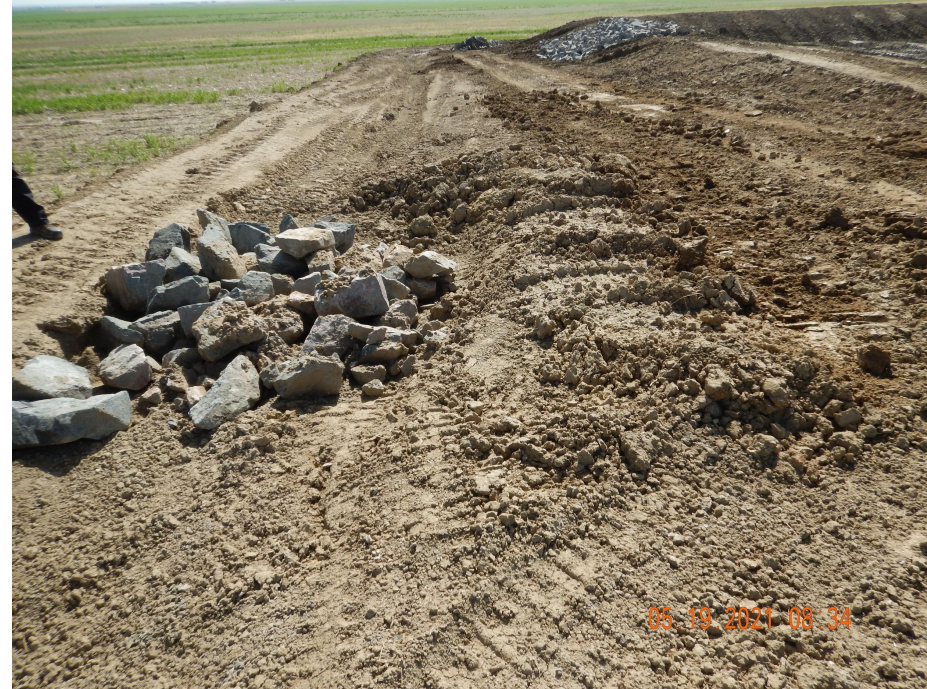
Photo 6. Photo taken from the northeastern location, facing East. Photo illustrates a check dam that is in need of further construction.

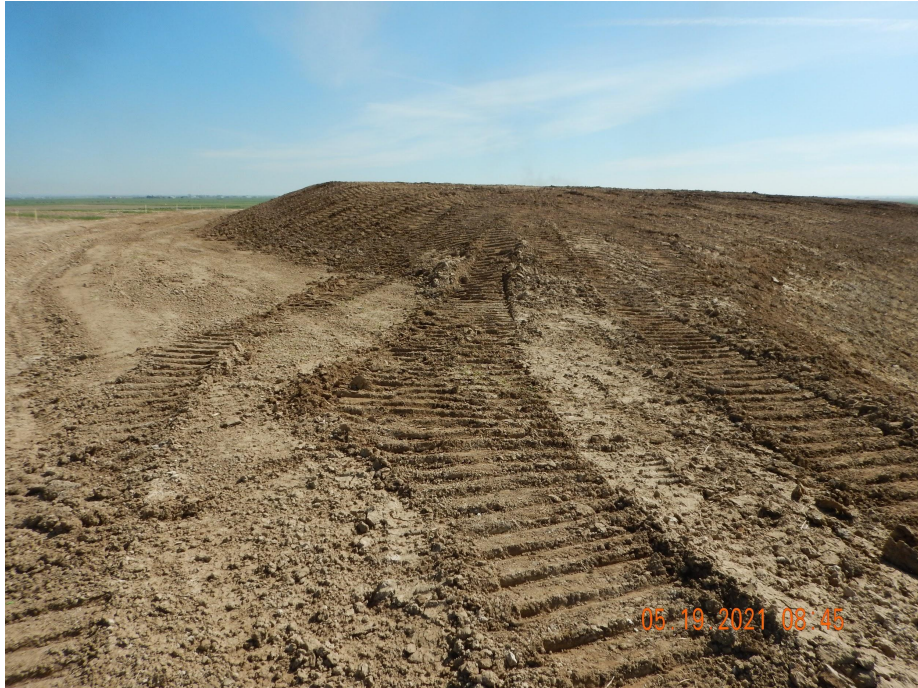
Photo 7. Photo taken from the northwestern location, facing North. Photo illustrates the topsoil stockpile which has been temporarily stabilized with equipment tracking.

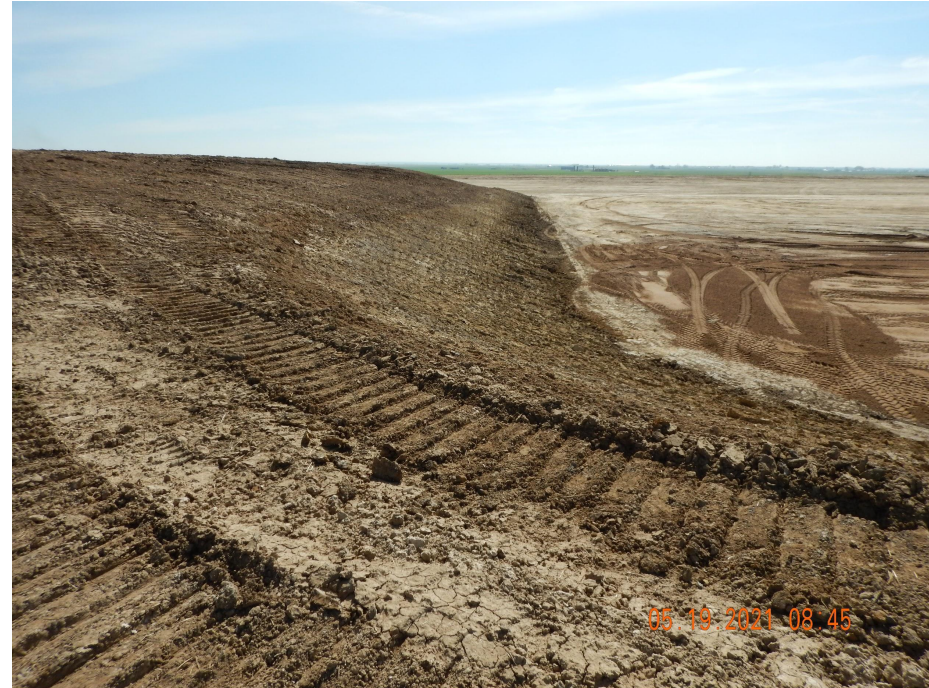
Photo 8. Photo taken from the northwestern location, facing East. See comments under Photo 7.

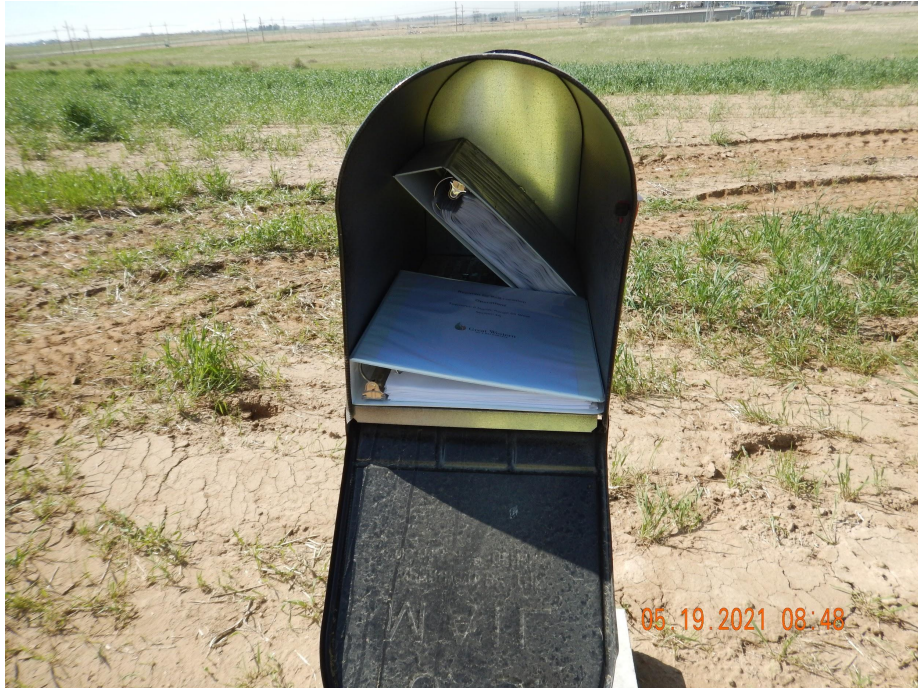
Photo 9. Photo taken from the entrance of the facility. Photo illustrates the approved Form 2A permits.

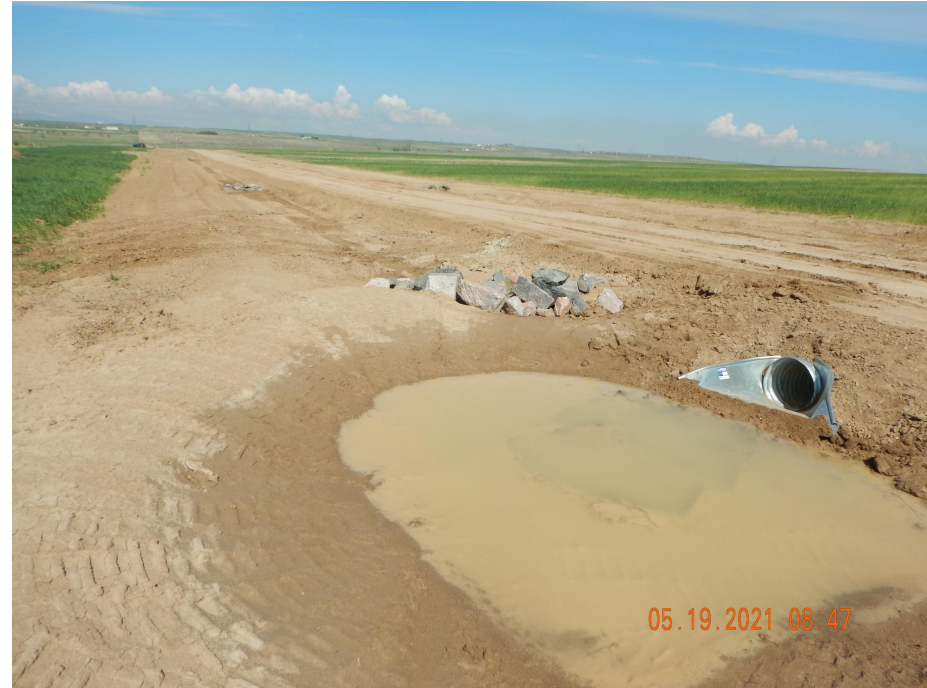
Photo 10. Photo taken from the entrance of the facility, facing West. Photo illustrates no outlet protection has been installed.

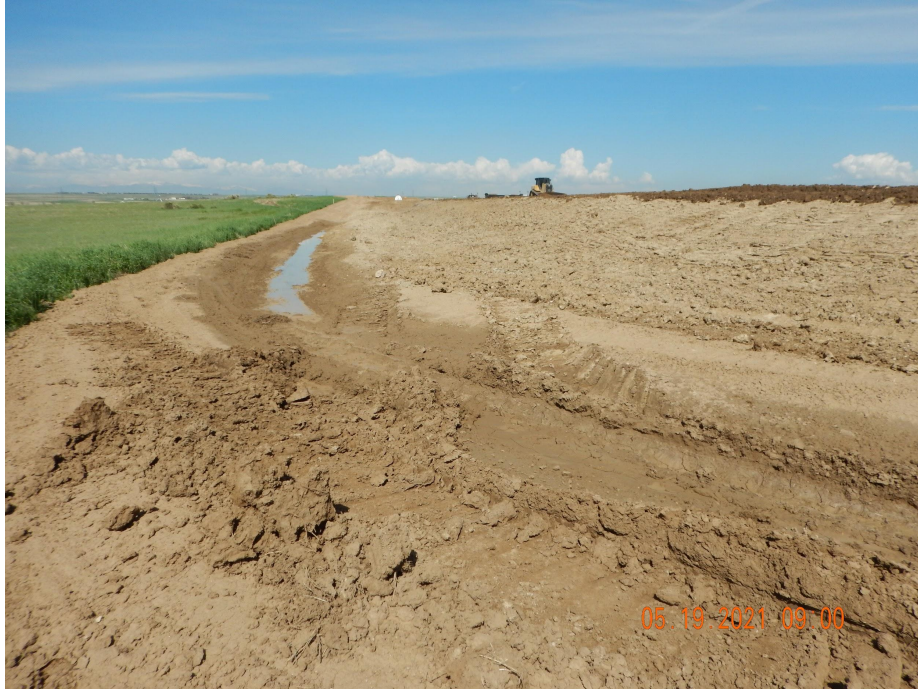
Photo 11. Photo taken from the southeastern location, facing West. Photo illustrates ponding in the ditch which is not being directed to the detention pond.

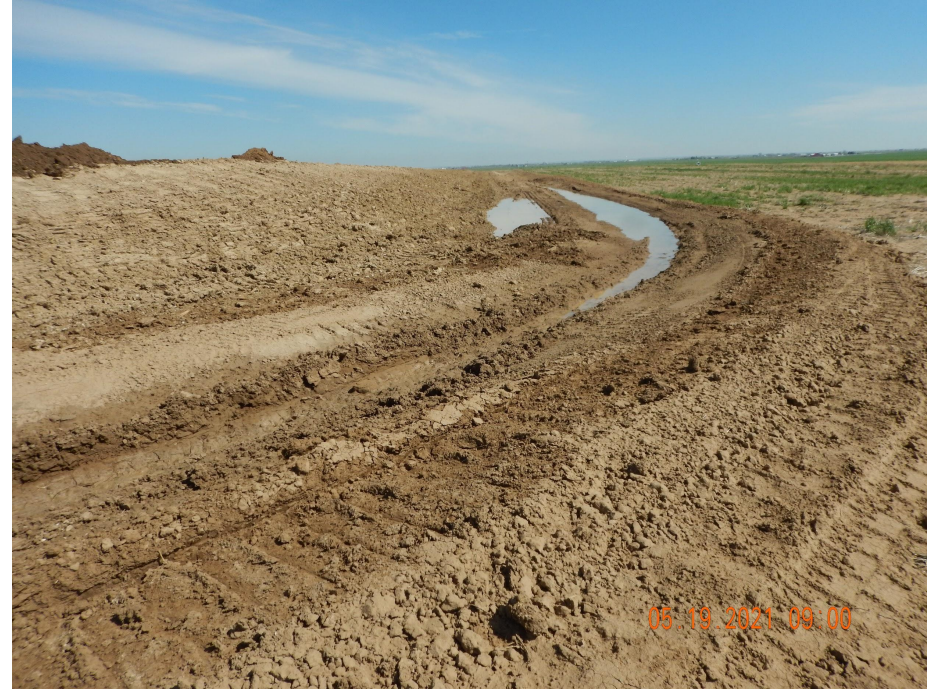
Photo 12. Photo taken from the southeastern location, facing North. See comments under Photo 11.
