Inspection Photos

API# 081-06240

Operator: GRMR

Inspection Photos: GRMR PA Beaver Durham API#081-06240

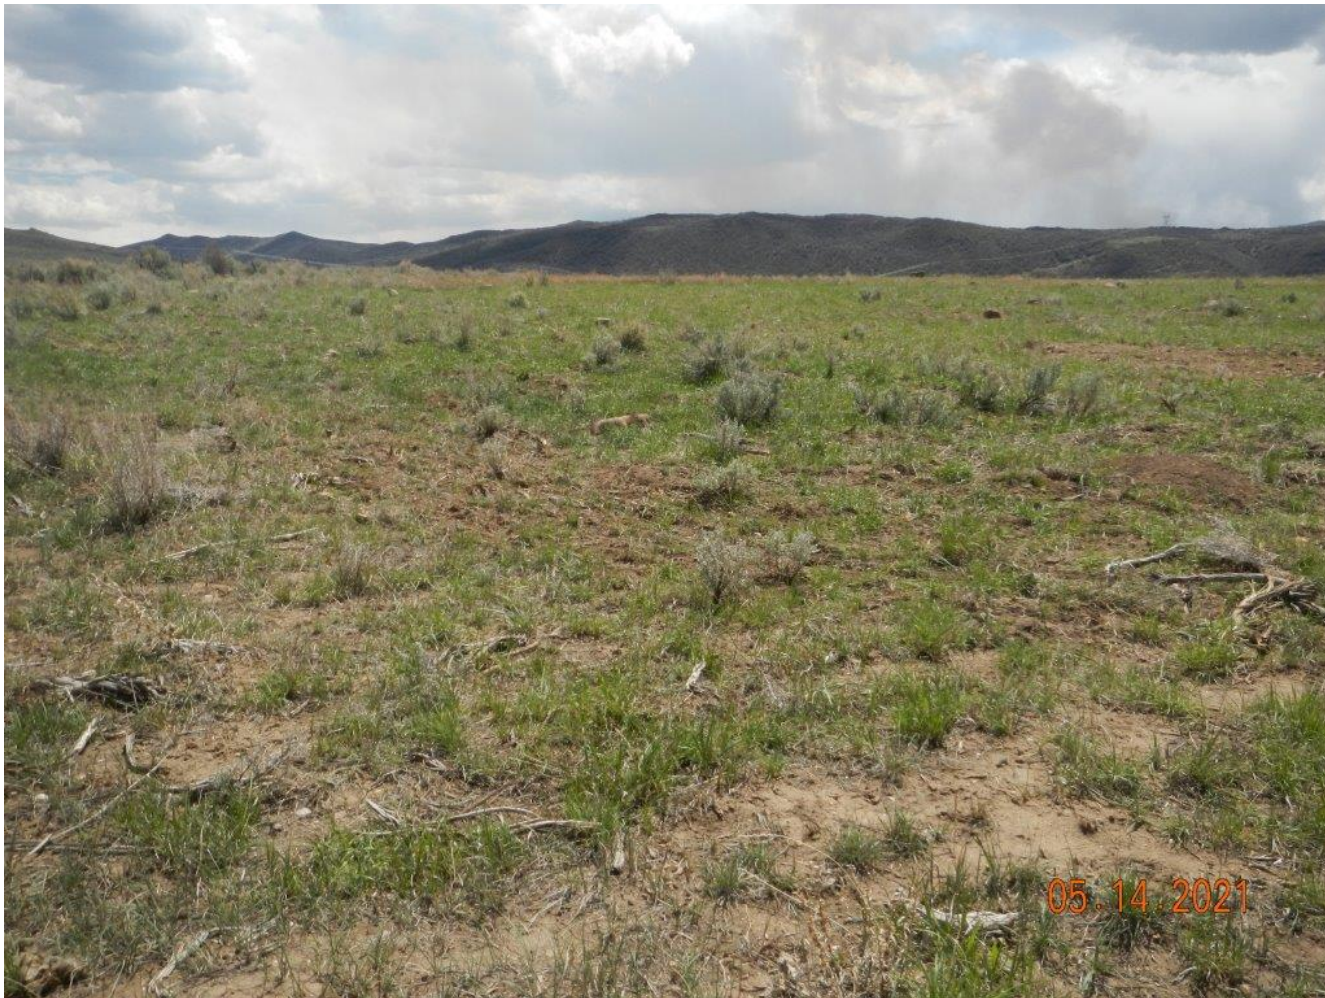
Photo#1:
View over Location to South.

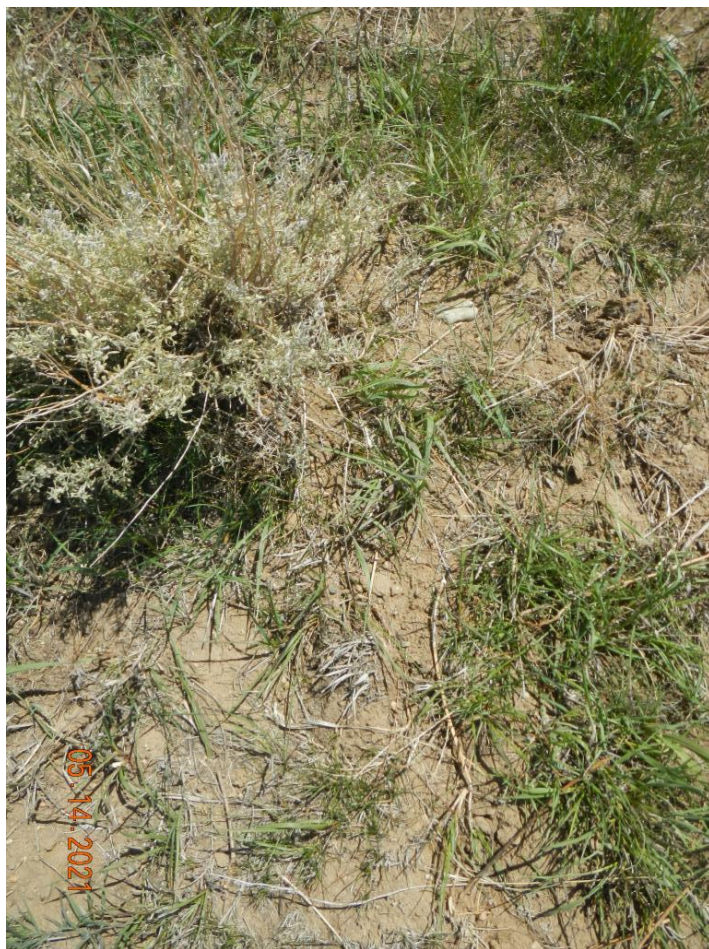
Photo#2:
Close up of ground conditions.

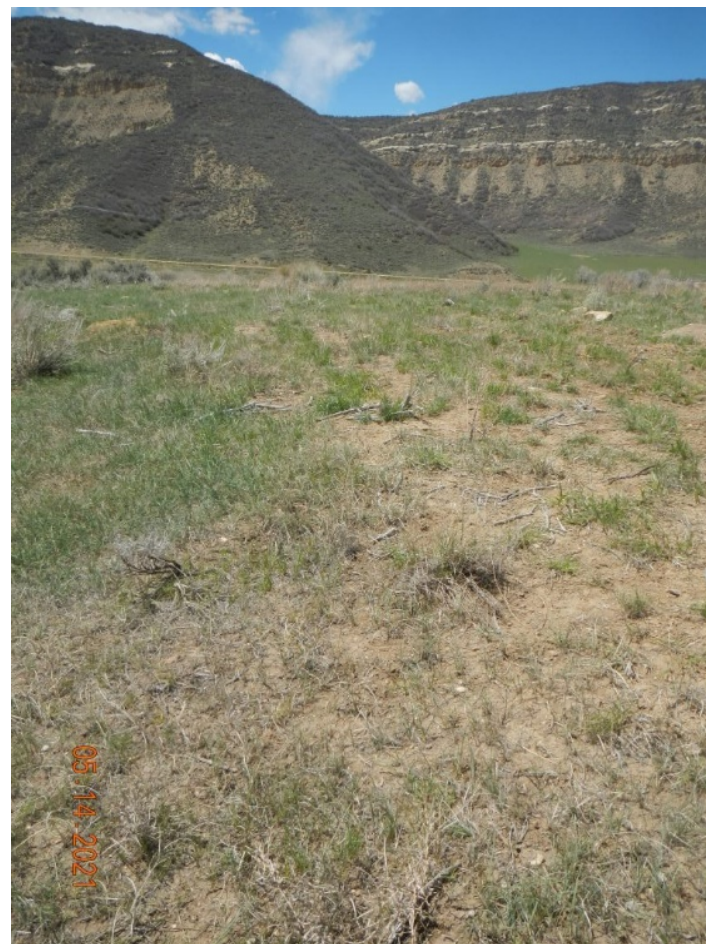
Photo#3:
View into Location from point where access
road had entered site.

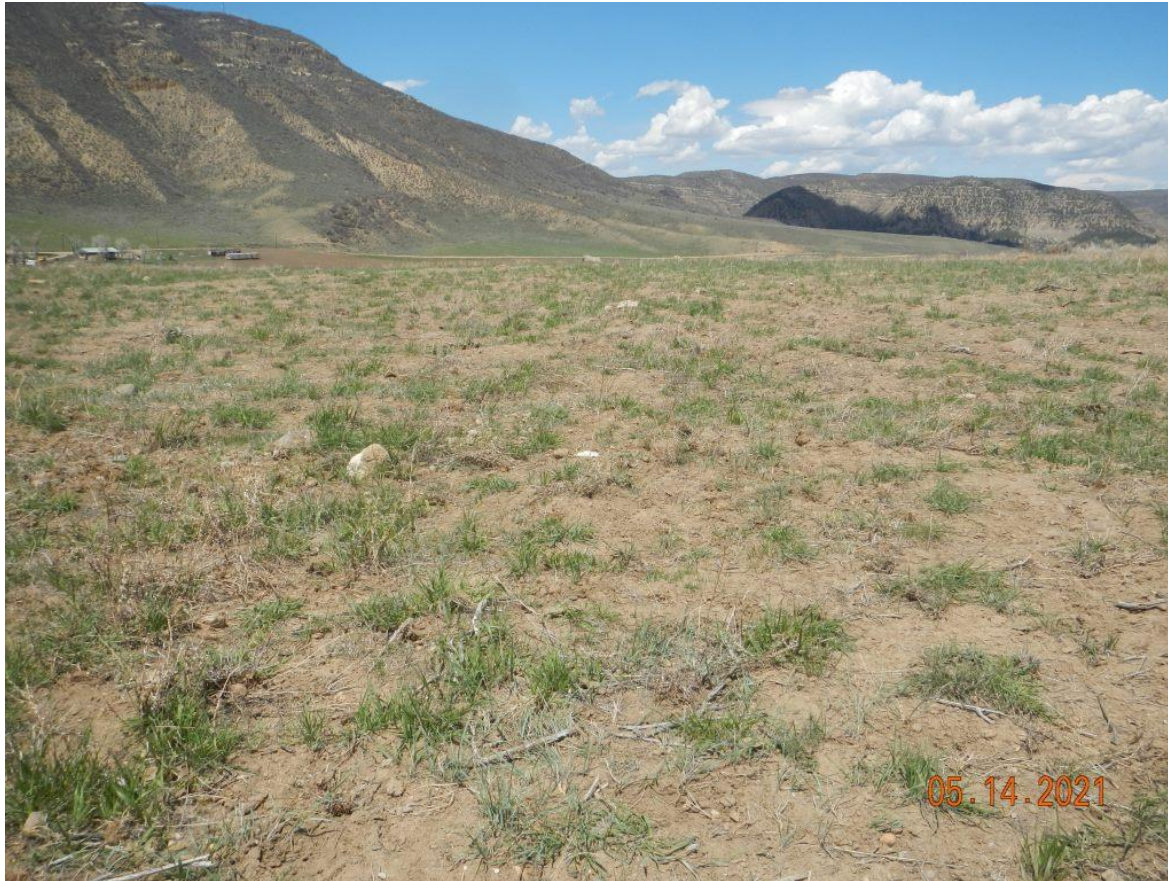
Photo#4:
View over Location to Northwest.

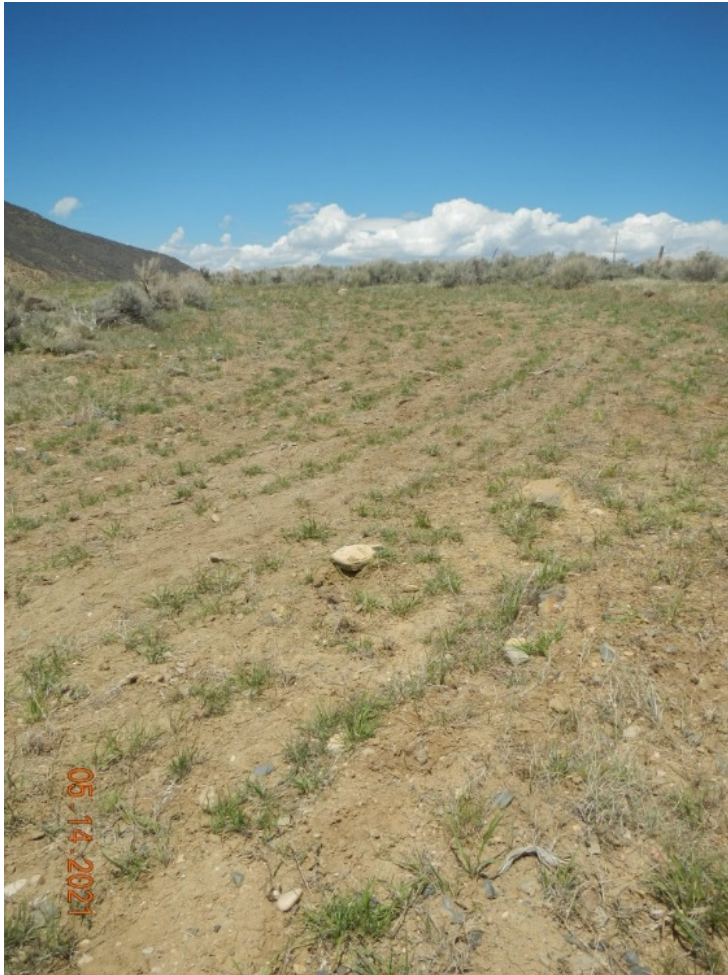
Photo#5:
Access road leading into site to Northwest.

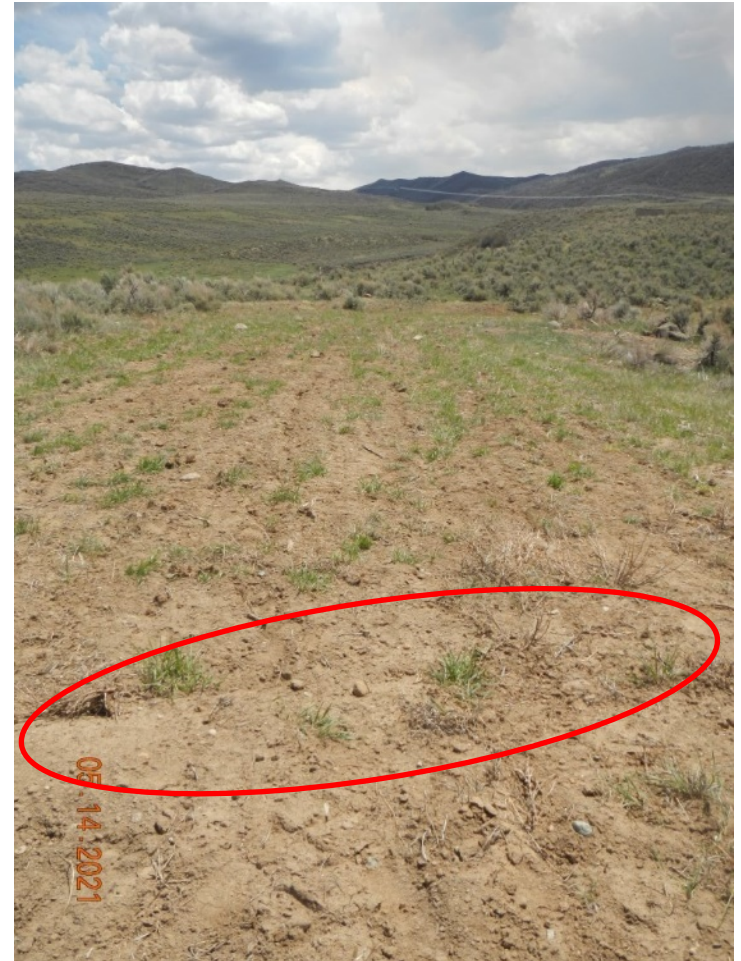
Photo#6:
Access road leading out of site to Southeast. Circled area will need to be monitored for initiation of stormwater concern.
