Inspection Photos

Location Name: LARAMIE ENERGY LLC Esperanza /9-5 Pad

Location ID: 334510

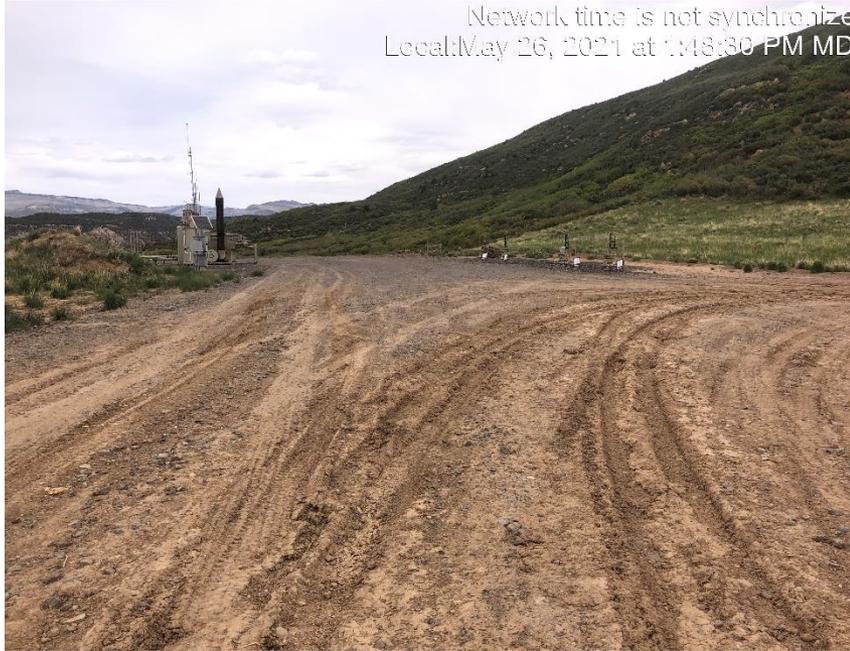
Photo #3941 from entrance to location.

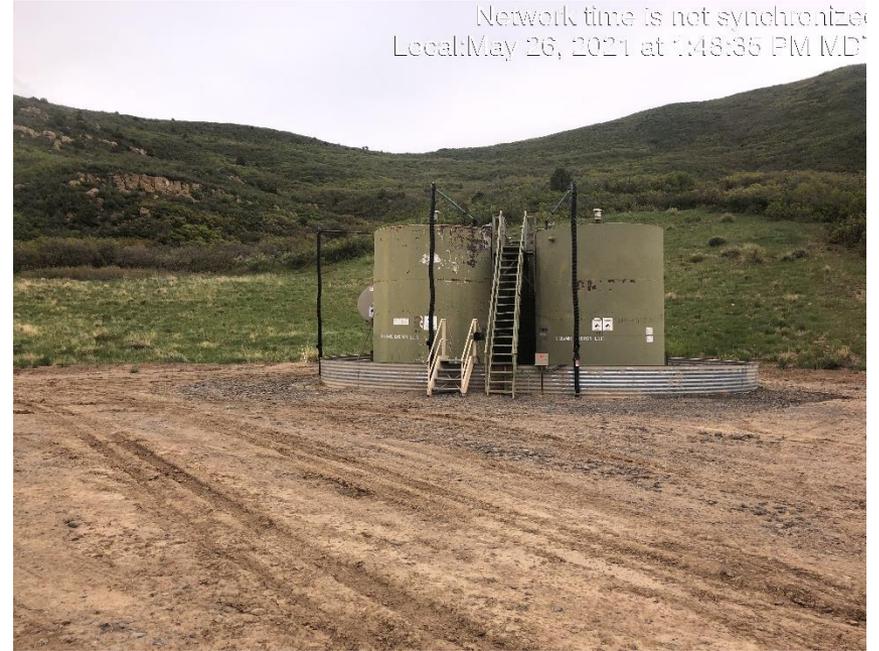
Photo #3942 from entrance to location.

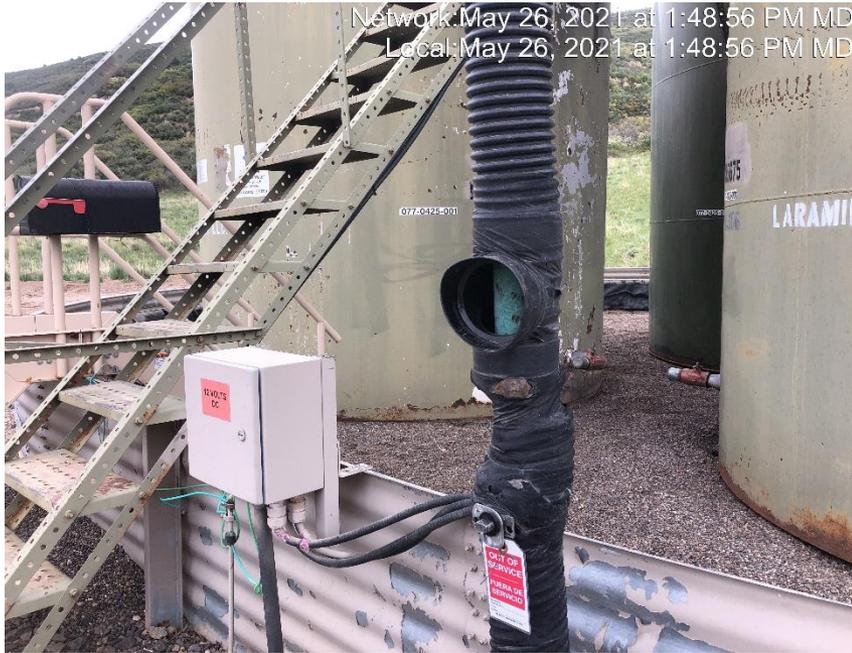
Photo #3943 Flow line heating insulation open ended and not capped.

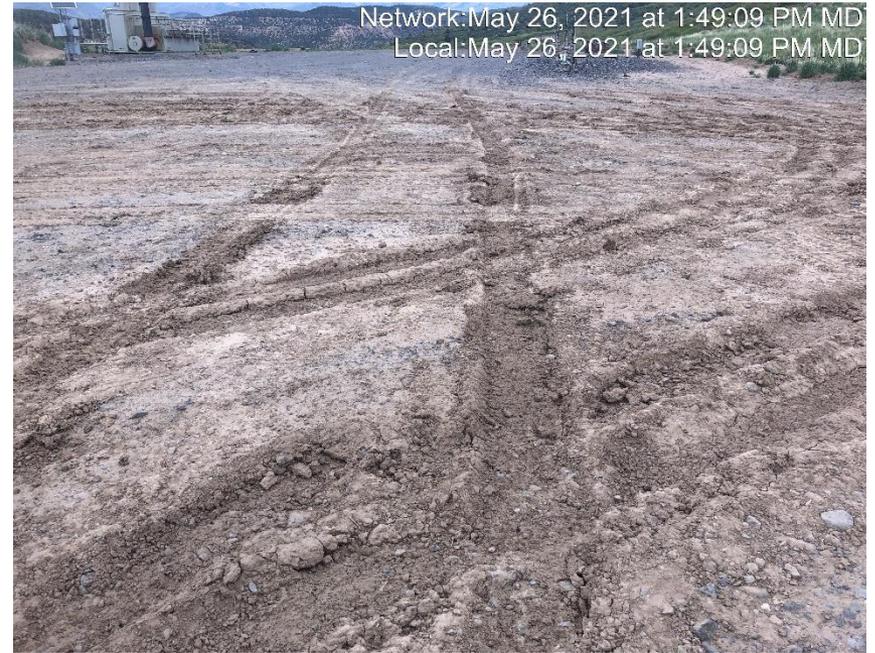
Photo #3944 Location lacks stabilization.

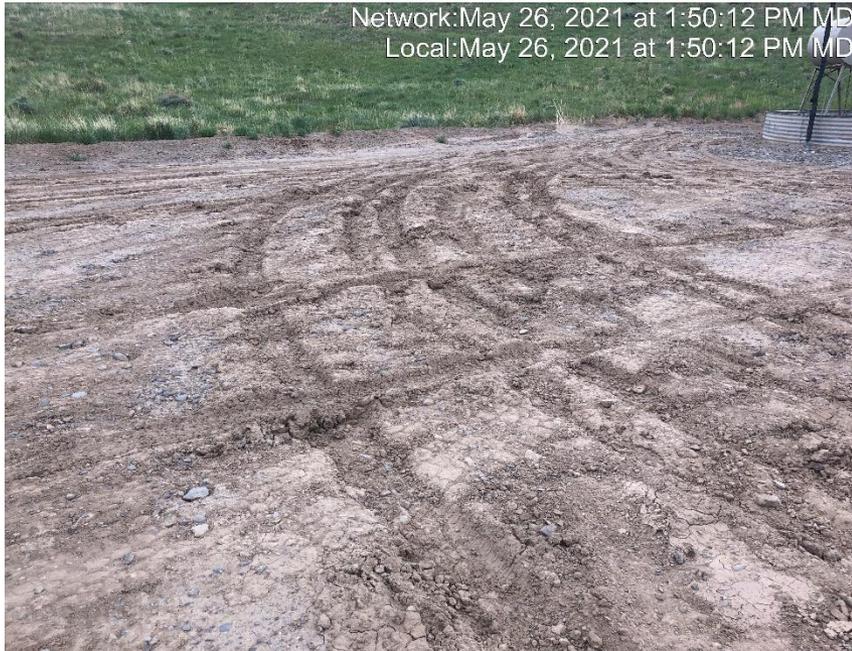
Photo #3945 Location lacks stabilization.

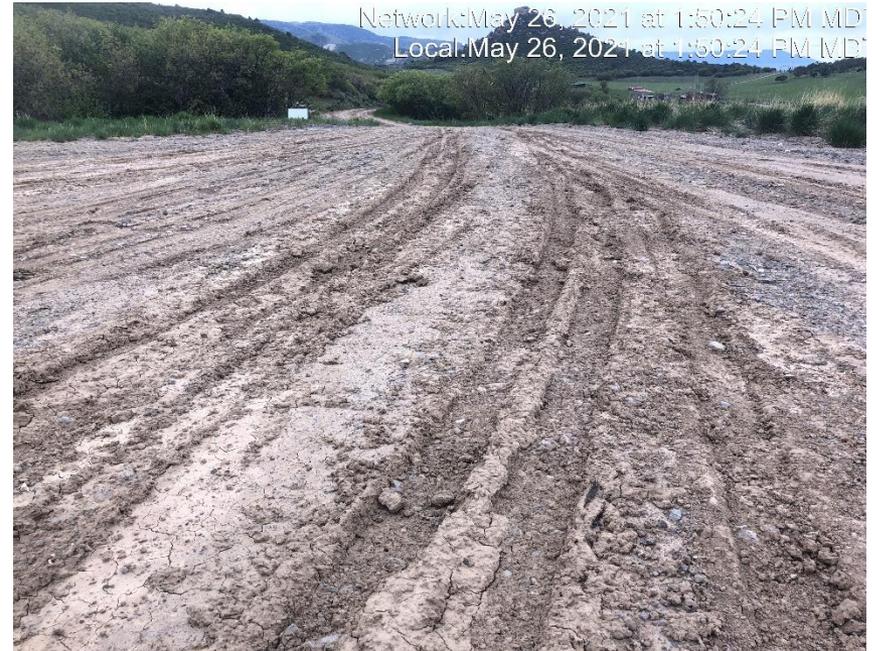
Photo #3946 No form of tracking BMP at entrance to location.

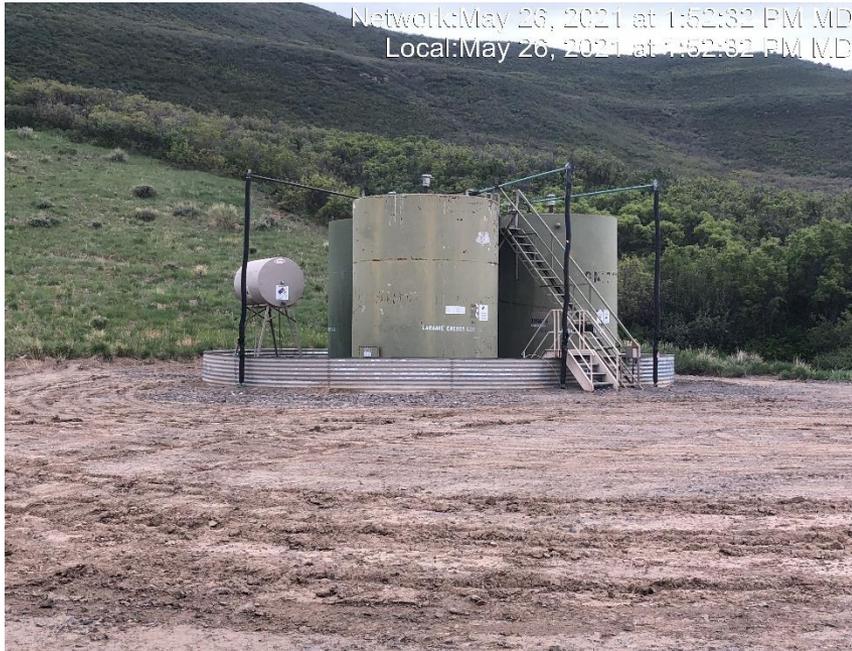
Photo #3947 No battery sign located at the tank battery.
