Inspection Photos

API: 055-06101

Operator: MANZANO LLC

Inspection Date: 5/26/2021

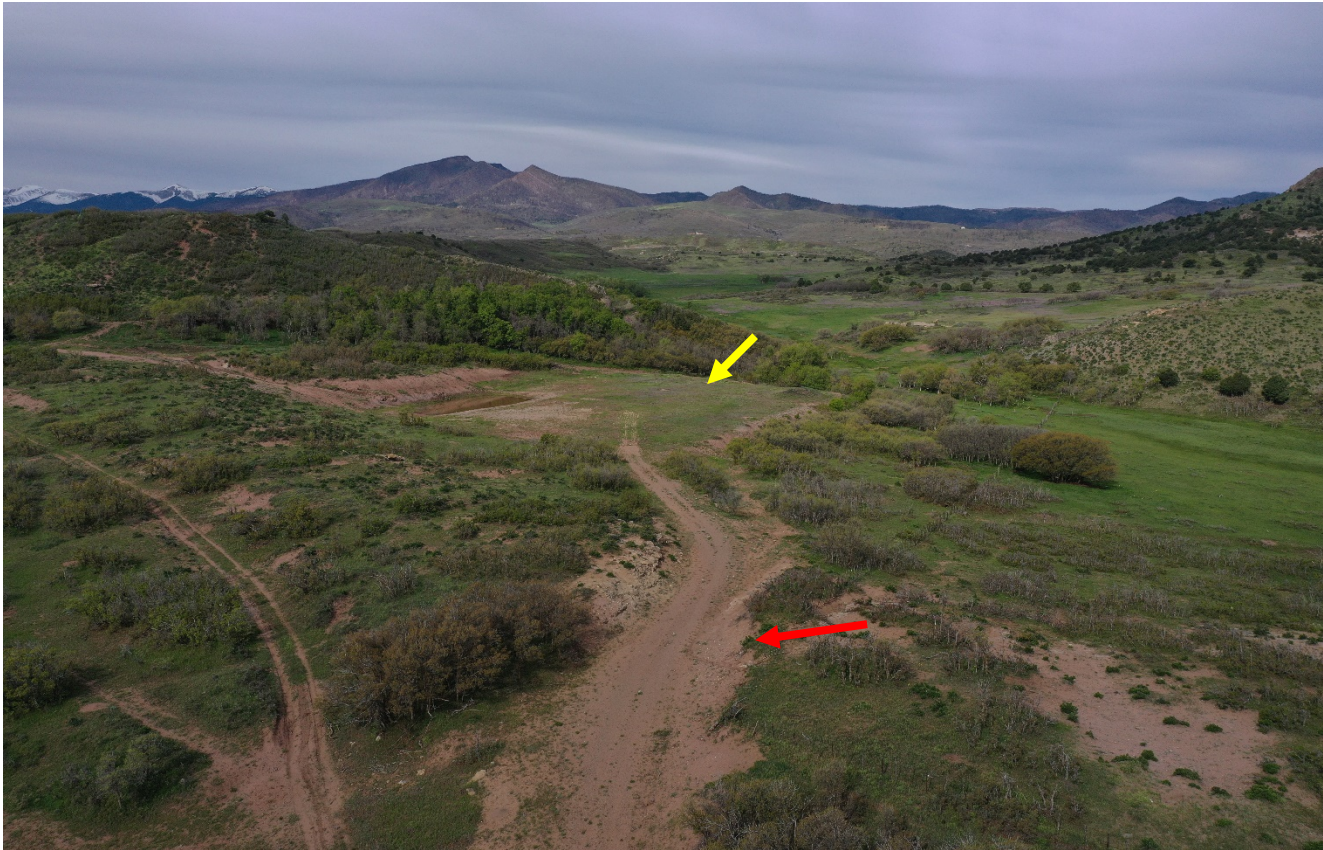
Photo 1. Drone aerial photo facing northwest along the access road toward the location. Red arrow points the the access road and yellow arrow points to the location which have not been reclaimed per rule 1004.

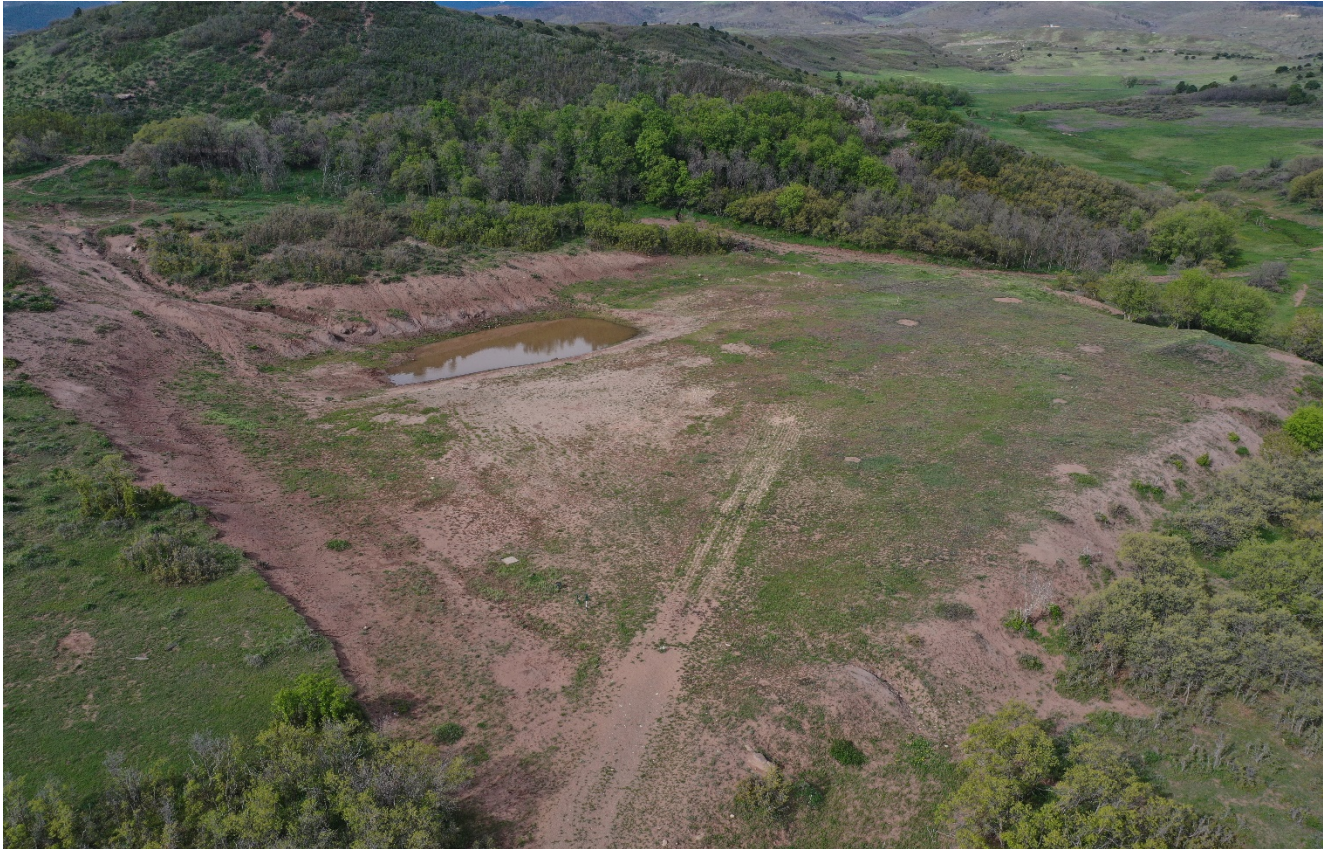
Photo 2. Aerial image of the location shows it has not been recontoured and reclaimed. The location is approximately 3.3 acres.

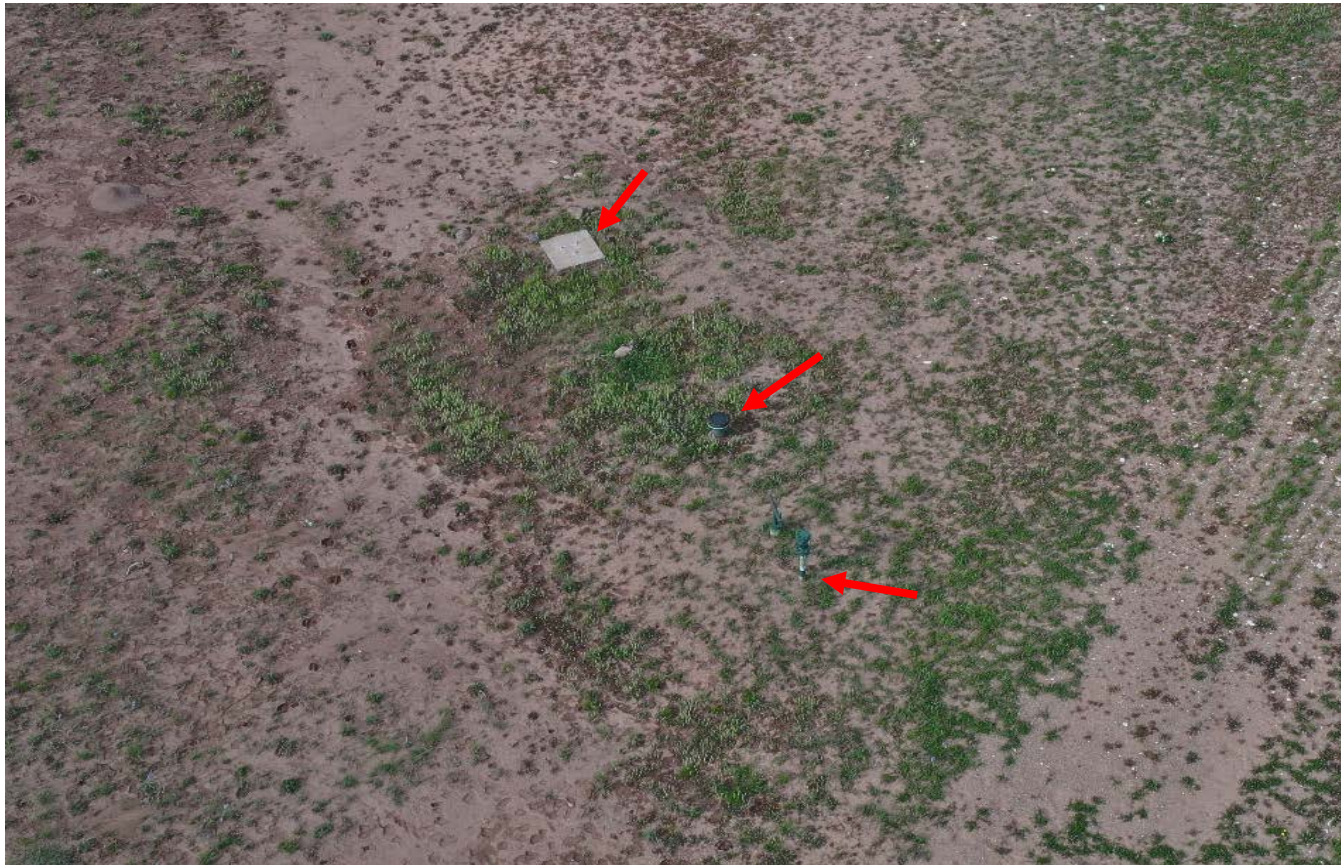
Photo 3. The pipeline risers still remain at the location.

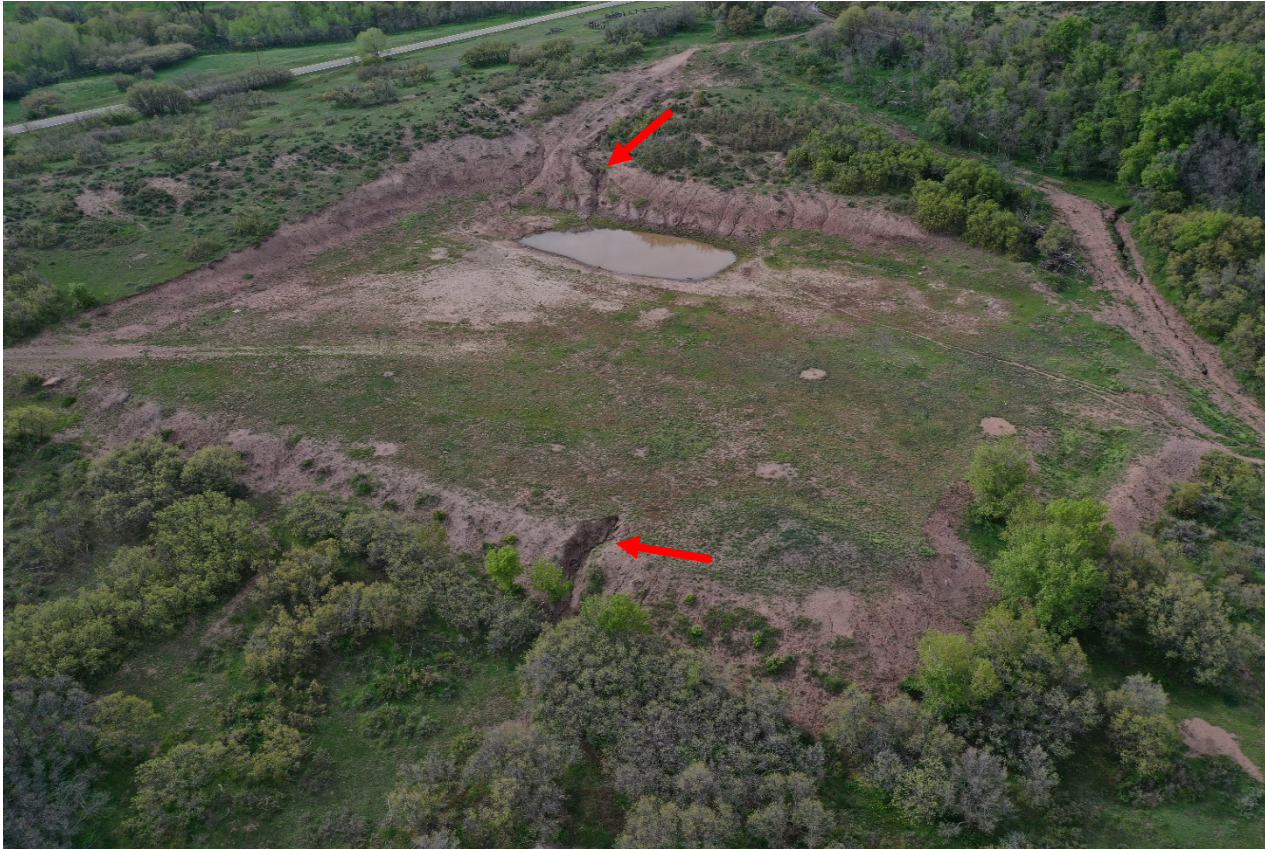
Photo 4. Facing southwest overlooking the location. There are multiple areas of erosion along the cut slope and fill slope shown at red arrows.

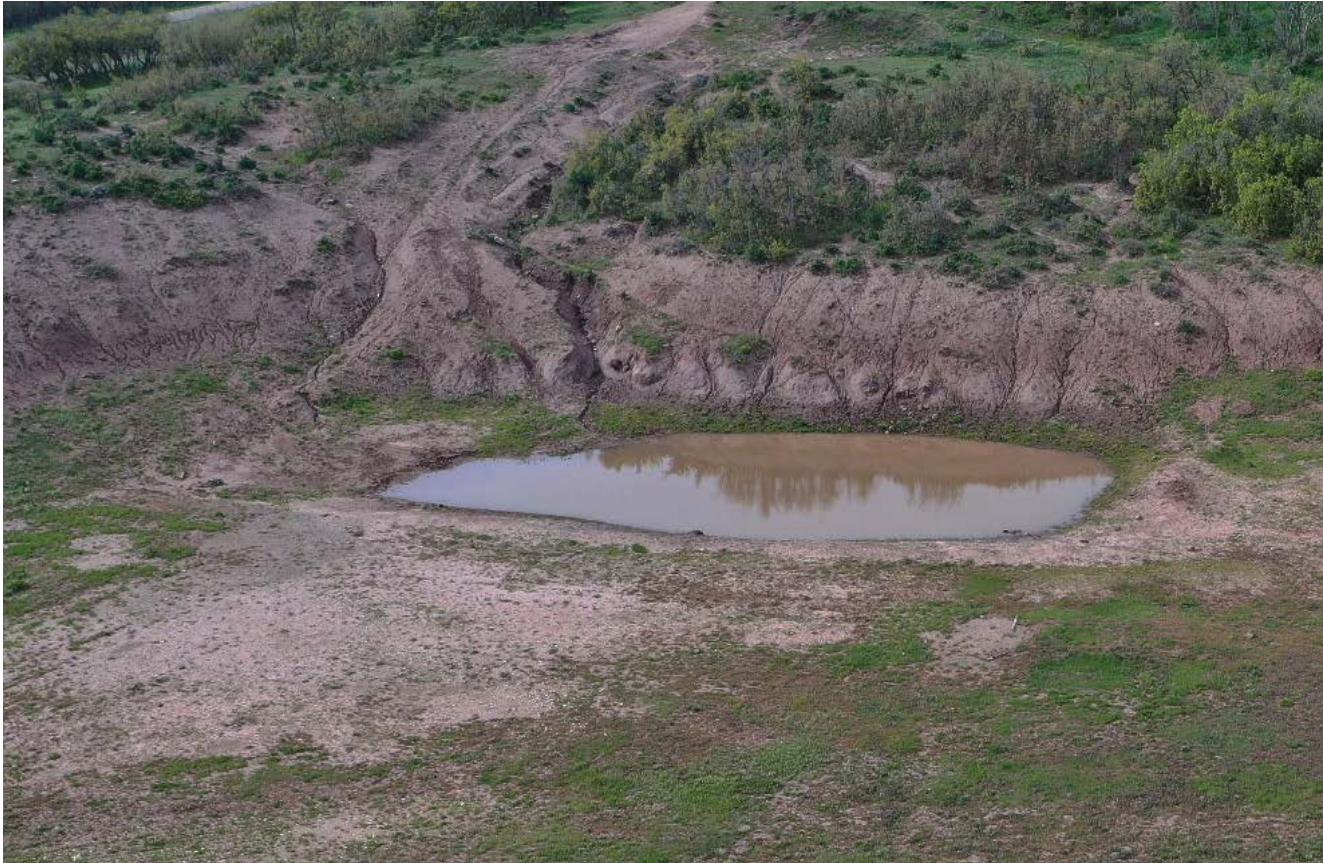
Photo 5. The pit remains and is filled in with stormwater. This photo shows the erosion along the cut slope.
