Inspection Photos

API: 055-06306

Operator: MANZANO LLC

Inspection Date: 5/26/2021

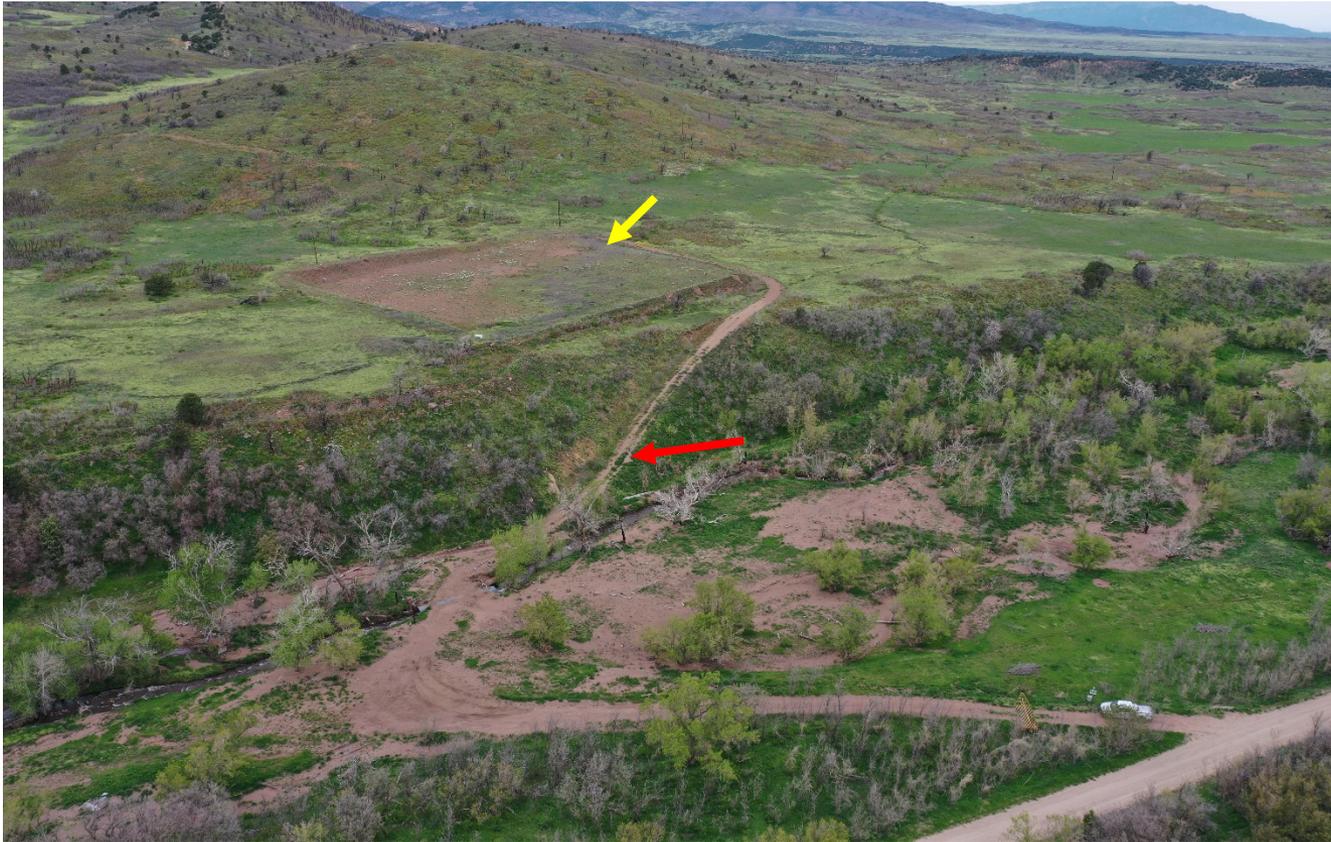
Photo 1. Drone aerial photo facing northwest toward the access road and the location. Red arrow points the the access road and yellow arrow points to the location which have not been reclaimed per rule 1004.

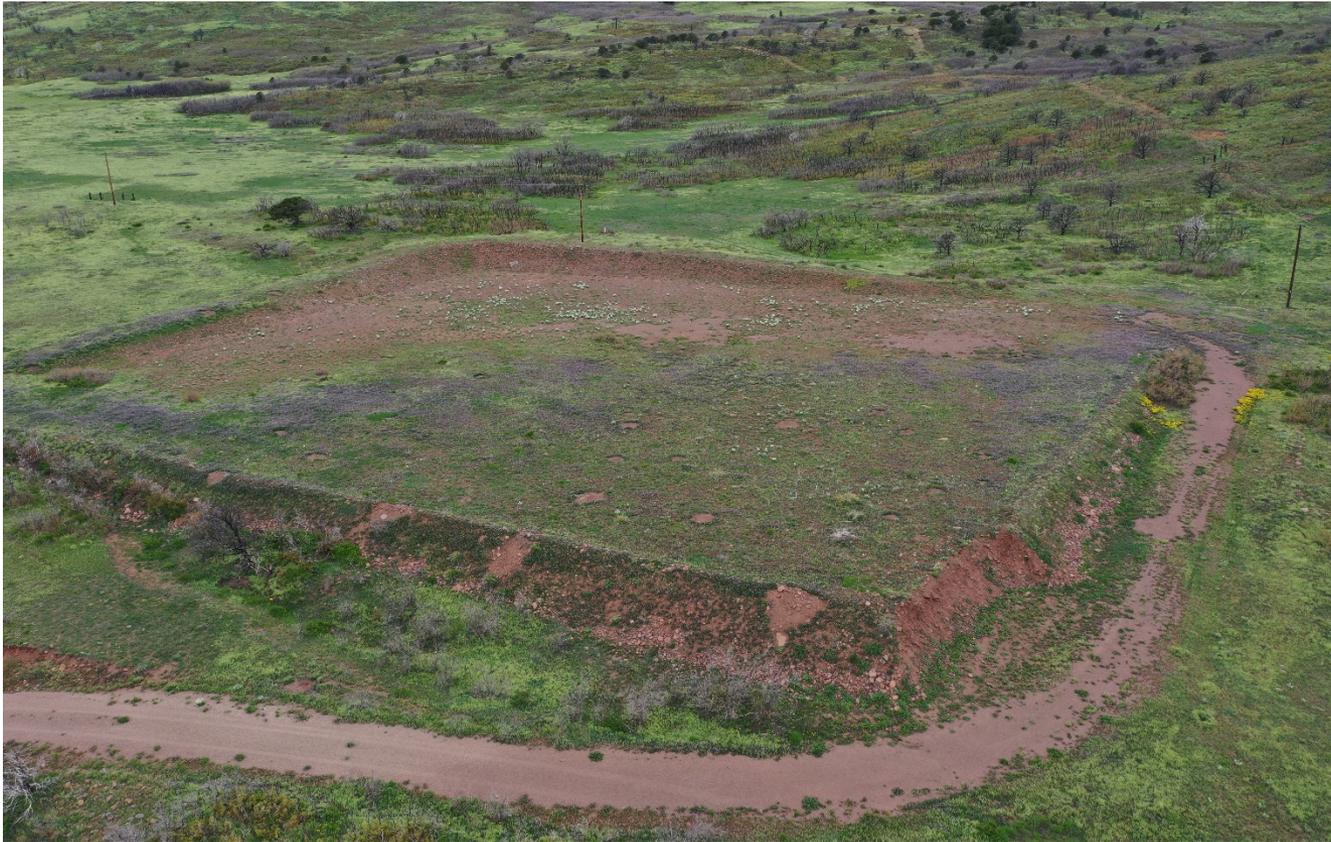
Photo 2. Aerial image of the location shows the location has not been recontoured and reclaimed.

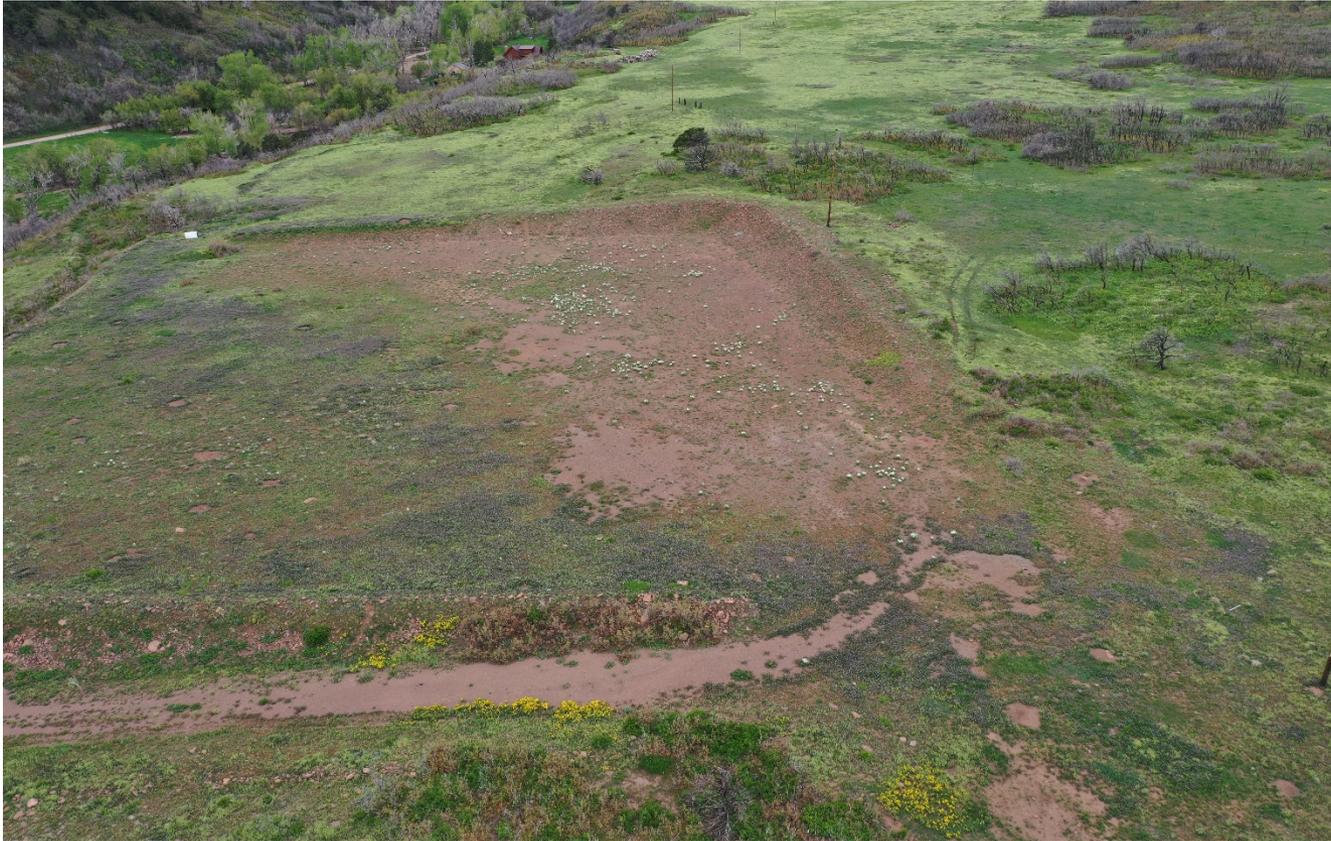
Photo 3. Facing southwest overlooking the location. Part of the location has no vegetation growth and previous inspection identified noxious weeds growing throughout the location.

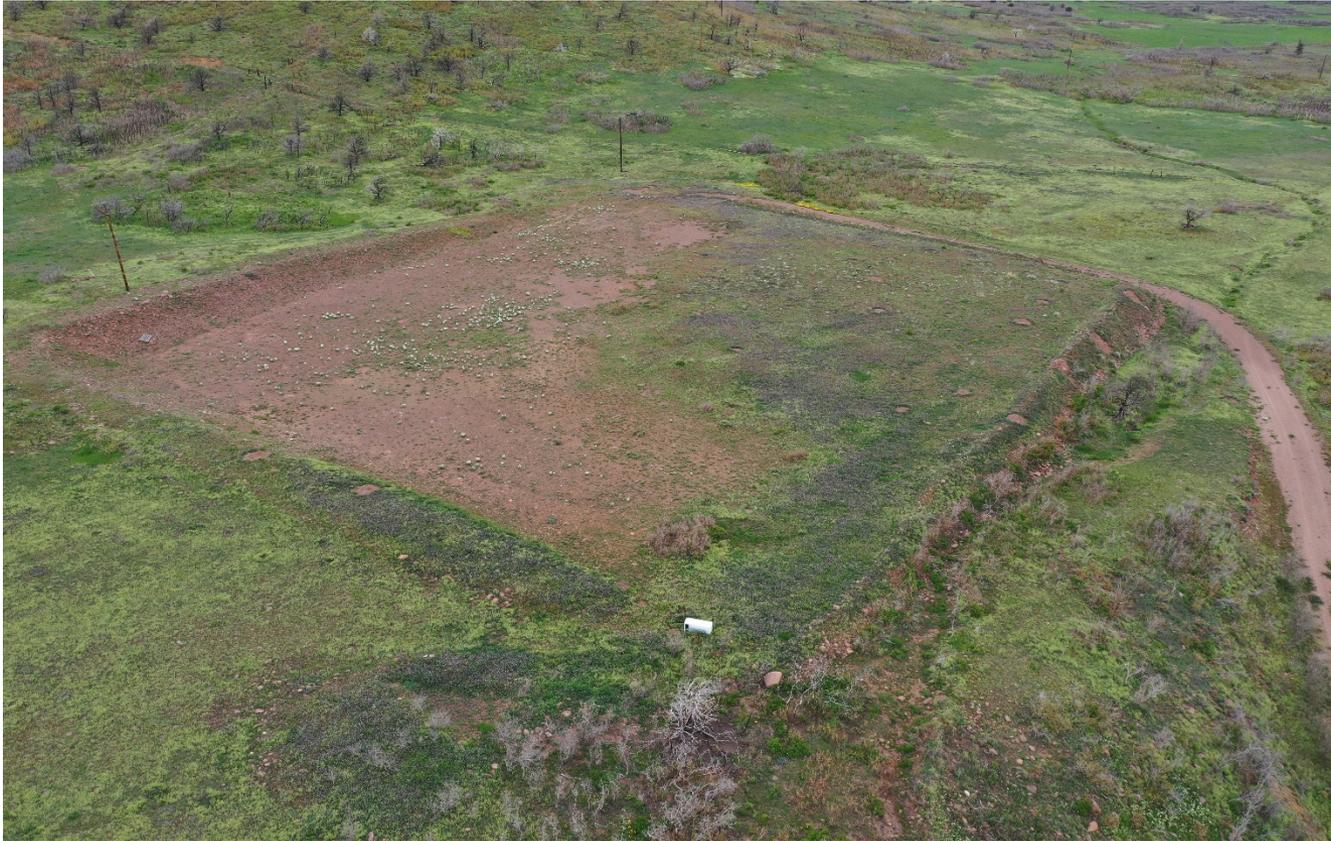
Photo 4. Facing north overlooking the location which is approximately 2.3 acres in size.
