Inspection Photos
Operator: Simcoe
API: 067-06679
Date: 5/24/2021

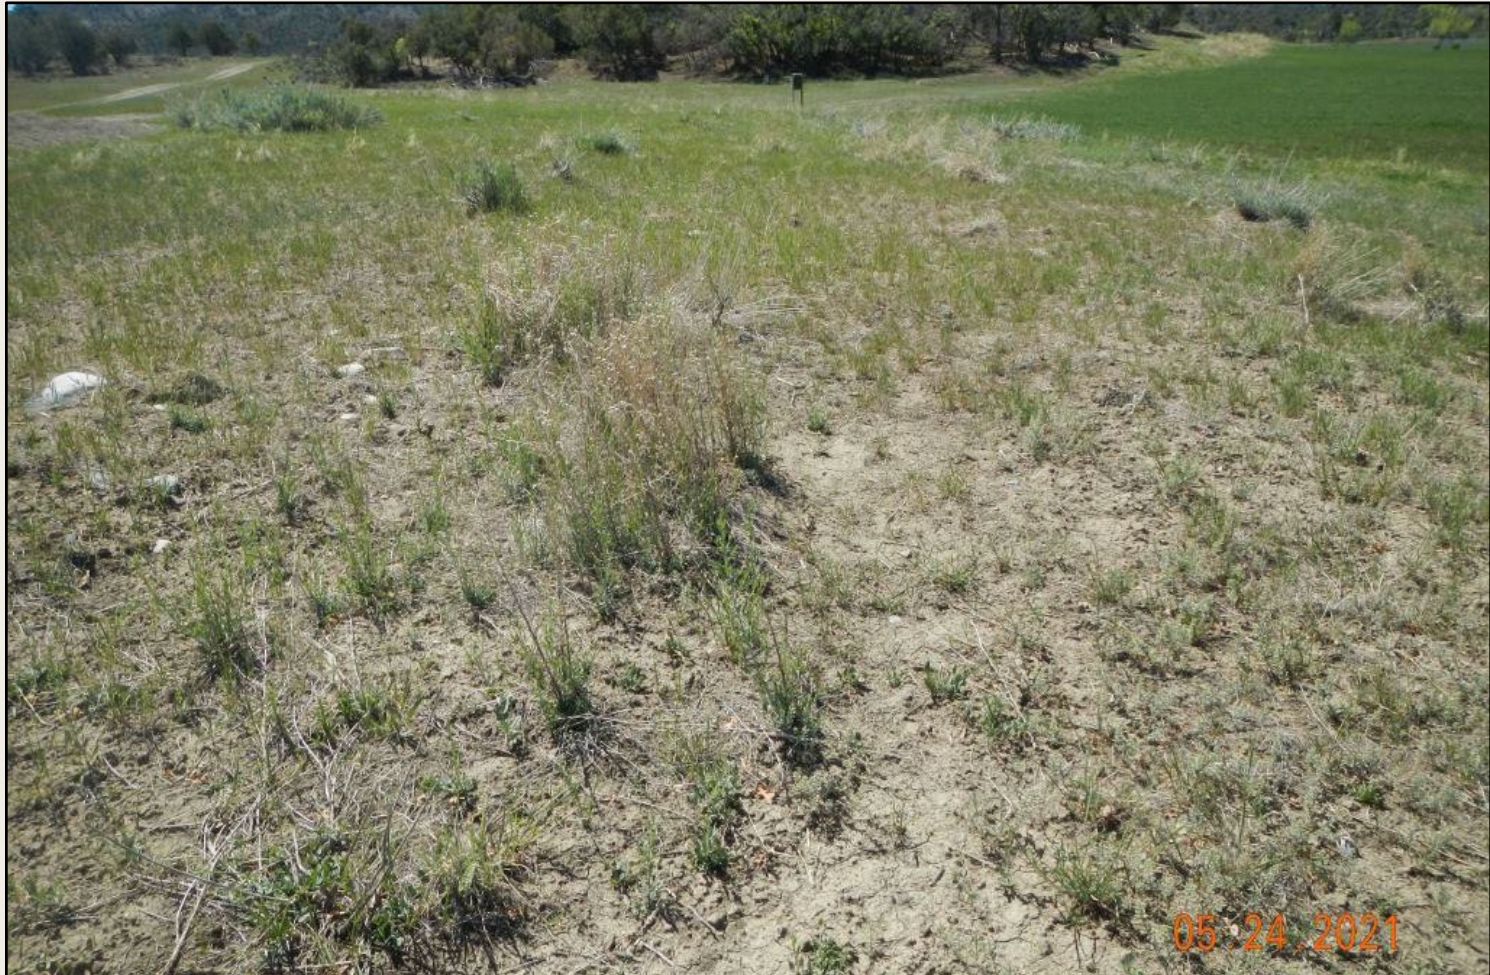
Photo 2. View of the southwestern project area from the northwestern corner facing southeastward. Revegetation is progressing in portions with western wheatgrass and smooth brome. Some portions remain sparse and revegetation should be assessed after weed control efforts.

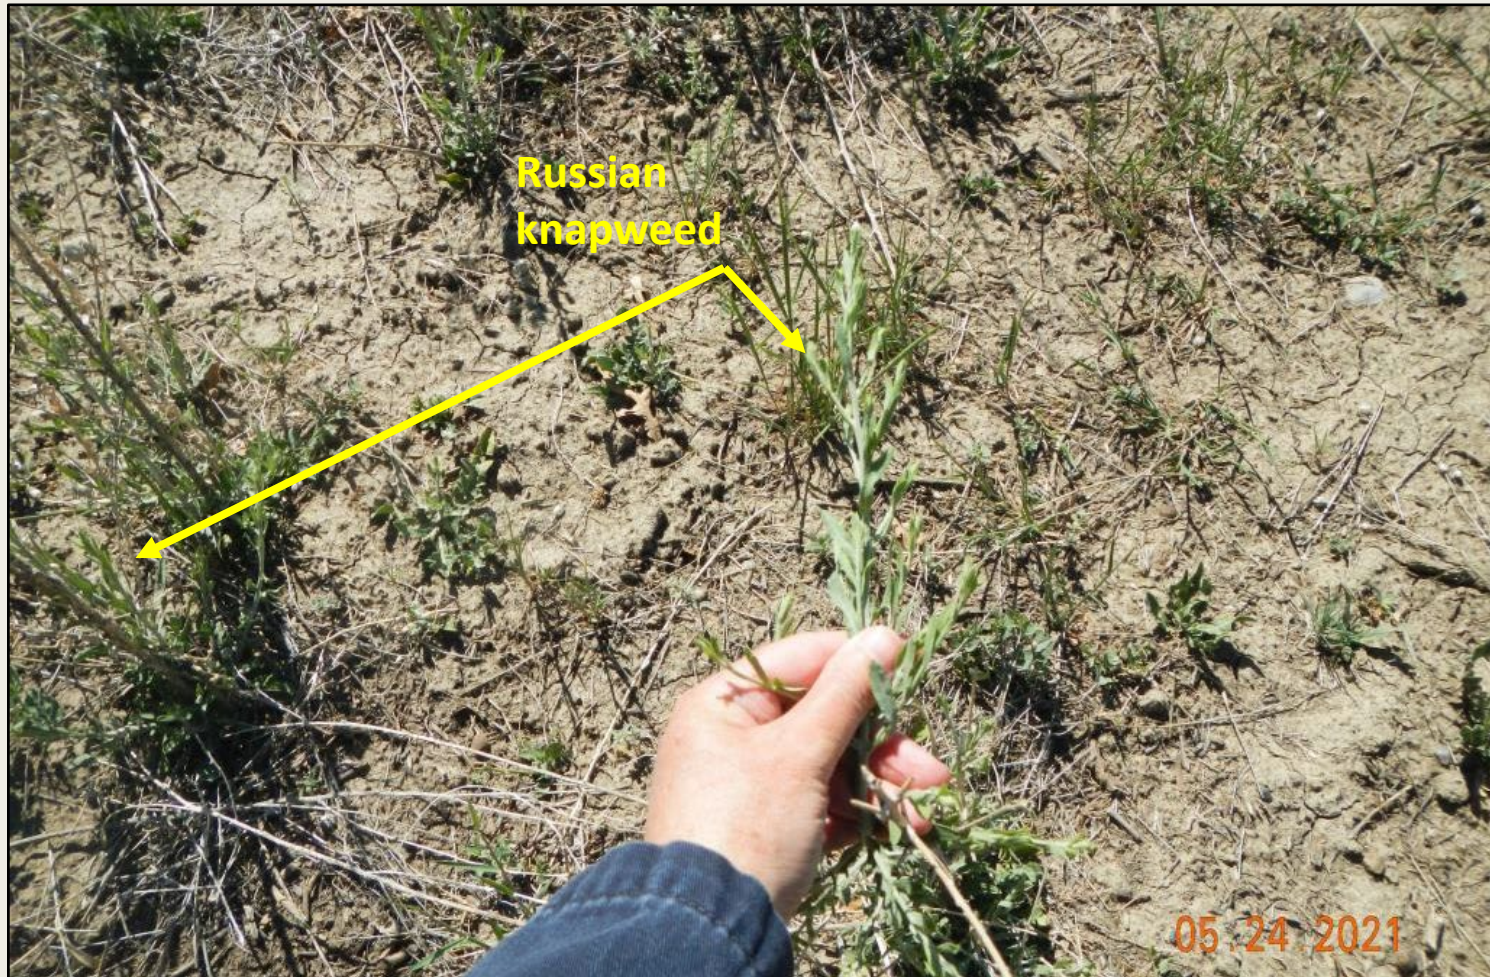
Photos 3. View of Russian knapweed observed within the project area. Approximately 200 individuals observed.

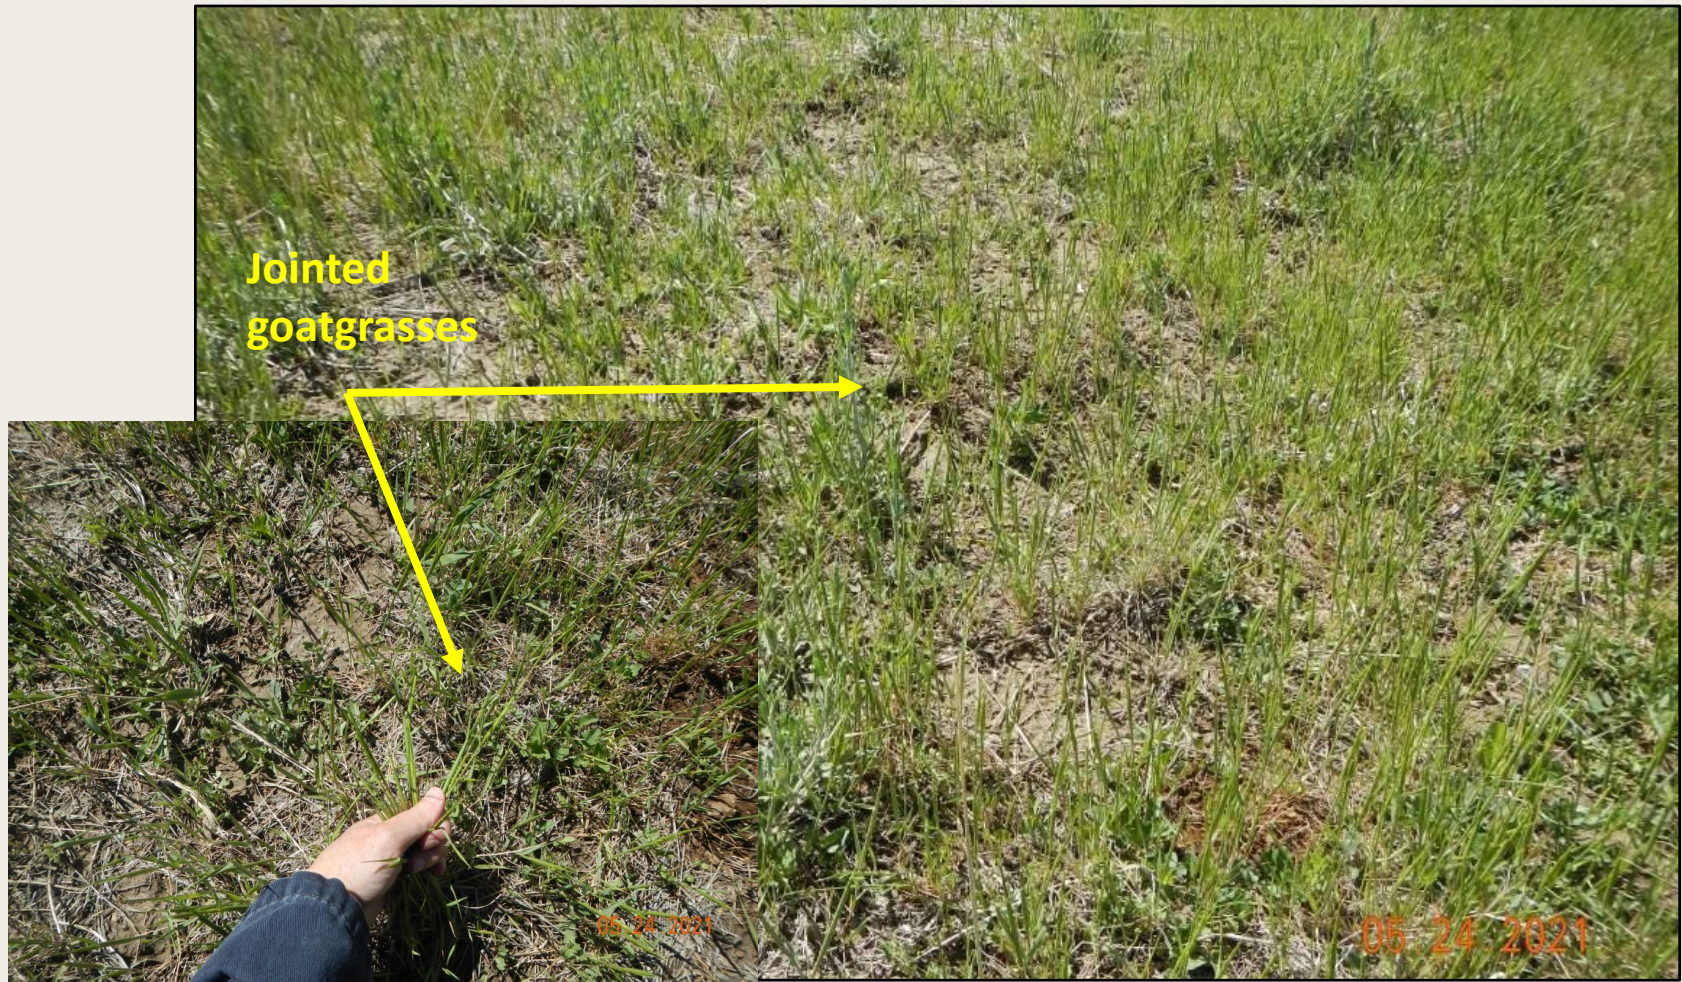
Photo 4. View of dense jointed goatgrass within the project area. Areas with jointed goatgrass infestation will require re-seeding after infestation is controlled.
