Inspection Photos
Operator: Simcoe
API: 067-06481
Date: 5/24/2021

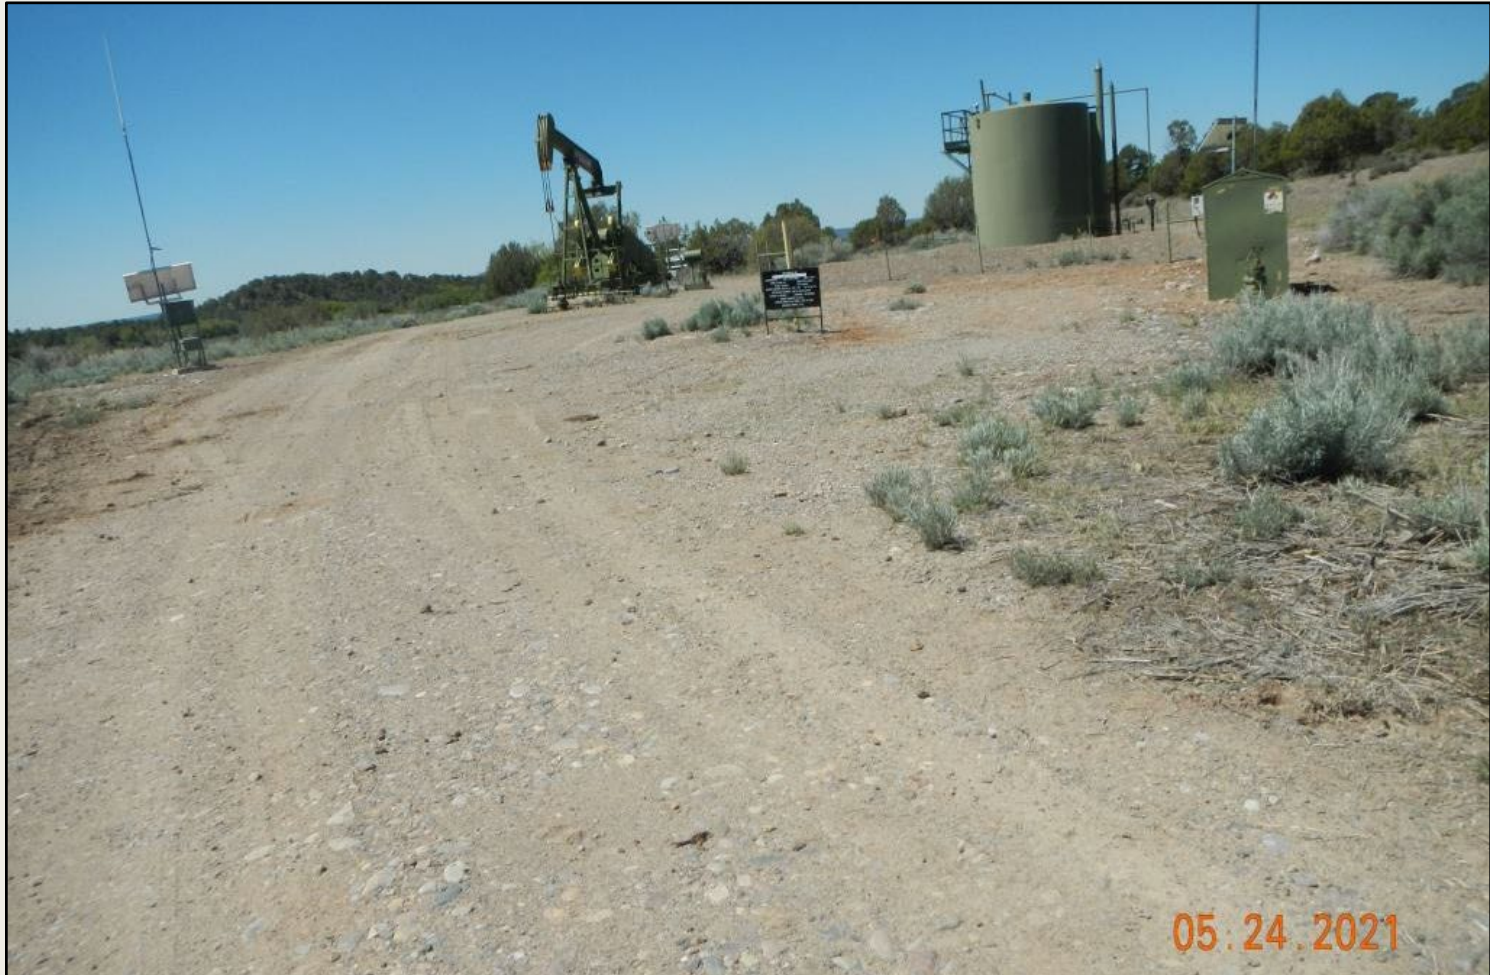
Photo 1. View of project area from the well pad entrance facing center.

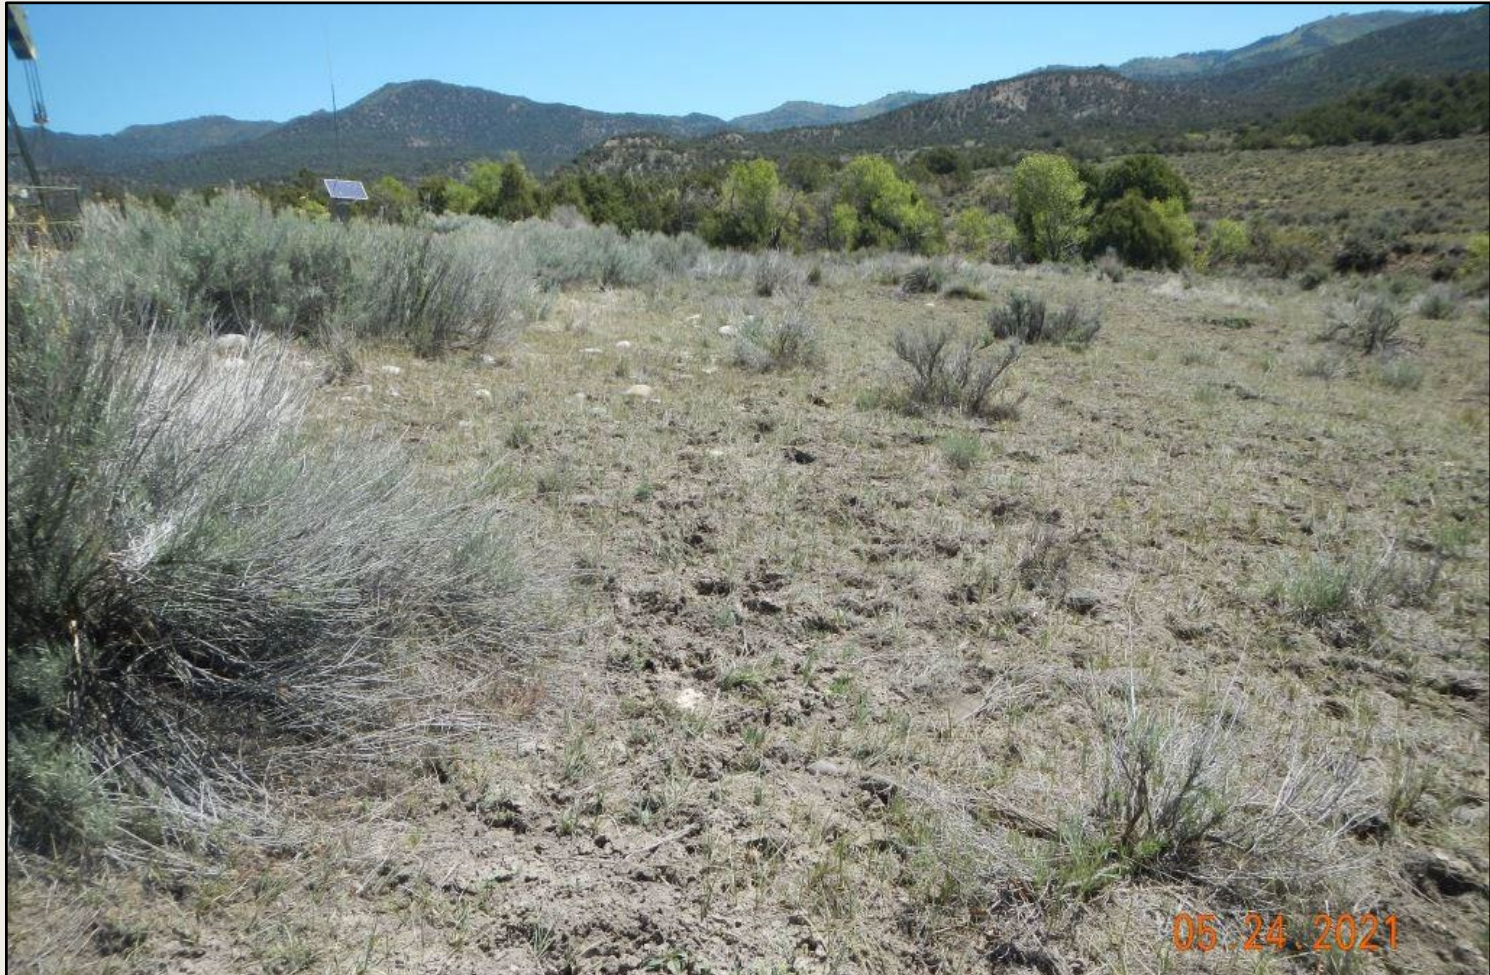
Photo 2. View of the southern project area from the southwestern corner facing eastward. Revegetation is progressing in portions with western wheatgrass, rubber rabbitbrush, and blue grama. Cows are present at the time of the inspection.

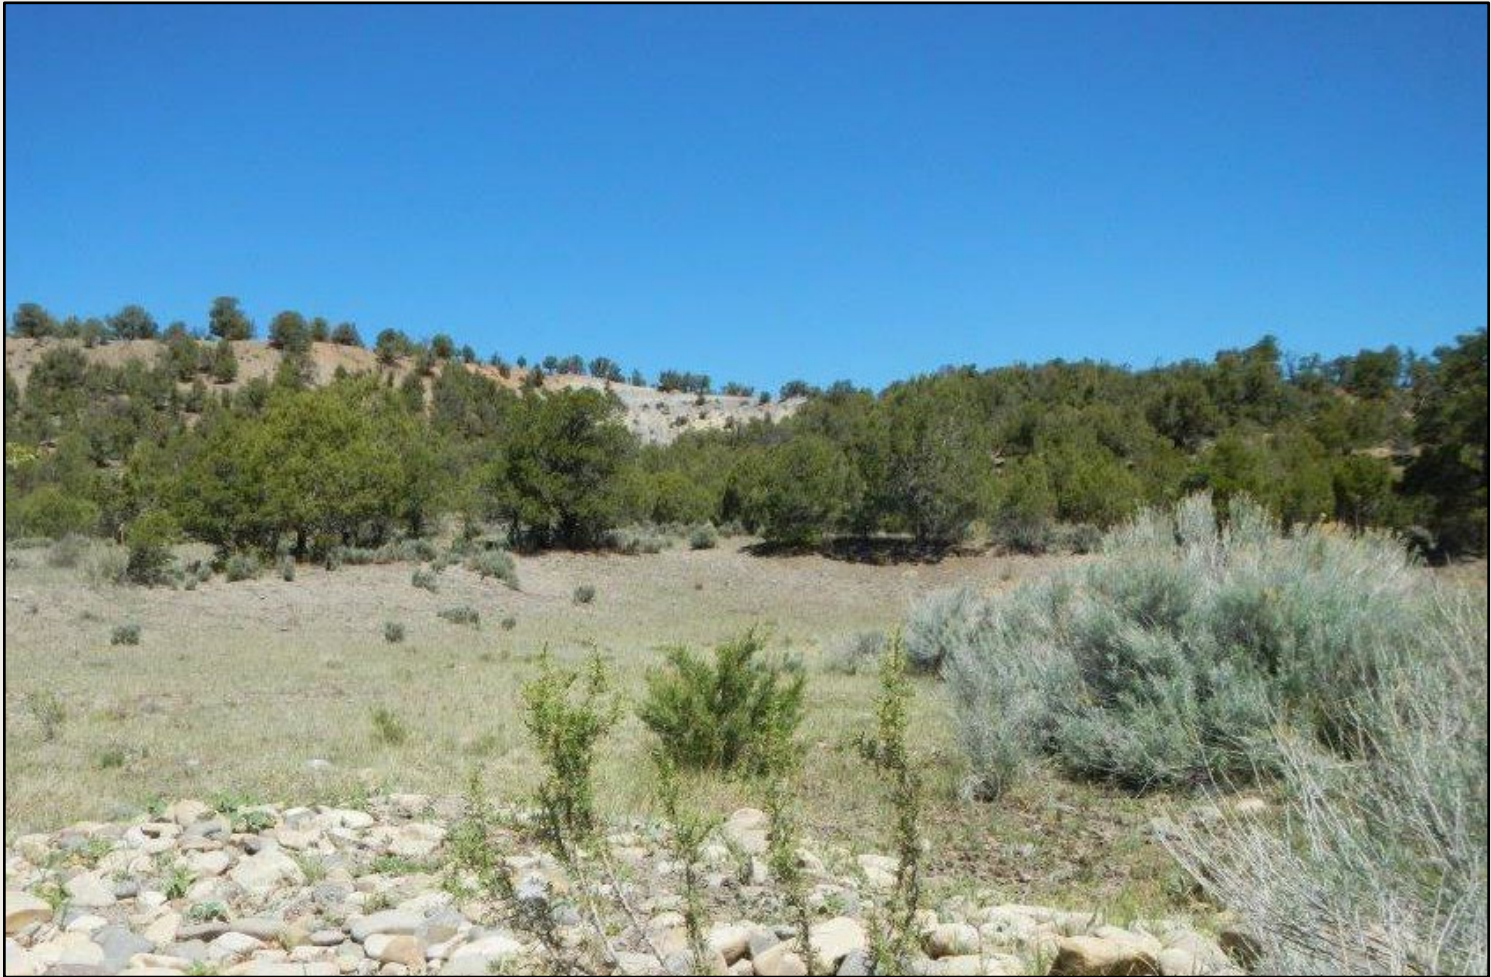
Photos 3. View of the western project area from the southwestern corner facing northward.

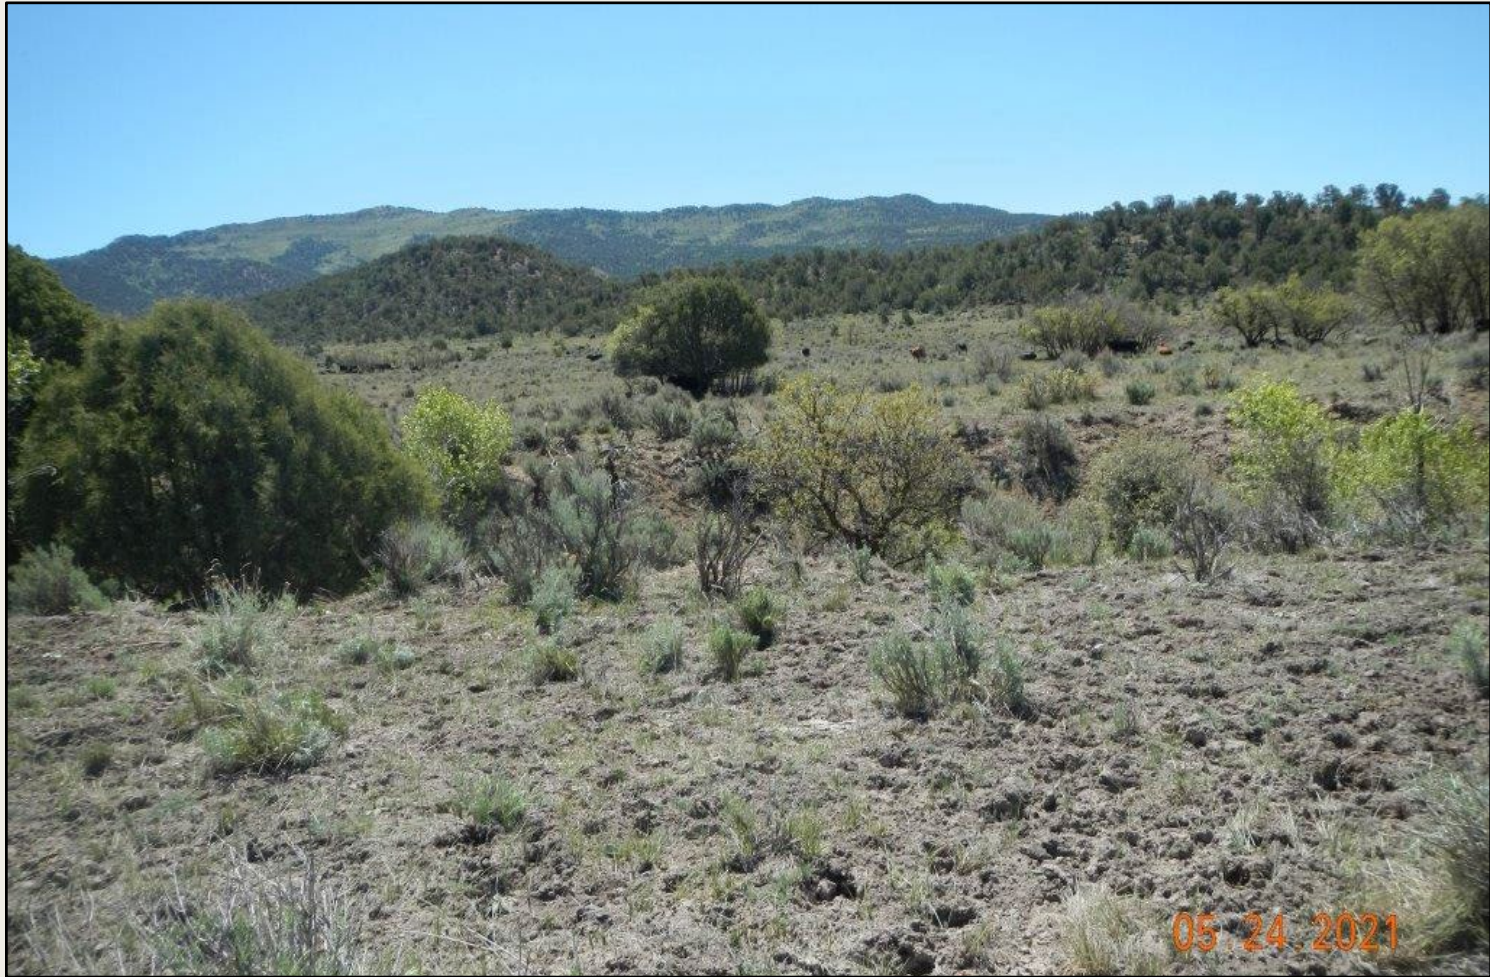
Photo 4. View of reference area comprised of sagebrush shrubland, with gambel oaks, scattered pinyon and juniper trees, western wheatgrass, pricklypear, phlox, and blue grama in the understory.
