Inspection Photos
Operator: Catamount
API: 007-06095
Date: 5/24/2021

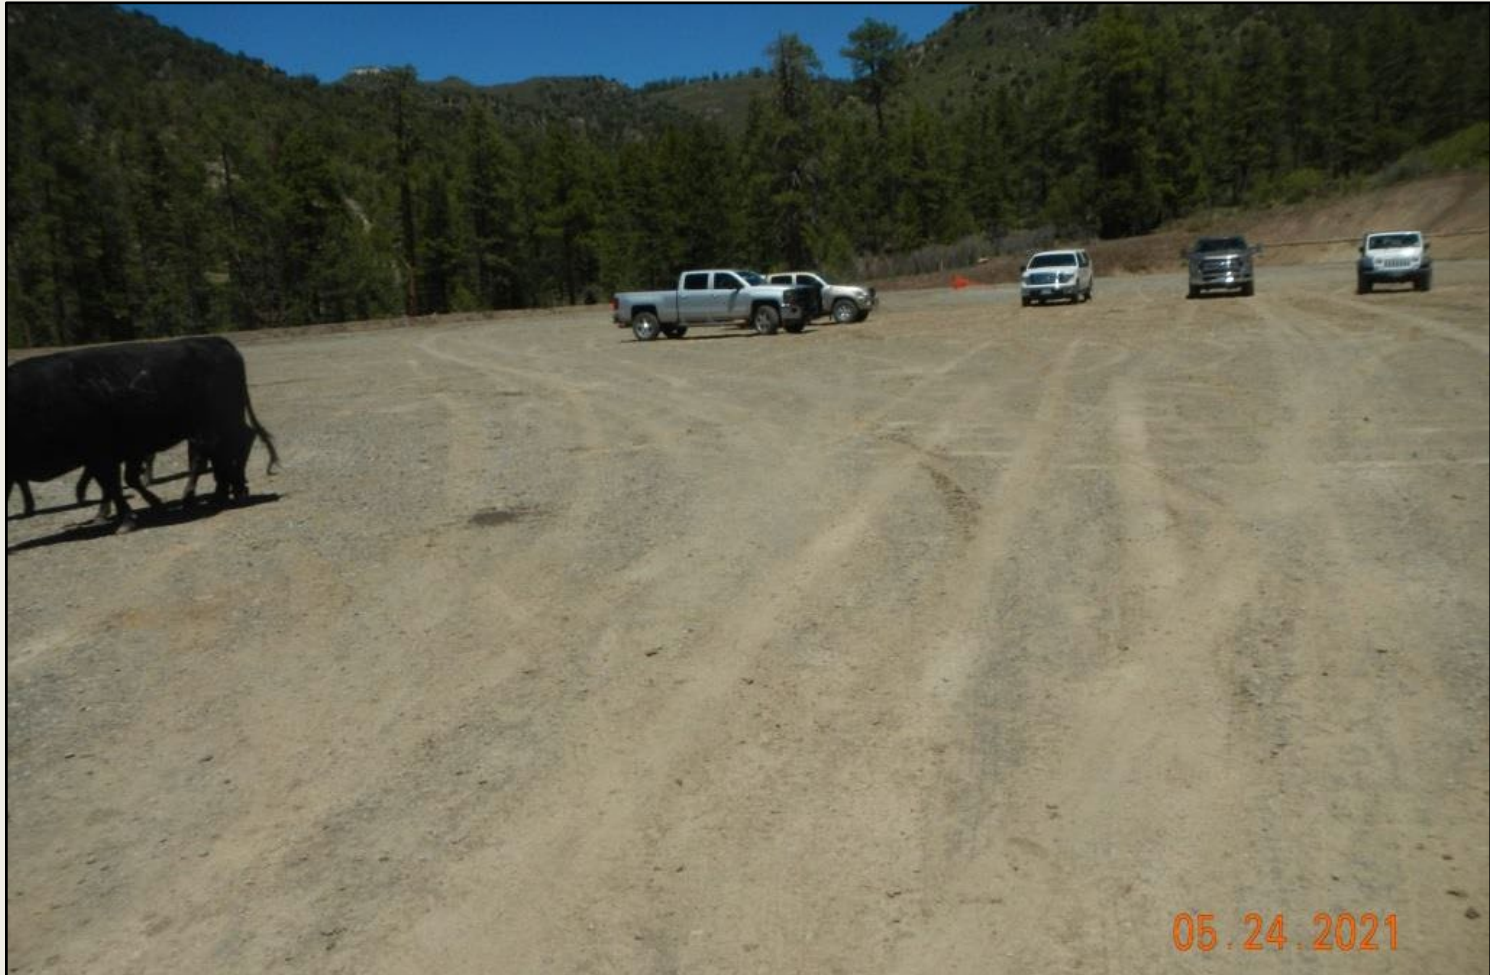
Photo 1. View of project area from the western project area facing center.

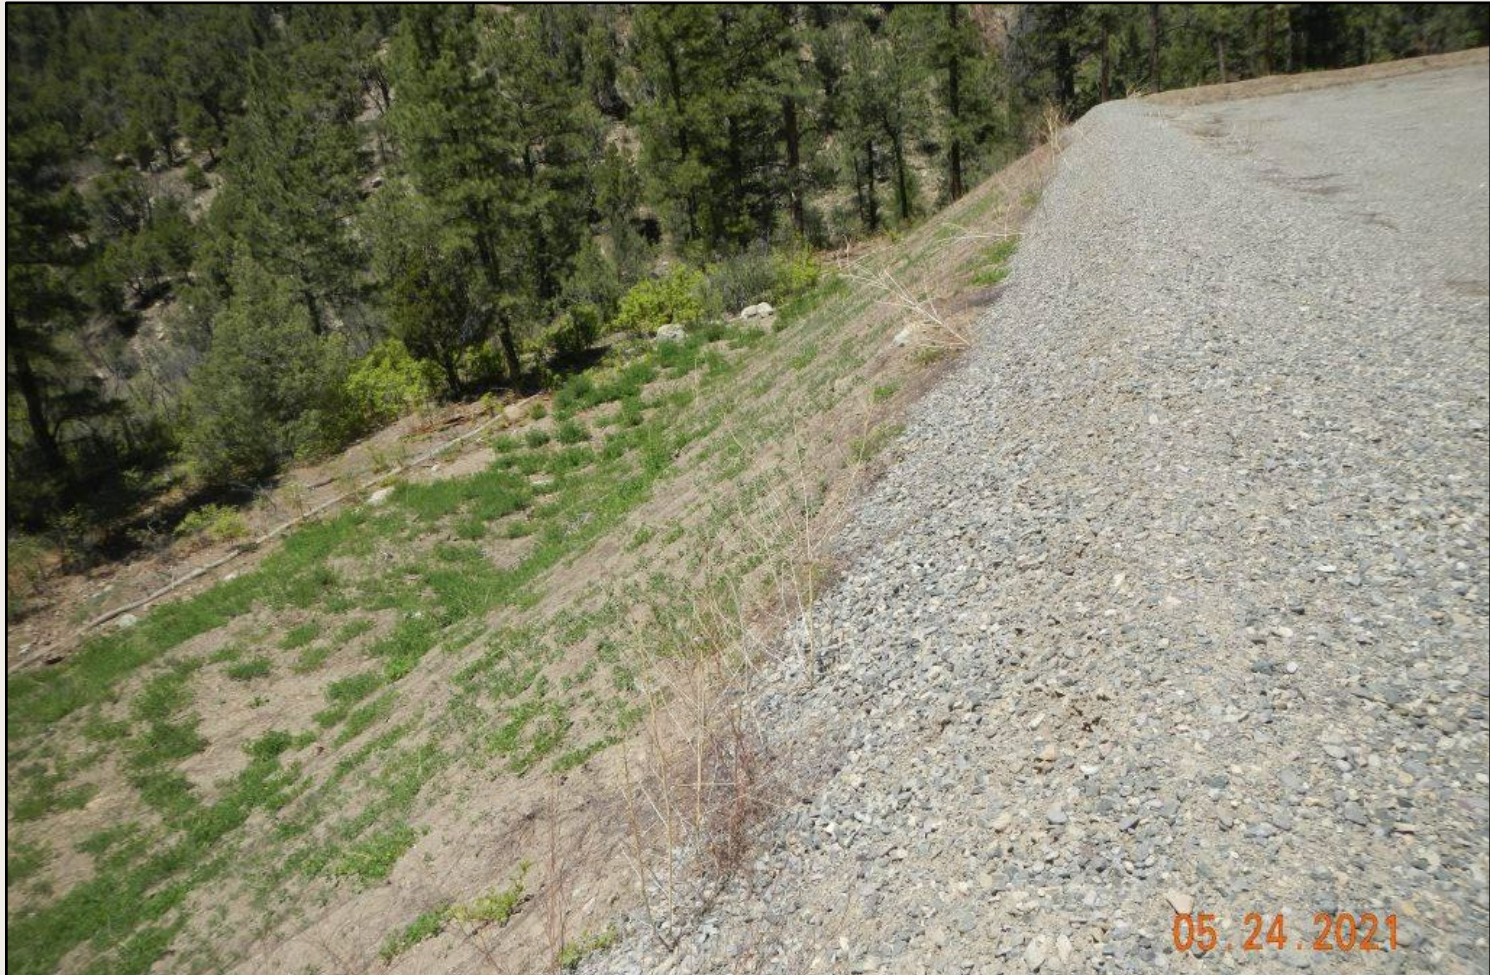
Photo 2. View of the northern project area from the northwestern corner facing westward. Revegetation is sparse. Operator discussed need to conduct spot seeding within the interim reclamation areas.

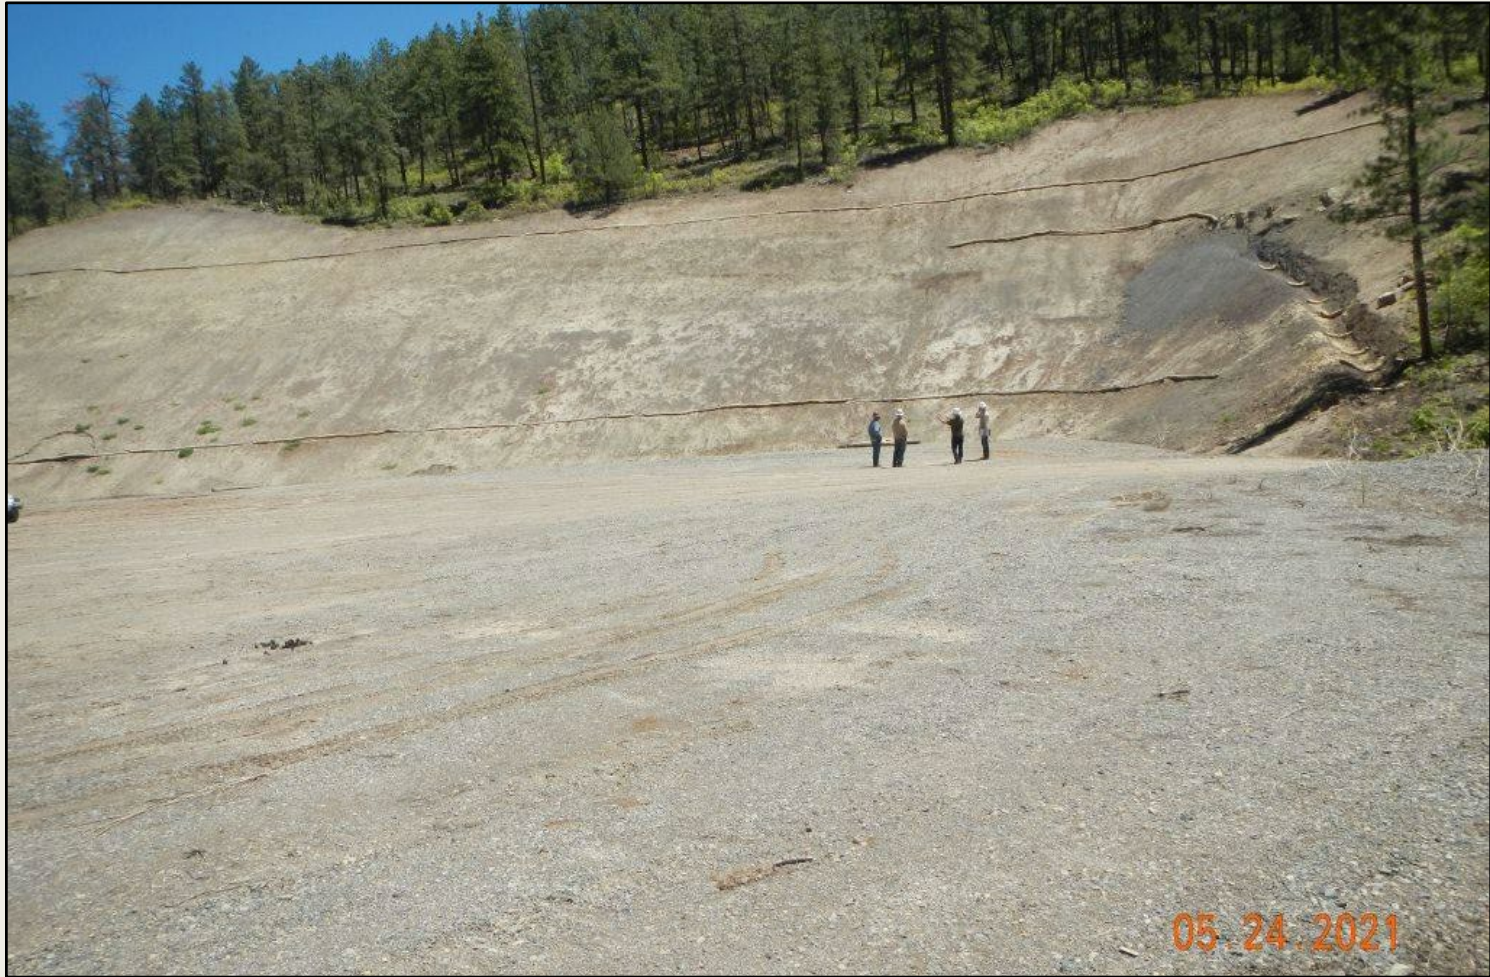
Photos 3. View of the eastern cut-slope. Operator and USFS discussed long term stabilization measures including construction of a ditch, seeding with three different hydro mulch compositions, and erosion control blankets.

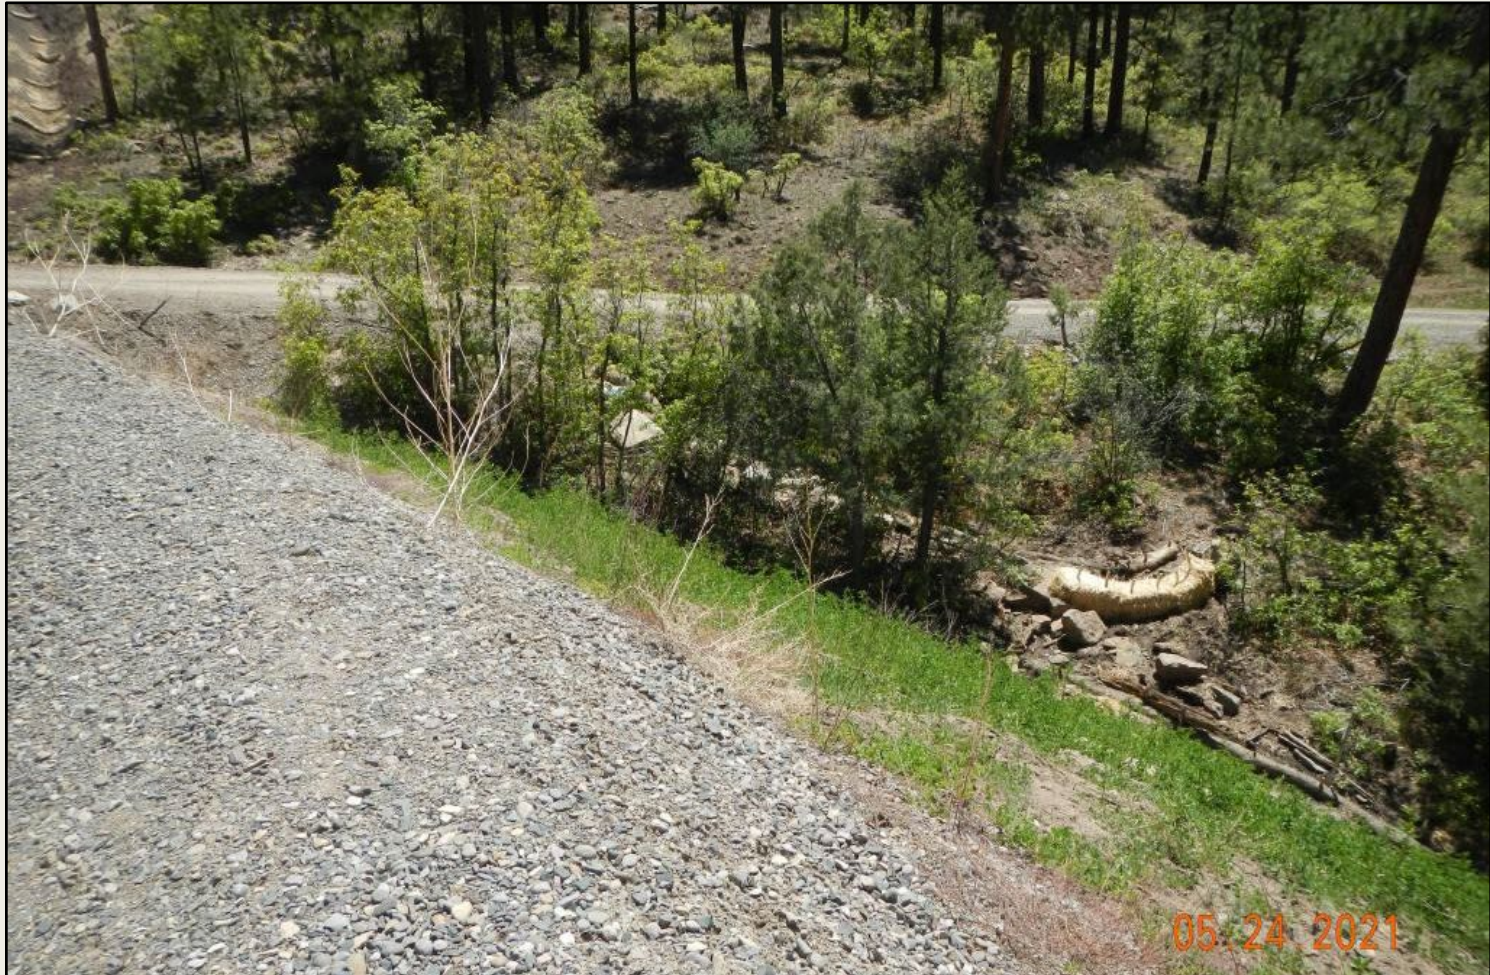
Photo 4. View of area at well pad entrance where concentrated stormwater flows out of a culvert and downslope toward a drainage exiting the western edge of the project area. Operator and USFS discussed installing an extended rock apron here and rock checks along erosional channeling (stormwater flowline) downslope.

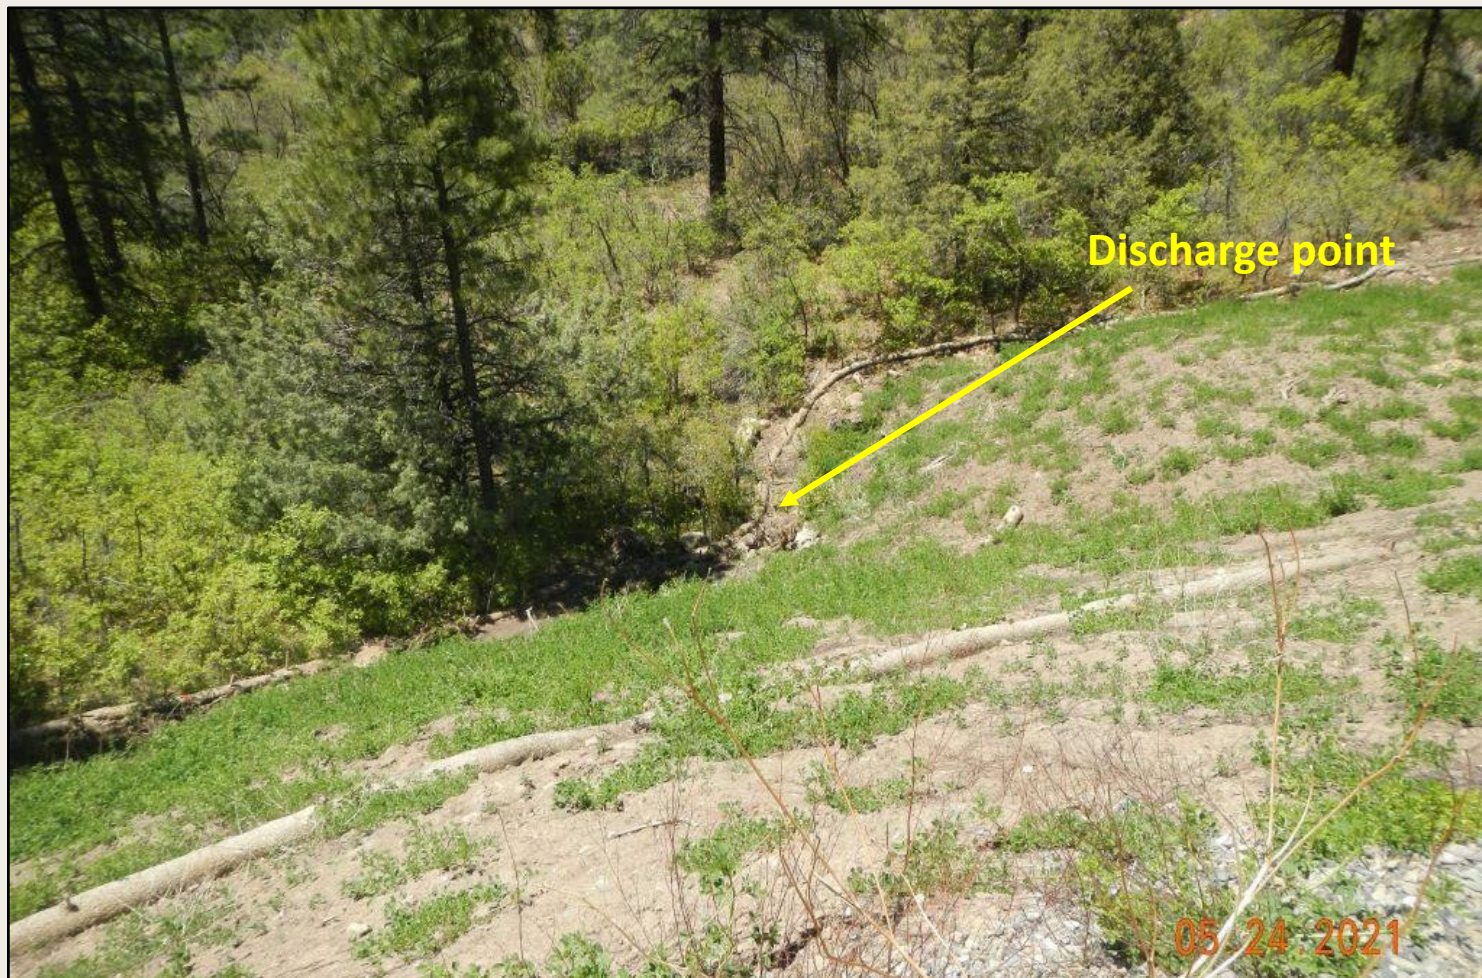
Photo 5. View of discharge point for the well pad and cut-slope into an ephemeral drainage. Operator and USFS discussed installation of an armored silt trap and discharge point here.
