Inspection Photos
Operator: Maralex
API: 067-09880
Date: 5/24/2021

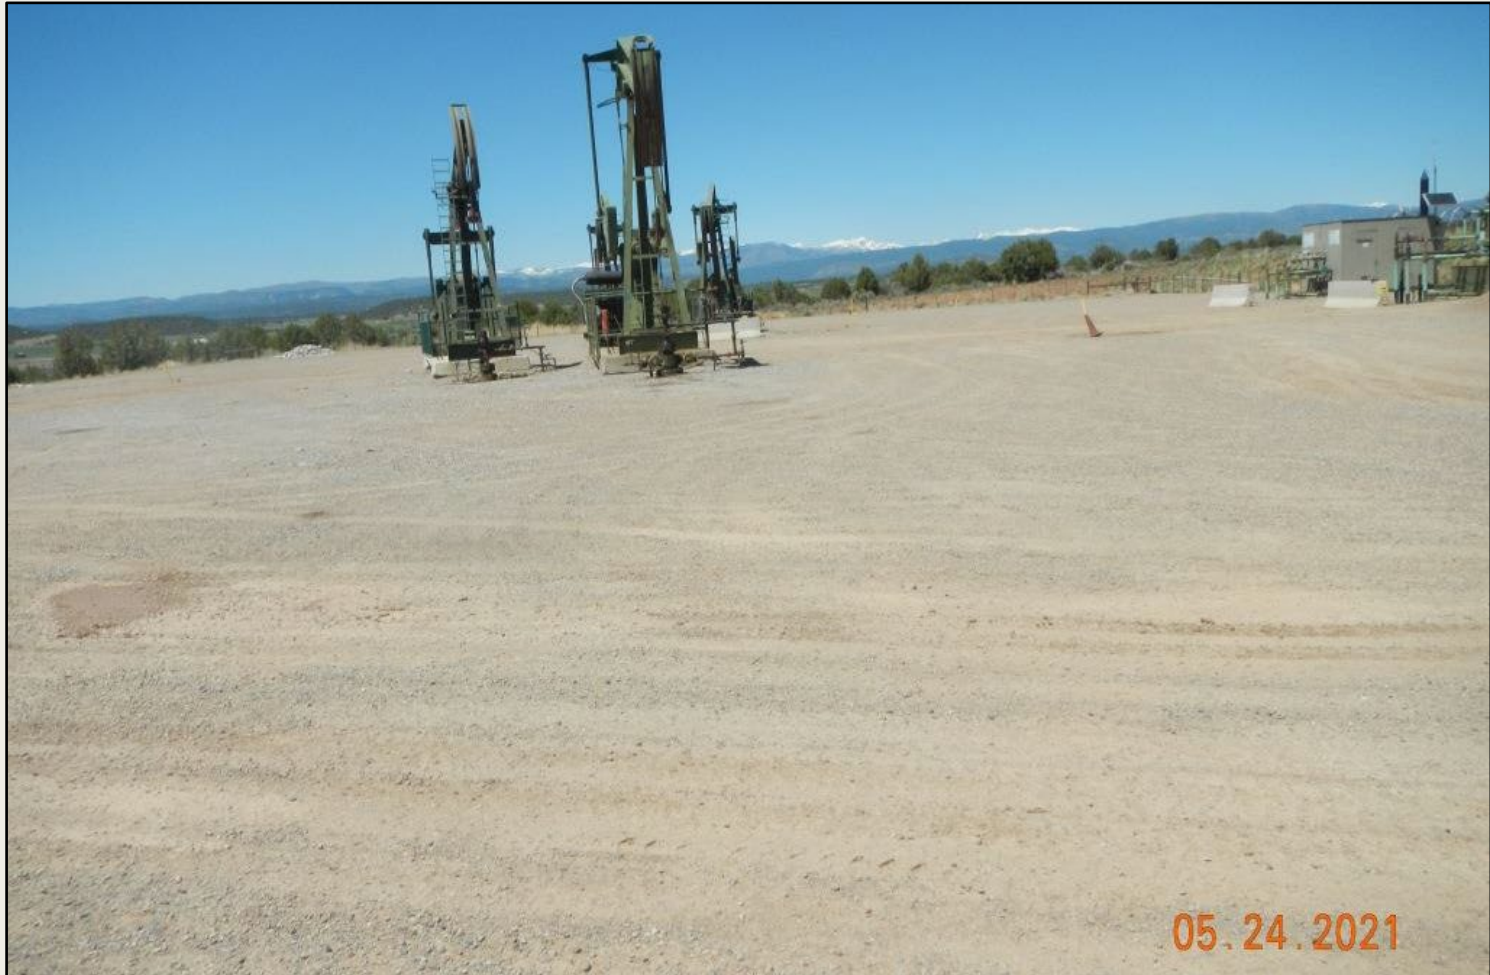
Photo 1. View of project area from the southwestern project area facing center.

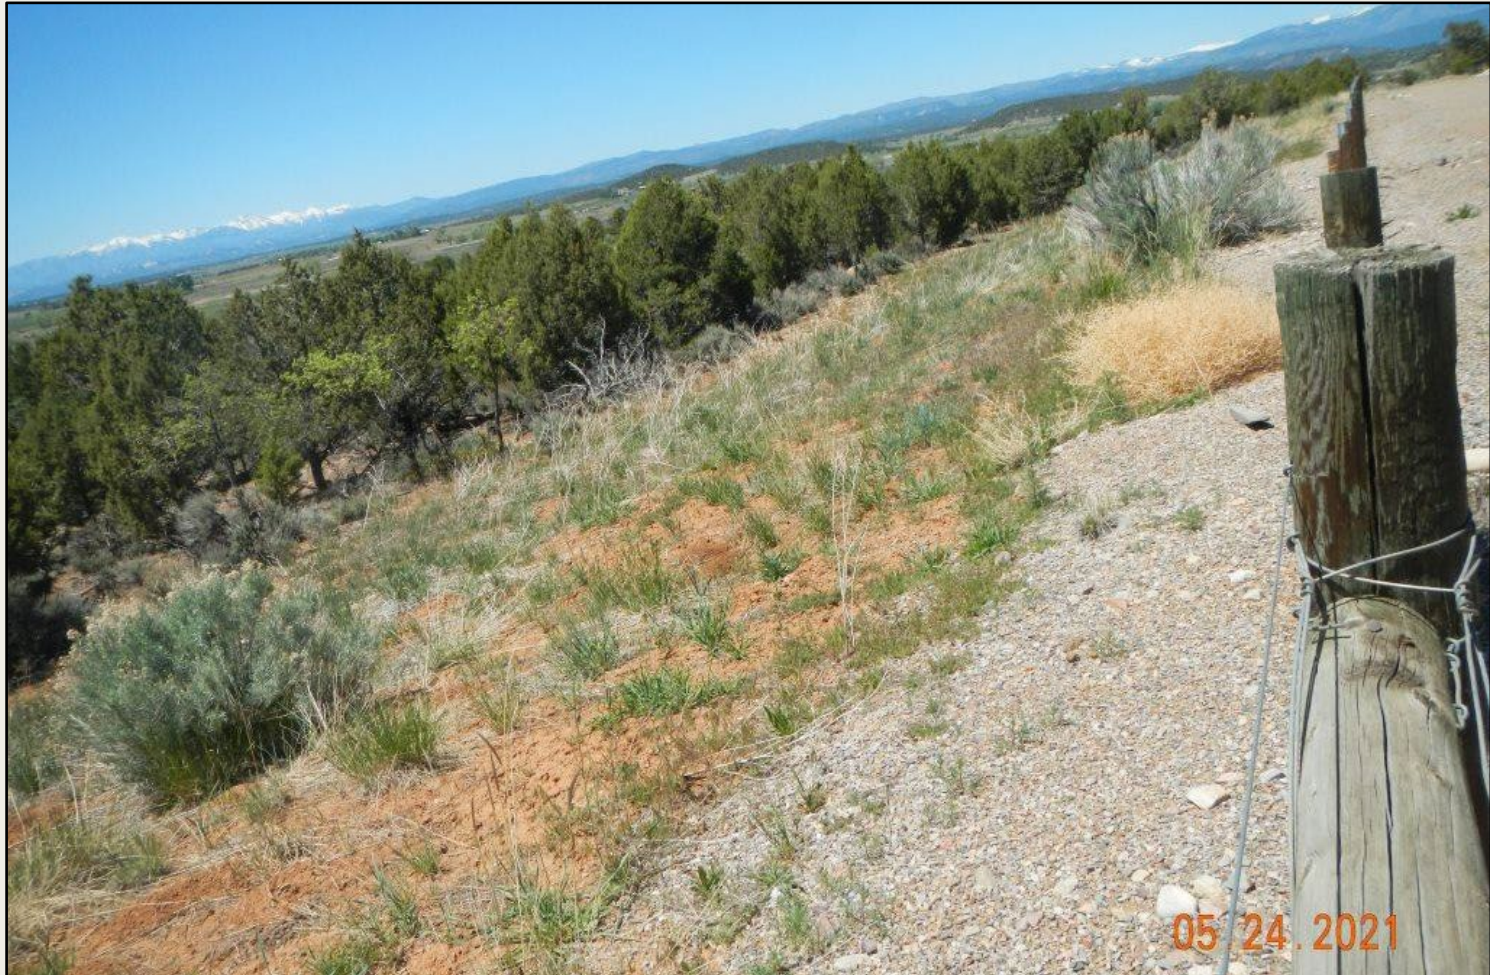
Photo 2. View of the western project area from the southwestern corner facing northward. Revegetation is progressing with crested wheatgrass, western wheatgrass, and rubber rabbitbrush.

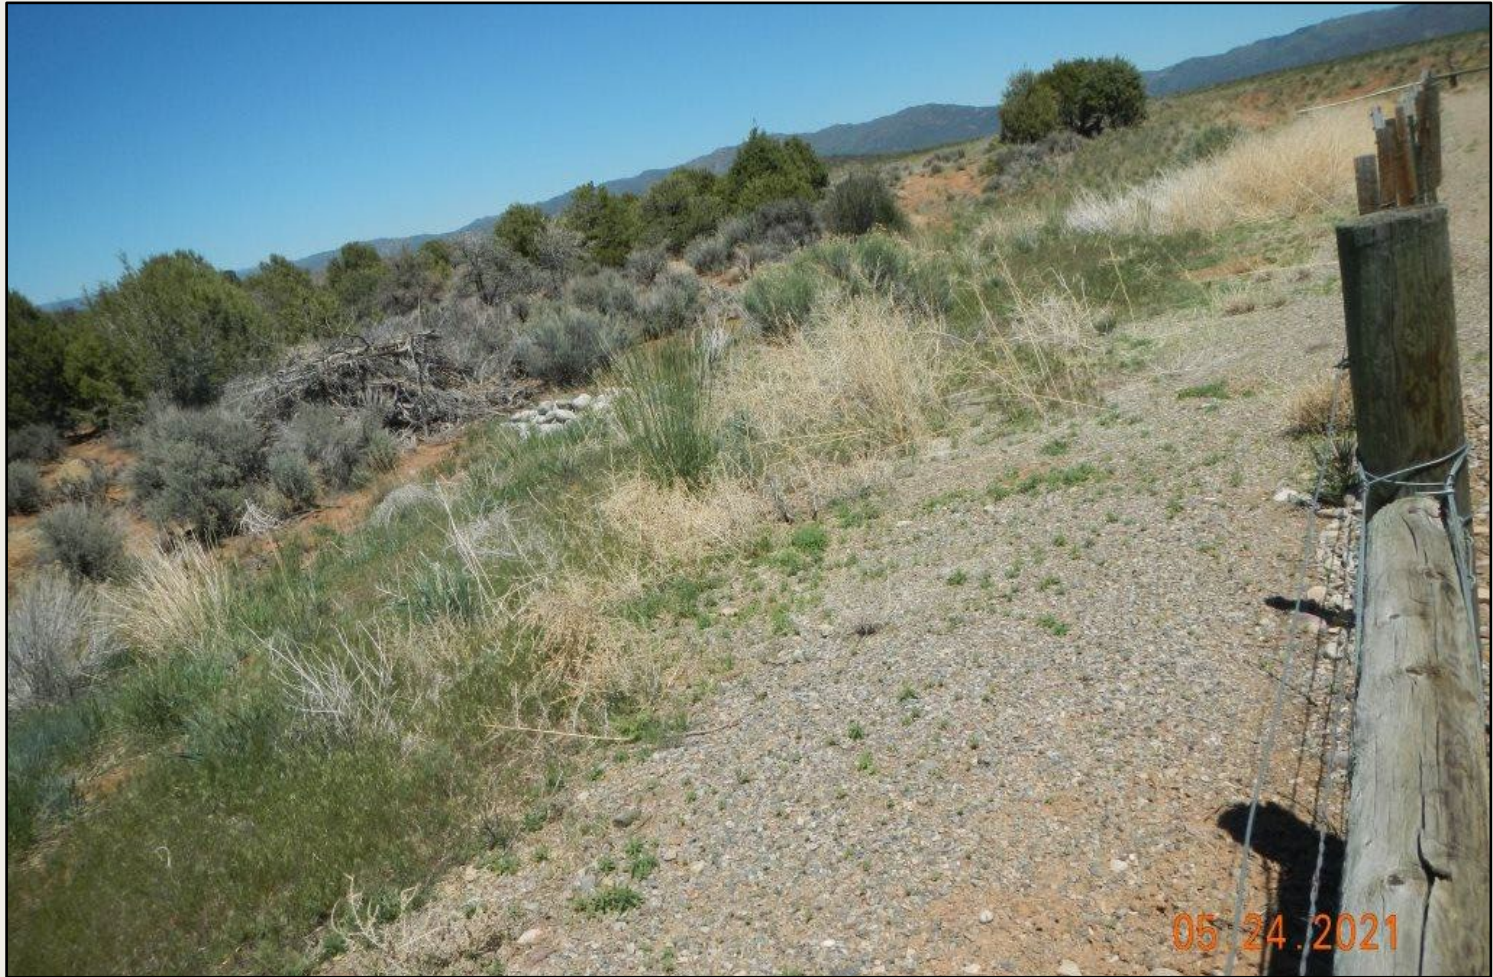
Photos 3. View of the northern project area from the northwestern corner facing eastward.

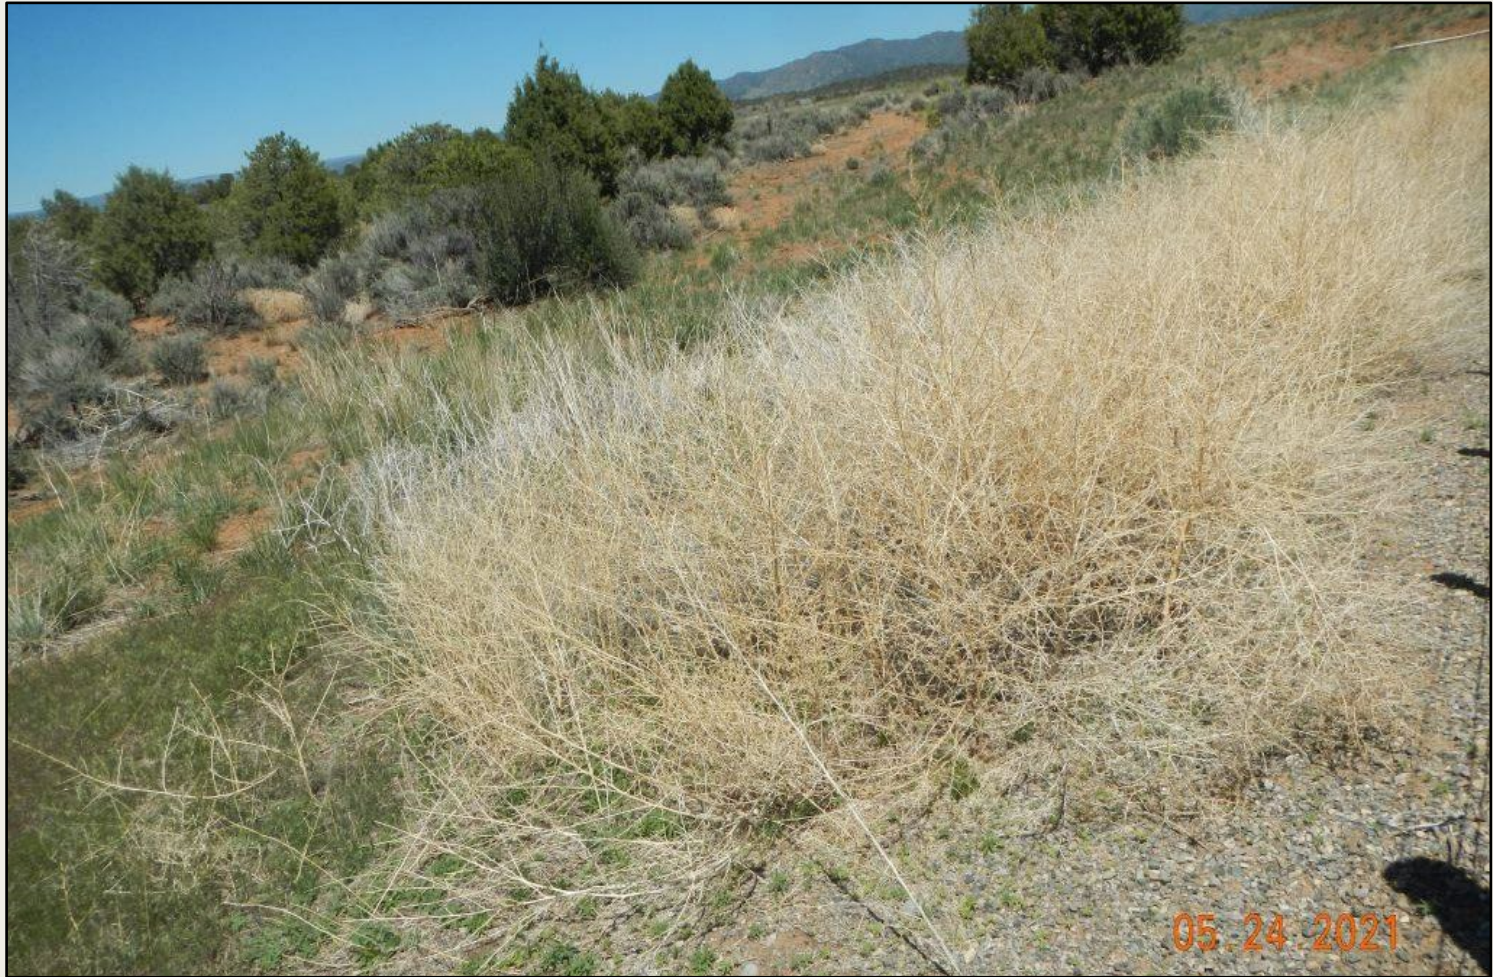
Photo 4. View of dense kochia debris along the northern edge of the working area (up to 4 feet tall).

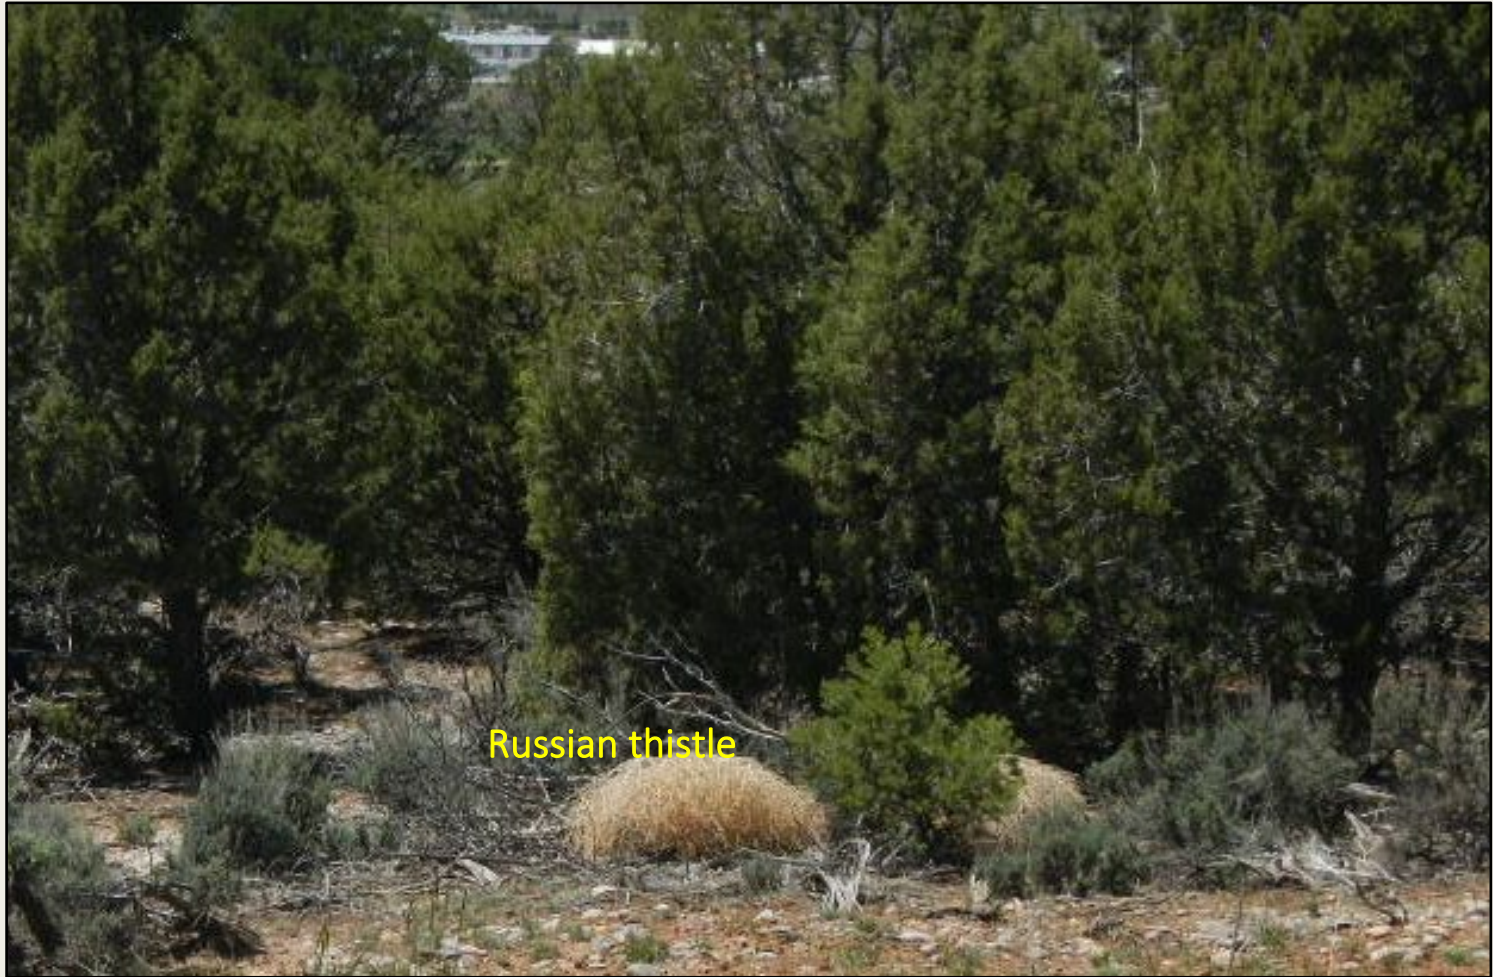
Photo 5. View of reference area vegetation comprised of pinyon and juniper woodland with sagebrush, squirreltail, penstemon, and blue grama in the understory. Russian thistle debris appears to have blown off site.
