# Inspection Photos

5/26/2021

Operator: CAERUS PICEANCE LLC #10456

Location ID: 335904

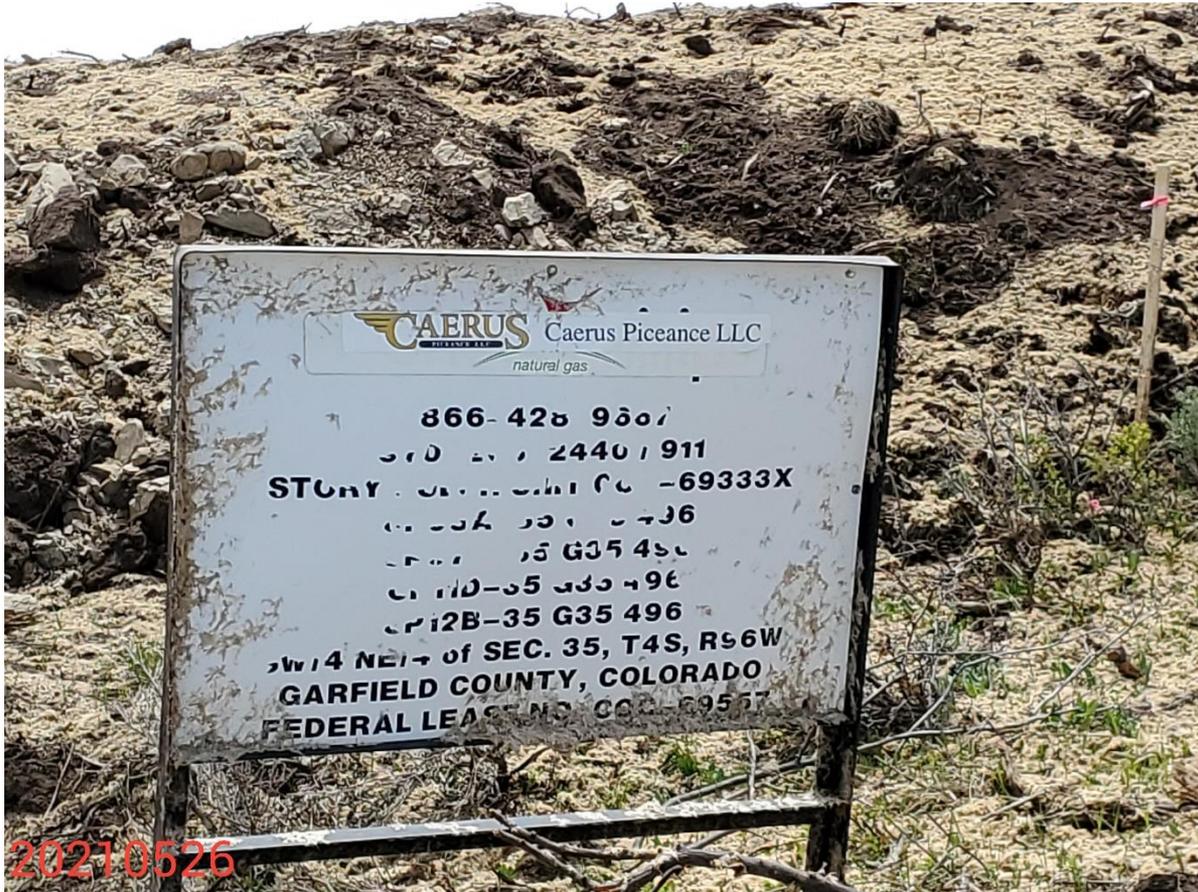
Photo 1: Photo shows signage at Location entrance is no longer legible.

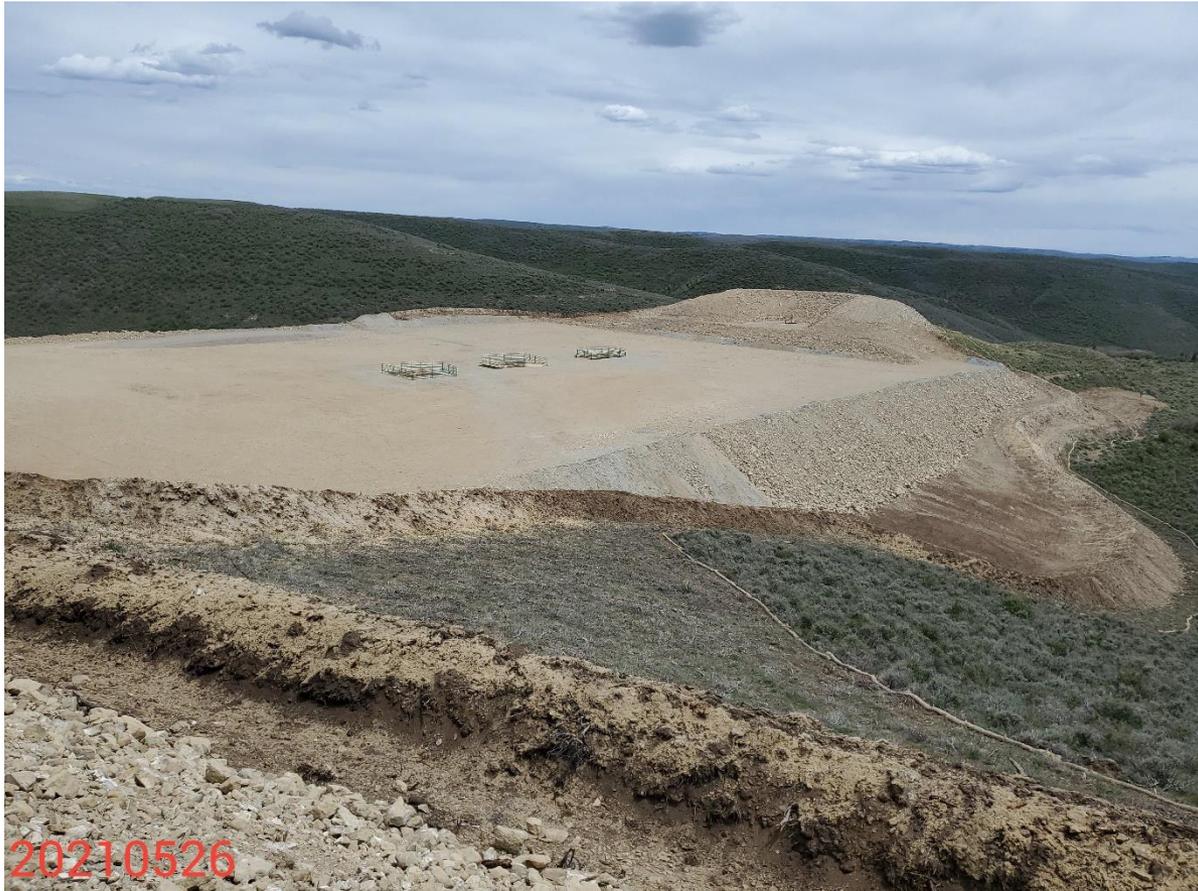
**Photo 2:** Photo taken from the south end of the frac pad, facing southeast. Photo provides an overview of the Location. Photo also shows Operator has utilized topsoil at the base of the fill slopes/subsoils of the Location as a berm and sediment trap/pond to manage stormwater; topsoil at risk of degradation, loss and displacement due to stormwater discharge

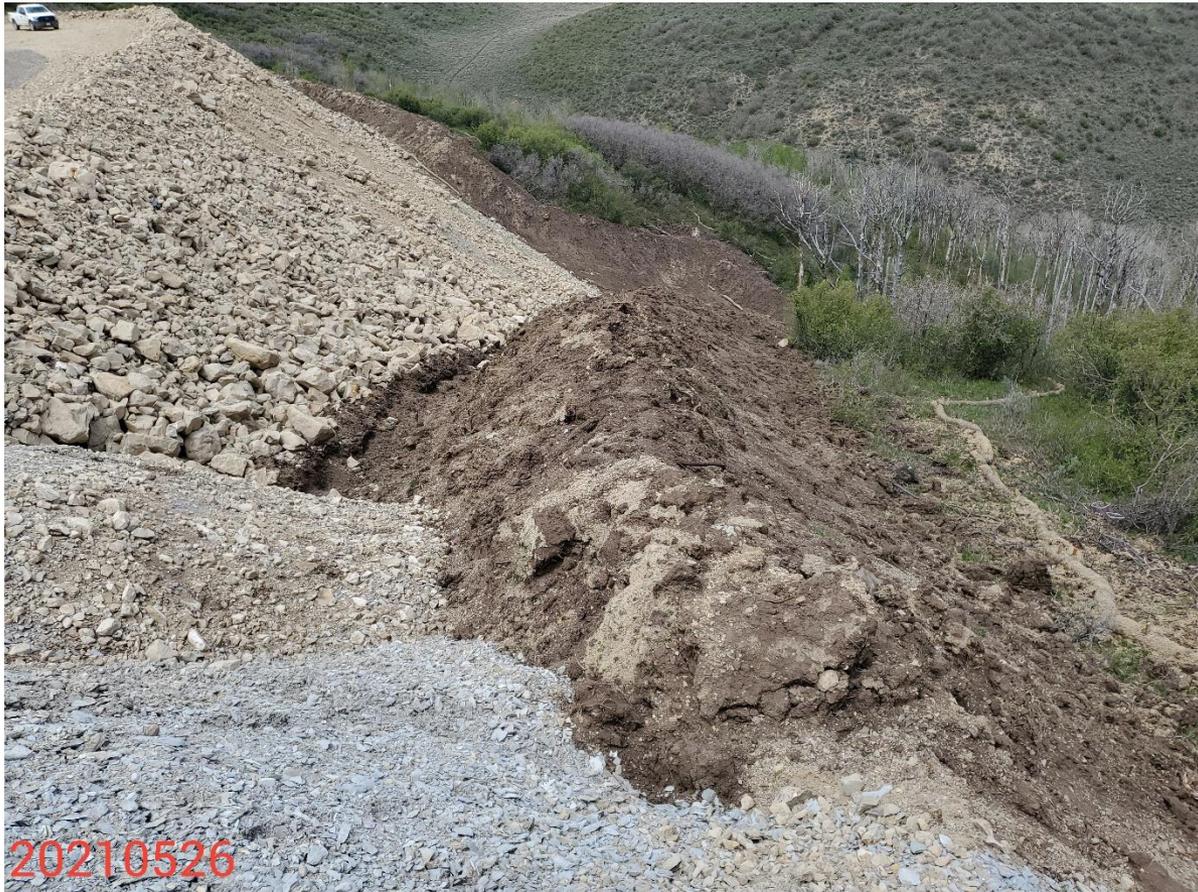
**Photo 3:** Photo taken from the east end of the Location, facing north. Photo show Operator has utilized topsoil at the base of the fill slopes/subsoils of the Location as a berm and sediment trap/pond to manage stormwater; topsoil at risk of degradation, loss and displacement due to stormwater discharge. Photo also shows hydromulch on soils is no longer in proper functioning condition.

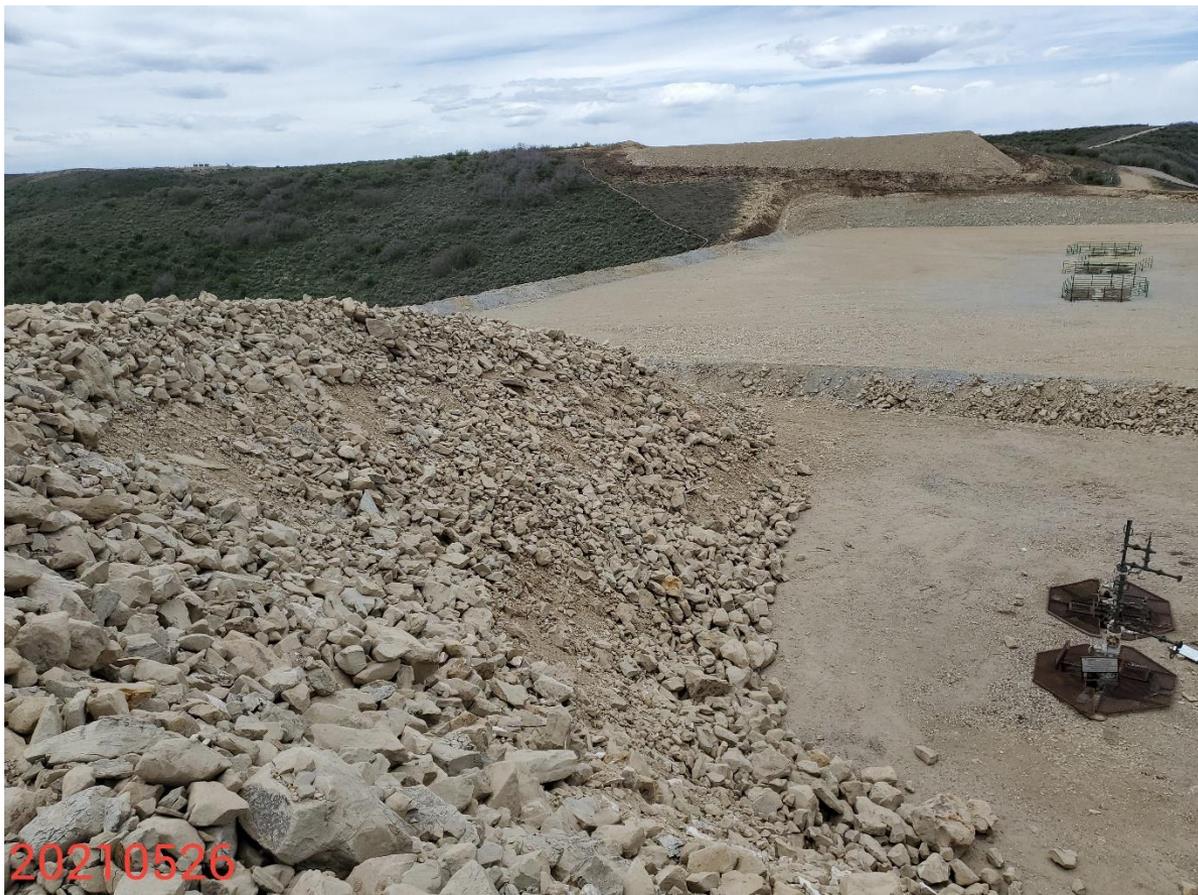
**Photo 4:** Photo taken from the south end of the Location, facing northwest. Photo provides an overview of the Location.

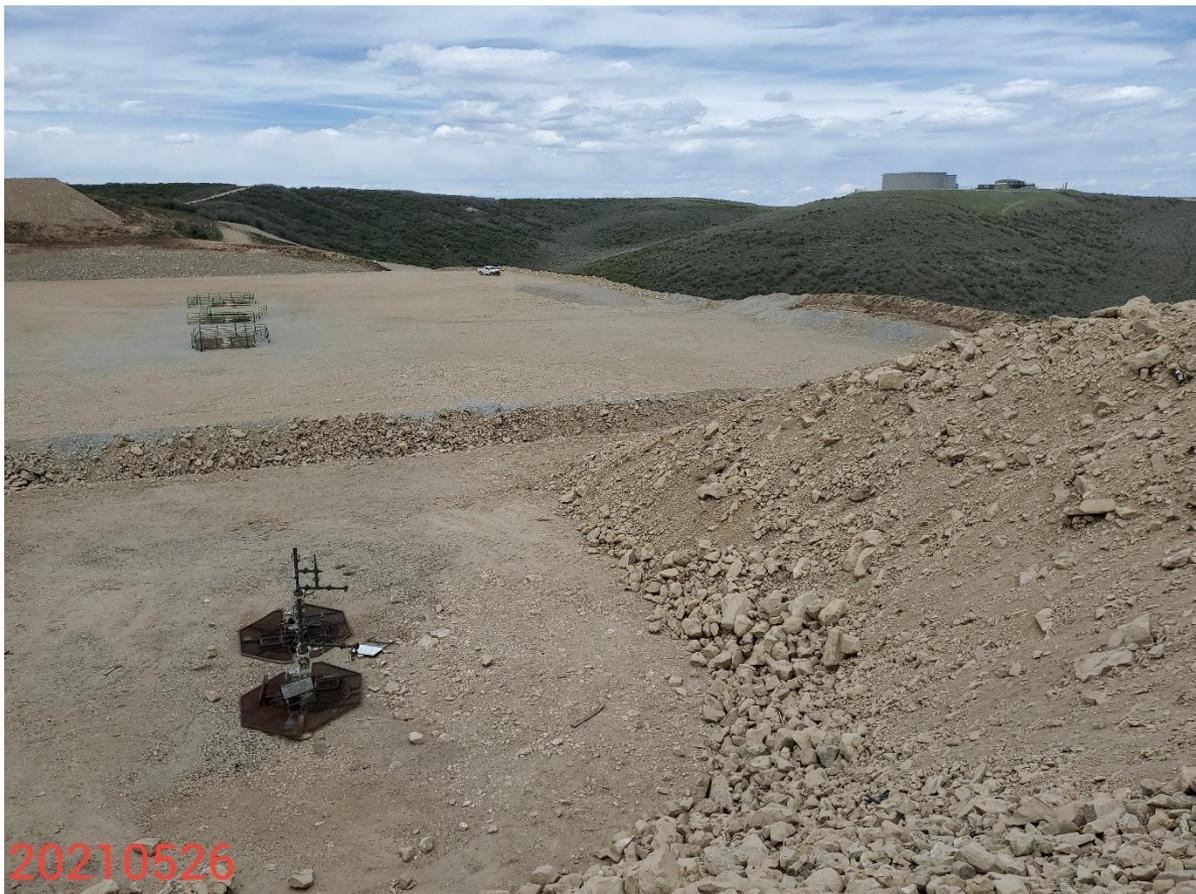
**Photo 5:** Photo taken from the south end of the Location, facing northeast. Photo provides an overview of the Location.

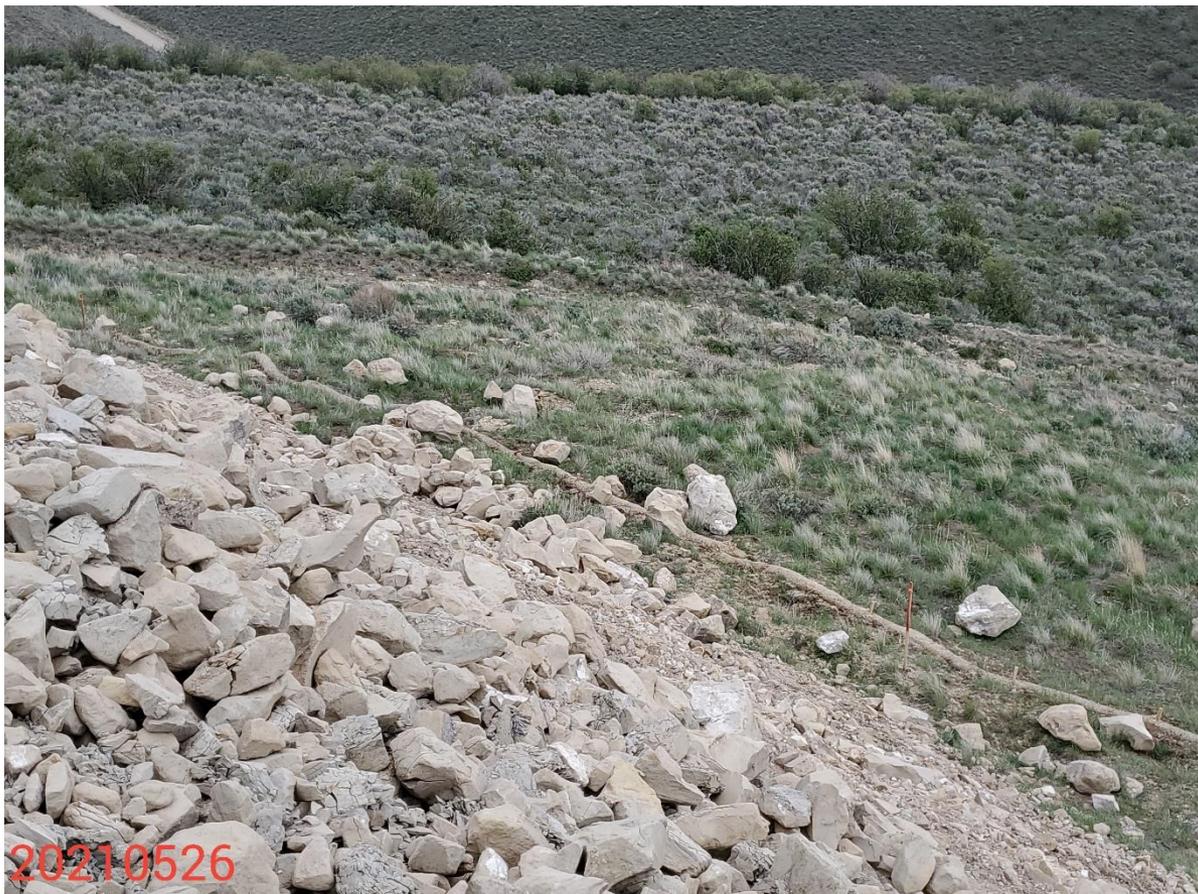
**Photo 6:** Photo shows control measures to protect/stabilize the cut/fill slopes of the Location is missing or insufficient.

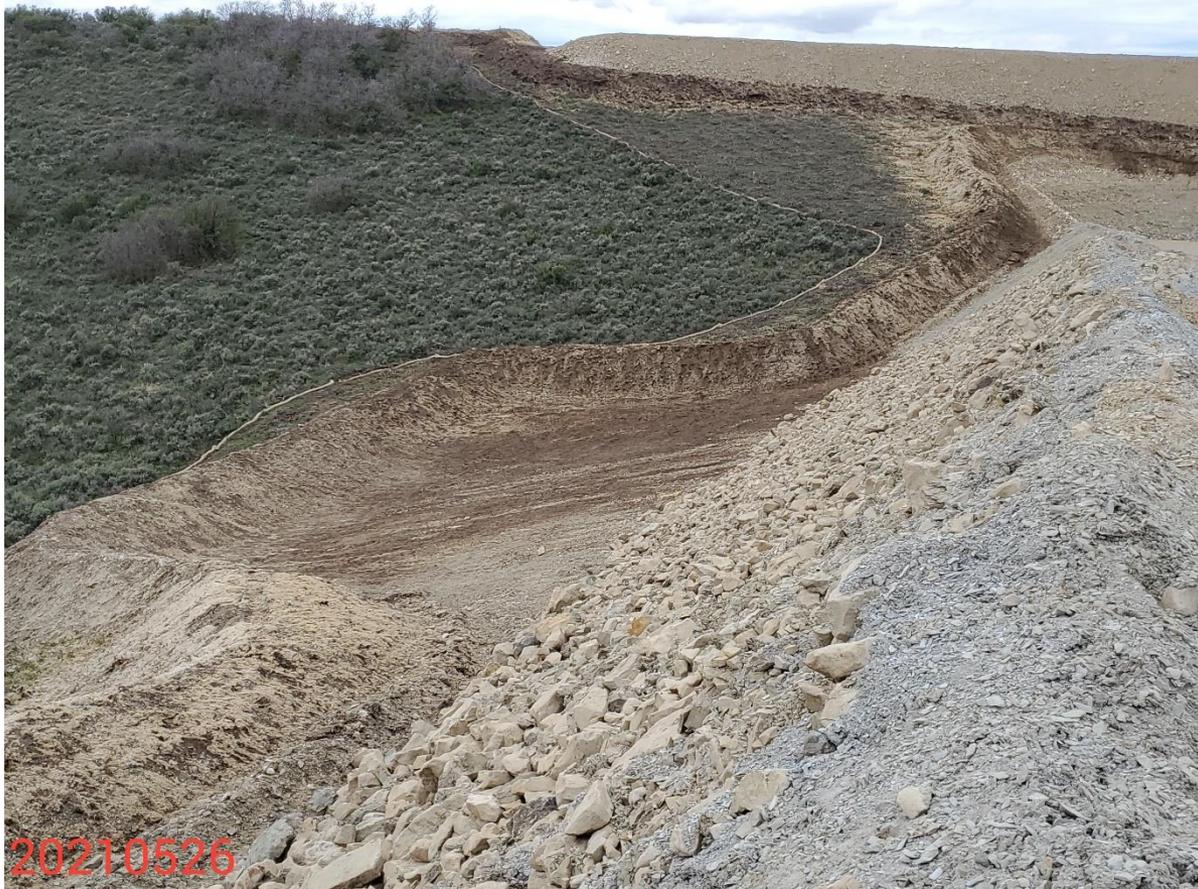
**Photo 7:** Photo taken from the west end of the Location, facing northwest. Photo shows Operator has utilized topsoil at the base of the fill slopes/subsoils of the Location as a berm and sediment trap/pond to manage stormwater; topsoil at risk of degradation, loss and displacement due to stormwater discharge

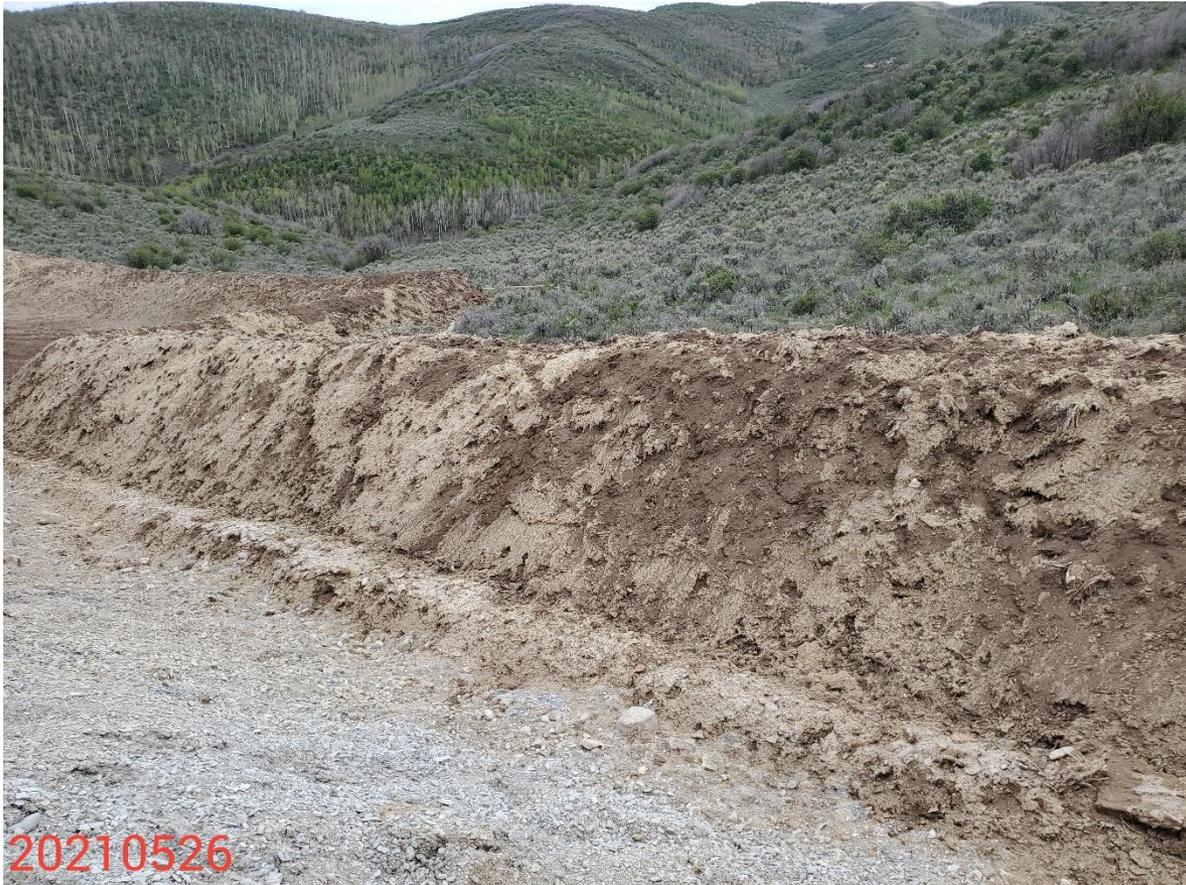
**Photo 8:** Photo taken from the west end of the Location, facing southwest. Photo show Operator has utilized topsoil at the base of the fill slopes/subsoils of the Location as a berm and sediment trap/pond to manage stormwater; topsoil at risk of degradation, loss and displacement due to stormwater discharge. Photo also shows hydromulch on soils is no longer in proper functioning condition.

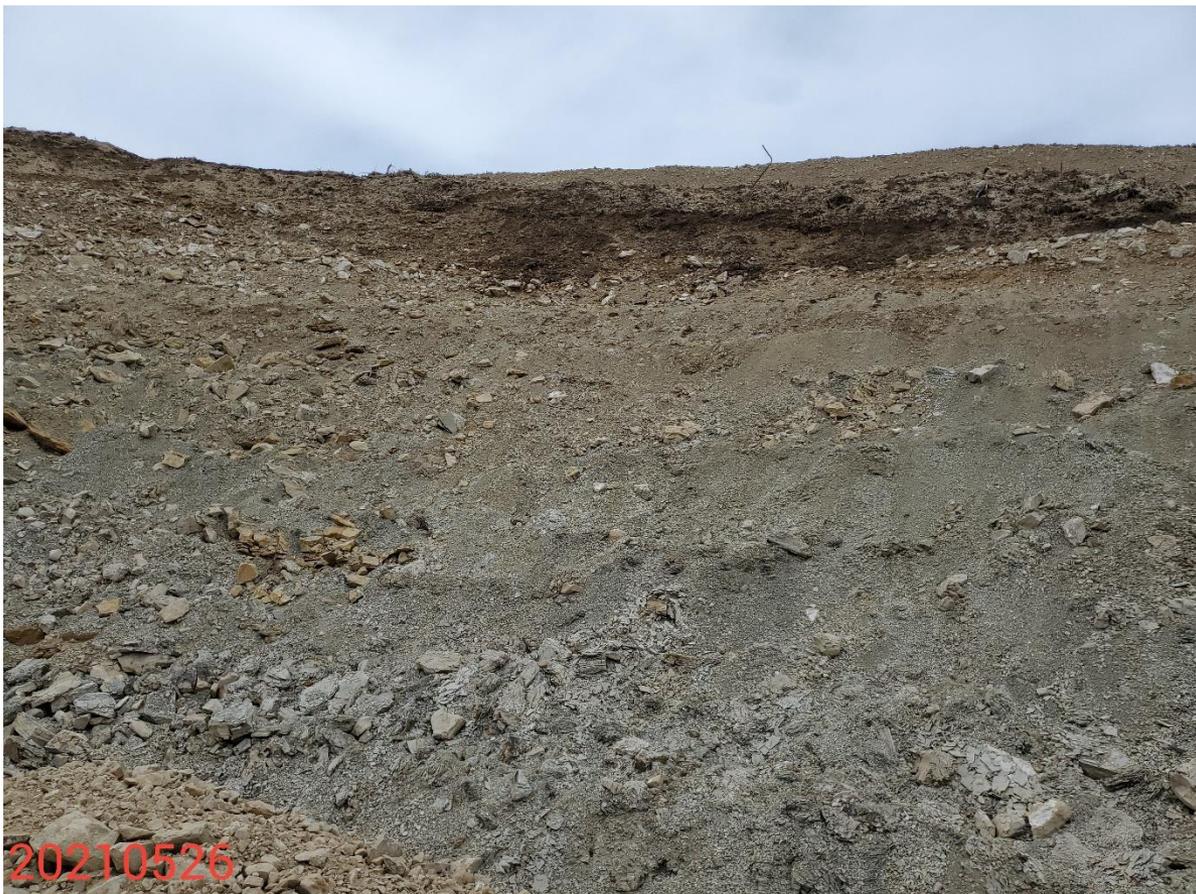
**Photo 9:** Photo shows control measures to protect/stabilize the cut/fill slopes of the Location is missing or insufficient.

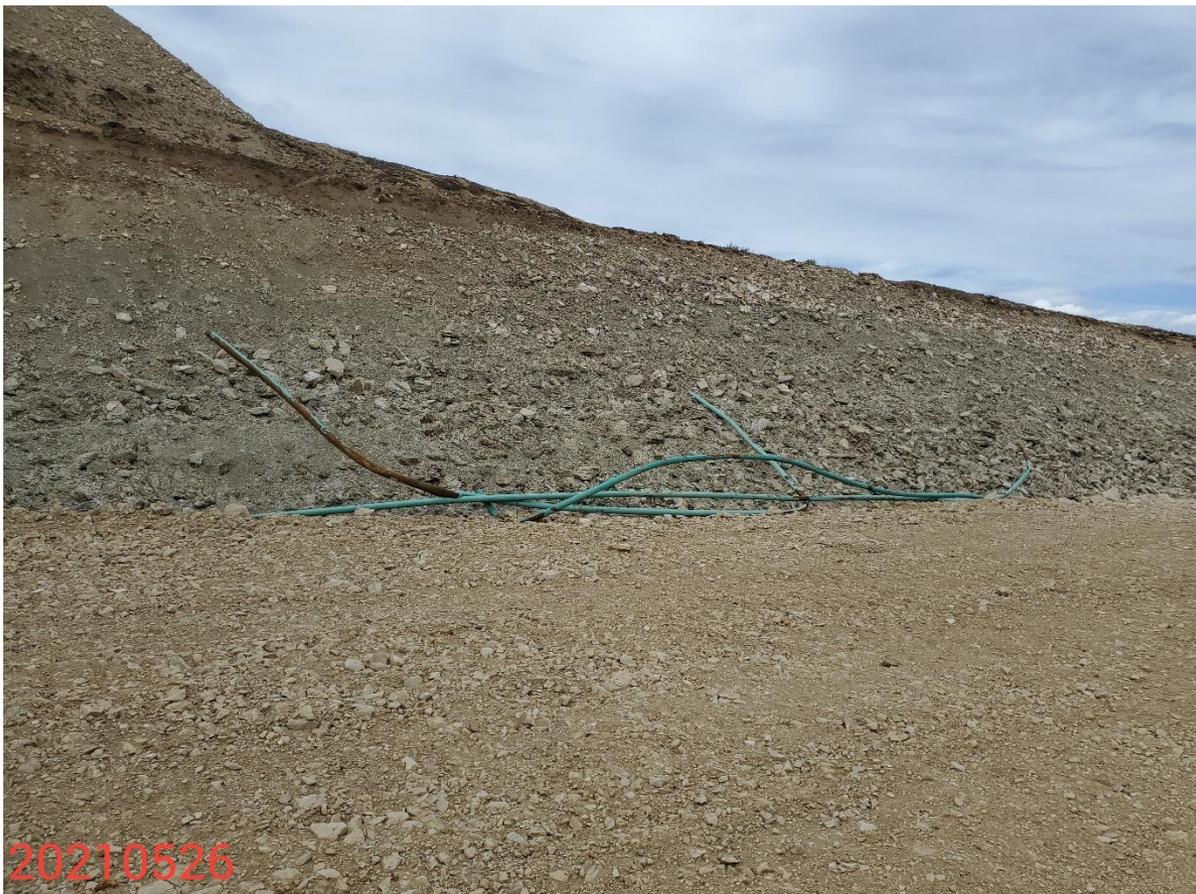
**Photo 10:** Photo shows unused pipe equipment/debris observed on the north end of the Location.

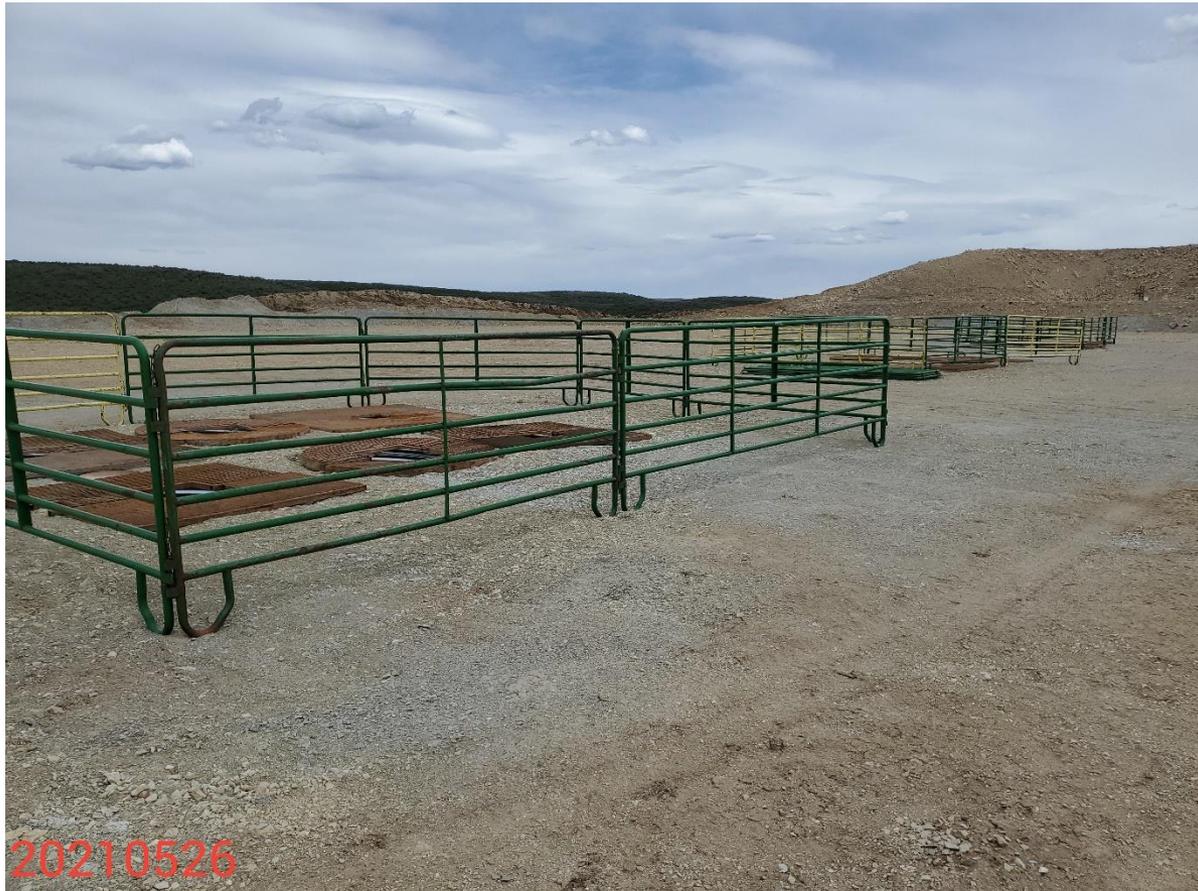
**Photo 11:** Photo shows conductors and cellars for the undrilled wells.

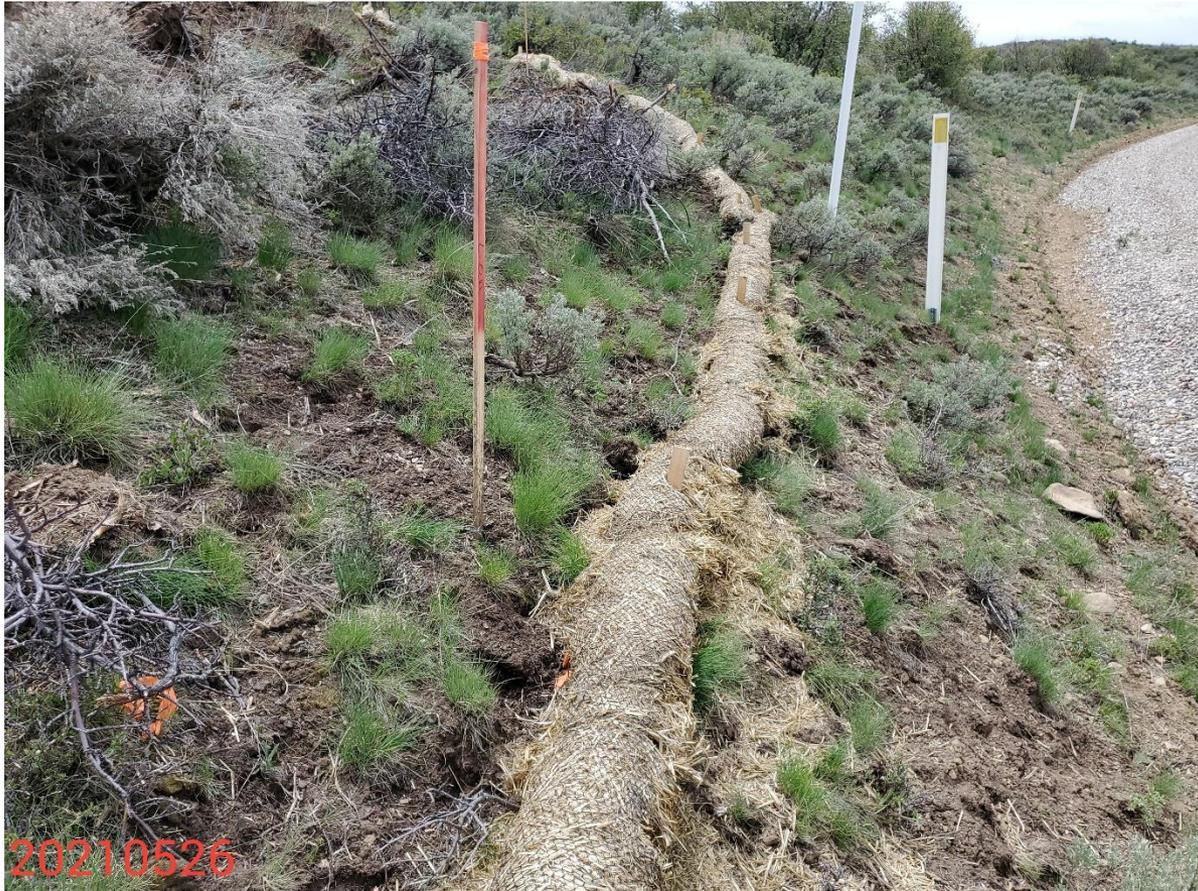
**Photo 12:** Photo shows examples of erosion logs observed that are either not installed in accordance with good engineering practices, or maintained in a proper functioning condition; wattles not trenched/backfilled.

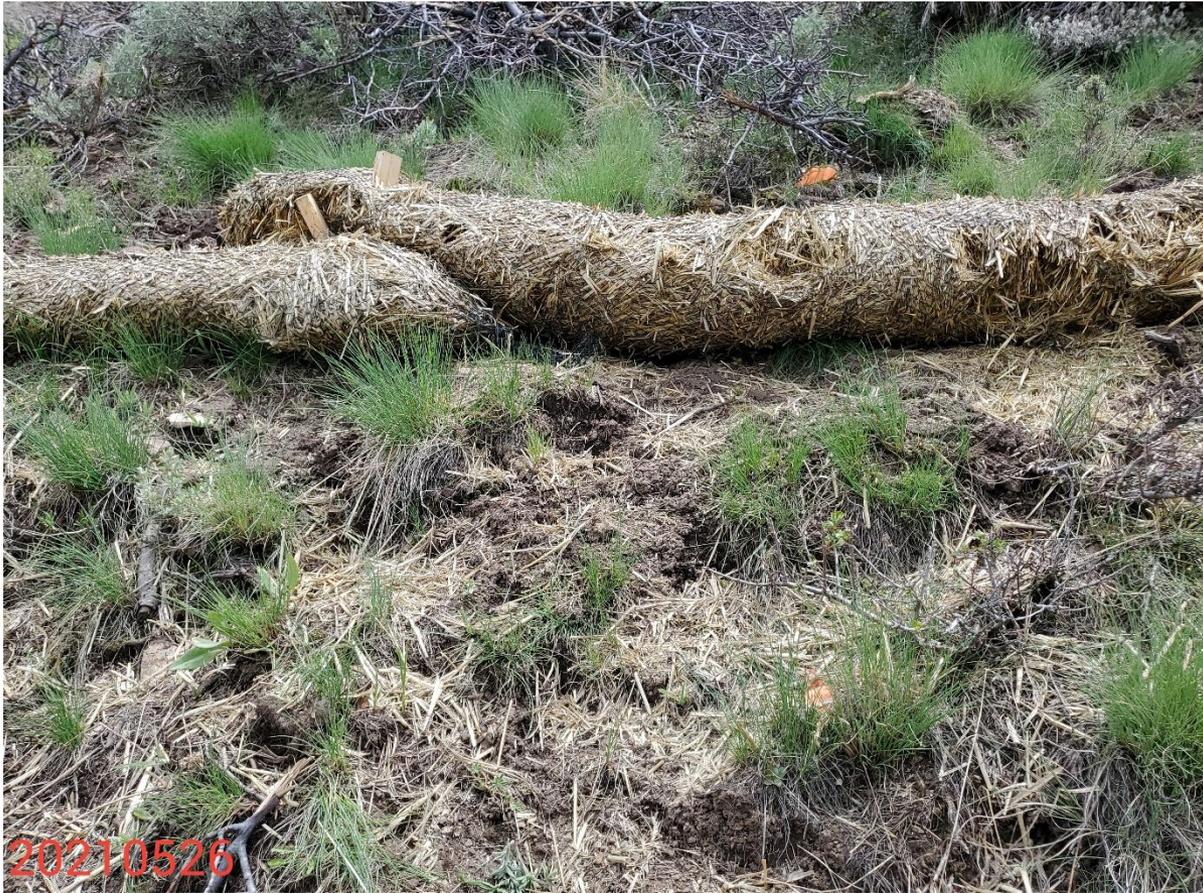
**Photo 13:** See comments under photo 11.

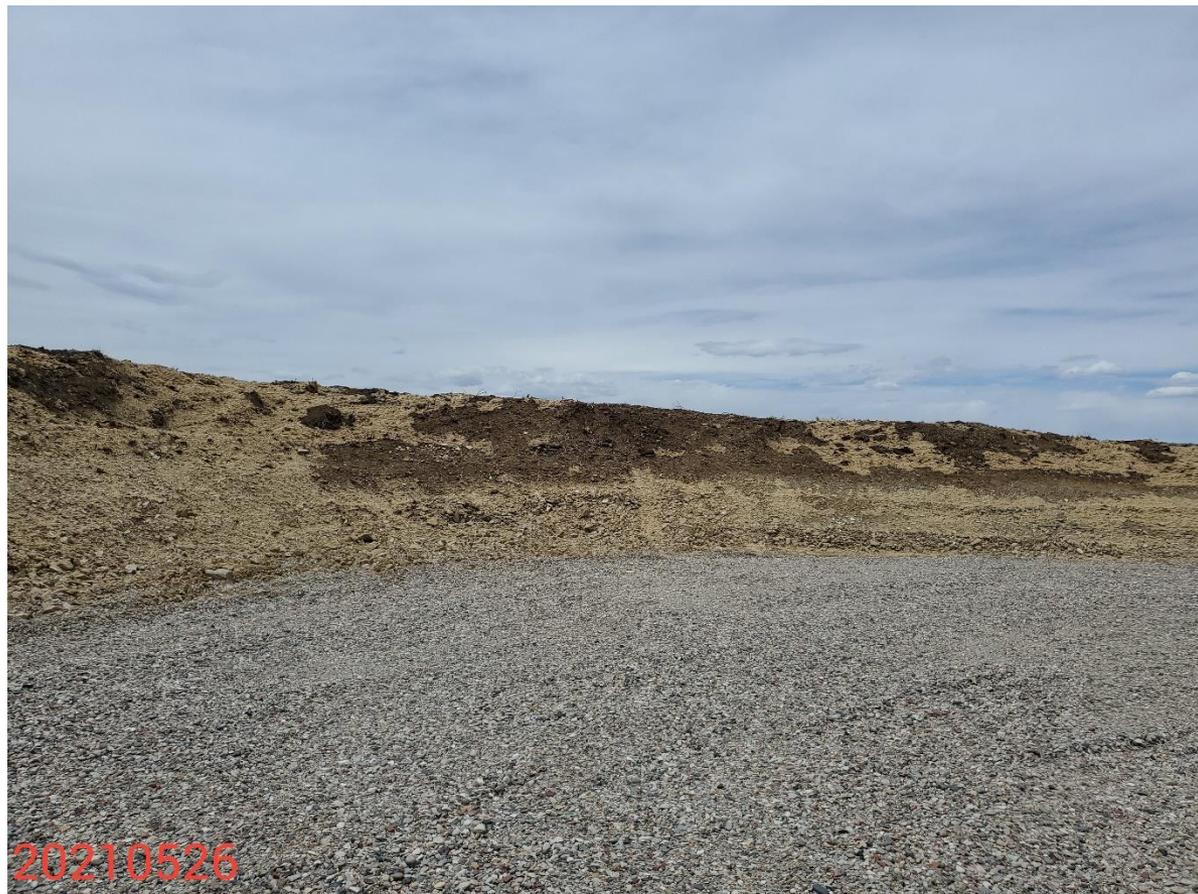
**Photo 14:** Photo taken from the frac pad, facing northwest. Photo shows hydromulch on soils is no longer in proper functioning condition.
