Construction and Stormwater Inspection

May 25, 2021

Operator: PROVIDENCE OPERATING LLC DBA POCO
OPERATING- #10694

Inspection Photos
Location Name: Double J /35-11 Pad
Location ID: 460271

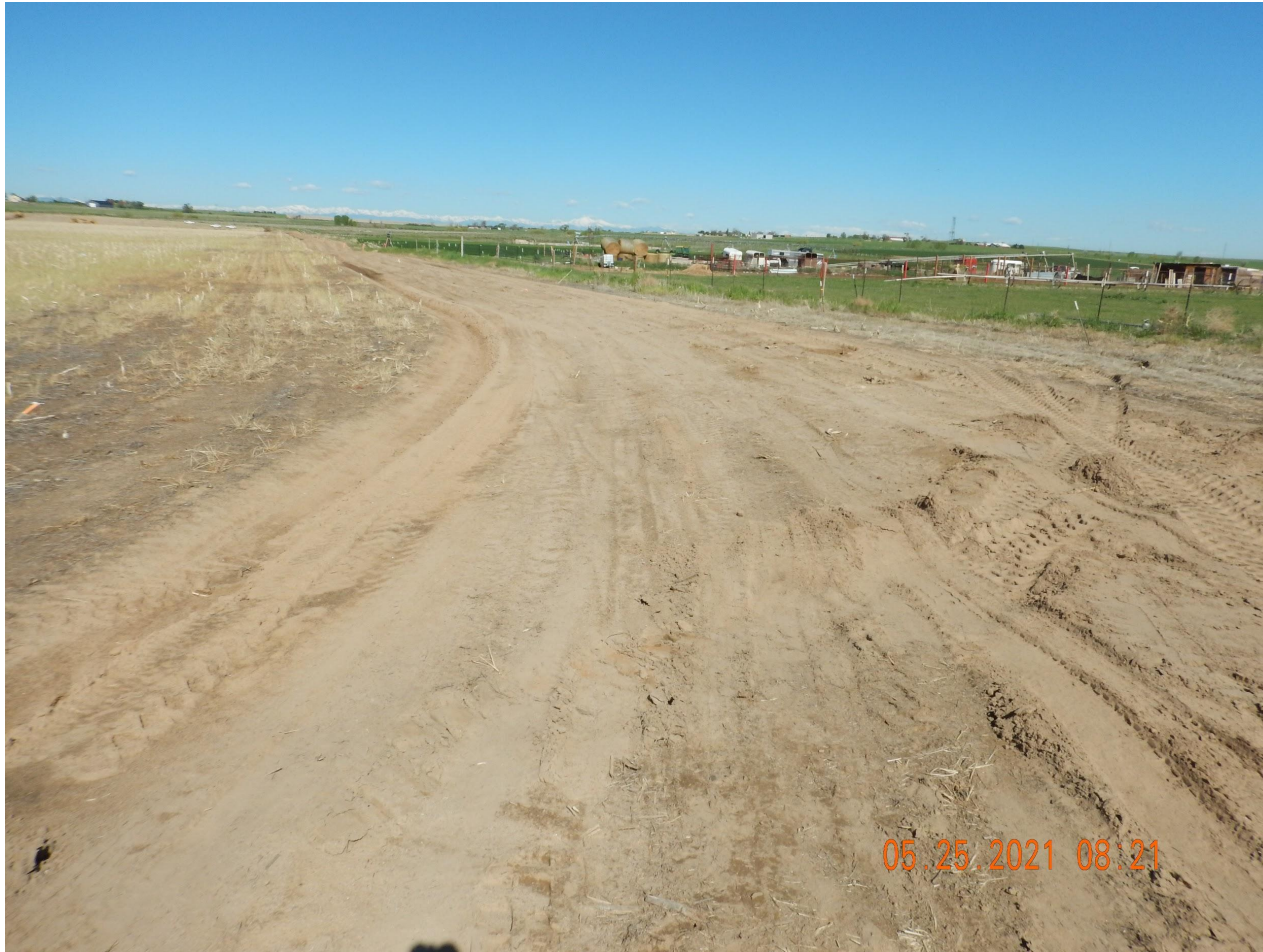
Photo 1. Photo taken from the entrance of location, facing West. Photo illustrates major construction activities have commenced. Operator has installed a ditch BMP along the outer perimeter of the access road.

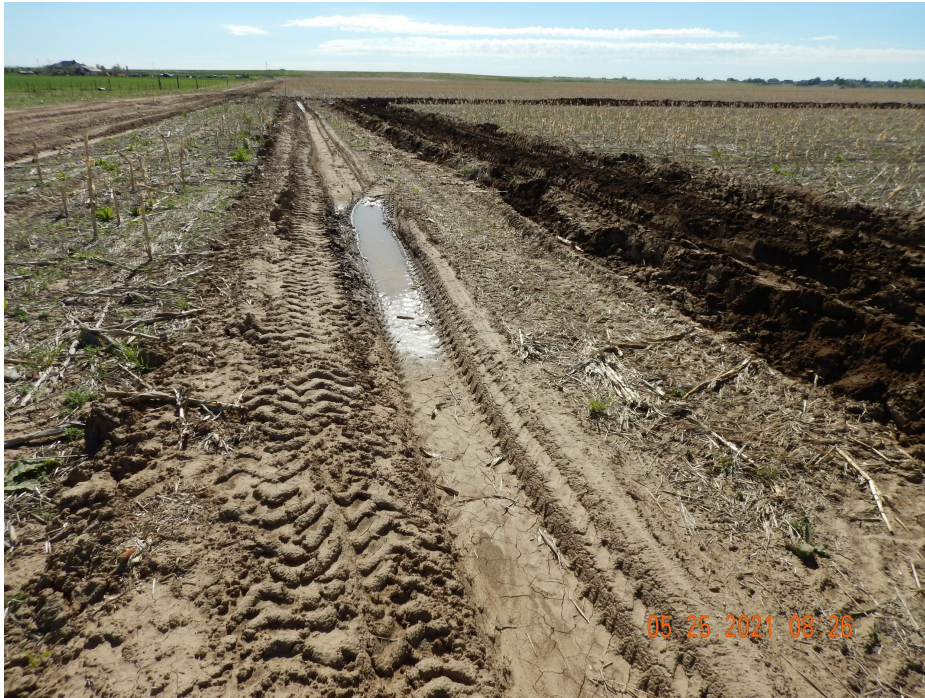
Photo 2. Photo taken from the northern location, facing East. Photo illustrates Operator has installed a ditch and berm BMP around the entire perimeter of the location during construction activities.

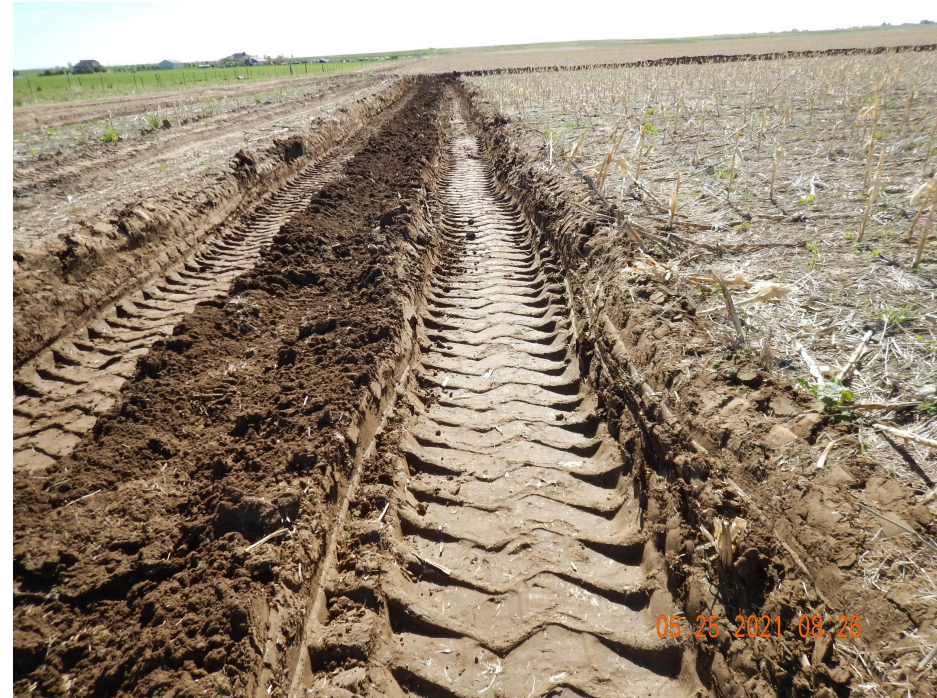
Photo 3. Photo taken from the northern location, facing East. Photo illustrates that topsoil appears to be stored along the northern and eastern perimeter of location.

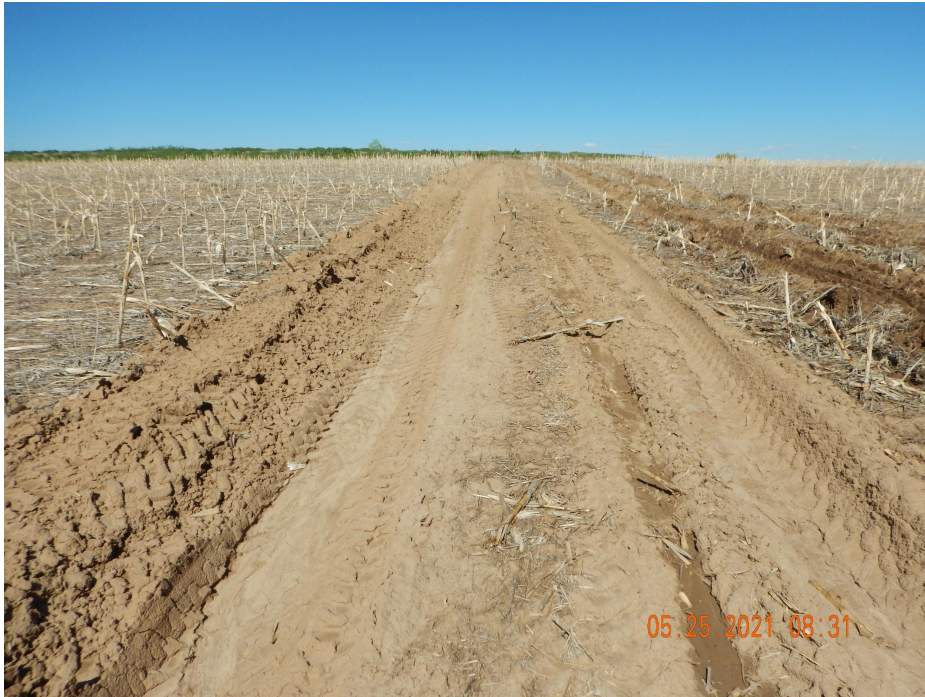
Photo 4. Photo taken from the southern location, facing West. See comments under Photo 2.

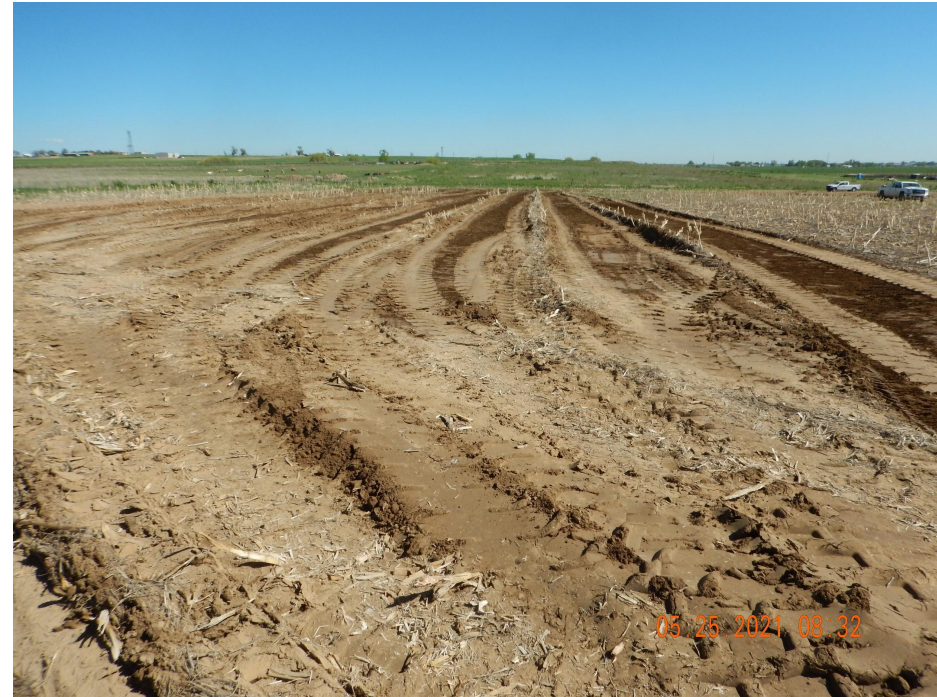
Photo 5. Photo taken from the western location, facing North. Photo illustrates topsoil salvage operations are underway at the time of this inspection along the production facility.
