Inspection Photos

API: 055-06316

Operator: OXY USA INC

Inspection Date: 5/26/2021

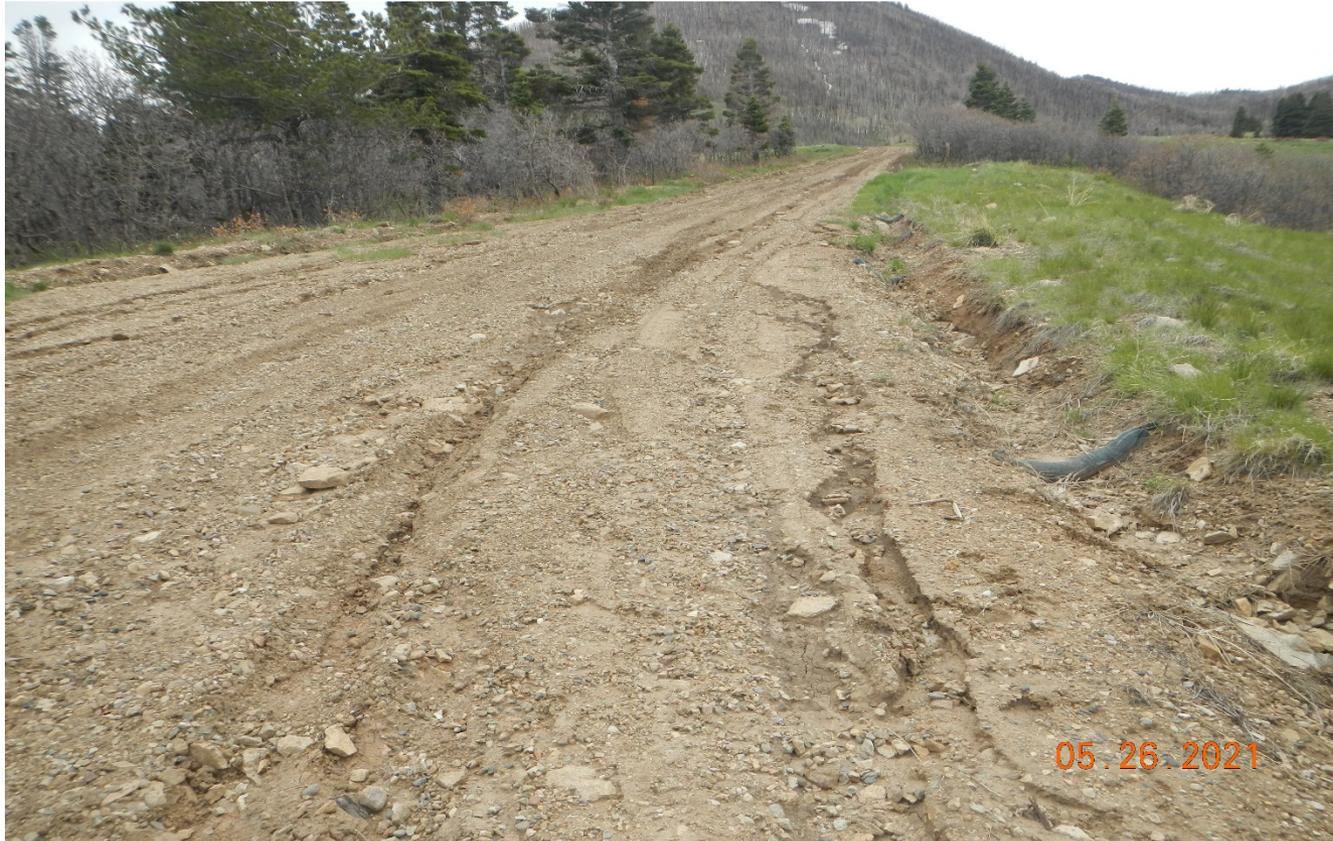
Photo 1. There is erosion occurring down the road ascending to the location. Areas of erosion will need to be repaired and BMP's need maintenance.

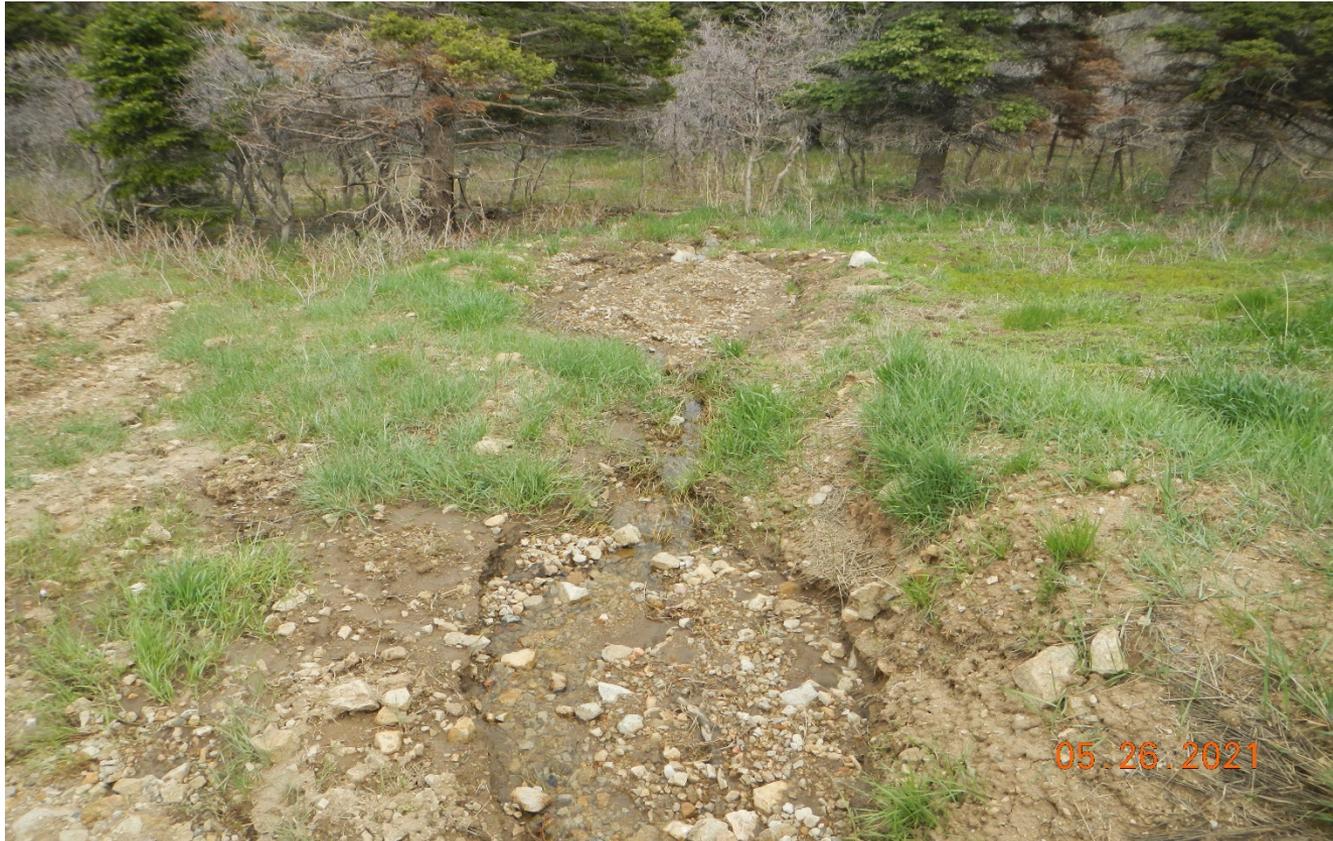
Photo 2. The sediment trap along the road has filled in with sediment.

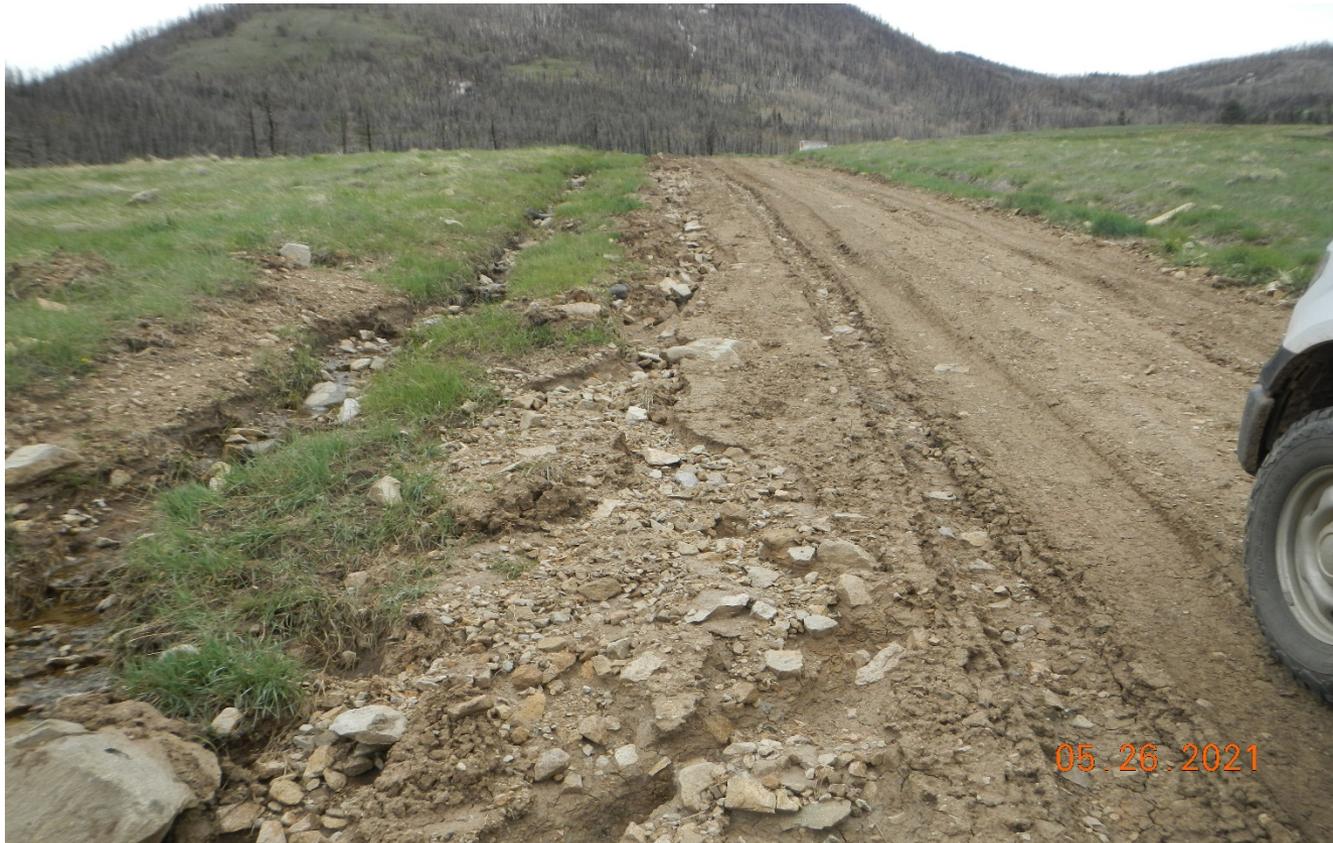
Photo 3. Stormwater is causing erosion along the road near the location.
