Inspection Photos  
Operator: Simcoe  
API: 067-07228  
Date: 5/28/2021

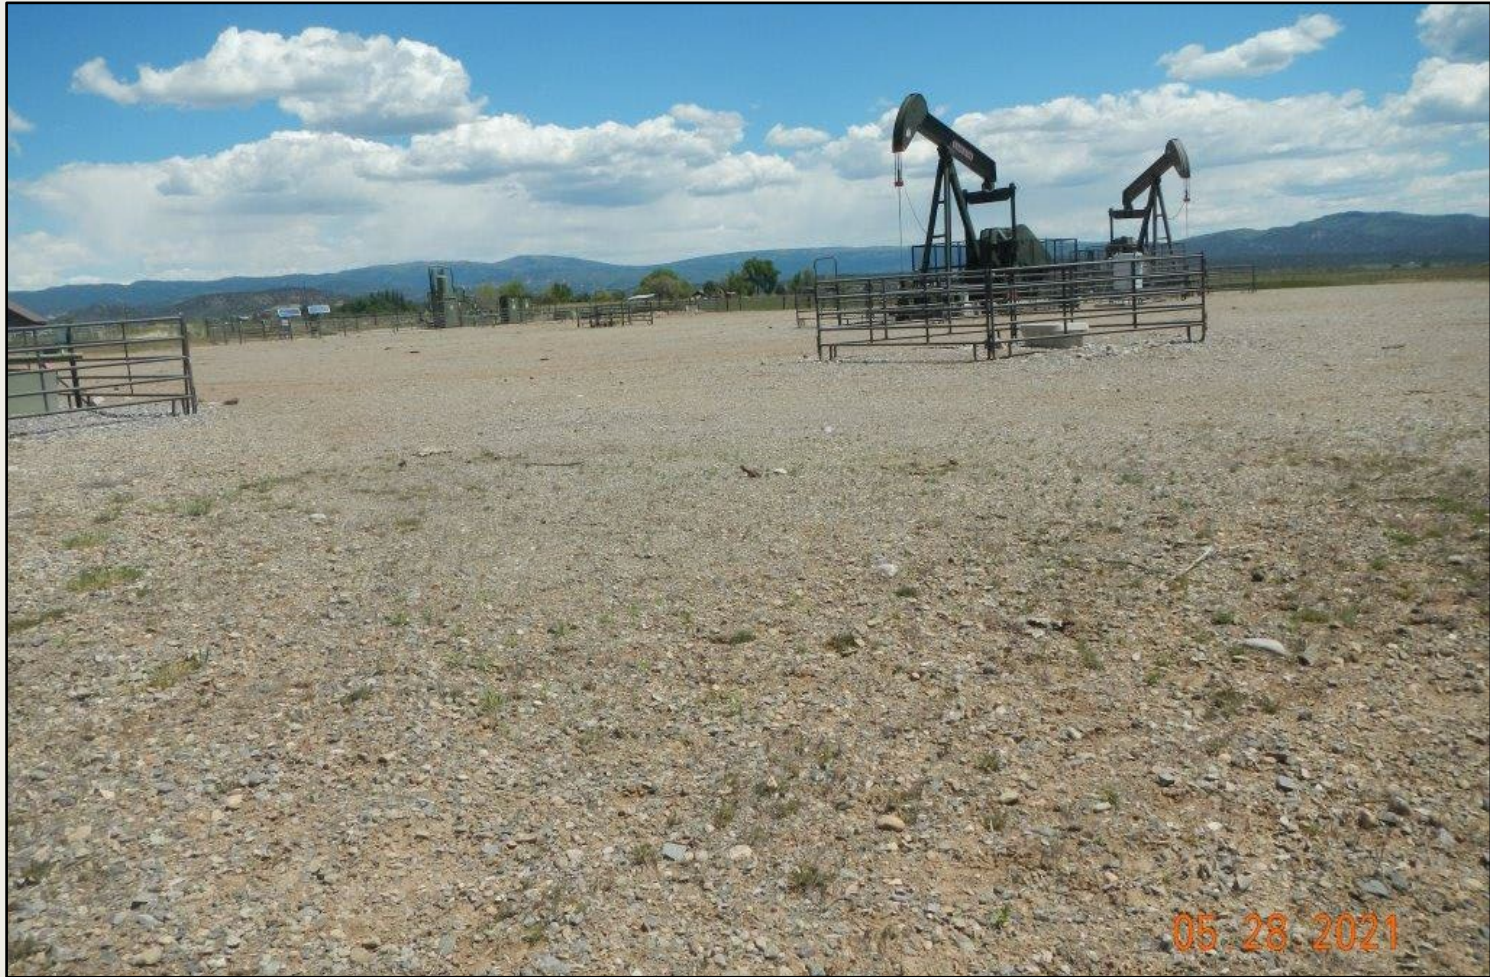
Photo 1. View of project area from the southwestern project area facing center.

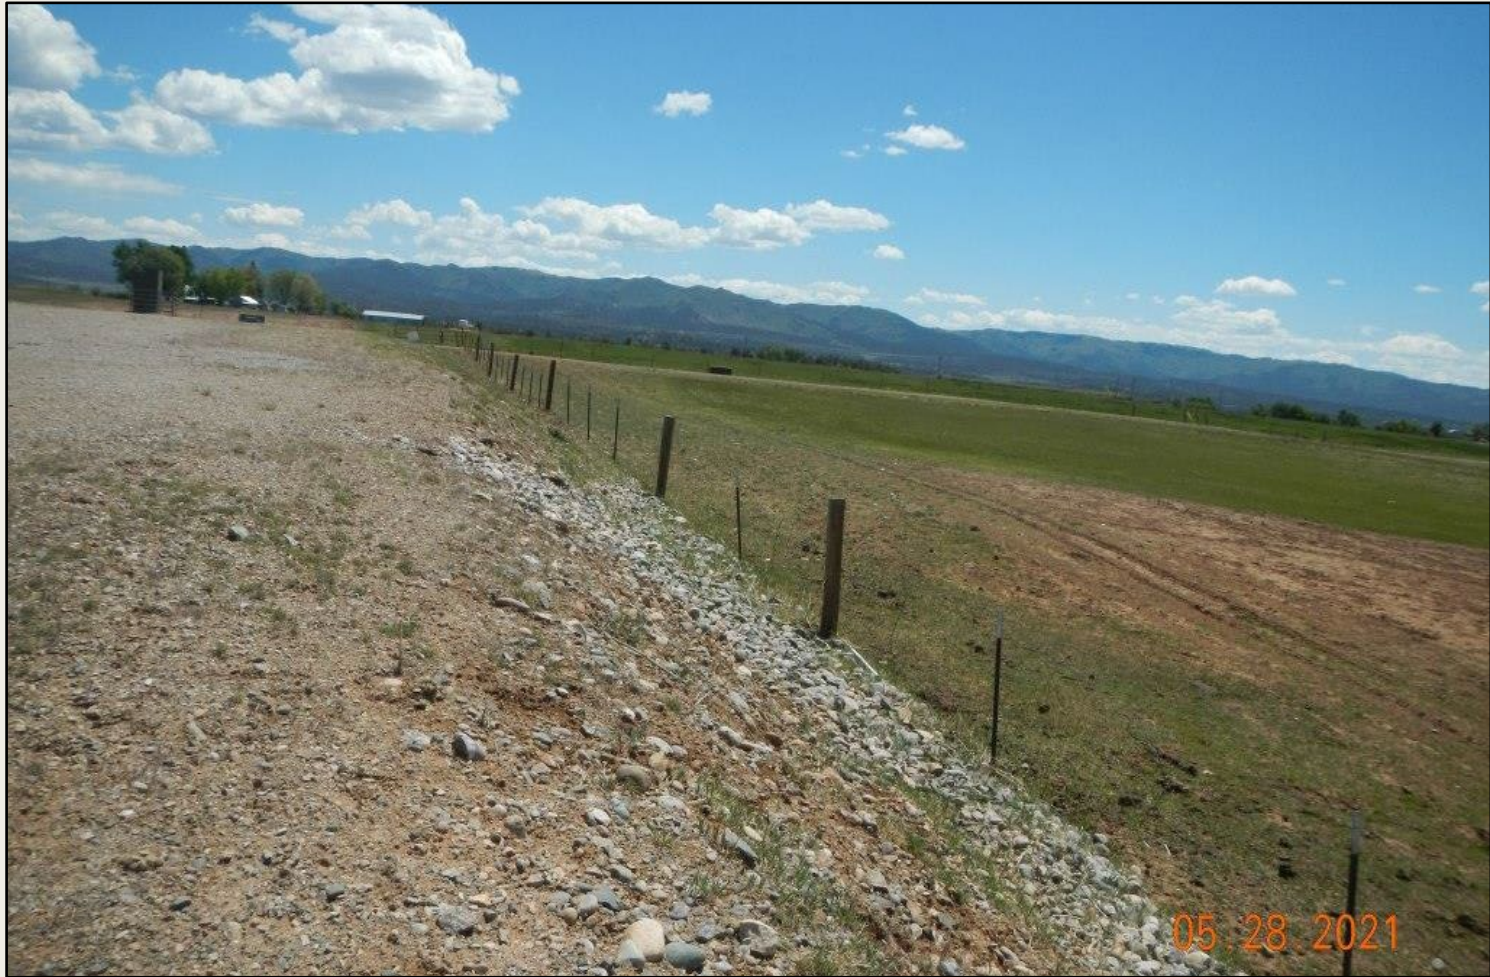
Photo 2. View of the southern project area from the southwestern corner facing eastward. Revegetation is progressing with crested wheatgrass, western wheatgrass, and smooth brome, largely in a grazed condition.

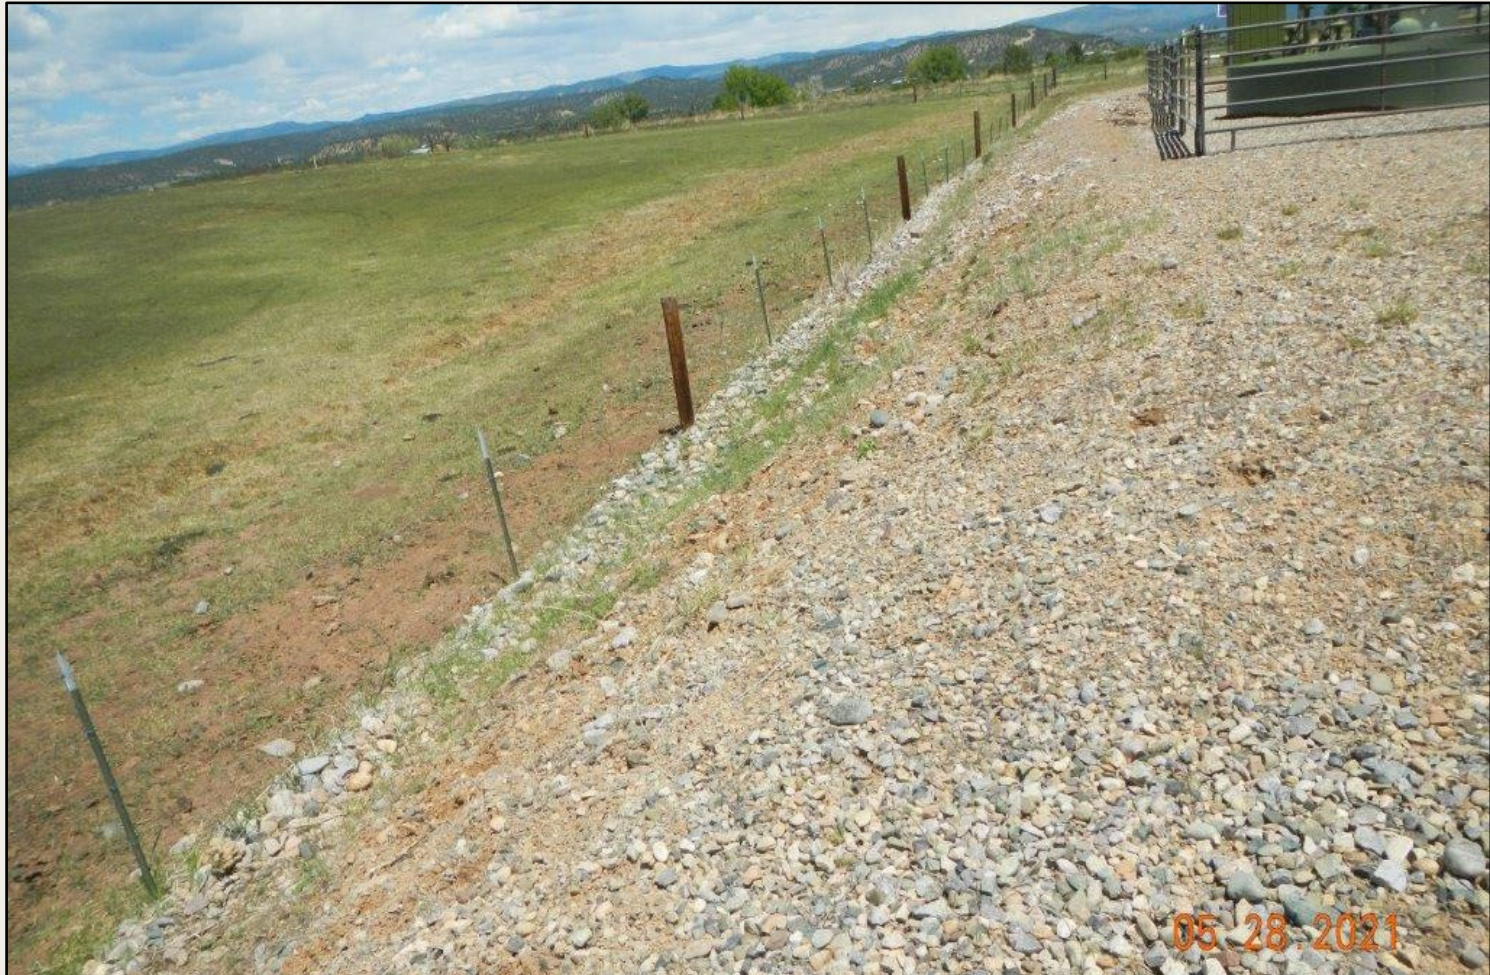
Photos 3. View of the western project area from the southwestern corner facing northward.

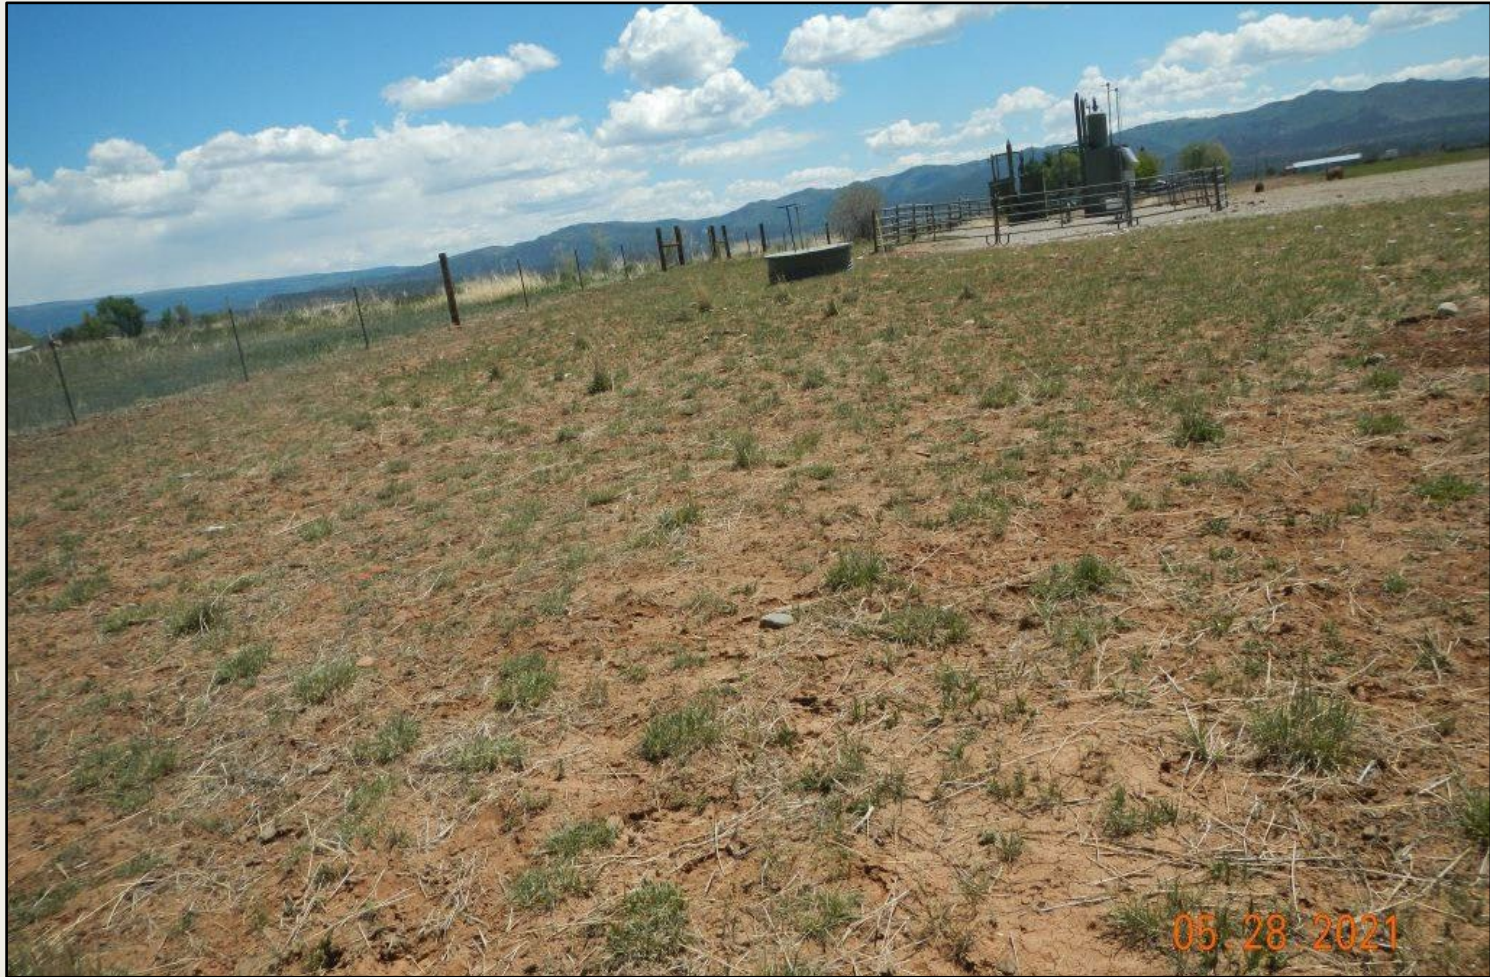
Photo 4. View of the northern project area from the northwestern corner facing eastward.

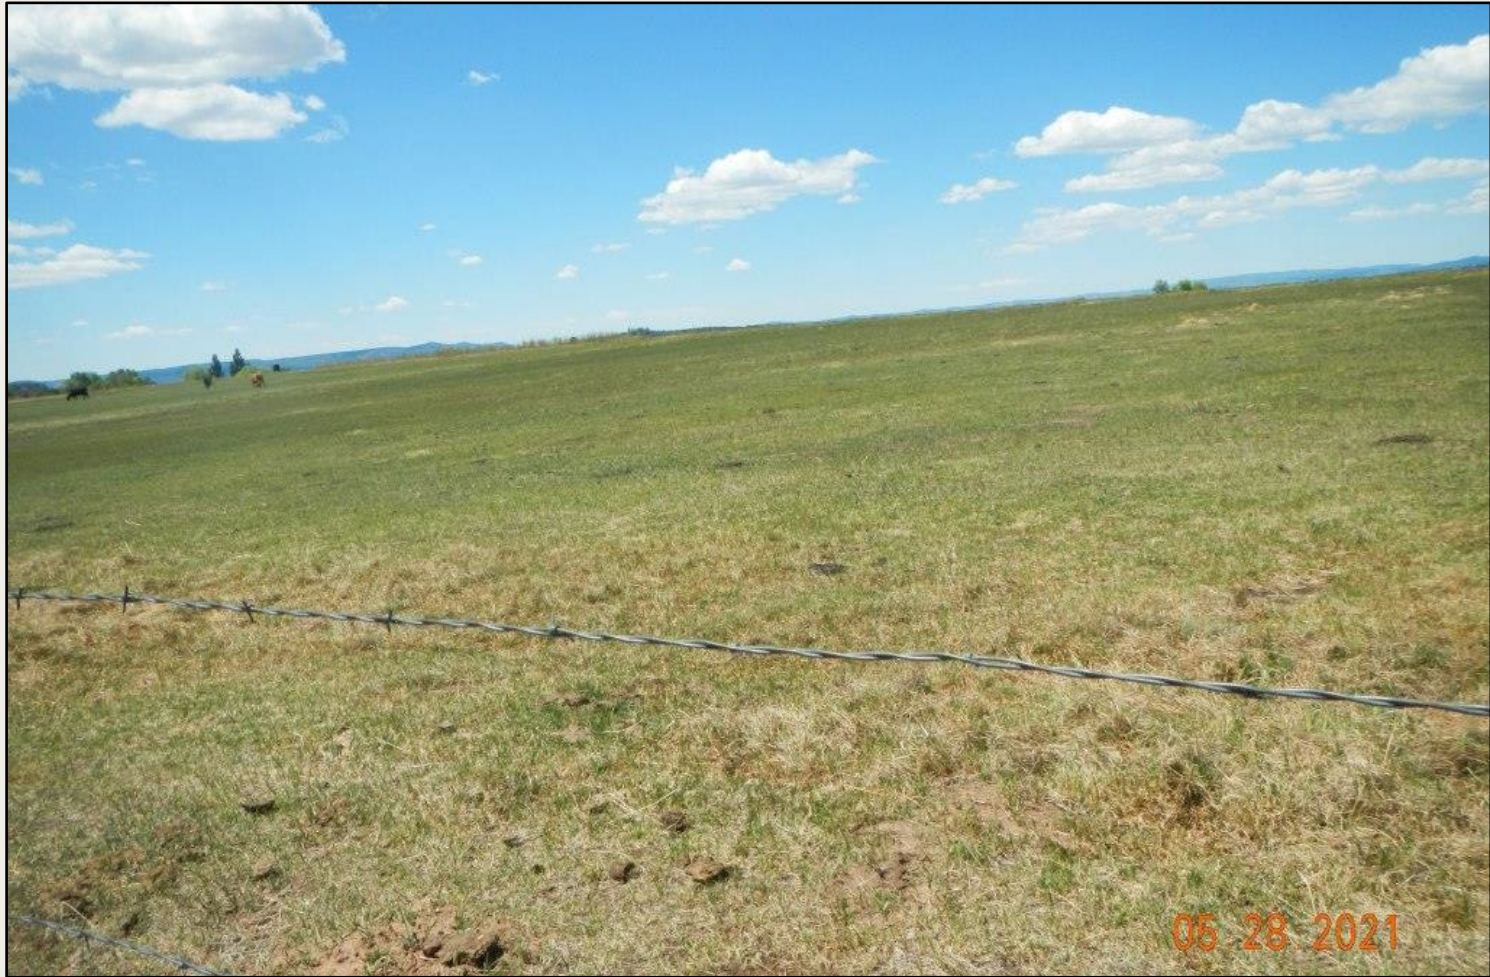
Photo 5. View of reference area vegetation comprised of irrigated grass field, largely in a grazed vegetative condition.

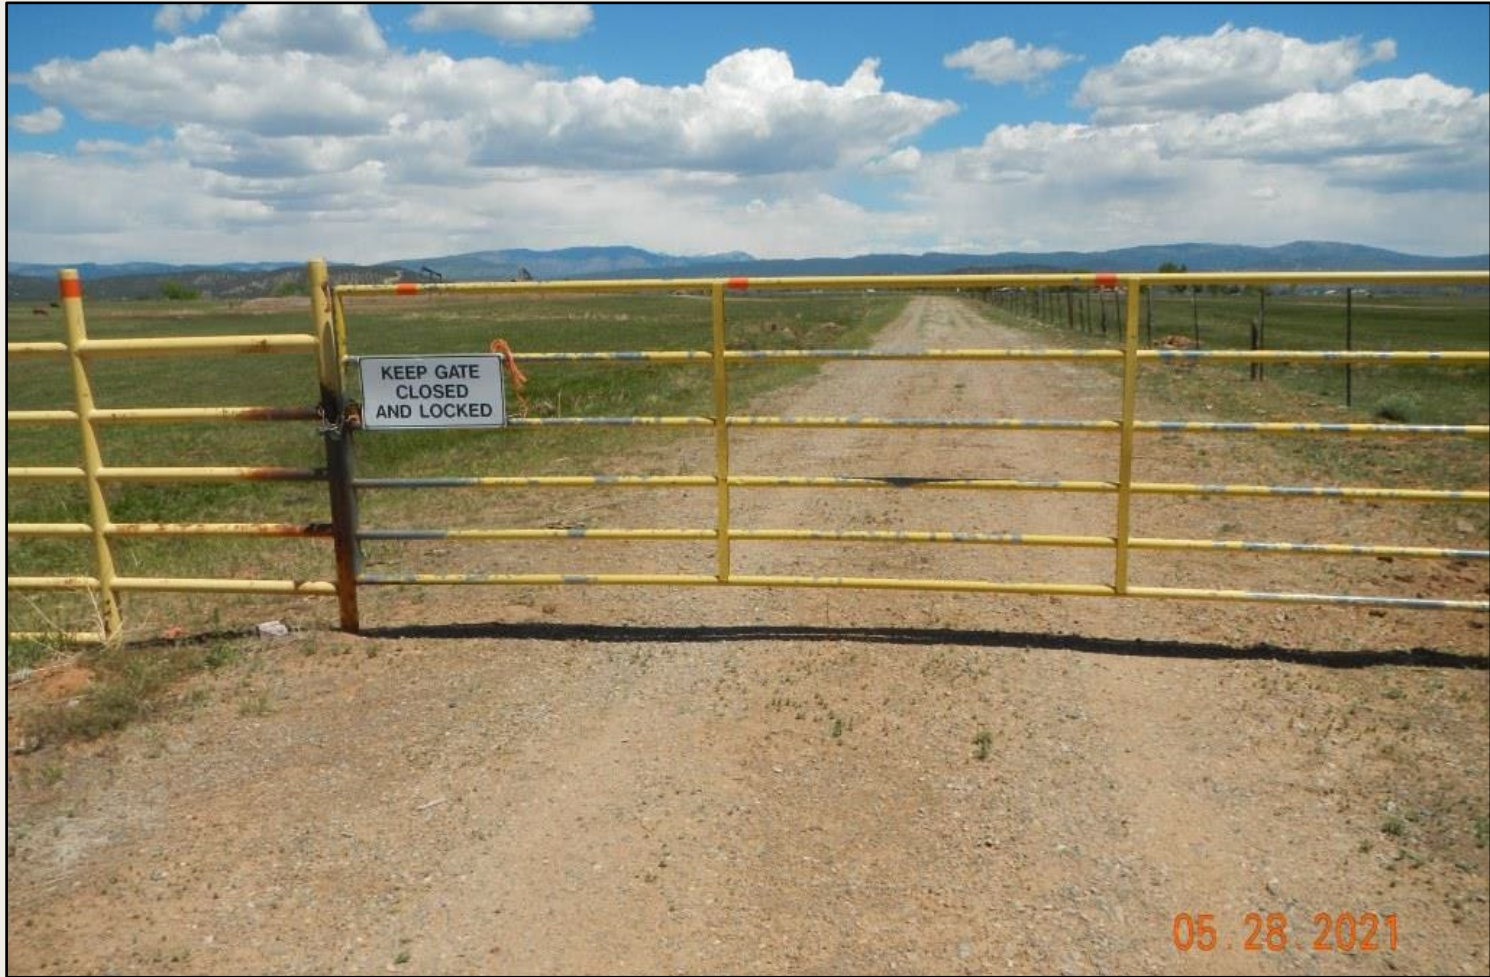
Photo 6. View of closed gate after leaving location.
