Inspection Photos
Operator: Simcoe
API: 067-06567
Date: 5/28/2021

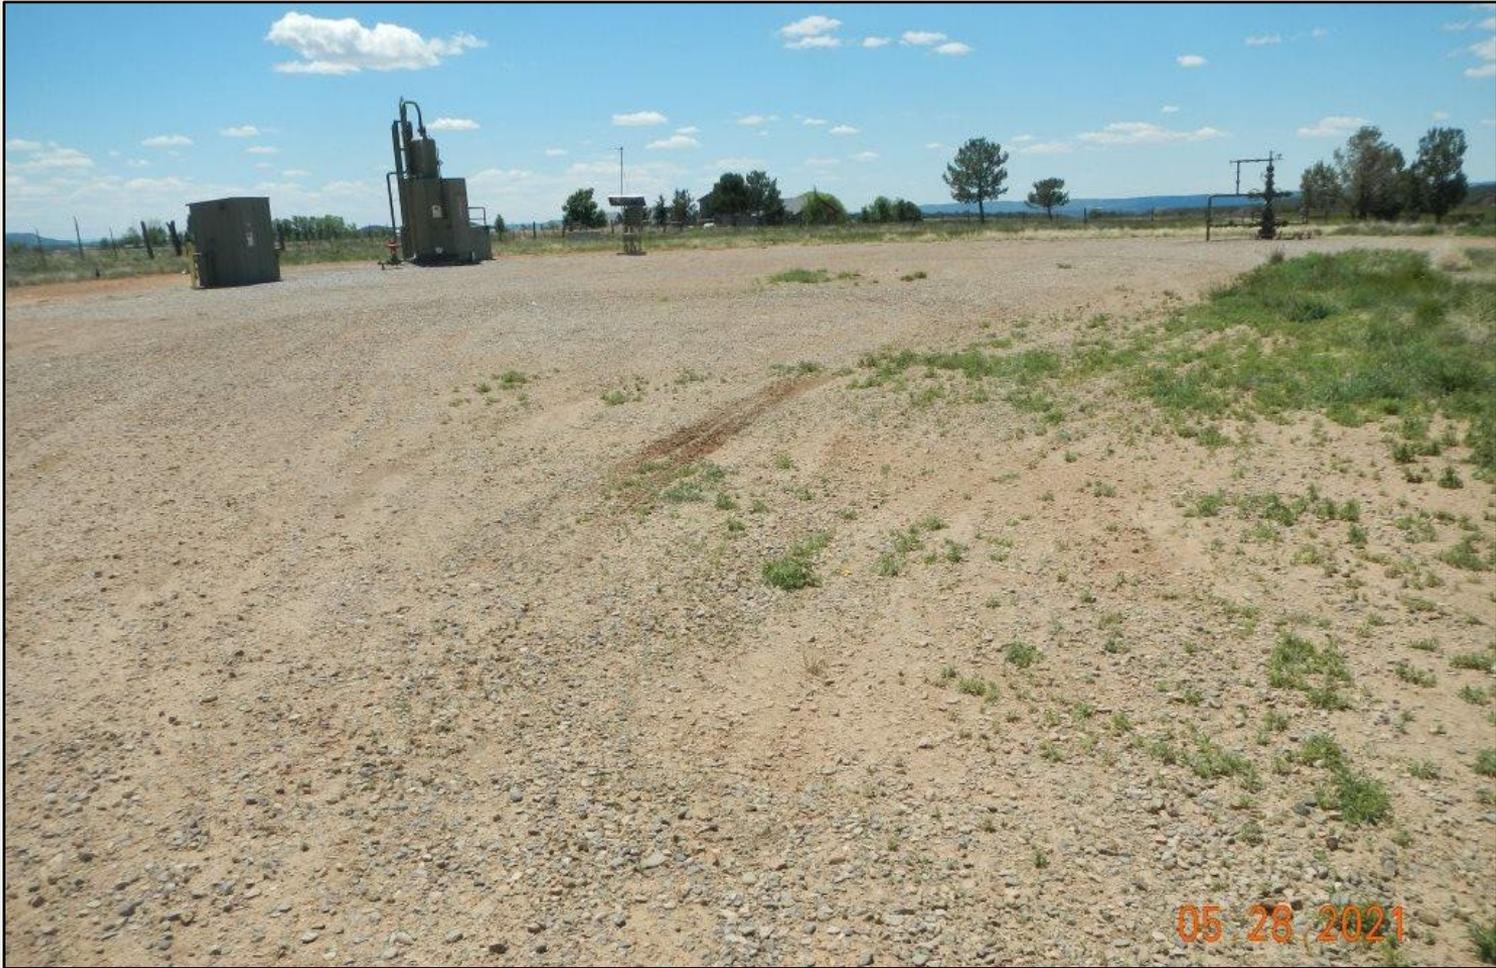
Photo 1. View of project area from the well pad entrance facing center.

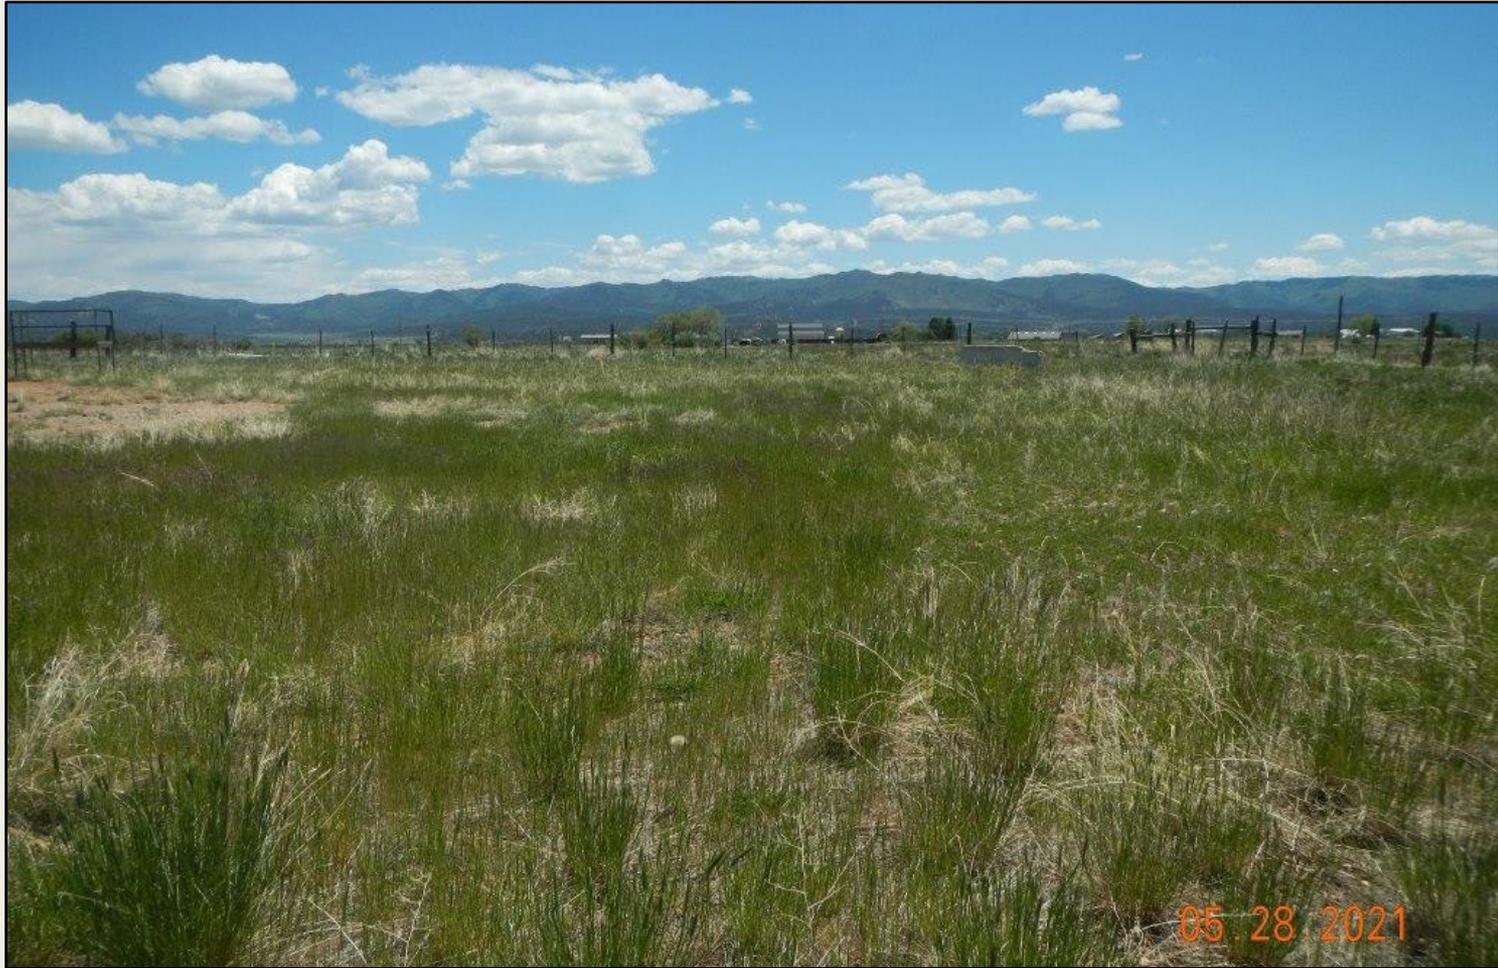
Photo 2. View of the southern project area from the southwestern corner facing eastward. Revegetation is progressing with intermediate wheatgrass, crested wheatgrass, and sand dropseed.

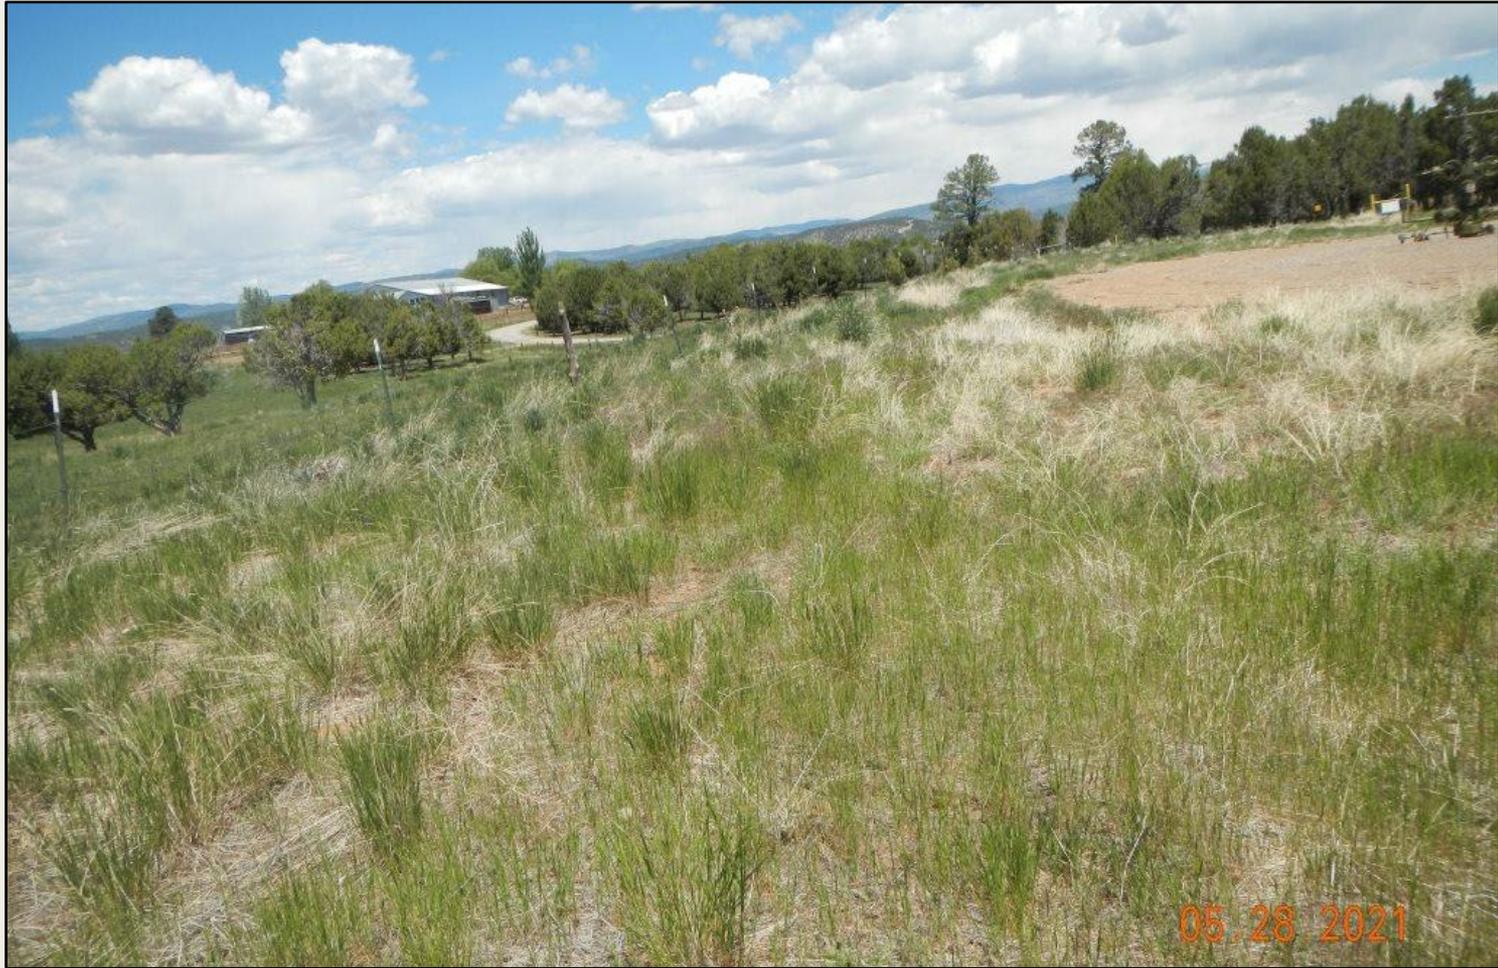
Photos 3. View of the western project area from the southwestern corner facing northward.

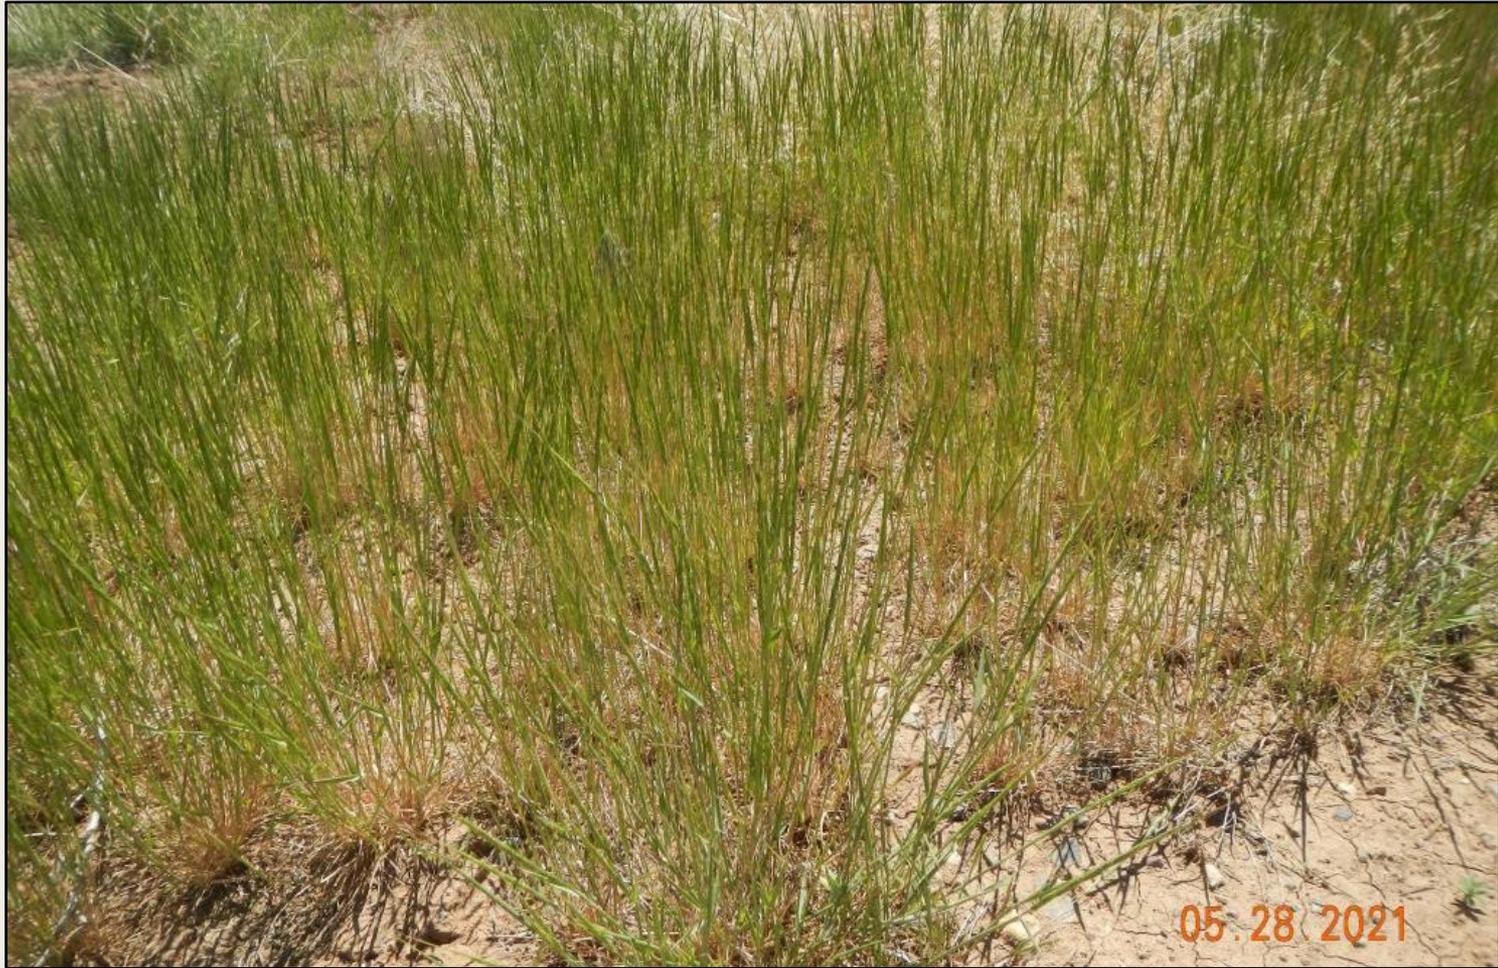
Photos 4. View of dense jointed goatgrass within the interim reclamation area.

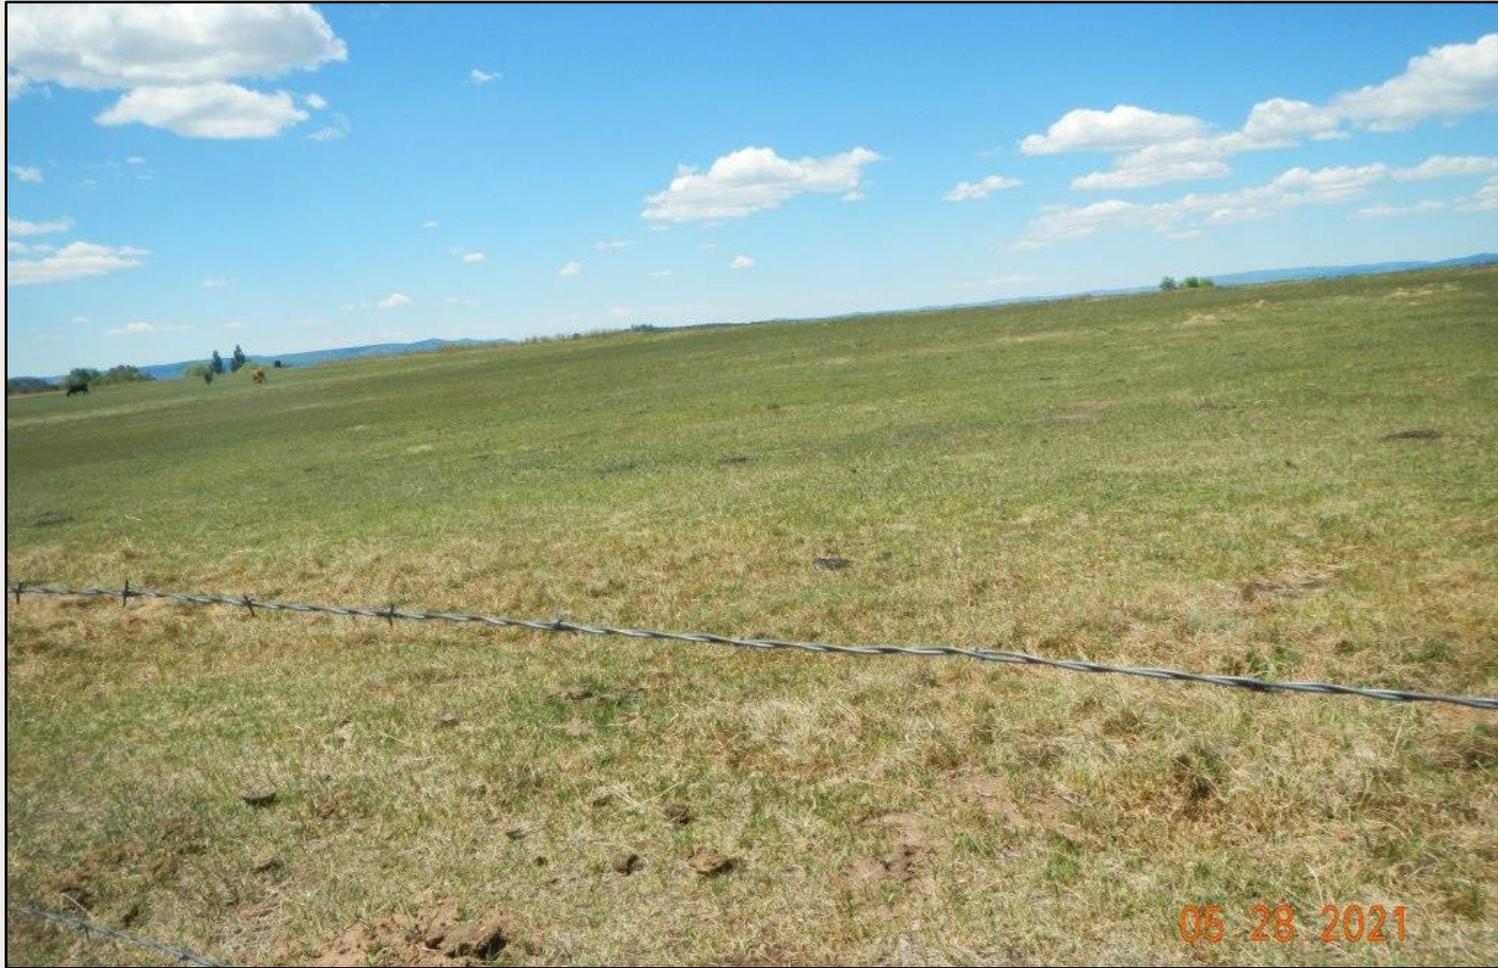
Photo 5. View of reference area vegetation comprised of irrigated grass field, largely in a grazed vegetative condition.
