Inspection Photos
Operator: Simcoe
API: 067-07856
Date: 5/28/2021

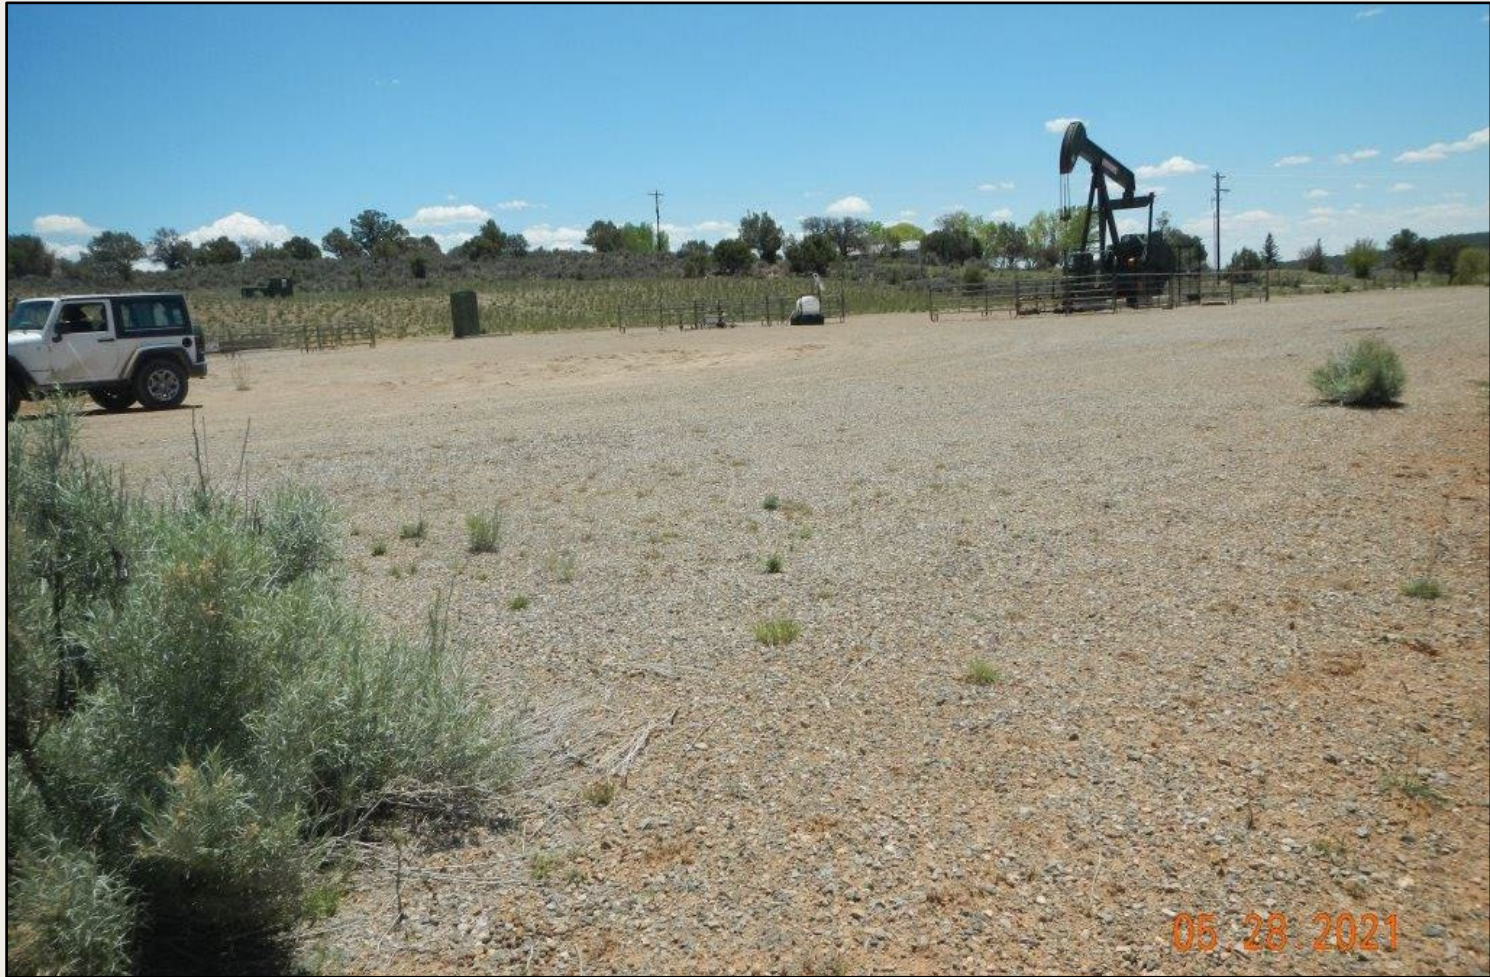
Photo 1. View of project area from the northwestern corner facing center.

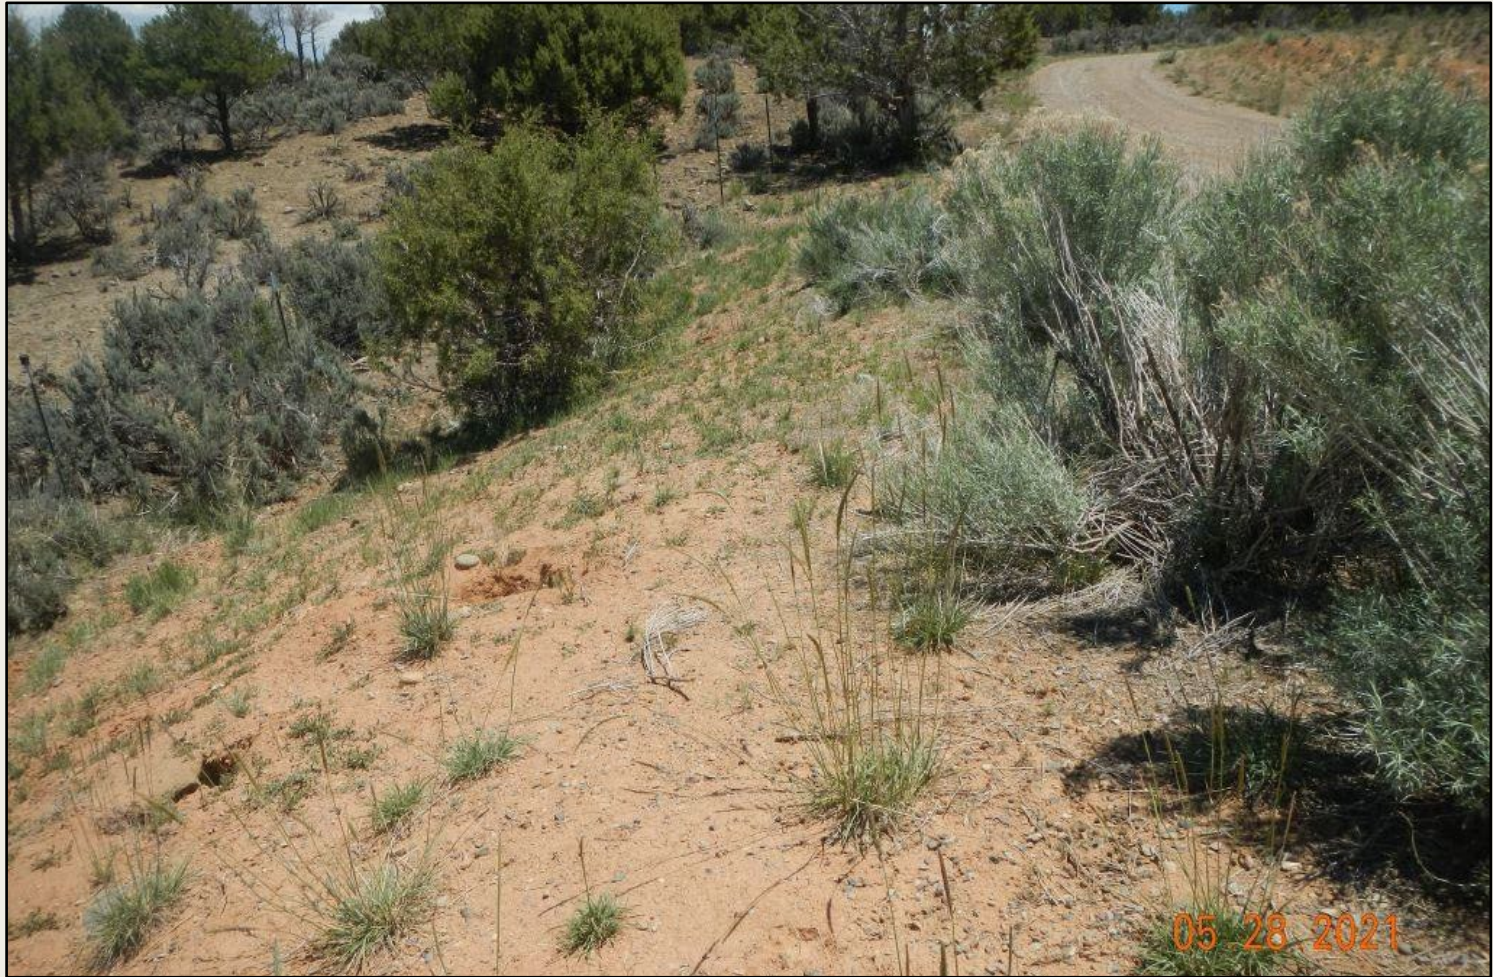
Photo 2. View of the northern project area from the northwestern corner facing eastward. Revegetation is progressing in portions with intermediate wheatgrass, crested wheatgrass, and sand dropseed.

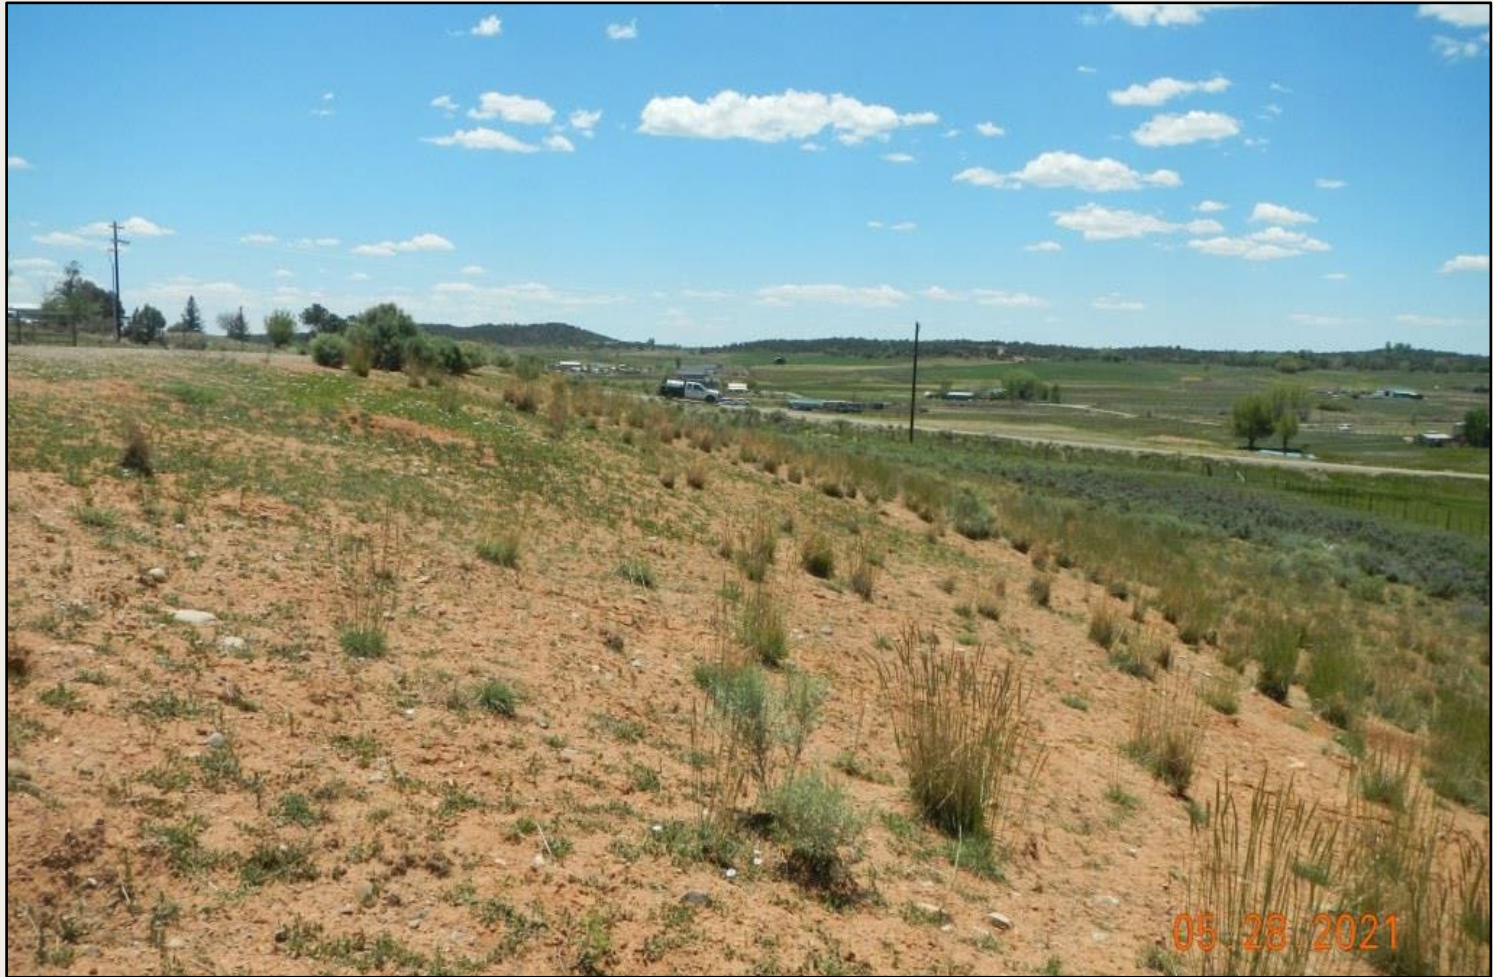
Photos 3. View of the western project area from the northwestern corner facing southward. Revgetation remains sparse and weedy in portions of the western fill slope.

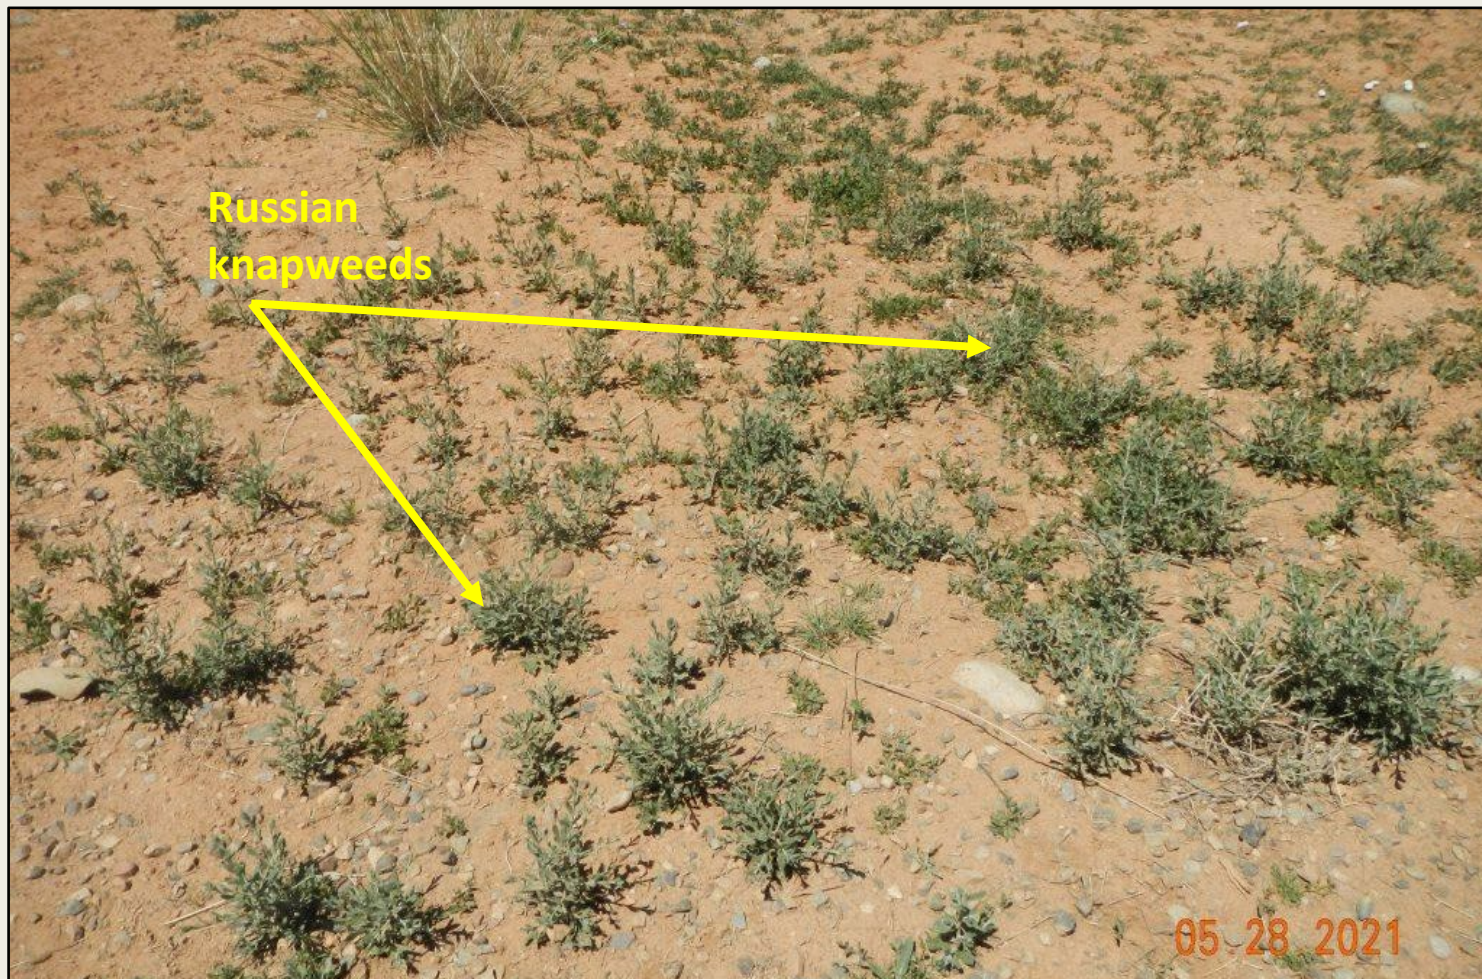
Photos 4. View of Russian knapweeds observed within the project area. Approximately 250 individuals observed.

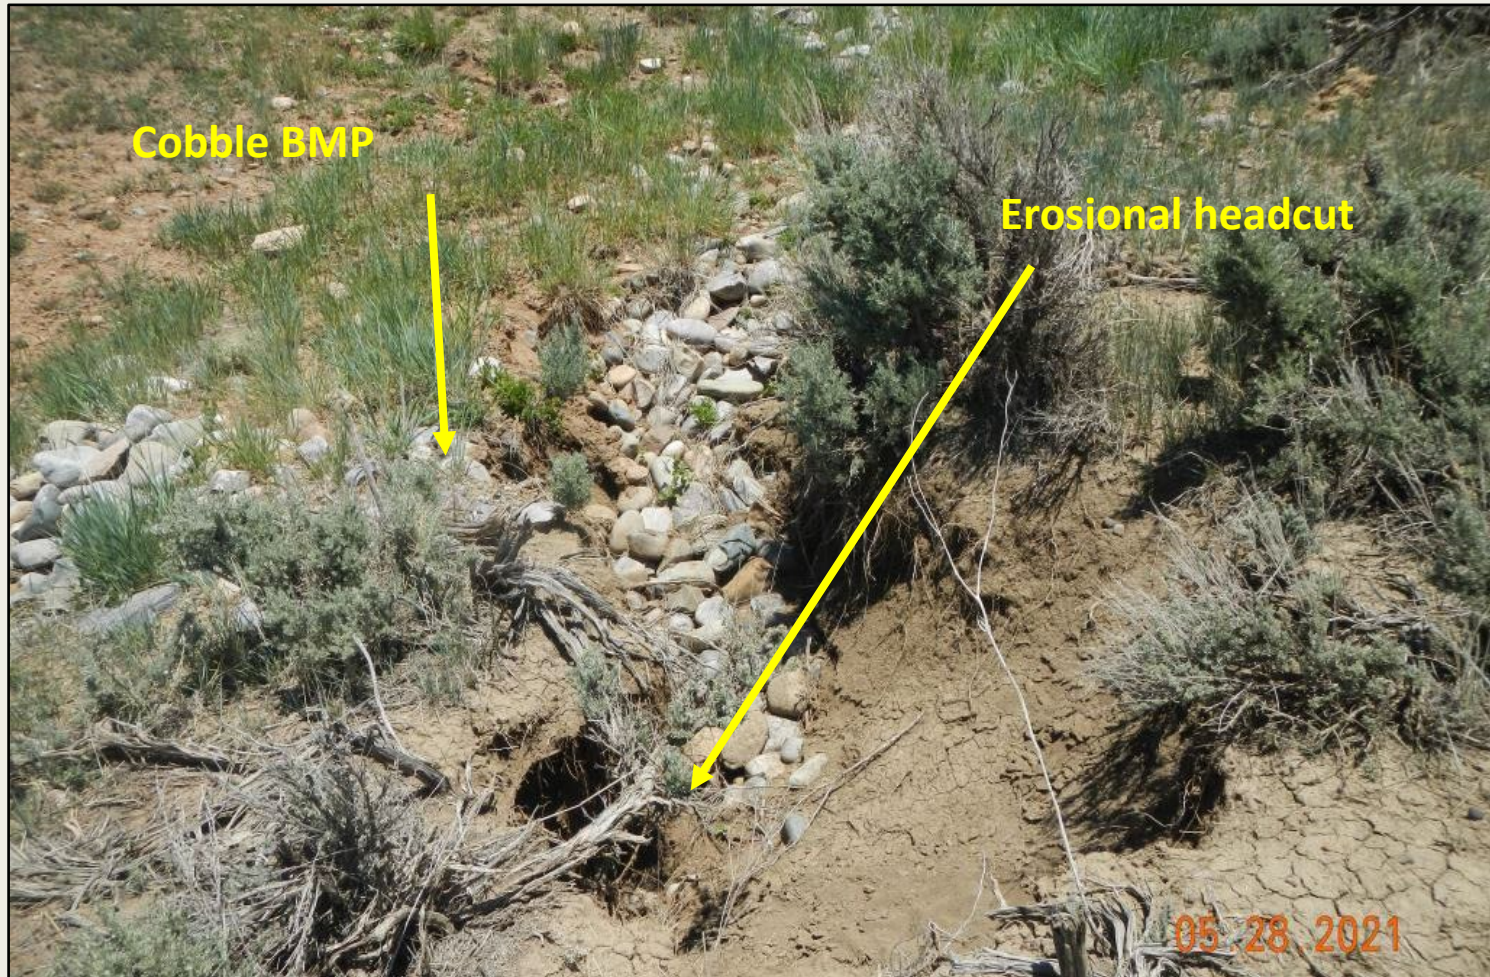
Photos 5. View of erosional headcutting within the northern project area (facing upslope). Stormwater flows are diverting around cobble BMP and forming a new channel and headcutting.

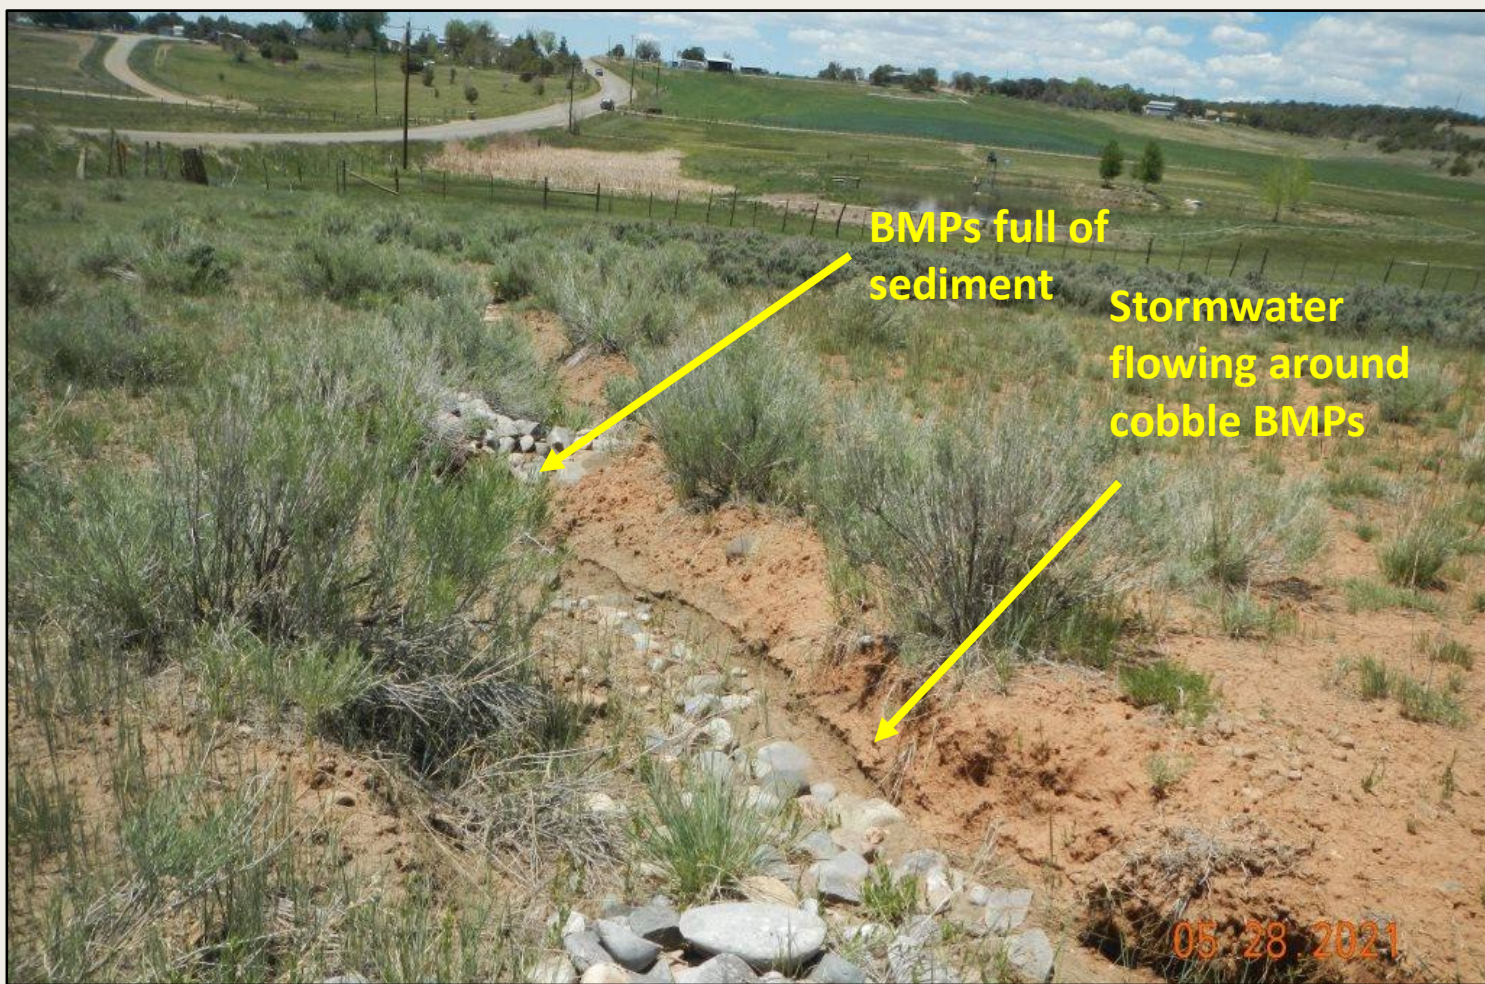
Photos 6. View of cobble BMPs placed in erosional channel that are full of sediment and stormwater is eroding around the BMPs.

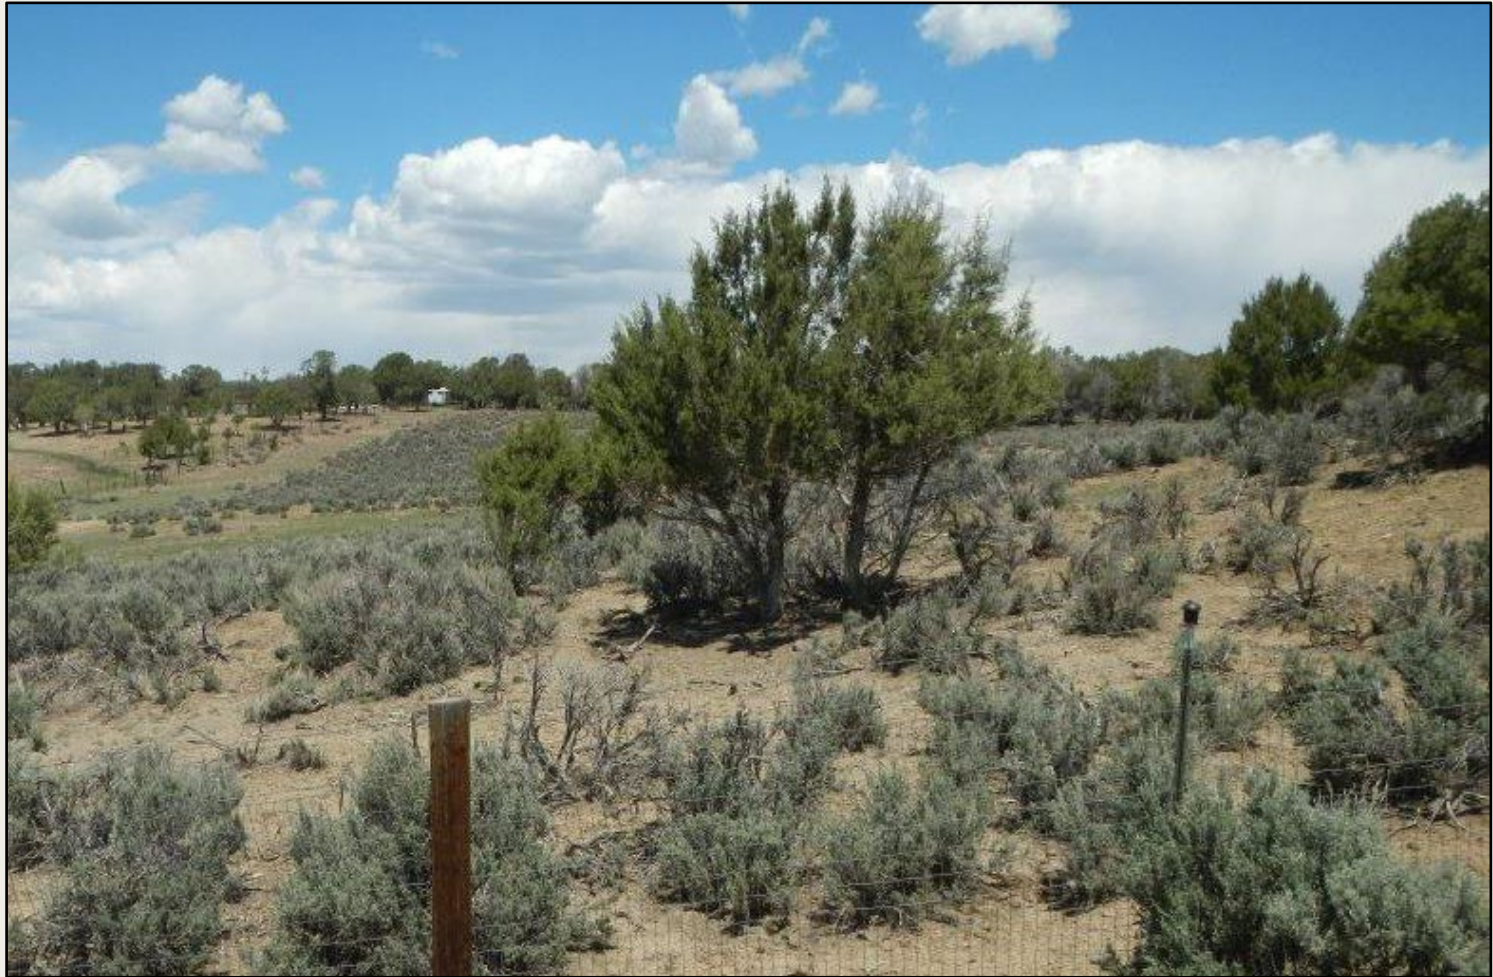
Photo 7. View of reference area vegetation comprised of sagebrush shrubland with scattered pinyon and juniper trees, as well as squirreltail, western wheatgrass, phlox, and penstemon in the understory.
