Inspection Photos
Operator: Simcoe
API: 067-07845
Date: 5/28/2021

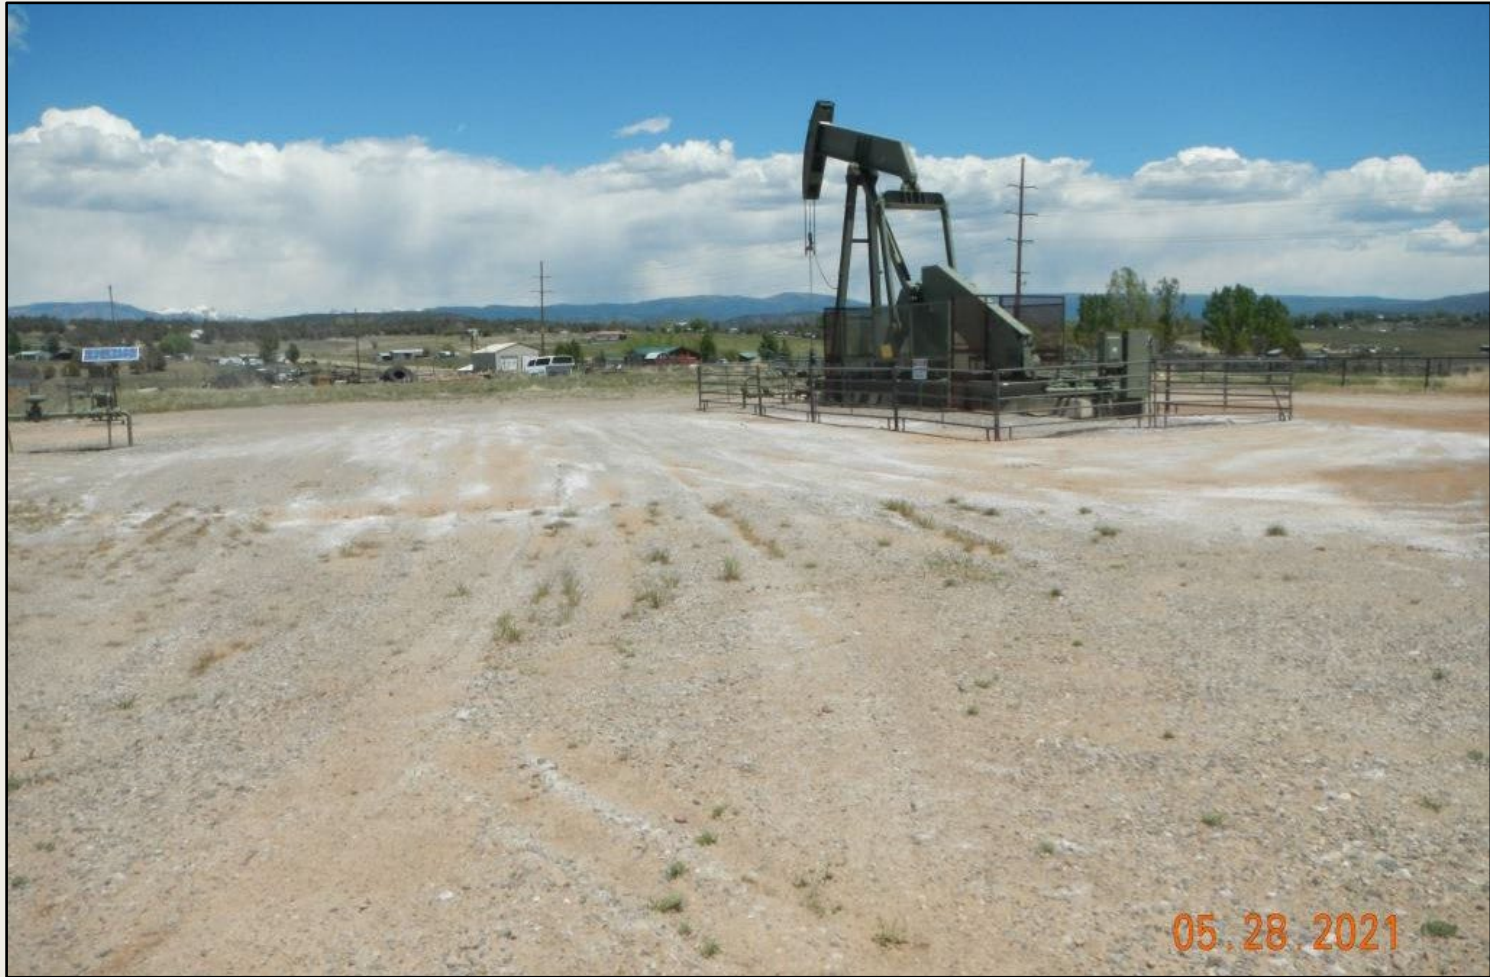
Photo 1. View of project area from the well pad entrance facing center.

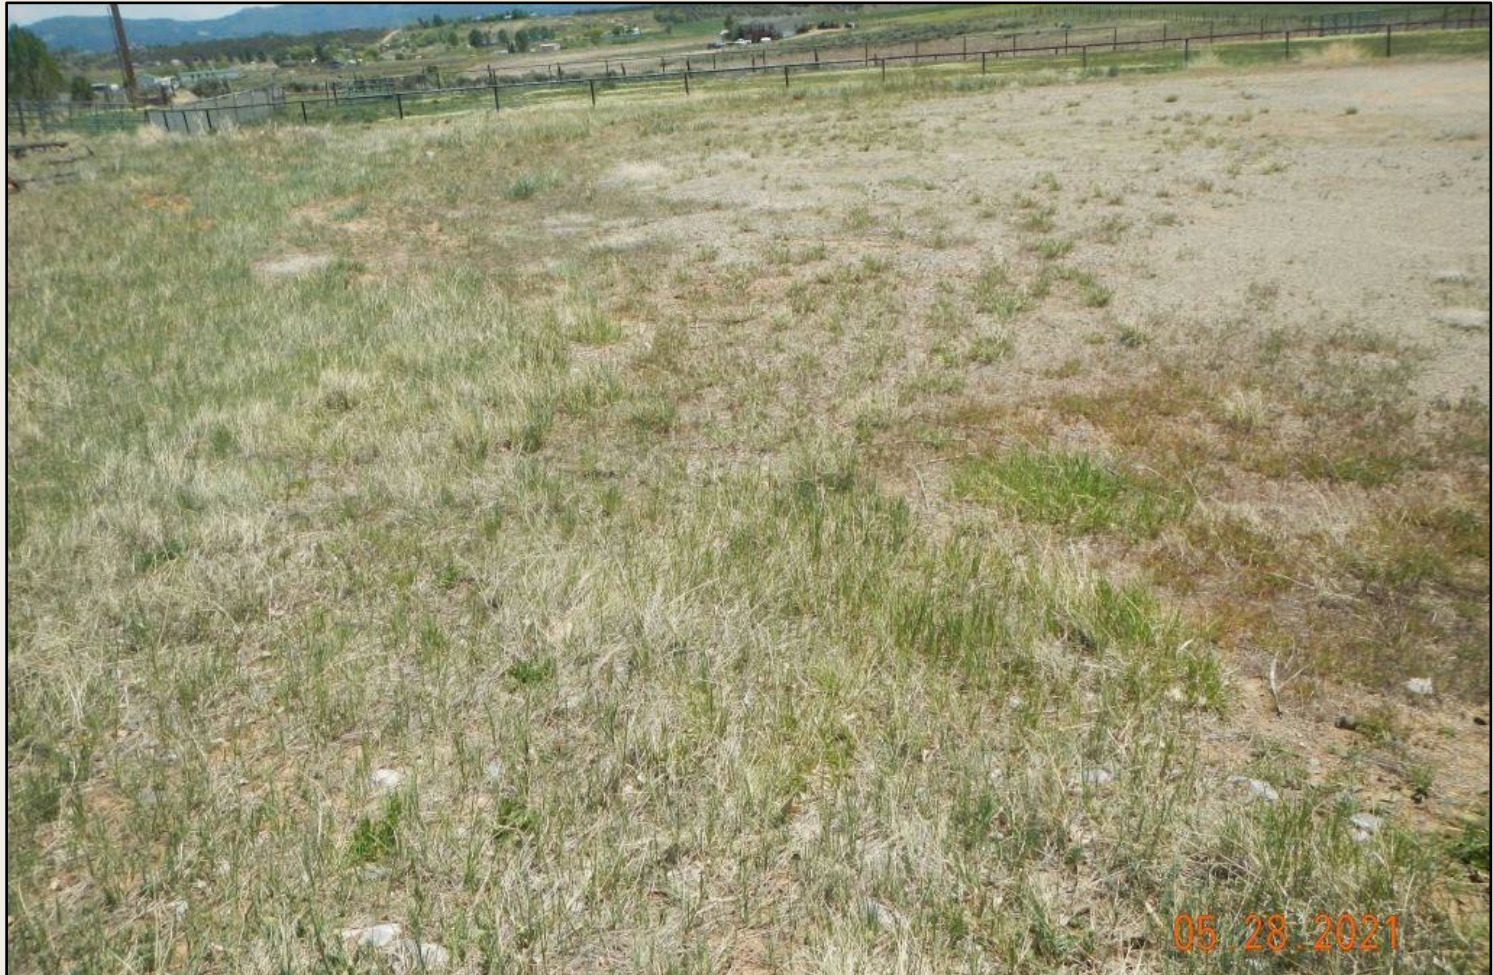
Photo 2. View of the northern project area from the northwestern corner facing eastward. Revegetation is progressing with western wheatgrass and sand dropseed.

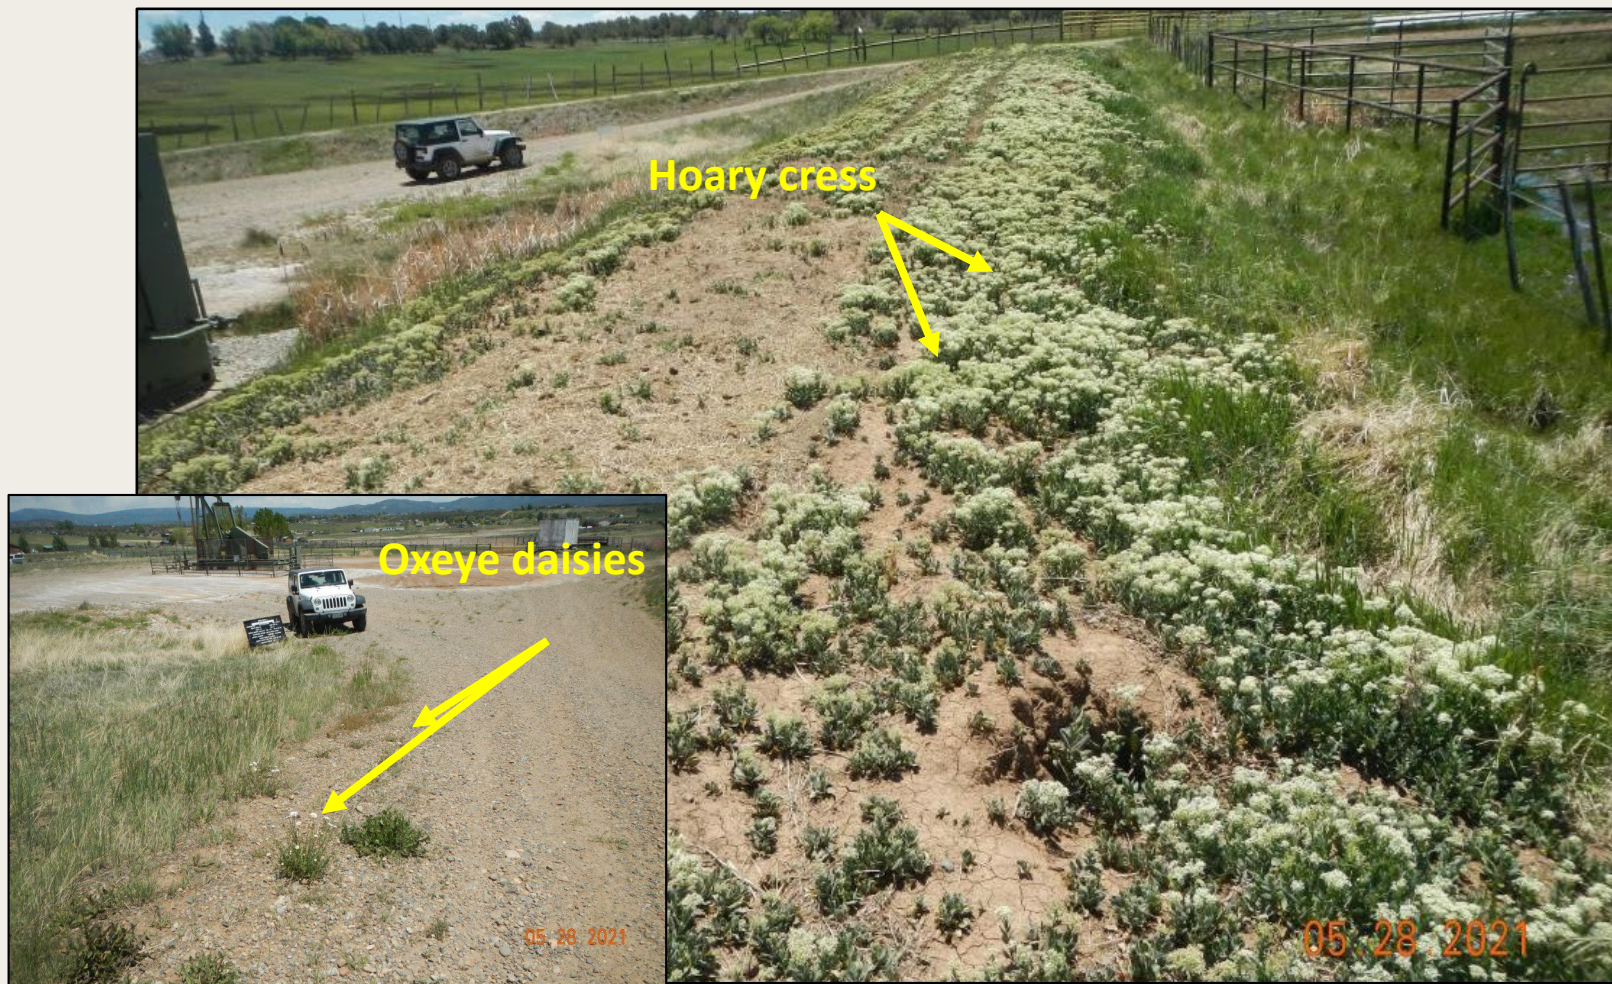
Photos 3. View of the western project area from the northwestern corner facing southward. Dense hoary cress infestation observed on the western berm. Approximately 2000 individuals observed. Approximately 10 oxeye daisies observed at the well pad entrance (see inset).

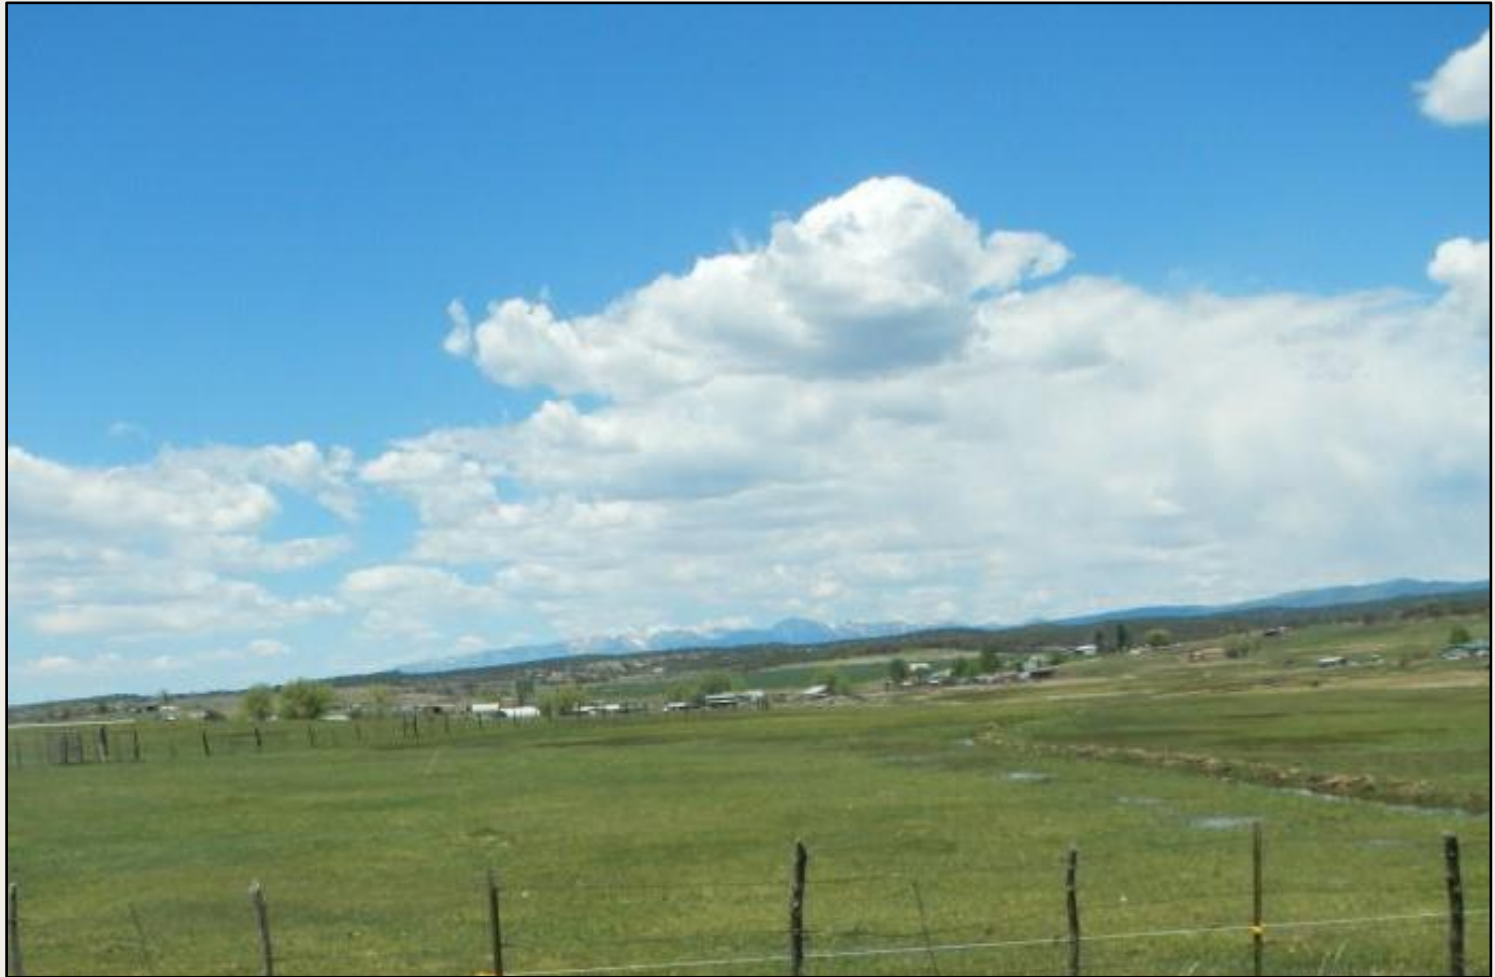
Photos 4. View of reference area, comprised of irrigated grass field.
